LEO EFFECTS ON CANDIDATE SOLAR CELL COVER MATERIALS

Paul M. Stella
Jet Propulsion Laboratory
California Institute of Technology
Pasadena, CA 91109

SUMMARY

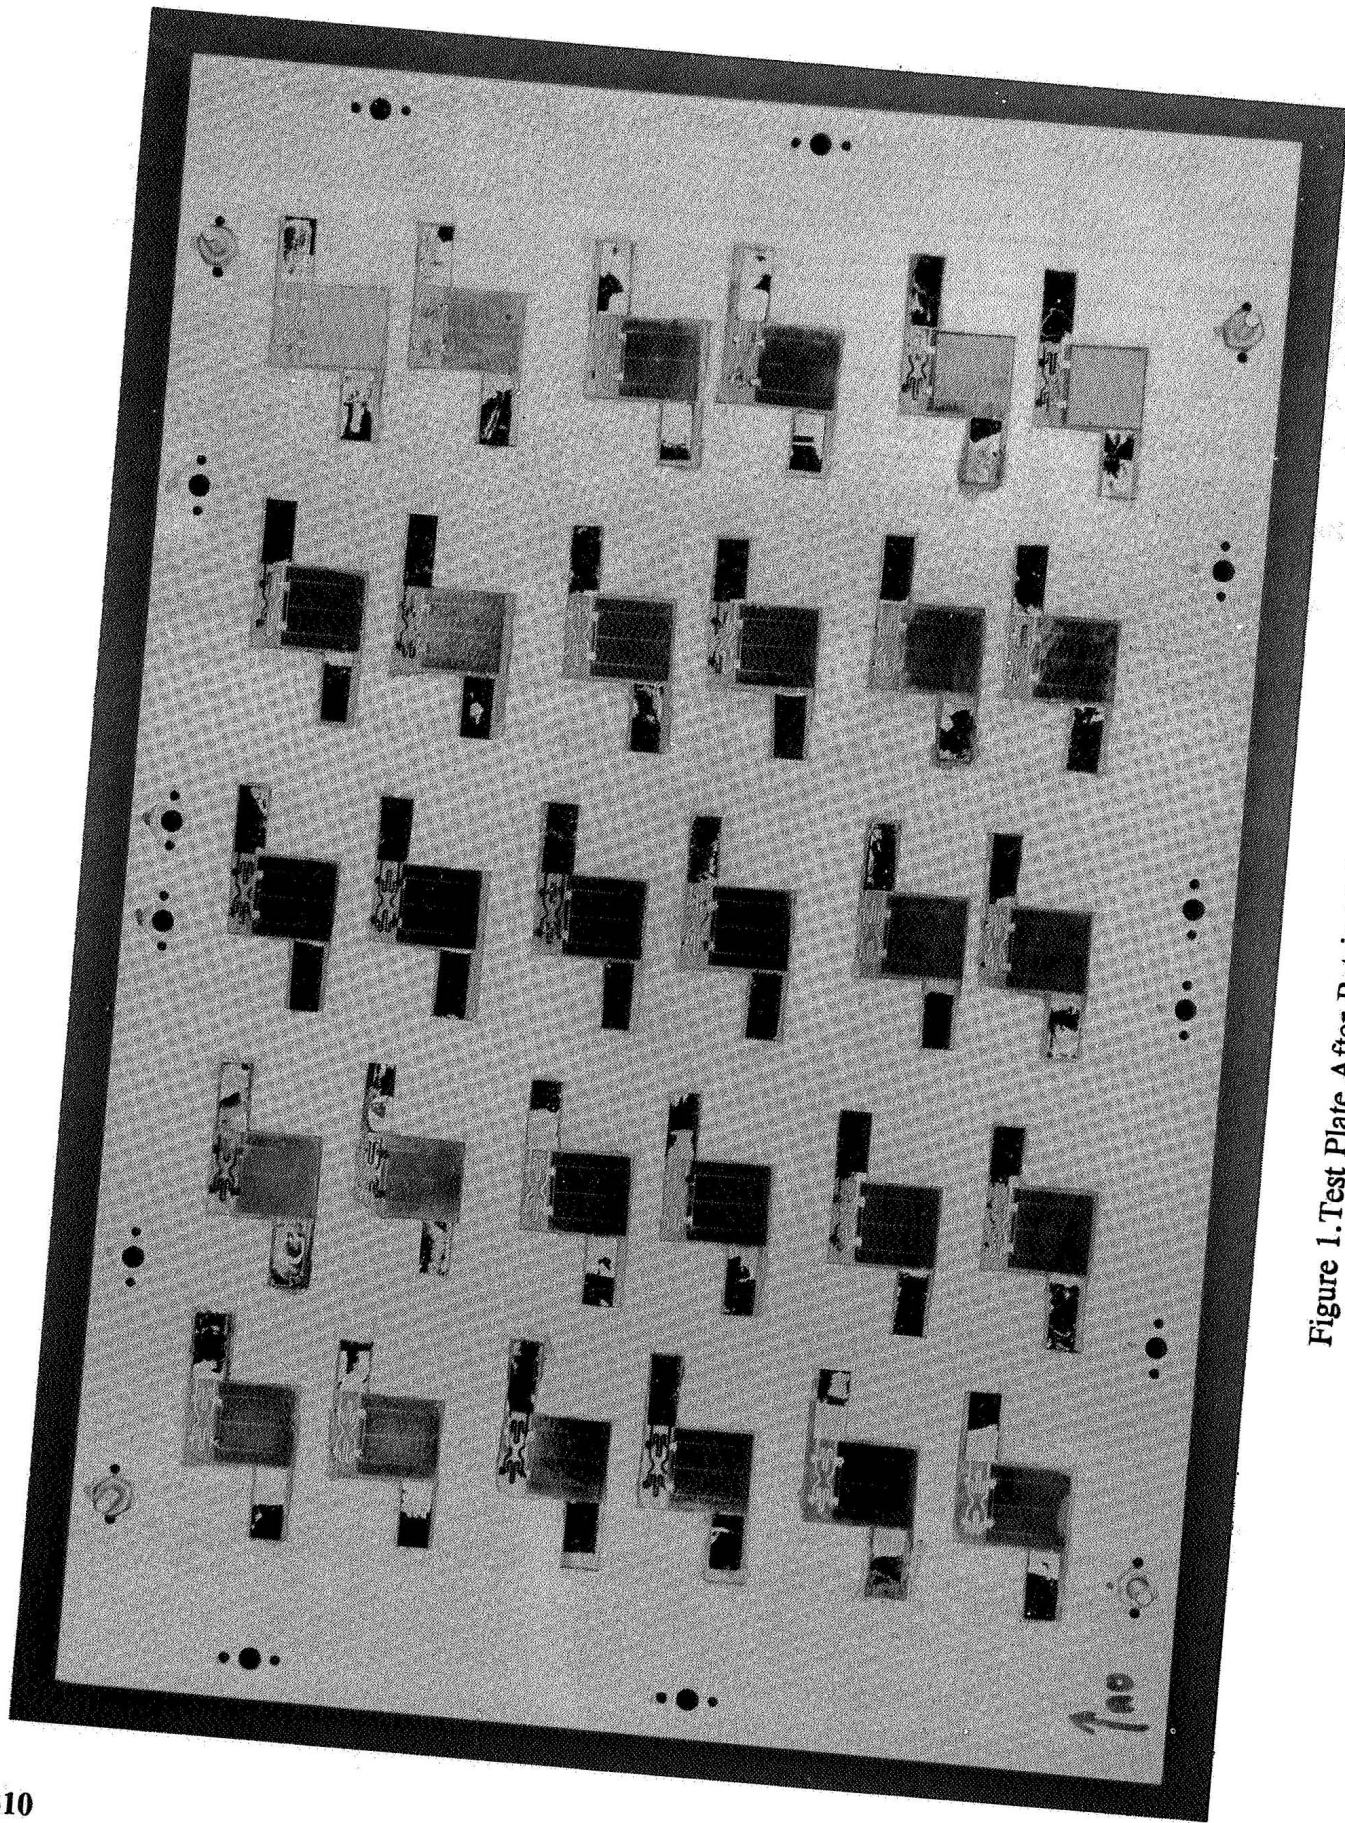
Observation of the recovered test plate revealed a number of changes (Figure 1). All exposed (uncovered by adhesive or encapsulant) tab surfaces darkened from the original shiny silver

appearance as the result of atomic oxygen interactions. In many cases, the darkened silver tab surfaces showed signs of stress by the formation of platelets. The dark surface material was readily removed by gentle mechanical abrasion revealing a shiny, albeit rough, surface underneath. In some areas, it appeared that the original surface had flaked off during the mission. The resultant surface region was slightly lower than the surrounding regions and the color was less dark -- more gray than blue/black -- suggesting less exposure time to the pertinent environment. Although initially it appeared that the damage to the silver plating did not extend to the Invar, recent efforts to rub off additional blackened regions showed that this was not completely correct. There were a few small areas on the tabs where removal of the darkened surface revealed the Invar surface, suggesting that a minimum thickness of unreacted silver remains on the exposed interconnector. The initial silver thickness was not noted (the problem of atomic oxygen not anticipated at the time of experiment assembly), but typically ranged from four to six microns.

The initial view of the test plate quickly revealed many changes had occurred. Although no major damage was noted, the test plate and samples looked contaminated, with brownish-orange stains particularly apparent around the test samples. This was apparently the residue of silicone adhesives and/or encapsulants that had reacted with the LDEF space environment. The samples with Teflon covers appeared "charred" with the Teflon surface appearing brownish-gray. The cell gridlines were visible as yellow brown lines. Various samples with encapsulants were distinct in the lack of the normal dark blue cell appearance. Instead, colors varied from medium to very light blue (almost green), with clear indication of encapsulant crazing, peeling and flaking. Some cells with silicone encapsulants had exposed areas free of coating where the cell surface was clearly visible (with AR coating intact), although exposed silver grid lines were now blackened. Beyond these rather large scale changes, some of the larger impact craters were evident, such as an impact with a cell covered by Teflon (Figure 2). On a smaller scale, some light-colored, hazy areas evident along the sides of the test samples were most likely attributable to outgassing of cell to Kapton or Kapton to substrate silicone adhesives.

Figure 1. Test Plate After Retrieval (note darkened tabs)

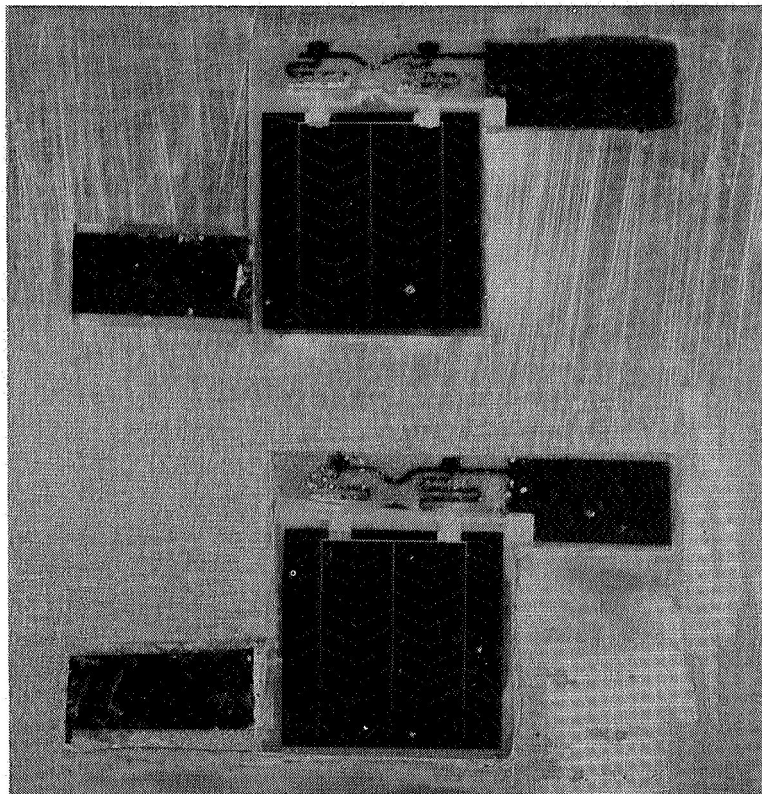
Figure 2. Impact with Teflon Cover (Lower Part of Upper Cell)

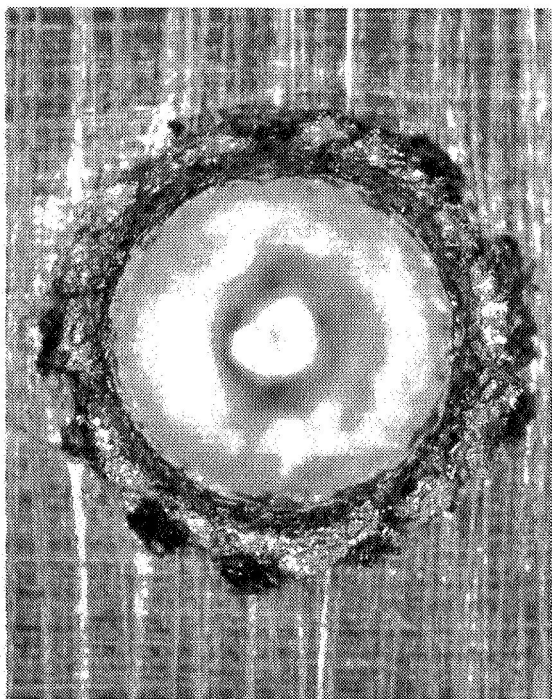
Inspection of the plate revealed a large number of impact craters, predominantly in the aluminum plate, ranging in size from 1 mm (Figure 3) to 0.05 mm in diameter. Most impacts appear to be normal to the plate (circular crater). The physical appearance of these impacts is discussed for various impact surfaces in the following sections.

Since the majority of the test plate area consisted of the uncovered aluminum mounting plate, the majority of impacts were located in the plate. These were generally similar in appearance, and typified by the example in Figure 3. The impact formed a circular crater with a surrounding ridge ejected out from and over the plate surface. The crater bottom was crystalline in appearance, unlike

the scratched and machined plate surface, showing evidence of melting and resolidification. This crater pattern was observed for all sizes from 1 mm diameter on down. Of the 157 impacts observed (over the entire test plate/sample surface), seven were 0.5mm or larger. Depth measurement of the seven indicated a crater depth (measured from crater bottom to top of surrounding ridge) ranging from one-half to one-third the crater diameter. Only a few craters were noted with an elliptical shape that might be attributable to an impact with a particle with a large non-normal velocity component.

Figure 3. Largest Impact Crater (~ 1 mm diameter)

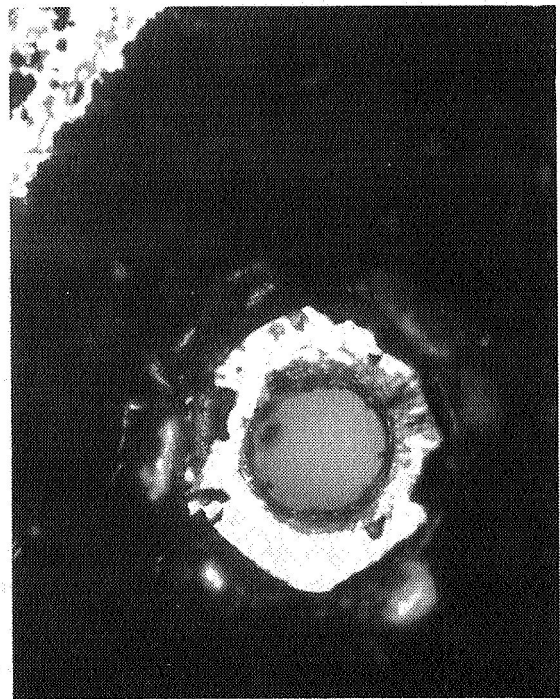
Although the total area occupied by the silver-plated Invar tabs was small, tab impacts did occur. The results of the impacts were visually surprising, but offer clear indication of the high particle impact velocities and corresponding impact energies. Figure 4 is a typical example of one such impact. It is observed that the tab has been completely penetrated. The region of Invar immediately surrounding the 0.5mm diameter penetration hole shows clear indication of melting and resolidifying. In addition, the impact generated gases have peeled the top silver plating away from the Invar and blown those layers out from the impact area. The silver/Invar separation is well-identified by the lack of any atomic oxygen darkened residual silver. Indeed, the inner surface of the peeled back silver plating has now darkened from atomic oxygen interaction. The remainder of the silver plated Invar tab away from the impact still appears shiny due to a thin layer of silicone adhesive which has provided protection during the mission.

Figure 4. Ag Plated Invar Impact

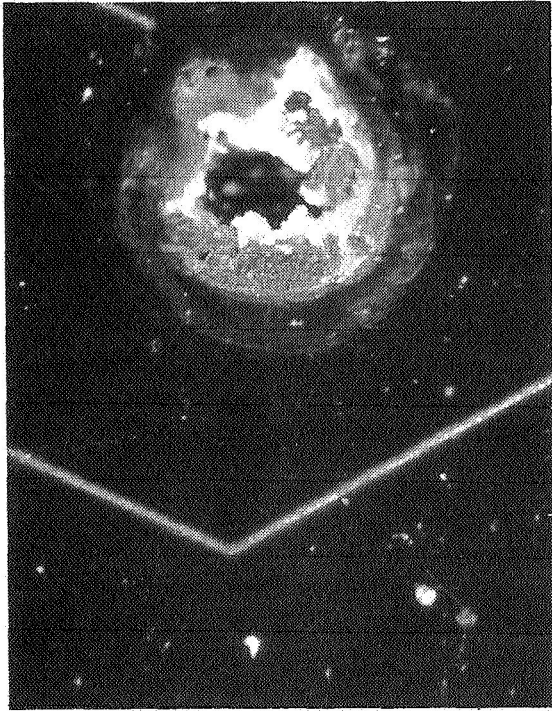
The appearance of impacts with a relatively thick polymer cell cover, such as Teflon FEP, shown in Figure 5, is remarkably similar to the above-described silver-plated Invar tab. For Teflon, the incident particle readily penetrated and impacted the silicon cell below. The impact with the silicon has generated gases which, in turn, lifted the Teflon away from the cell and blew out the central area. The flexible Teflon, unlike the rigid silver metallization, has settled back somewhat onto the cell surface. A light-colored ring can be observed around the blowout region, corresponding to an area of Teflon/silicon delamination, where physical contact, if not adherence, has been recovered. It is clear that the Teflon provides negligible protection against the high energy impacts. However, it was noted that the electrical performance of this cell was not noticeably different from other similarly covered cells, indicating minimal effects from the impact.

Figure 5. Teflon Cover Impact

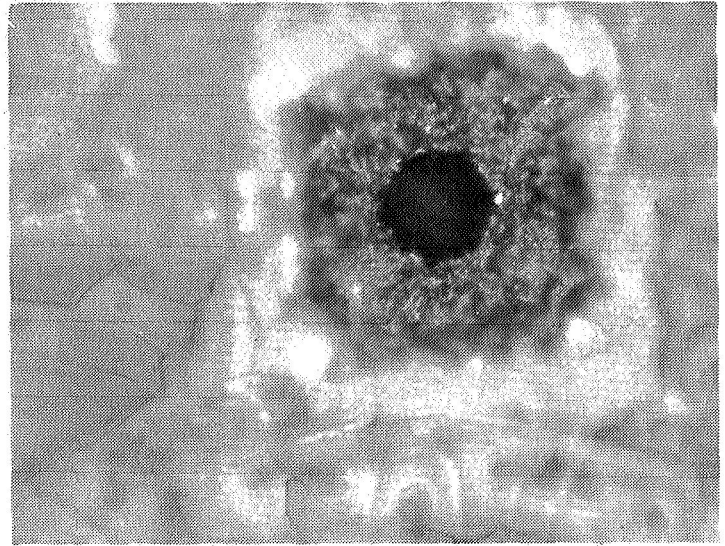
The silicon and microsheet impacts are discussed together because of the many similarities. Both materials are brittle and tend to shatter under severe loading. Figure 6 is a photograph of an impact in silicon (through a few micron thick polymer cover) and Figure 7 is a view of an impact into a 100 micron thick microsheet coverslide. Both impact areas are comparable in size (~0.1mm central "hole"), the difference in the photographs being due to different magnification levels. In view of the limited number of such impacts, it is not clear if these are truly typical. However, both materials have a well-defined crater with any ejected material blown completely away. Both crater perimeters appear nearly rectangular. For the silicon, this reflects the crystalline nature of the material, although this would not be expected for the microsheet. Of interest, the silicon cell was completely penetrated, with the formation of a near hexagonal-shaped through hole. The microsheet impact is limited in area, and radiating cracks were not visible. In the case of the microsheet impact, it was not possible to determine with certainty that damage was limited to just the

Figure 6. Silicon Impact (200X)

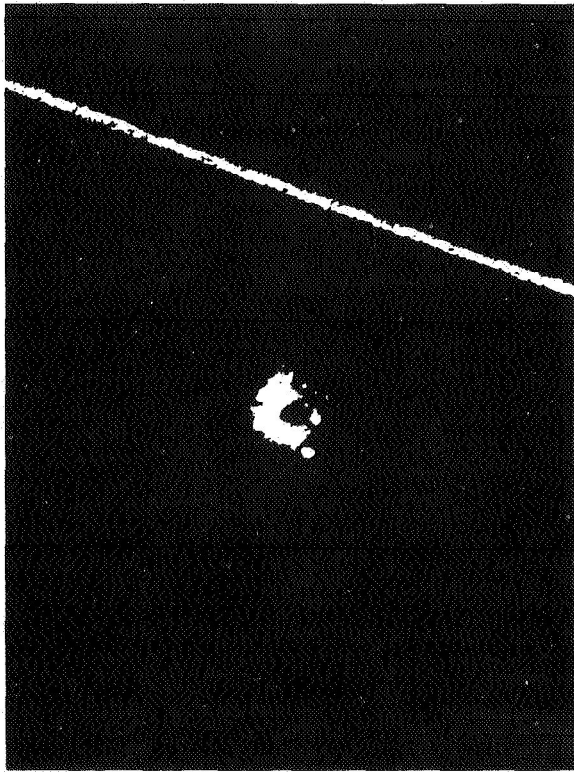
microsheet and immediately underlying silicone adhesive. However, it is believed that the impact was spent in the microsheet and that the adhesive was able to absorb any residual gas/debris, without a significant silicon interaction. No degradation was noted in the electrical performance of the covered solar cell.

Figure 7. Microsheet Cover Impact (7X)

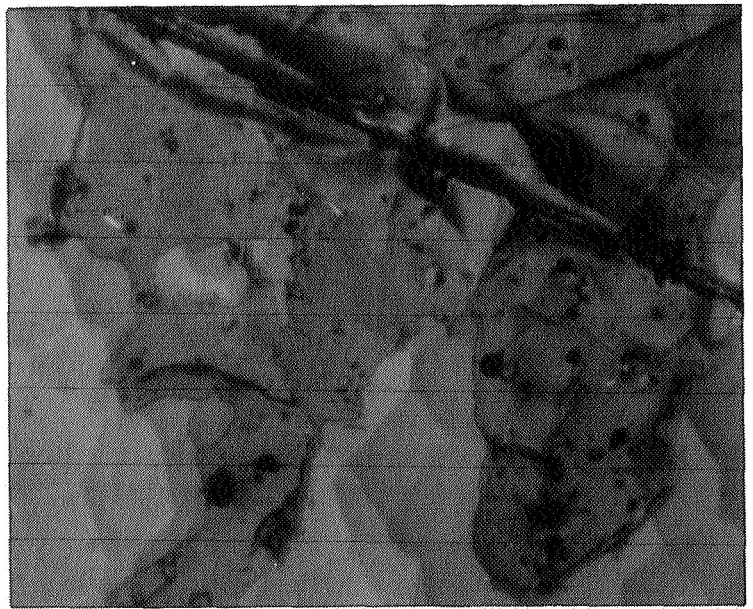
The smallest percentage loss measured was for the cerium doped microsheet samples and the BE-225HUP copolymer samples. The latter, however, had very low initial output current and the post flight samples had cell areas clearly free of encapsulant. The next lowest losses were measured on the polyimide encapsulant, soft silicone encapsulants and the hard coat silicone encapsulants. For the X-76 polyimide, the cell was extensively denuded of encapsulant, so the current shown is in some part that of a bare cell (Figure 8). The hard coat silicones also exhibited some coating loss and crazing (Figure 9). In general, minimal cell exposure was noted for the various soft silicone encapsulants and only at the cell corners. Thickness measurements of the encapsulants were not taken post flight due to the lack of sufficiently accurate pre-flight data, so that the only assessment of coating removal was based on noting any visible exposure of the underlying solar cell.

Figure 8. Polyimide Encapsulant Degradation

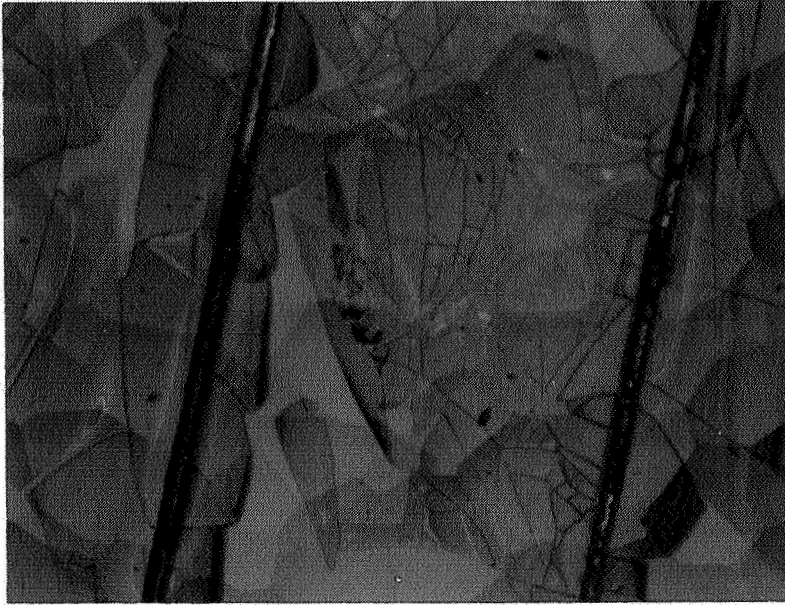
Figure 9.Hard Coat Silicone Degradation

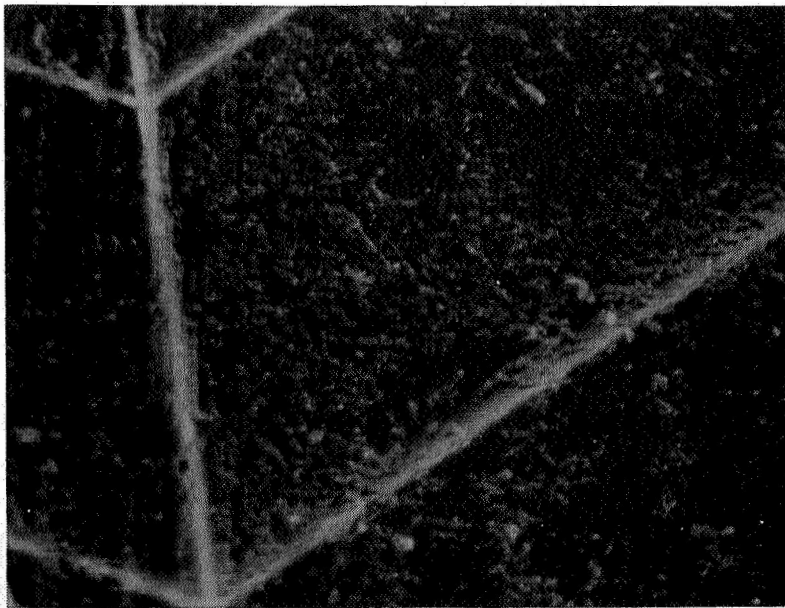
The largest current loss was exhibited by the Teflon covered samples, although the variation was extremely high, ranging from a loss of 10 percent to a loss of 43 percent. In one case the Teflon cover was missing with only a layer of RTV remaining on the cell. Whether this occurred during flight or during retrieval is not known. The cell current with only an RTV layer left showed an I_{sc} loss of 10 percent equal to the best of the remaining Teflon covers. The variation in losses for the Teflon covers is not understood. However, UV reaction with Teflon has been well-documented and the top surface of the Teflon covers exhibited considerable damage as defined earlier. In review, the surface appearance varied from a hazy white to a brownish discoloration. The later samples showed the greatest I_{sc} loss. In addition, the surface was soft and somewhat tacky (Figure 10). In terms of electrical performance then, no encapsulant or Teflon cover system provided output at the

Figure 10.Softened Teflon Cover
