NASA Technical Memorandum 104766

Thermal Certification Tests of Orbiter Thermal Protection System Tiles Coated with KSC Coating Slurries

James D. Milhoan
Vuong T. Pham
William D. Sherborne

April 1993

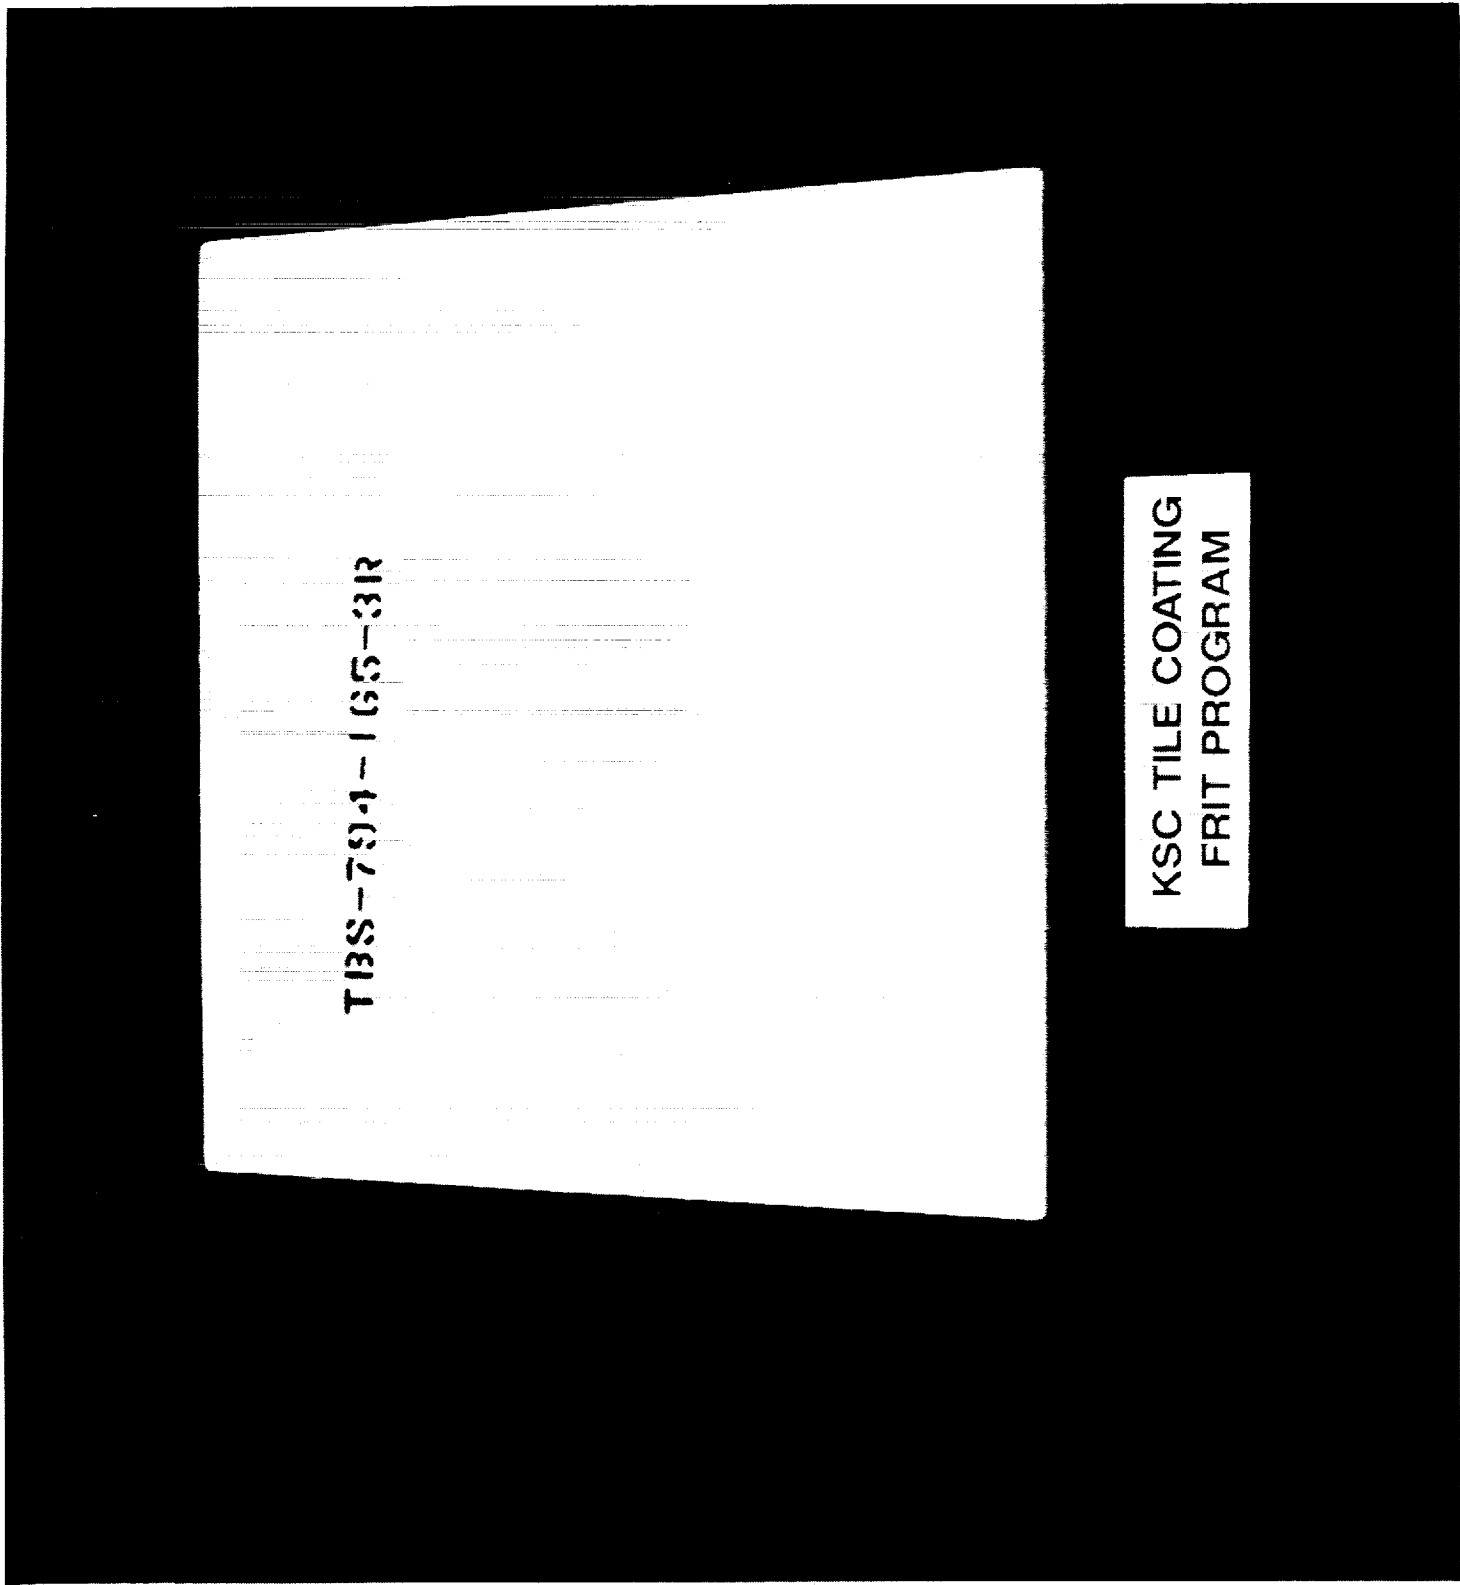
Figure 7: Pre-test Photo of a LRSI Specimen (Radiant)

For the radiant heat test, typical surface conditions of a test specimen of both before and after the test are shown in Figures 7 through 10. The tiny white dots on the surface of the HRSI test specimen were speculated to be fiberfrax (insulation used around the tile arrays and the heater) particulates deposited onto the test specimens as the heater traveled in and out of a heating cycle. Typical surface temperature and pressure responses during the test are summarized in Appendices A-1 and A-2, respectively. Due

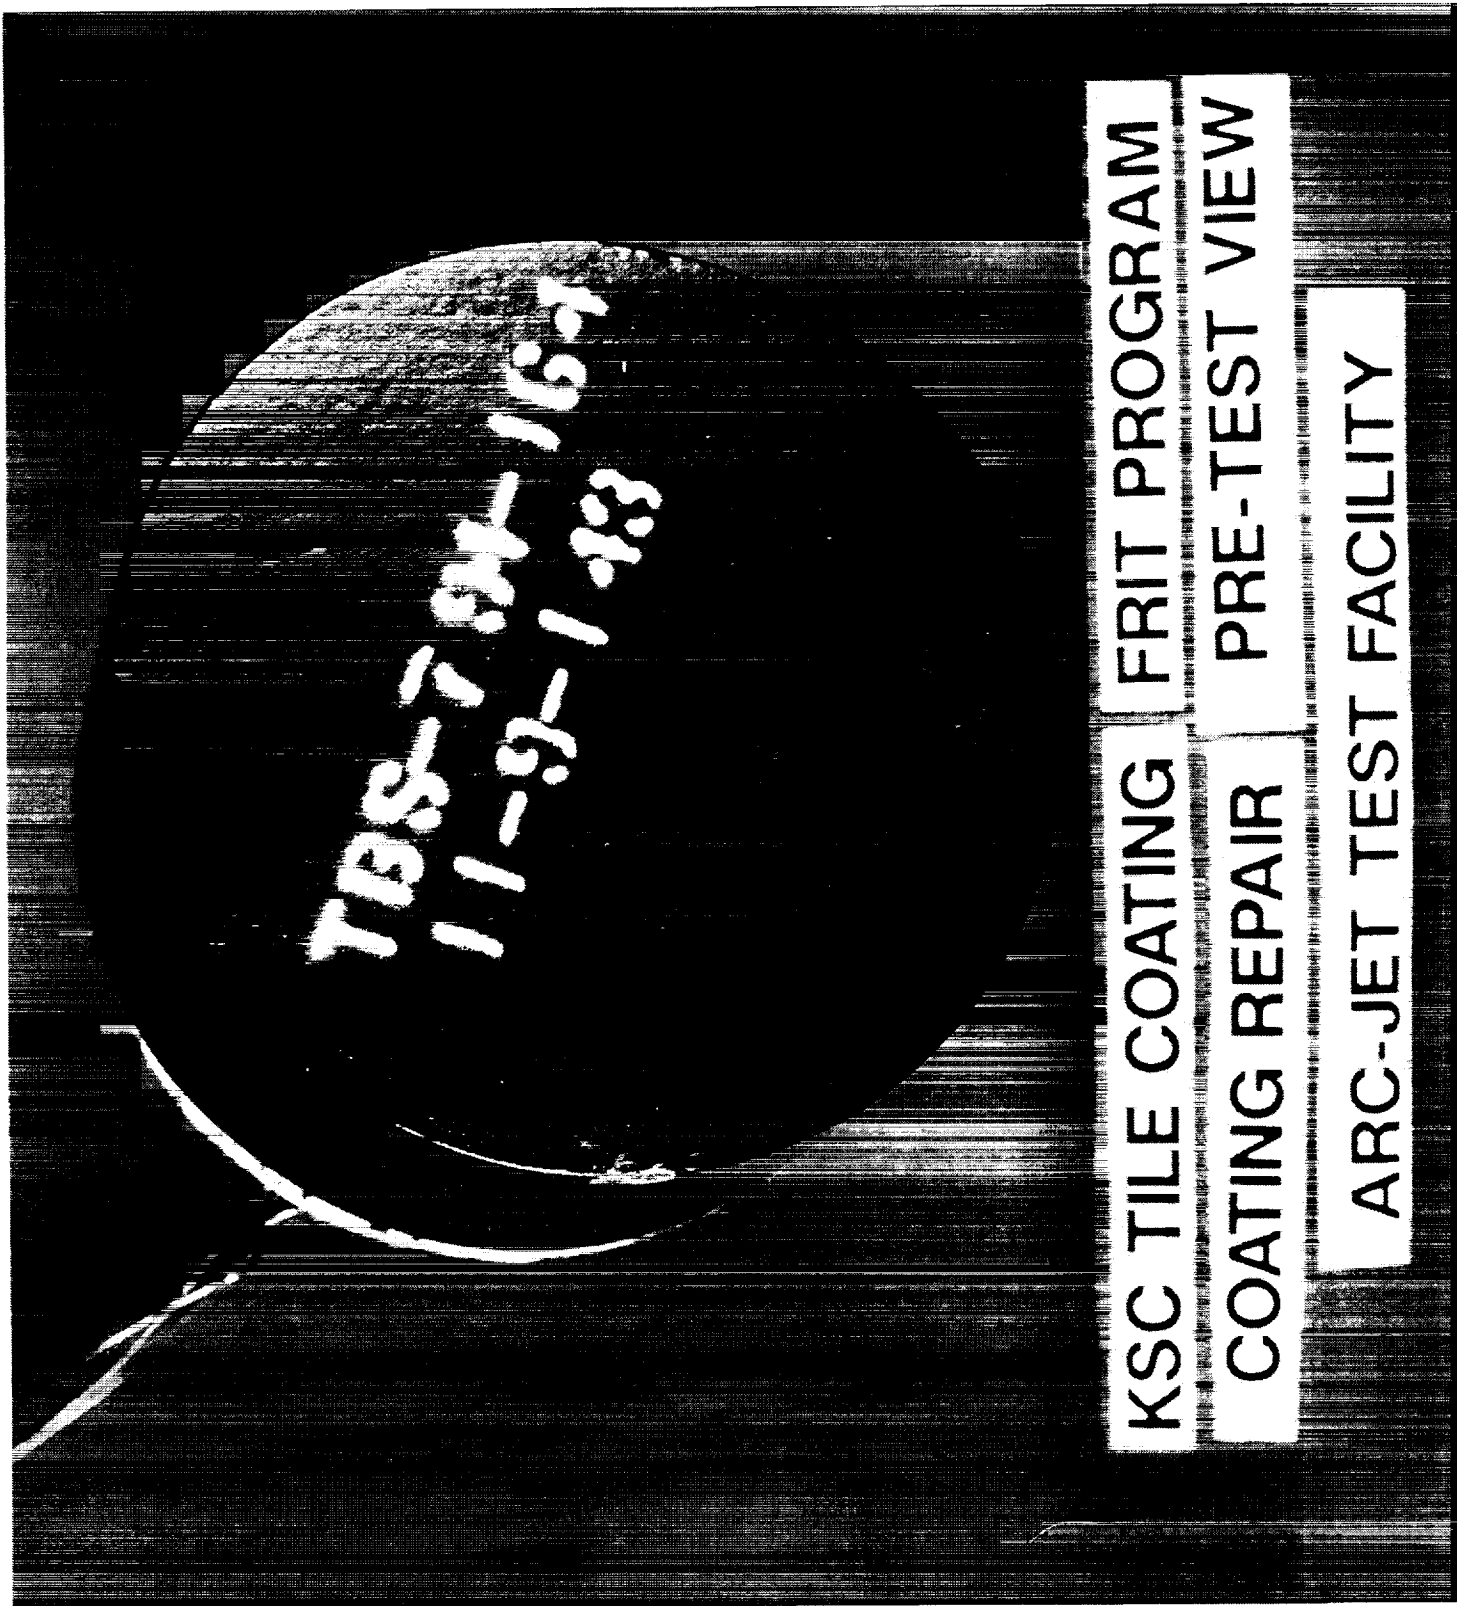
Figure 11: Pre-test Photo of a LI-900 Specimen (Convective)

For the convective heat test, pre- and post-test photographs of a LI-900 test specimen are shown in Figures 11 and 12. Although not shown well in the photograph (Figure 12), the LI-900 test specimens have minor slumping underneath the painted identification number. This slumping in the tiles was caused partially by the low emissivity of the paint, the low density of the tiles, and the stagnation pressure of the test. This phenomenon was not seen on the radiant test specimens because the emissivity of the test specimens became unimportant in the radiant test (blackbody radiation). Pre- and post-test photographs of a LI-2200 test specimen are shown in Figures 13 and 14. These figures indicated that the identification paint was burnt and evaporated at some temperature above 2700°F. Typical surface temperature plots are summarized in Appendix B-1. The surface reflectivities of the test specimens before and after testing are summarized in Appendix B-2. Appendix B-3 contains a crack map for the only tile that developed cracks. Because the convective test specimens were bonded to a SIP and an aluminum plate with RTV adhesive, the specimens' dimensions and weights can not be measured accurately and consequently were not performed.
