CONTAMINATION ON LDEF: SOURCES, DISTRIBUTION, AND HISTORY

Gary Pippin and Russ Crutcher
Boeing Defense & Space Group
Seattle, WA 98124-2499
Phone: 206/773-2846, Fax: 206/773-4946

In this paper we present an introduction to contamination effects observed on the Long Duration Exposure Facility (ref 1). The activities reported here are part of Boeing's obligation to the LDEF Materials Special Investigation Group (ref 2).

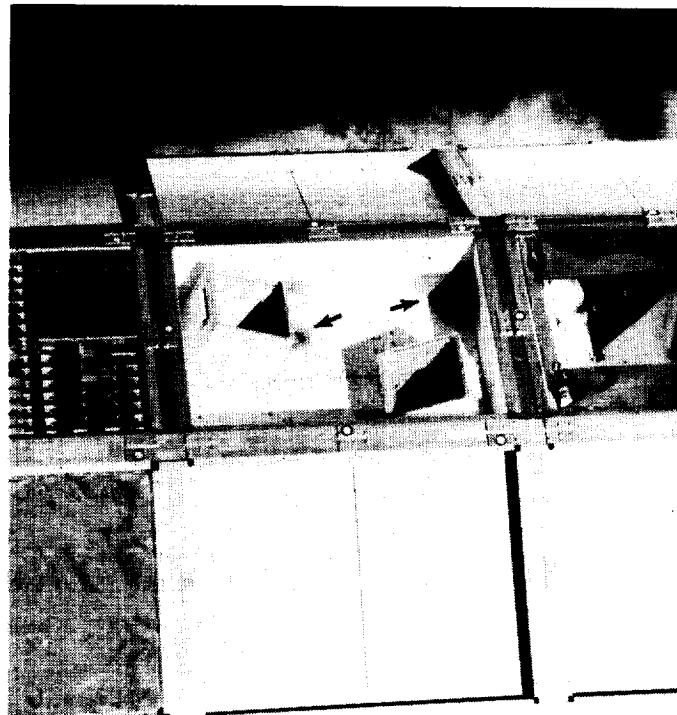
Figure 6. On-Orbit Photo of Tray E12 Showing Molecular Contamination
Patterns

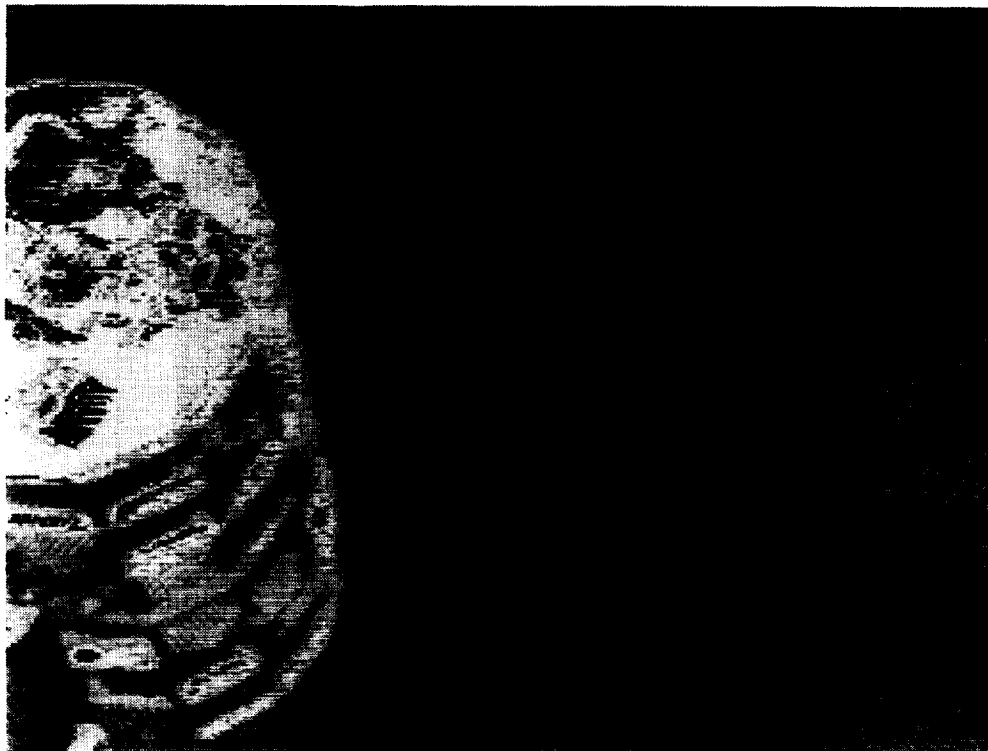
Figure 8. Image made from one Frame of NASA Video Downlink During LDEF Recovery. Particles Observed in LDEF Wake are Visible

Images from NASA's video downlink have been examined and image enhanced using a computer. Figure 8 shows one frame from the downlink and individual debris particles are seen in the LDEF wake. These particles are visible on the video as they reflect sunlight in the direction of the camera, then disappear as they rotate, and then reappear on a later frame. This debris has collected in the wake of LDEF. No particles were visible on the ram side. Individual particles may be moving away from the LDEF structure at very low relative velocities, taking weeks or months to leave the vicinity of the spacecraft, until they trail LDEF by such a distance that they are back in the ambient environment.
