NASA
Contractor Report 191079

Sikorsky Aircraft Advanced Rotorcraft Transmission (ART) Program— Final Report

Jules G. Kish
United Technologies Corporation
Stratford, Connecticut

March 1993

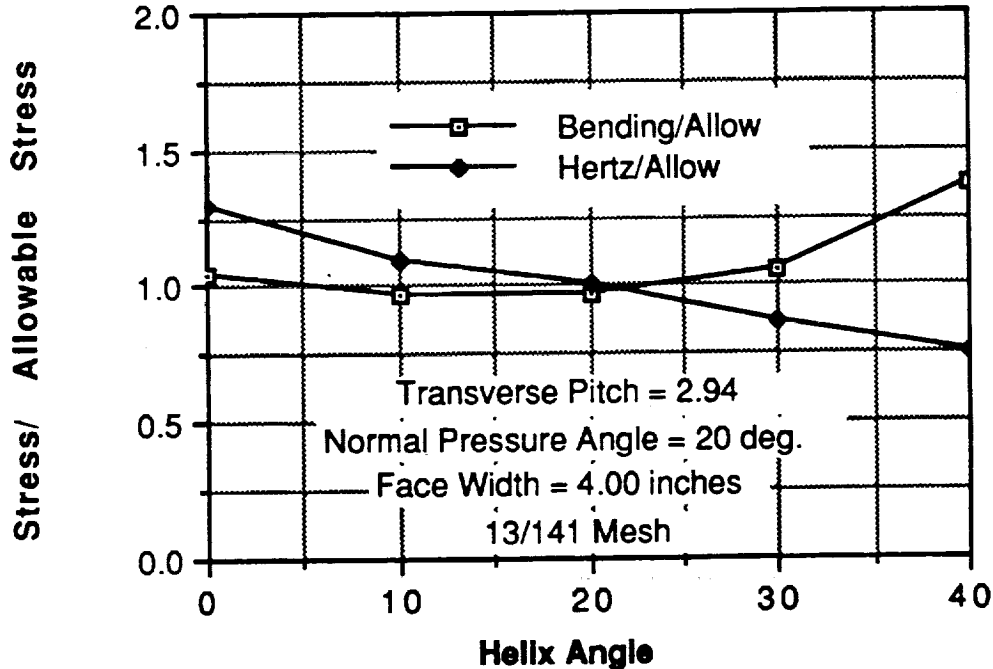
Figure 25. Herringbone Gear Mesh Design Parameters

A typical result can be seen in Figure 25 which is a plot of stress divided by the allowable stress (or factor of safety) vs helix angle. The plot is for the 13/141 mesh. As helix angle increases, contact stress continues to decrease whereas bending stress decreases slightly to about 20°, then increases slightly to about 30°, and then increases sharply above 30°. This is a typical plot for all designs. The maximum helix angle used was reduced as a result of this phenomenon to approximately 30°.

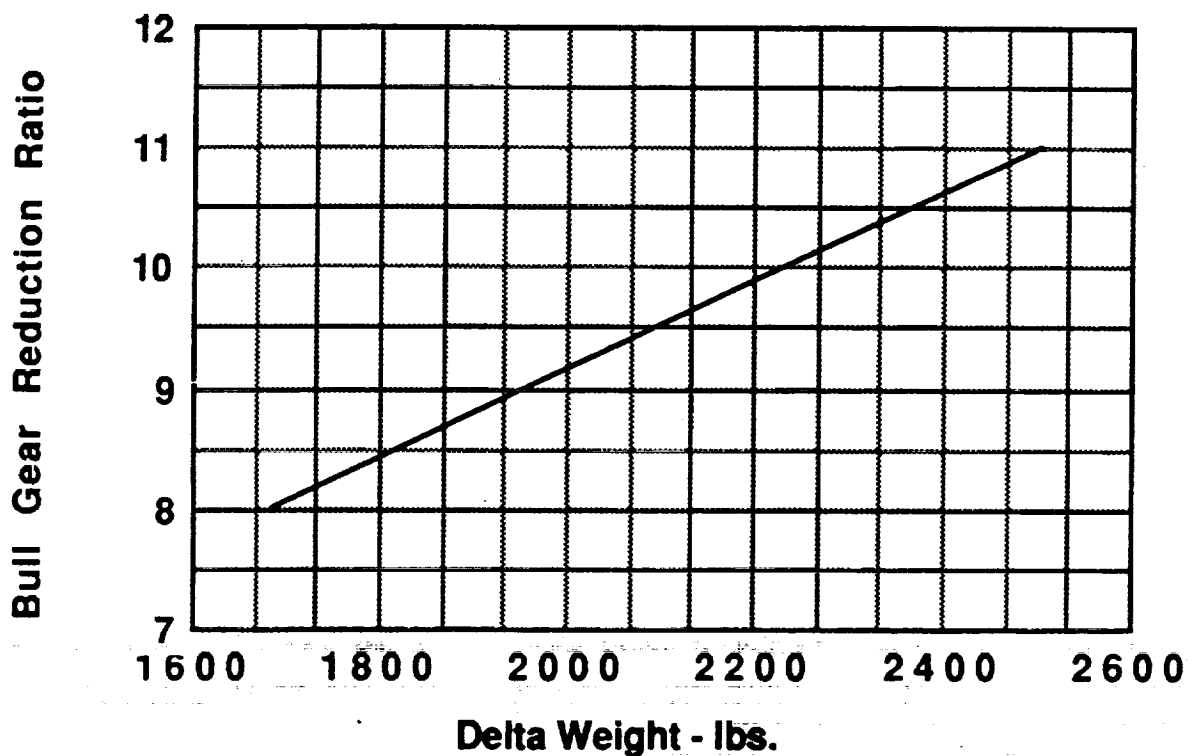
Figure 26. ART/ACA Weight Savings vs Reduction Ratio

Preliminary layouts were prepared for 8:1 and 11:1 ratio bull gears. It was found that last stage reduction ratio had a profound effect on weight. This fact is illustrated in Figure 26. The reason for the weight savings can be realized when considering for a moment what happens when the output bull gear is left alone and the bull pinion pitch diameter is decreased. First of all, the bull gear face width remains the same since the output torque, and hence output tangential tooth load has not changed. Secondly, the weight of the bull pinions themselves is reduced since the size of the pinion is smaller. Lastly, the reduction ratio is increasing and hence the speed of the bull pinions is increasing. This results in less torque on the bull pinions and in fact, all stages prior to the bull gear can now have reduced ratios and reduced weight because of the lower torque and lower reduction ratio requirements. Therefore, increasing the reduction ratio at the last stage has the direct effect of reducing sizes of all gearing prior to the output bull gear.

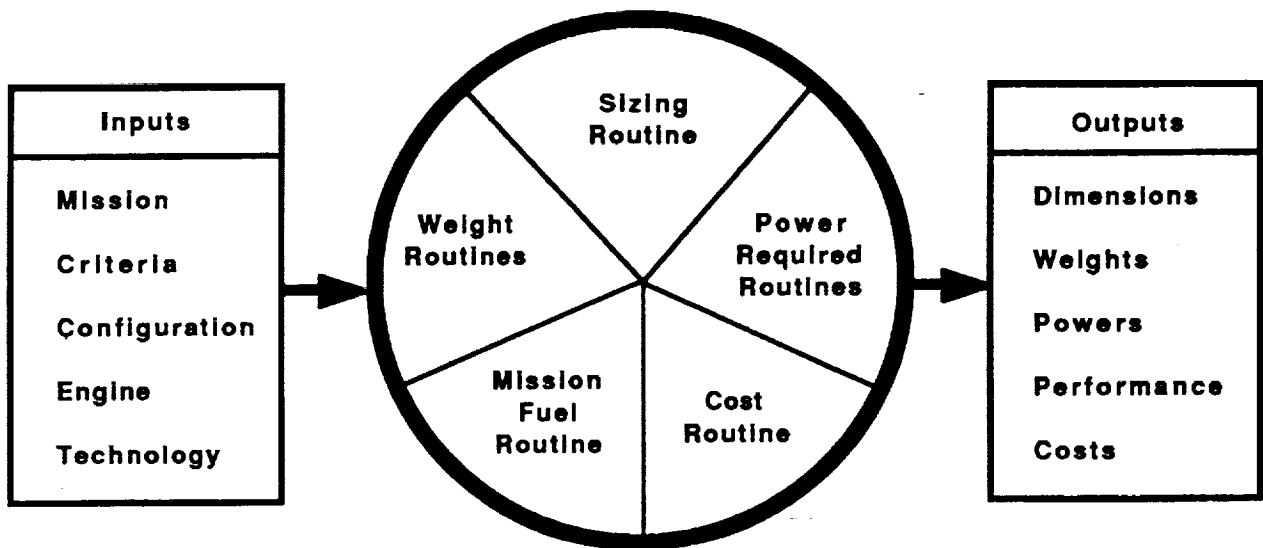
Figure 45. Helicopter Design Model

All aircraft design analysis was accomplished with the helicopter design model (HDM) as shown in Figure 45. The HDM is a computer program which uses basic input data of mission requirements, design criteria, configuration, engine, and technology. The program then calculates dimensions, weights, powers, performance parameters, and costs. The HDM uses experience factors for calculation of many of the outputs. For example, weight trending equations are provided for the main gearbox, main rotor shaft, main rotor blades, intermediate gearbox, tail gearbox, and tail drive shafting. These equations use parameters such as horsepower, rpm, and reduction ratio with coefficients derived from previous designs to calculate weights. Figure 46 shows the excellent correlation achieved not only with Sikorsky designs but for all helicopter drive systems.

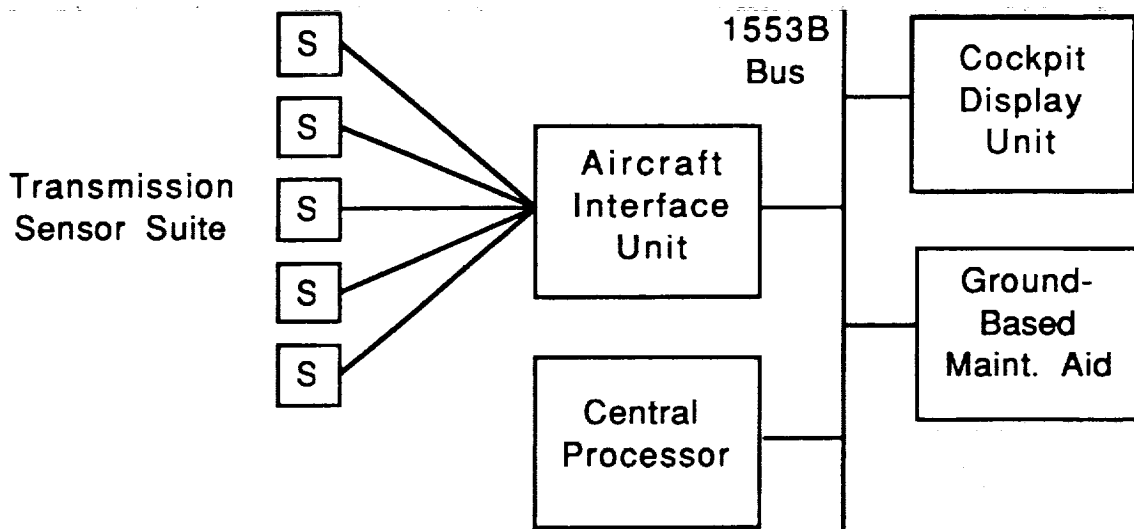
Figure 64. Generalized Diagnostic System

The ART diagnostic system includes all aspects of the diagnostic process including sensors, signal conditioning, conversion, data, information processing software and hardware, and information display. The data and information processing software and hardware include both on-aircraft and off-aircraft sub-systems. The diagnostic system is shown conceptually in Figure 64.
