JPL Publication 91-10

An Investigation of the Degradation of Fluorinated Ethylene Propylene (FEP) Copolymer Thermal Blanketing Materials Aboard LDEF and in the Laboratory

May 15, 1991

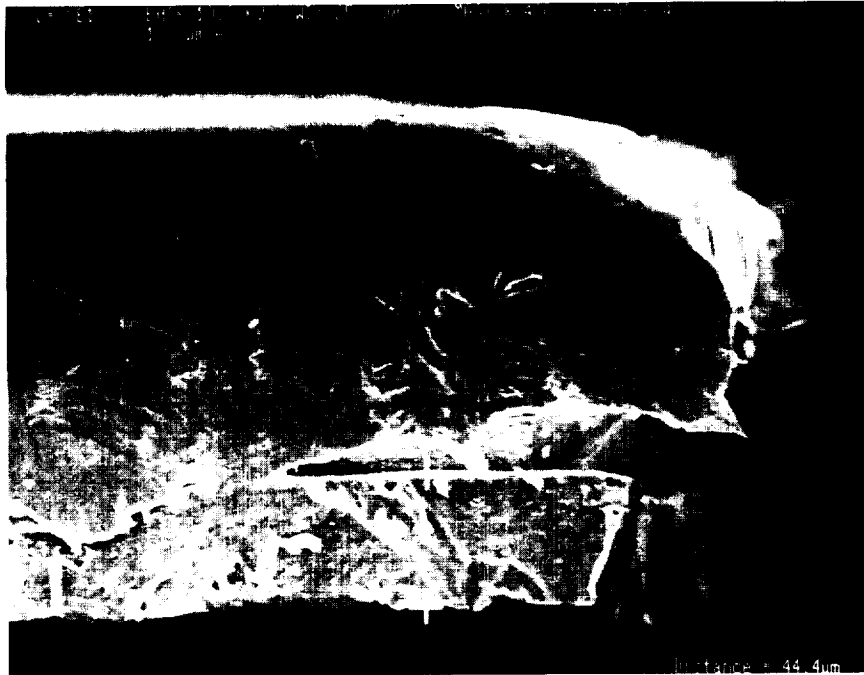
The material, viewed at the edge in Figure 1 and showing some delamination at the corner, has a thickness of approximately 170 μm (as measured in the SEM) with 40 μm of black paint constituting the bottom layer and 120 μm of FEP constituting the top. The silver coating can be seen in Figure 1 as particles on the underside of the peeled away FEP layer.

Figure 1. SEM of a control sample of an FEP thermal blanket, viewed at the edge (at a magnification of 400), showing the laminate structure of the bulk material.

Thermal blankets in spacecraft applications are a laminate of 5-mil FEP with a reflective silver coating (~1000–2000 Å), which is vapor deposited on one surface. The layer of silver is subsequently coated with a layer of black paint (Chemglaze Z306). The FEP acts as a thermal (infrared) emitter, as well as a transparent “window,” to protect the reflective properties of the silver and, as a consequence of this, receives direct exposure to the space environment. A scanning electron micrograph of a control sample of FEP thermal blanket (Figure 1) reveals this laminate structure.

This hard layer has no counterpart in either the reference sample (Figure 1) or the atomic-oxygen exposed sample and, therefore, must be formed from exposure to VUV radiation. It is likely that this hard layer is formed from the photochemical cleavage of the polymer chains at the surface. Recent electron spin resonance (ESR) studies have shown that VUV light induces chain scission in the polymer-yielding radical species. This chain cleavage process results in the erosion of the surface by the ejection of small molecules with concomitant cross-linking of the remaining polymer, resulting in the formation of a hard brittle layer.¹⁰ This surface layer is absent in the atomic-oxygen exposed LDEF sample, leading to the conclusion that this surface structure is responsible for the

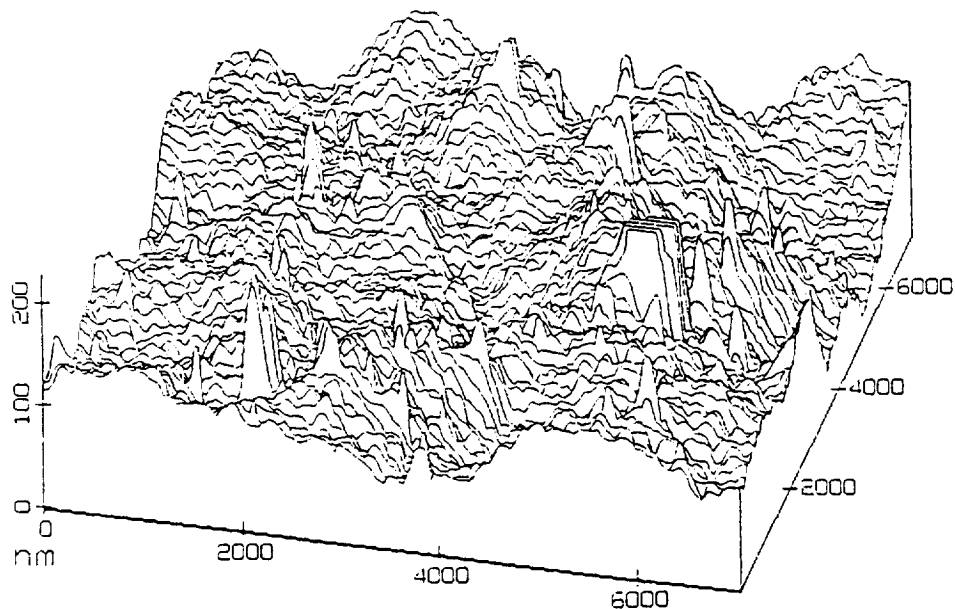
The LDEF samples that received predominantly VUV exposure (trailing edge) show a surface morphology that contrasts sharply with the morphology of the atomic-oxygen exposed sample. The SEM of the surface of this sample (Figure 6) shows some crazing and roughening of the surface; however, it is the AFM image (Figure 7) that shows the morphology in detail.

The VUV exposed surface shows a pattern of very sharp “jagged” peaks that are *superimposed* over a “rolling” background that is similar to the atomic-oxygen exposed sample. The peaks are very high frequency (a large number of peaks per unit area) with a moderate amount of roughness (standard deviation = 31.6 nm). This morphology suggests that VUV acting alone can erode FEP and that, due to the unique characteristics of the erosion morphology, its erosion mechanism is much different from that of simultaneous VUV and atomic-oxygen exposure.

Figure 7. AFM of the surface of an FEP thermal control blanket recovered from the trailing edge of LDEF.

The laboratory sample is remarkably similar to the LDEF sample (Figure 7) with comparable peak-to-valley heights and standard deviations (32 nm for the LDEF sample and 29 nm for the laboratory sample). The morphology is also qualitatively similar with high-frequency peaks that tend to be sharp and jagged. The laboratory sample lacks the “rolling” morphology that is seen as background in the VUV/UV-exposed LDEF sample (Figure 7) and is the dominant morphological pattern of the VUV and atomic-oxygen exposed sample (Figure 5). This is consistent with a suggestion that the “rolling” morphology is induced by atomic-oxygen exposure, while the sharp high-frequency pattern is the result of VUV/UV exposure.

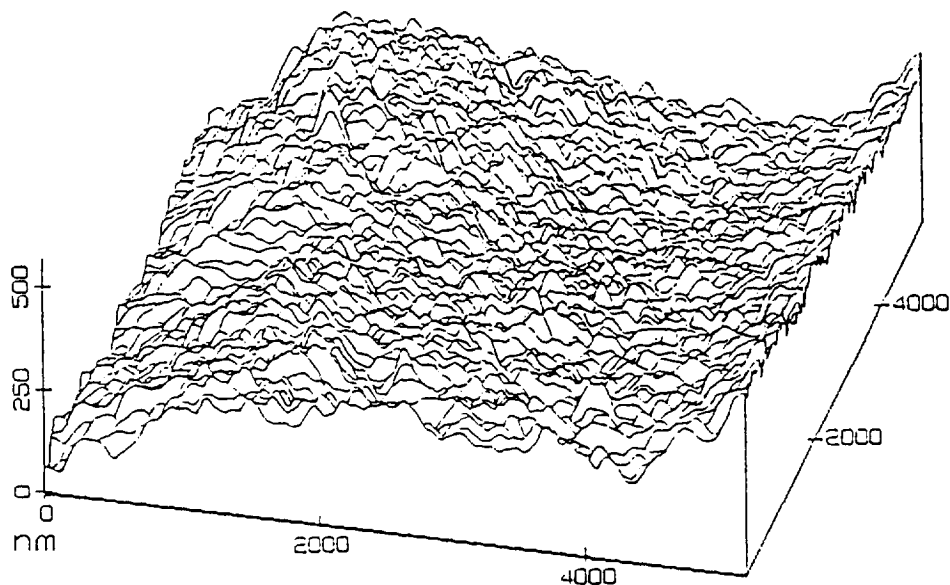
The AFM showing the surface morphology of FEP simultaneously exposed to atomic-oxygen and VUV radiation sources in the molecular beam apparatus is shown in Figure 12. The surface morphology of this sample contrasts sharply to the VUV-exposed sample. Qualitatively, it has an incipient low-frequency “rolling” morphology similar to the atomic-oxygen-exposed LDEF sample. The laboratory sample received much less total exposure than the space-exposed sample, resulting in much less total erosion and a relatively small standard deviation from average, especially compared to the LDEF material (22 nm versus 452 nm). While more quantitative work is necessary to fully duplicate the atomic-oxygen and VUV synergistic effect seen in space, some of the qualitative morphological changes seen in these samples suggest that this effect is, in fact, being adequately replicated.

Figure 12. AFM of the surface of an FEP film exposed to VUV radiation and atomic oxygen in the laboratory.
