**NASA TECHNICAL MEMORANDUM 107742**

**MONITORING DAMAGE GROWTH IN  
TITANIUM MATRIX COMPOSITES  
USING ACOUSTIC EMISSION**

**J. G. Bakuckas, Jr., W. H. Prosser,  
and W. S. Johnson**

**March 1993**

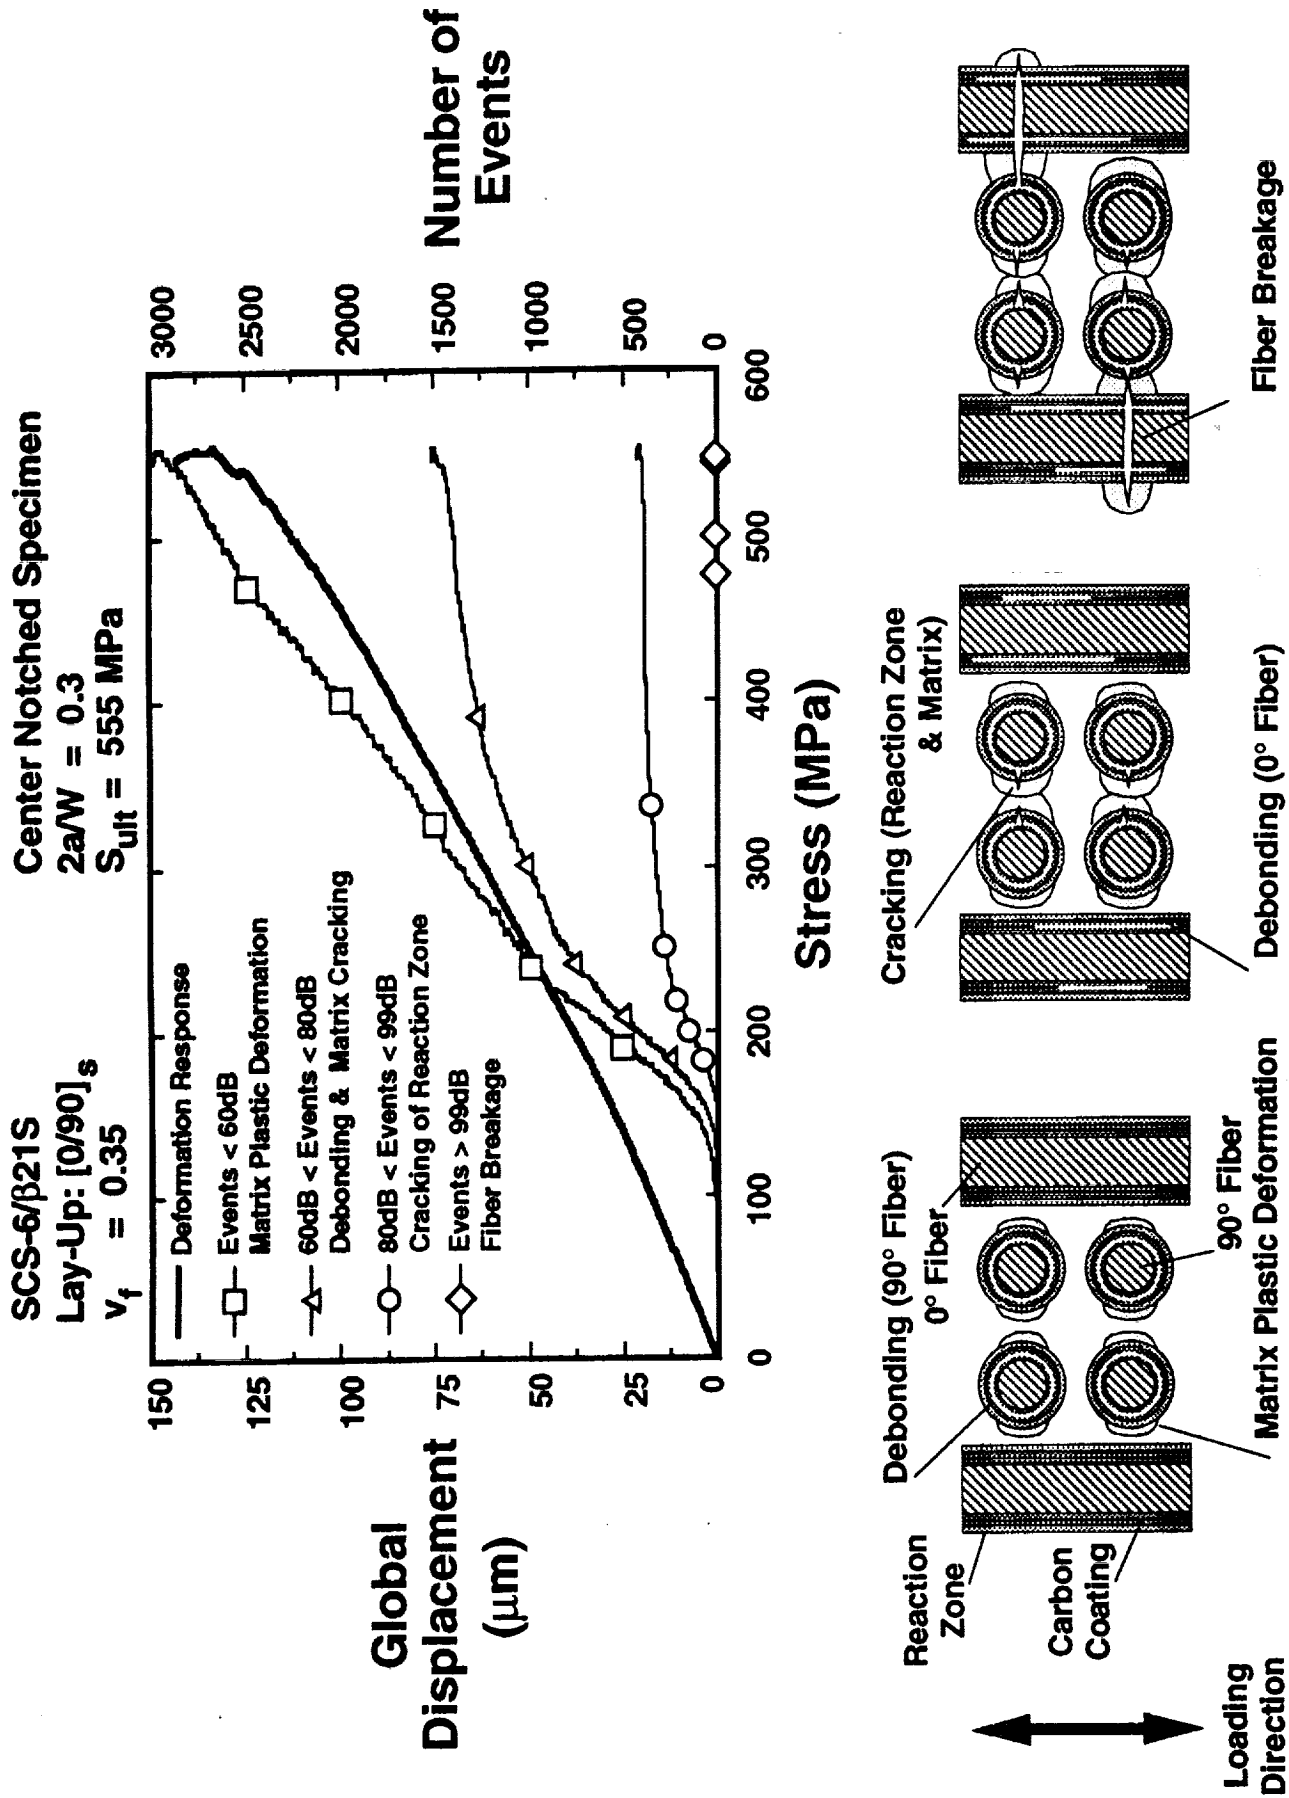
Figure 24. Monitoring damage growth in [0/90]<sub>s</sub> SCS-6/ $\beta$ 21S specimen using AE event amplitude.

For the  $[0/90]_s$  specimen, the initiation of low, middle and upper-middle amplitude events occurred at approximately 9%, 22% and 29% of the notched strength,  $S_{ult} = 555$  MPa, Figure 24. The rate of emission of the events in each of these amplitude ranges increased as the stress level increased in the initial stages of loading. At approximately 40% of the notched strength, the rates of emission decreased, particularly for the middle and upper-middle amplitude events. The majority of the AE events generated up to this point are likely to be associated with damage mechanisms occurring in the  $90^\circ$  plies as discussed previously for the  $[90]_4$  specimen: matrix plastic deformation, followed by fiber-matrix debonding, and then fracture of the brittle reaction zone. Each of these failure mechanisms are seen in the photomicrographs of the fracture surface, shown previously in Figure 4. Above approximately 40% of the notched strength, the number of upper-middle amplitude range events increased only slightly indicating that damage in the  $90^\circ$  plies is becoming saturated. The majority of AE events generated at loads above 40% of the notched strength are likely to be associated with damage occurring in the outer  $0^\circ$  plies. The occurrence of high amplitude events occurred at approximately 86% of the notched strength and are associated
