NASA Contractor Report 189120
MTI Report 91TR56

Heat Pipe Fatigue Test Specimen Metallurgical Evaluation

Steven E. Walak and Michael J. Cronin
Mechanical Technology Incorporated
Latham, New York

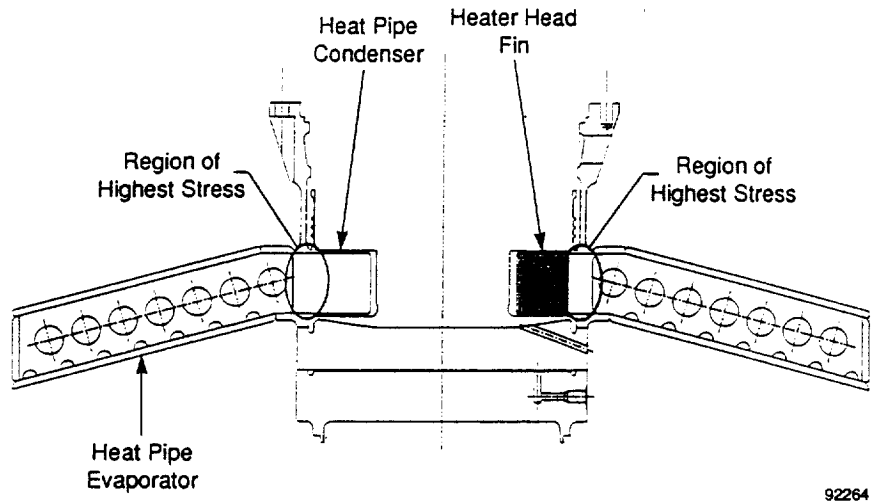
Figure 2. Component Test Power Converter (CTPC) Heater Head and Heat Pipe System Cross Section

The heat pipe envelope was fabricated from 32 mm (1-1/4 in.) diameter Inconel 718 bar stock, AMS 5662, and was approximately 203 mm (8.0 in.) in length with an internal diameter of 12.7 mm (0.5 in.). The pipe condenser was 51 mm (2 in.) long, with a wall thickness of 1.6 mm (0.062 in.). The evaporator was 102 mm (4 in.) long, with wall thickness of 4.8 mm (0.19 in.). The difference in wall thickness ensured that the most severe stress conditions were obtained in the condenser to best simulate the conditions that would be experienced during CTPC laboratory testing. The highest stress in the CTPC heat pipe system under development occurs at the outer edge of the heater head fins, as shown in Figure 2.

Under actual operating conditions, the highest-stress region of the CTPC heat pipe (Figure 2) will be exposed to condensing sodium vapor, elevated temperature, and combined static and cyclic mechanical loads. The sodium exposure, temperature, and stress conditions for the HPFTS were designed to simulate this region.
