NASA Contractor Report 189220

# Creep Fatigue Life Prediction for Engine Hot Section Materials (Isotropic)

## Second Interim Report

R.S. Nelson, G.W. Levan, and J.F. Schoendorf  
*United Technologies Corporation*  
*Pratt & Whitney*  
*Commercial Engineering*

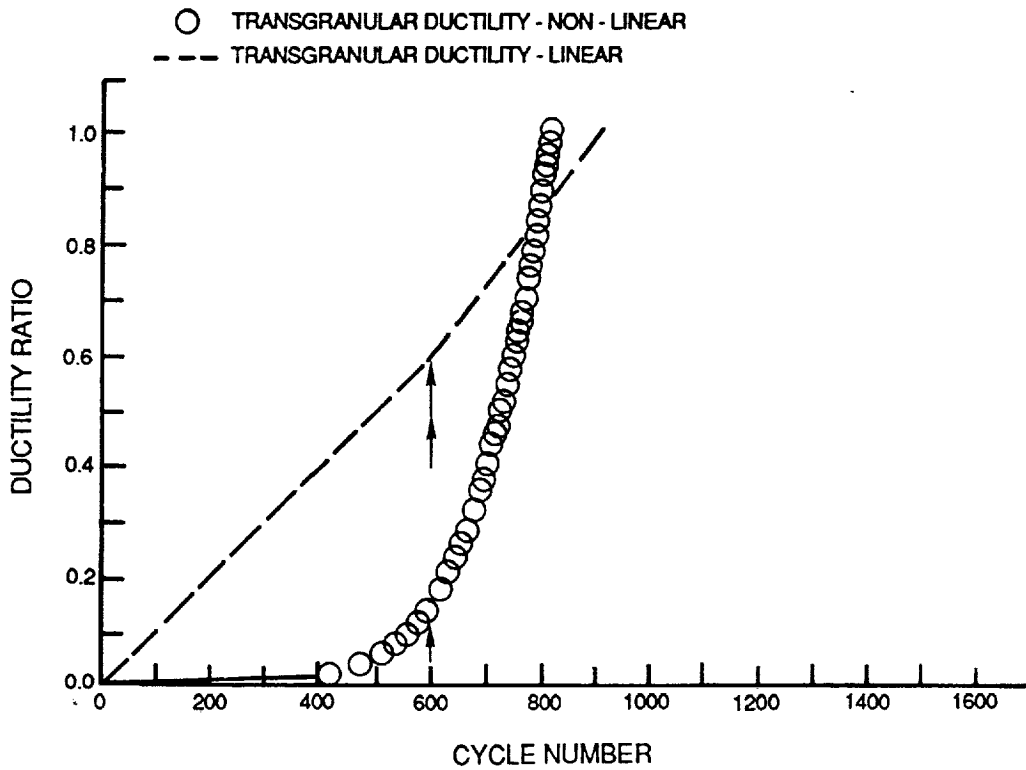
Figure 6.- Example of Lower Life Prediction with Non-Linear Accumulation

The effect of the inclusion of the non-linear function  $G(N/N_i)$  on the CDA life prediction for a strain ratio block test is shown by Figure 6. This plot shows how the ductility fraction increases as a function of cycles, both for linear and non-linear damage accumulation. In this case the non-linear prediction is lower than the linear prediction, because the basic damage rate (slope of the linear accumulation line) during the first block of the test is lower than the rate during the second block. This causes the ductility to be consumed earlier with the non-linear function than without it, and the net result is a lower prediction. The opposite effect is seen in Figure 7, where reversal of the order of the blocks causes the non-linear life prediction to be higher than the linear one. Note that this is the same effect which was observed during the specimen testing.

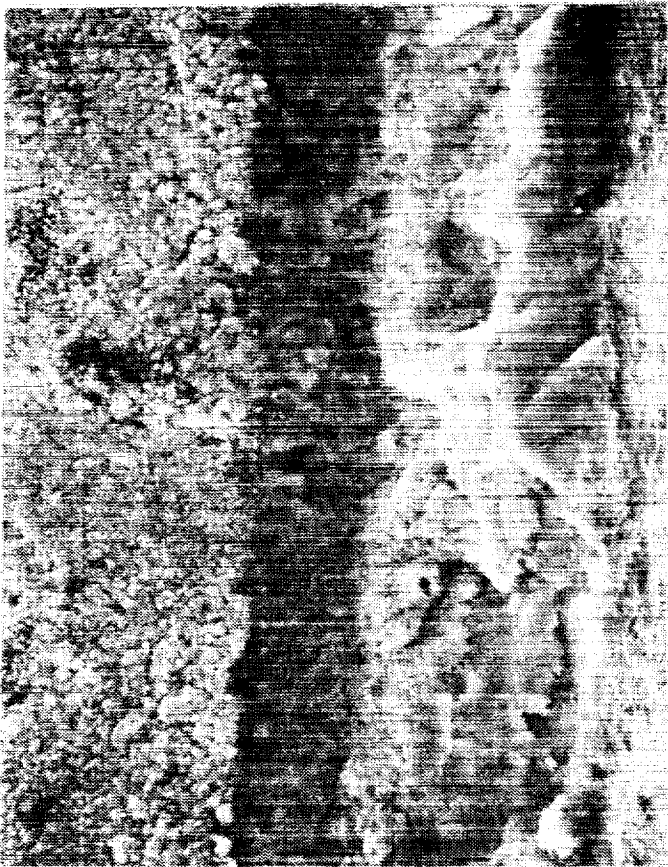
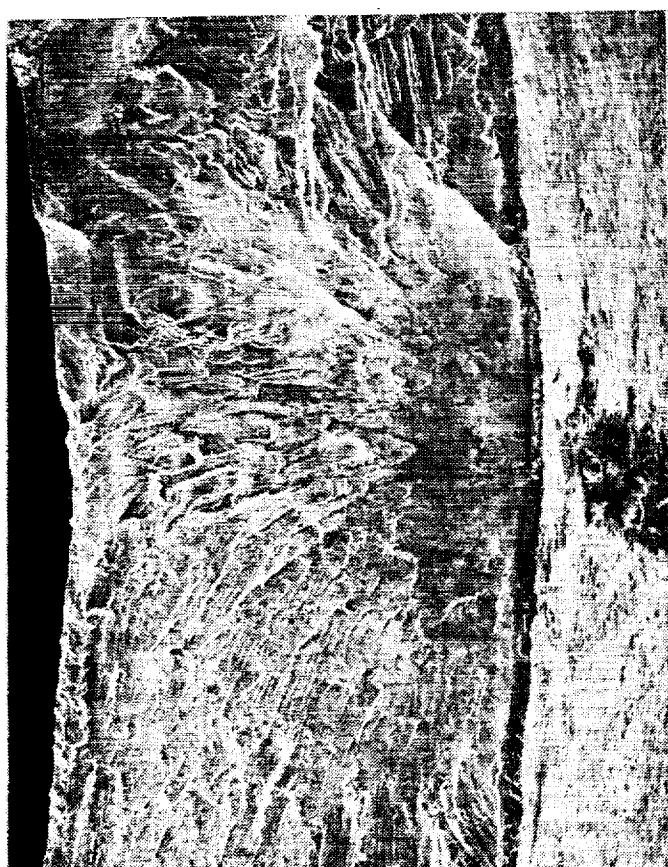
Figure 20 PWA 273 coated TMF specimen 114A, Cycle I,  $\Delta\epsilon = 0.4\%$ , 538-871°C (1000-1600°F), R = -1, initiation life = 4753 cycles. SEM micrographs of primary O.D. initiation site. Dark band between coating and base metal is the diffusion zone.

Specimen 114A, the first PWA 273 aluminide coated TMF specimen, was tested at 538-871°C (1000-1600°F), 0.4% strain range,  $R = -1$ , and out-of-phase cycling. Its observed separation life was 8195 cycles, which is nearly twice that of the overlay coated (PWA 286) specimens tested under the same conditions (120A, 120B). Replica data shows that the initiation life was 4753 cycles which is 1.4X higher than the lives of the PWA 286 coated specimens tested at similar conditions. Optical examination of specimen 114A shows that there were multiple initiation sites on both inner and outer diameters, but the majority of initiations as well as the primary initiation occurred on the outer diameter. Only the primary outer diameter initiation was examined by SEM as only the OD surface involves the coating. As shown in Figure 20, the fracture surface is heavily oxidized and the exact location of the crack origin cannot be identified. The dark band between the coating and base material is the diffusion zone.

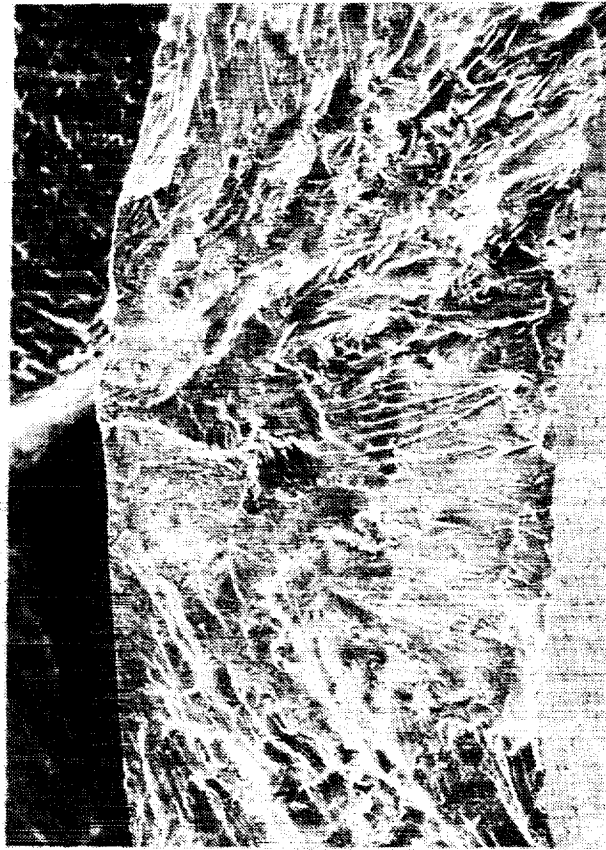
Figure 25 Specimen 108D (CCW elliptical,  $\epsilon = 0.5\%$ , initiation life = 3652 cycles, separation life = 7024 cycles), (a) optical and (b) SEM of initiation site. Minimal porosity was observed.

Optical and SEM examinations were also made on two uncoated CCW elliptical specimens tested at 538-871°C (1000-1600°F), 0.5% strain range, R=-1: 108D (initiation life = 3652 cycles, separation life = 7024 cycles, and 125D (initiation life = 1097 cycles, separation life = 2551 cycles). Both specimens exhibited multiple initiation sites. The major initiation site of 108D is shown in Figure 25 and that of 125D is shown in Figure 26. The shiny areas on the fracture surface of 108D shown in Figure 25(a) are the result of damage to the fracture surface that occurred after testing. Note that there is only minimal porosity at the initiation site of 108D, while Figure 26 shows that there is a high amount of porosity at the initiation site of 125D. This condition may be the cause of the lower fatigue lives observed in this specimen. No other features that may have played a role in the initiation of cracks in these specimens (such as the carbides observed in two of the PWA 273 coated specimens) were seen. The fracture surfaces of these specimens are similar overall to those of the other elliptical cycle specimens.

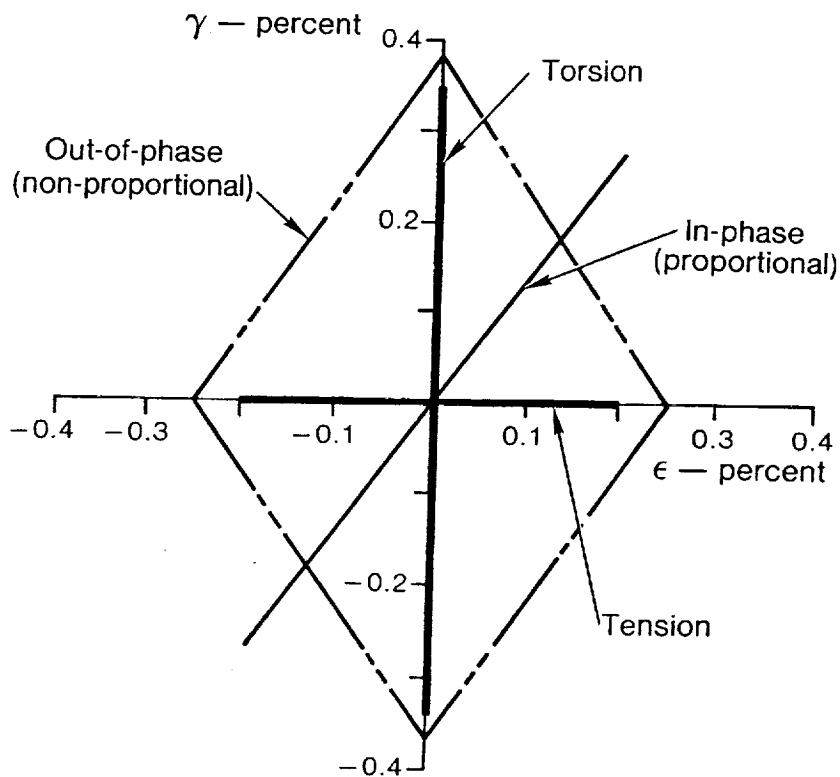
Figure 30.- Strain Cycles Used for Multiaxial Testing.

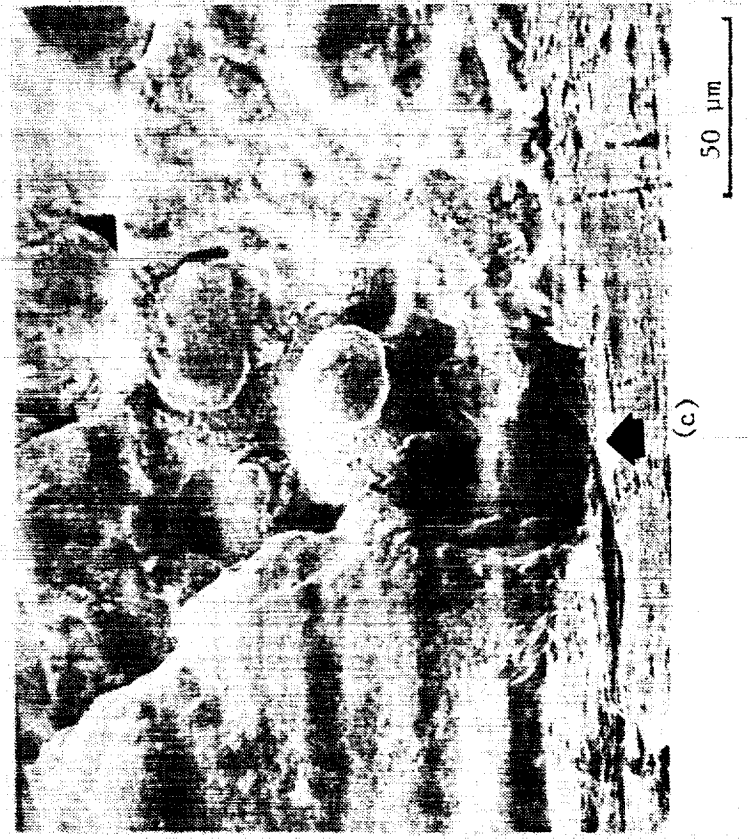
Multiaxial specimen #217 (tension only  
 ± 0.25%, 2442 cycles).

Specimen 217 was tested for a total of 2442 cycles at 871°C (1600°F) and 10 CPM using an axial strain range of 0.494%. The initiation life of approximately 1107 cycles was consistent with the uniaxial tests of solid specimens at the same conditions. Figure 32 shows optical and SEM micrographs of the crack initiation site of specimen 217. As shown in Figures 32(b) and 32(c), the crack initiated from porosity which is considered typical for the test material. Two separate cracks eventually coalesced, and their initiation sites were found on specimen surface replicas taken during test. Figure 33 presents replica micrographs that show a crack evolving at one of the initiation sites exhibiting an atypical surface appearance. As shown in Figure 33c, a 10-mil long crack evolved after 800 cycles. Figure 34 shows these crack surface length measurements from replicas versus cycles.

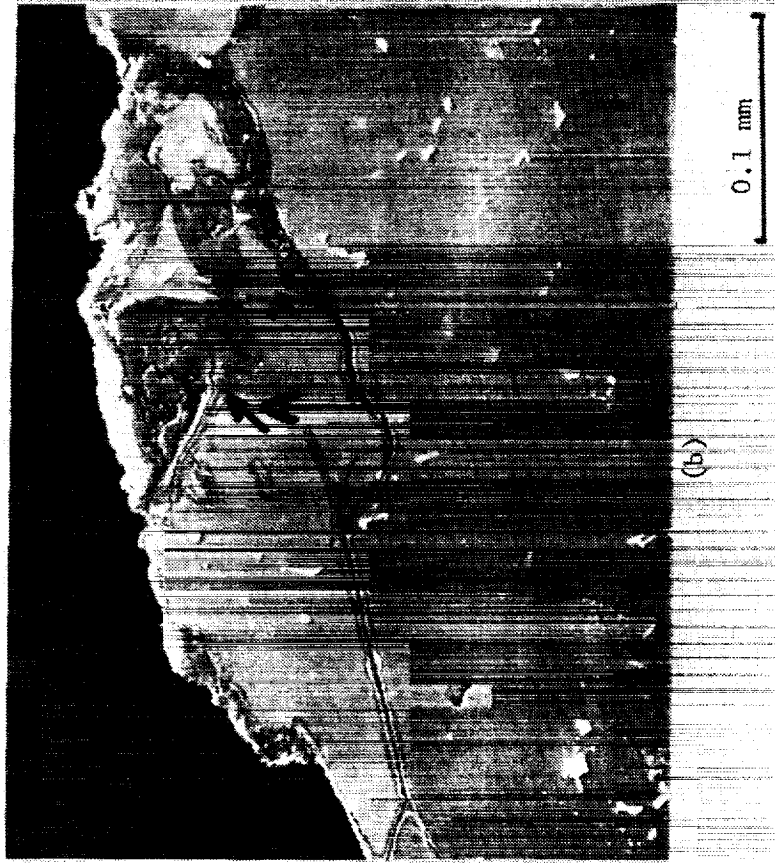
Figure 44 Characterization of longitudinal section through initiation site.

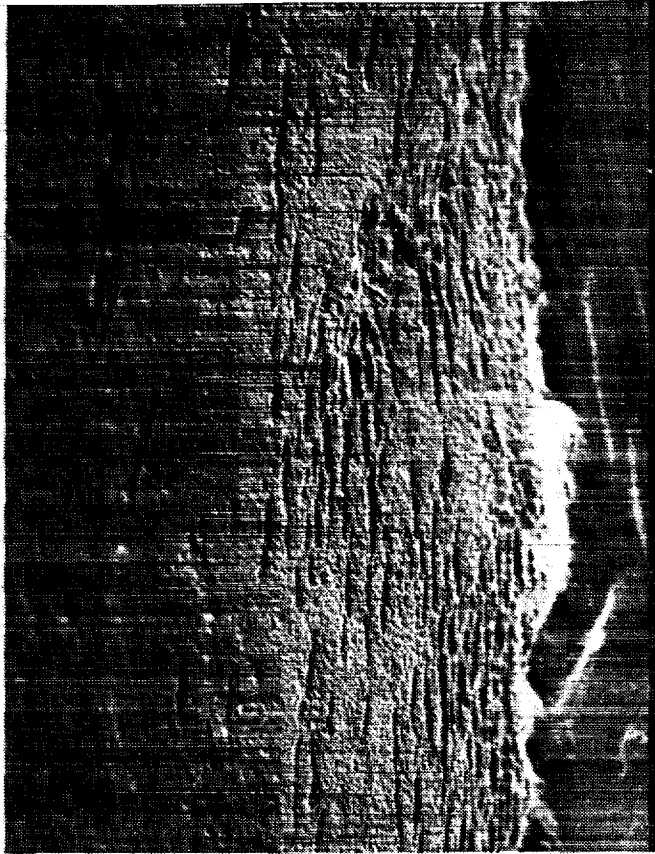
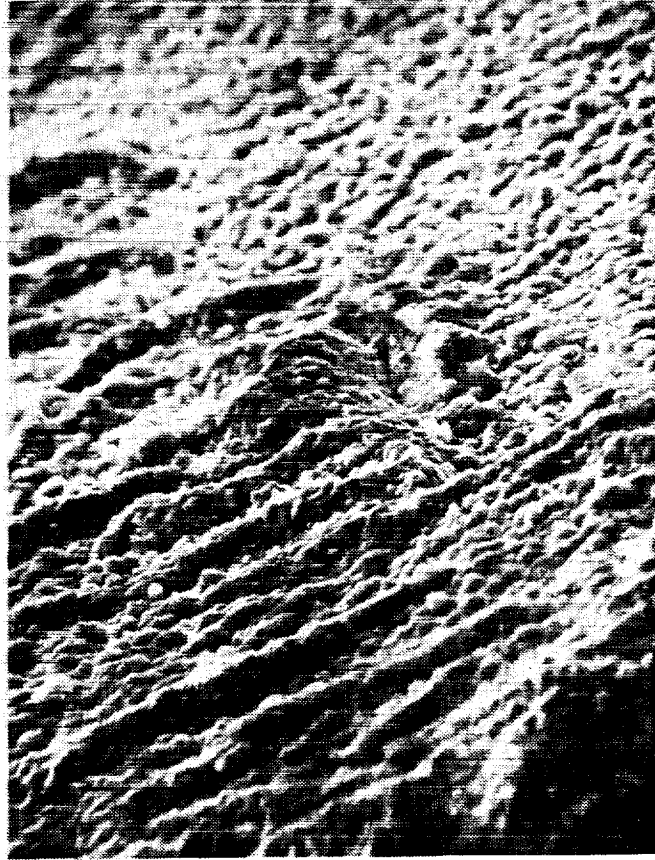
Figure 53 SEM micrographs of side of multi-axial specimen #205 showing rumppling occurs only in the vicinity of the fracture surface.

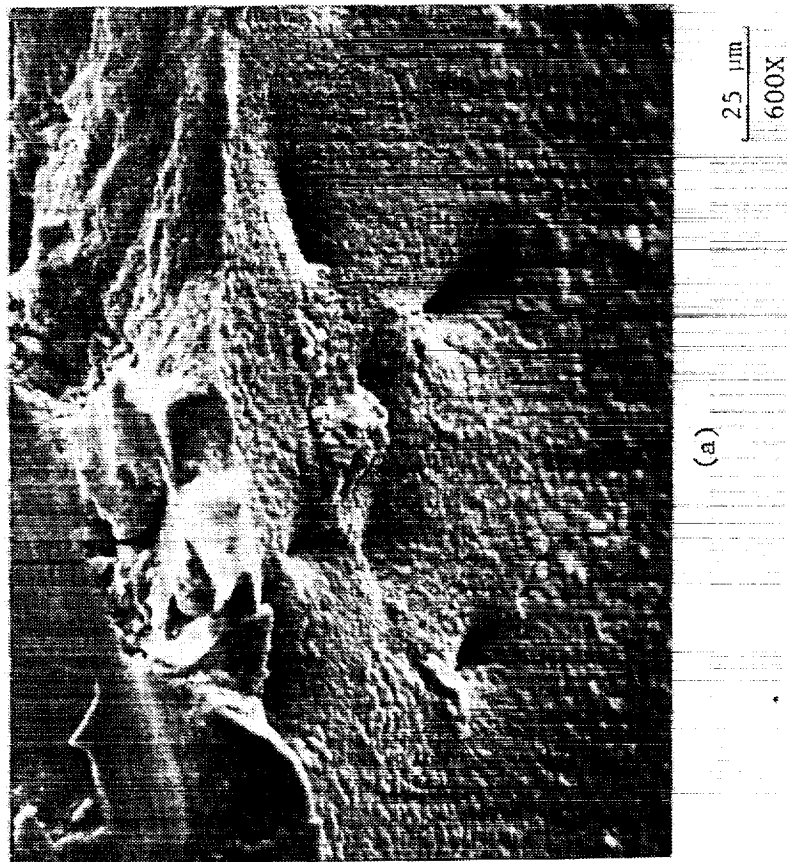
Figure 54 SEM micrographs of multiaxial specimen #205 showing evidence of porosity.
