1992 NASA/ASEE SUMMER FACULTY FELLOWSHIP PROGRAM

**JOHN F. KENNEDY SPACE CENTER
UNIVERSITY OF CENTRAL FLORIDA**

**EVALUATION OF ULTRASONIC CAVITATION OF
METALLIC AND NON-METALLIC SURFACES**

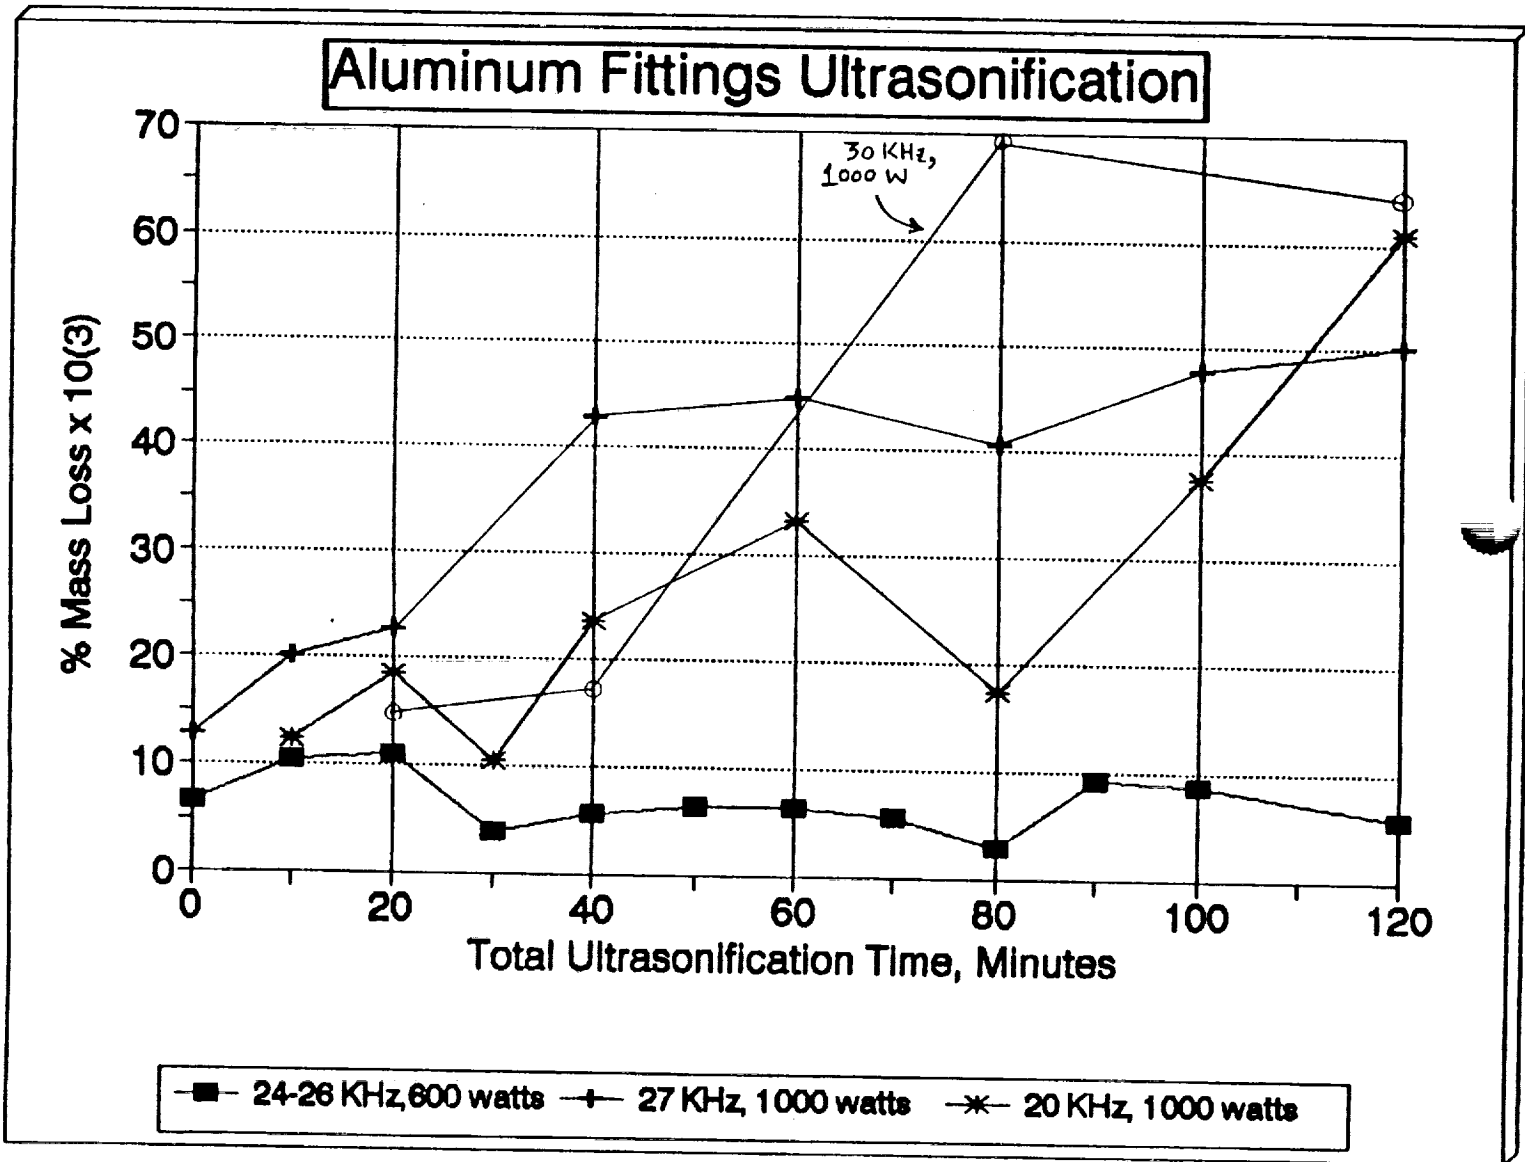
Figure 3-1

An anodized aluminum specimen (Figure 3-1) demonstrated the maximum percent mass loss of 11×10^{-3} for a 20-minute ultrasonic test cycle compared to a maximum of 5.4×10^{-3} for a 60-minute test run for a brass specimen (Figure 3-2), and 4.2×10^{-3} for a 20-minute test run for a stainless steel specimen (Figure 3-3). The data obtained on the anodized aluminum specimens reflect a random distribution of the percent mass loss ranging from 10.5×10^{-3} for a 10-minute cycle specimen to a 5.9×10^{-3} for a specimen tested for two hours. The brass specimens demonstrated a similar pattern of random fluctuation in the percent mass loss ranging from 1.1×10^{-3} for a 20-minute test run to 2.7×10^{-3} for a specimen tested for two hours. The mass loss pattern observed for the stainless steel specimens was similar to the brass and the
