TDA Progress Report 42-111

Fault Identification Using Multidisciplinary Techniques at the Mars/Uranus Station Antenna Sites

D. S. Santo¹M. B. Schluter²R. J. Shlemon³

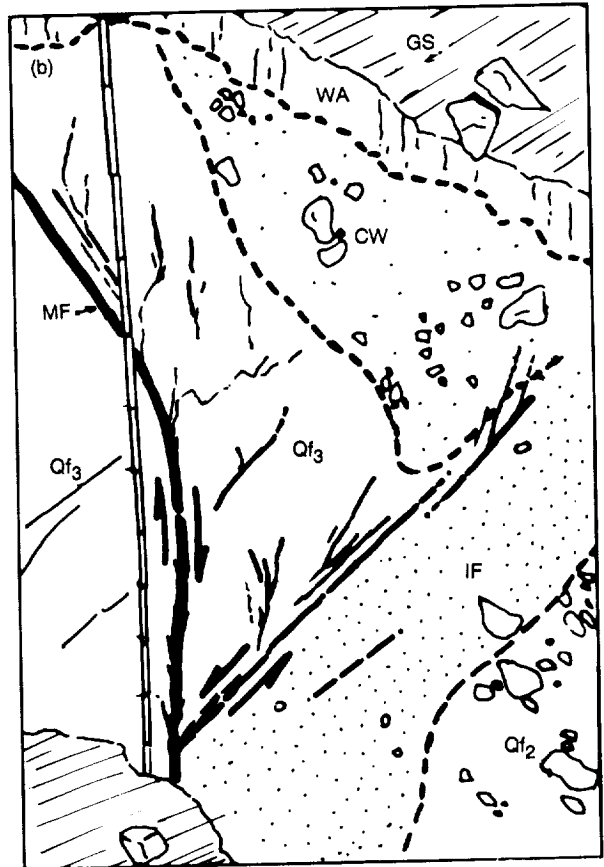
Fig. 8. Photo (a) and sketch (b) of fault observed in Trench 8 showing offset alluvial units and possible offset of scarp derived colluvial wedge. Qf_3 = Unit 3 fanglomerate, Qf_2 = Unit 2 alluvium, WA = weathered alluvium below active geomorphic surface, IF = loose, fine-grained infilling, MF = main fault splay, and GS = ground surface. The folding rule is 1.8 m long.

The Photolineament 1 fault system is characterized by a zone of dislocation several feet wide. Movement has been typically accommodated along multiple slip surfaces and fractures. The slip surfaces generally dip steeply 60 to 90 deg to the south with the north side up. Minimum offset was in each case greater than the maximum trench depth, which varied from 1.8 to 3 m. Further, some fault-associated fractures extend into a colluvial wedge, presumably deposited on a scarp formed by an earlier faulting event (Fig. 8). This fact, combined with a minimum offset observed of least 1.8 to 3 m, suggests that the multiple movements have occurred on the Photolineament 1 fault system. However, no site-specific information is presently available from which to judge the recurrence of individual tectonic events.

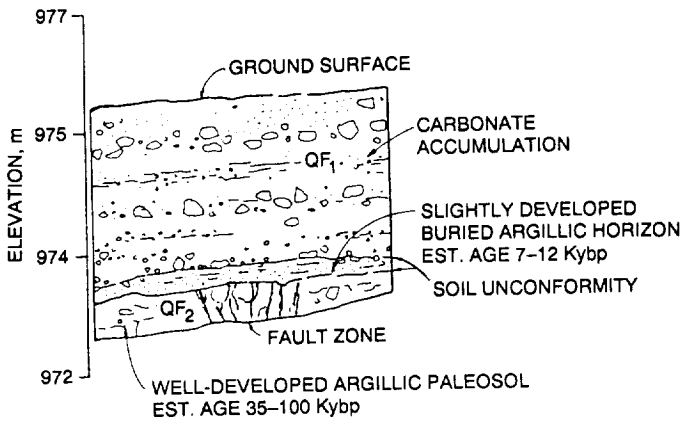
Fig. 9. Sketch of fault observed in Trench 9 showing diagnostic soil horizons used to bracket the age of most recent fault activity.

In Trench 11, the fault offsets a strongly developed buried argillic horizon in fan Unit 2 (Fig. 9). Based on relative profile development, this soil required at least 35,000 to 40,000 years to form; however, it may be much older [12]. Immediately above the fault at this location is a buried cumulic soil profile within fan Unit 1. The cumulic profile is characterized by a weakly developed argillic horizon (Btjk) with disseminated carbonate filaments. This soil is an estimated 7,000 to 12,000 years old [12] and is not offset by the Photolineament 1 fault. Accordingly, while not wholly definitive, the nondisplaced Unit 1 soil horizon exposed in Trench 11, the lack of any fault-controlled geomorphic expression in Unit 1 fans, and the subdued scarps characteristic of the older fans suggest that the last fault displacement most likely occurred in pre-Holocene time.

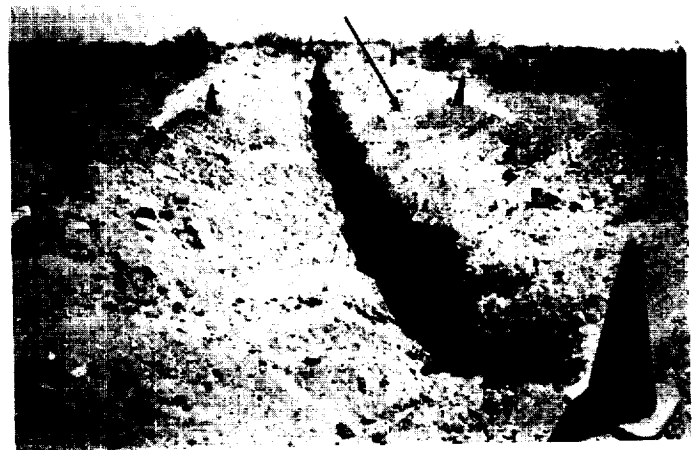
Fig. 10. Fault exposed in Trench 12 that juxtaposes Unit 2 and Unit 3 alluvium. Note color change at fault: Unit 3 is light colored, Unit 2 is dark colored.

Three trenches were excavated across the trace of Photolineament 3 (Fig. 7). Trench 12 exposed a fault that displaces Unit 2 and Unit 3 alluvium (Fig. 10).

Trench 13, located east of Trench 12, exposed both unbroken Unit 2 alluvium and a buried paleosol estimated to be at least 35,000 to 45,000 years old. These fault-paleosol relationships suggest that the last displacement of the Photolineament 3 fault occurred between about 35,000 to 100,000 years ago.
