NASA Technical Memorandum 105863

Integrity Testing of Brush Seal in Shroud Ring of T-700 Engine

INTEGRITY TESTING OF BRUSH SEAL IN SHROUD RING OF T-700 ENGINE

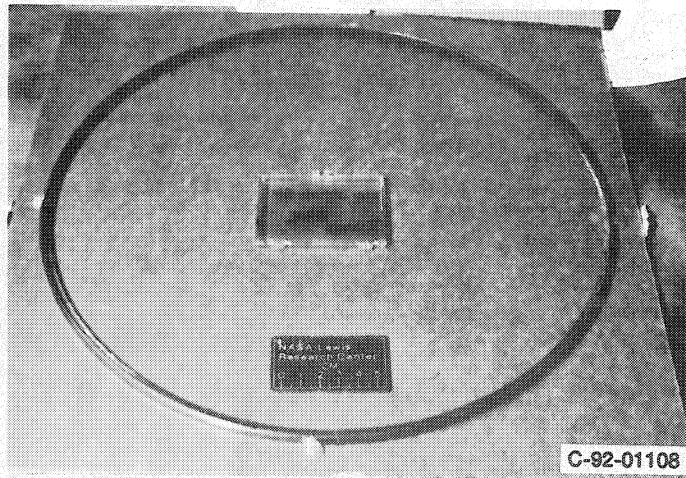
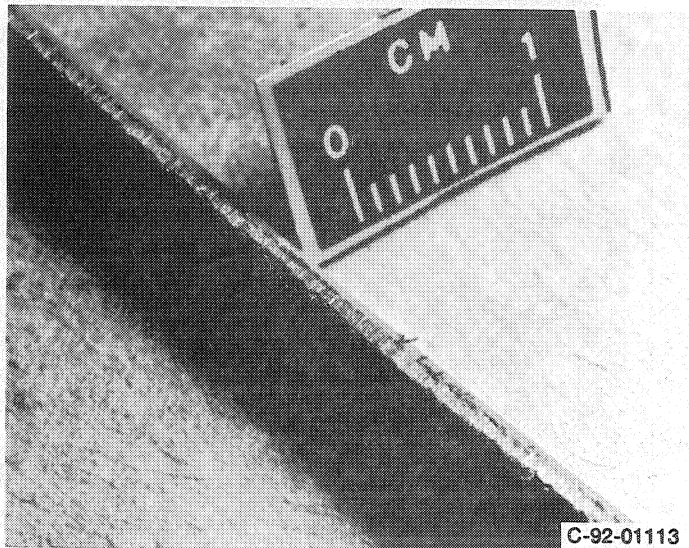
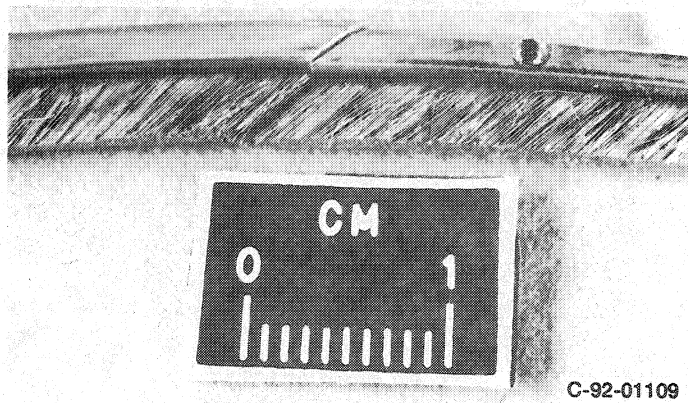
Figure 2.—Split-ring brush seal.

(a) Overview of brush seal.

(b) Edge view of brush seal.

(c) Split end view.

Figure 2 shows several views of the split-ring brush seal, illustrating the joint and the restraining pin hole. Figure 3 shows the unusual brush cross section that was crafted to fit the turbine shroud between the two labyrinth-honeycomb seals. Figure 4 shows a closeup view of the installed brush; and figure 5, an overall view of the installed brush. Figure 6(a) shows the pressure tap locations in one of the shrouds. A thermocouple was installed in each shroud (fig. 6(b)); three of the four were functional. Figures 6(c) and (d) show views of the shroud ring and instrumentation lines.

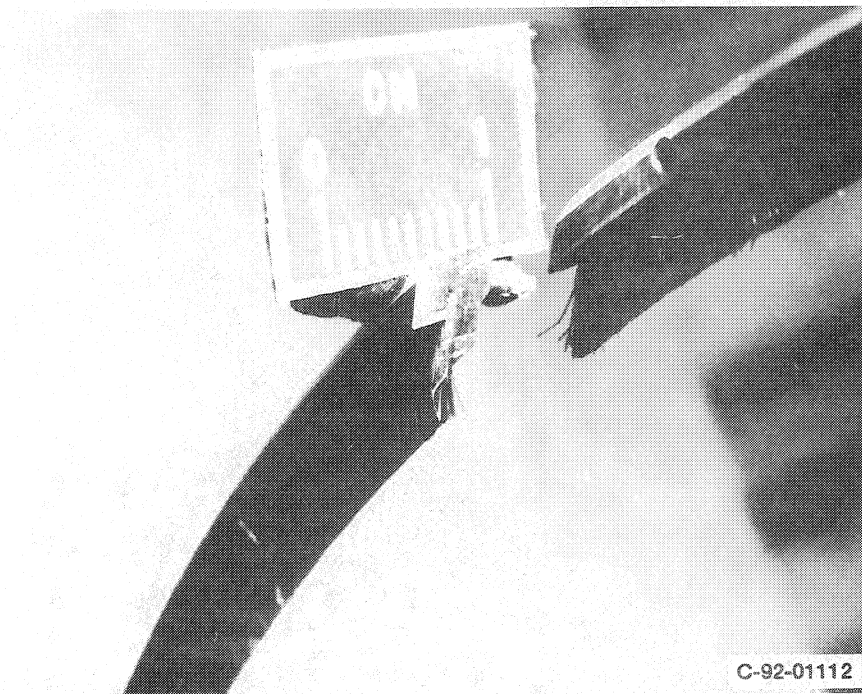
Figure 3.—Brush seal cross section crafted to fit turbine shroud between two labyrinth-honeycomb seals.

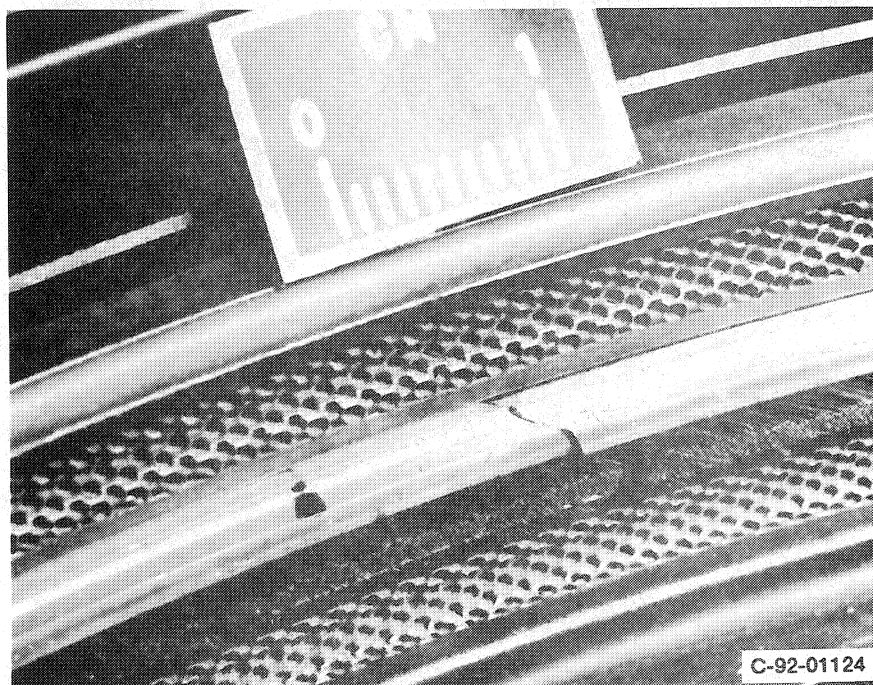
Figure 4.—View of installed brush seal.

Before proceeding to discuss post-test results, we return to the installation of the brush into the power turbine shroud. Figures 4, 5, and 7 show views of the installed brush seal. The brush was designed for an interference of 0.51 mm (0.020 in.) diametral. The actual interference could not be determined, but estimates of the pretest brush clearance were -0.51 to -1.27 mm (-0.02 to -0.05 in.) diametral. Measurements of the shrouds differed as did those for the rotor. Although the differences were only a few thousandths of an inch (mils), they represented a significant percentage of the clearance gap. It was also determined that individual blade sets could have a step change of 0.229 mm (0.009 in.) from one blade set to the next. These surface irregularities are shown in the post-test photograph (fig. 8).

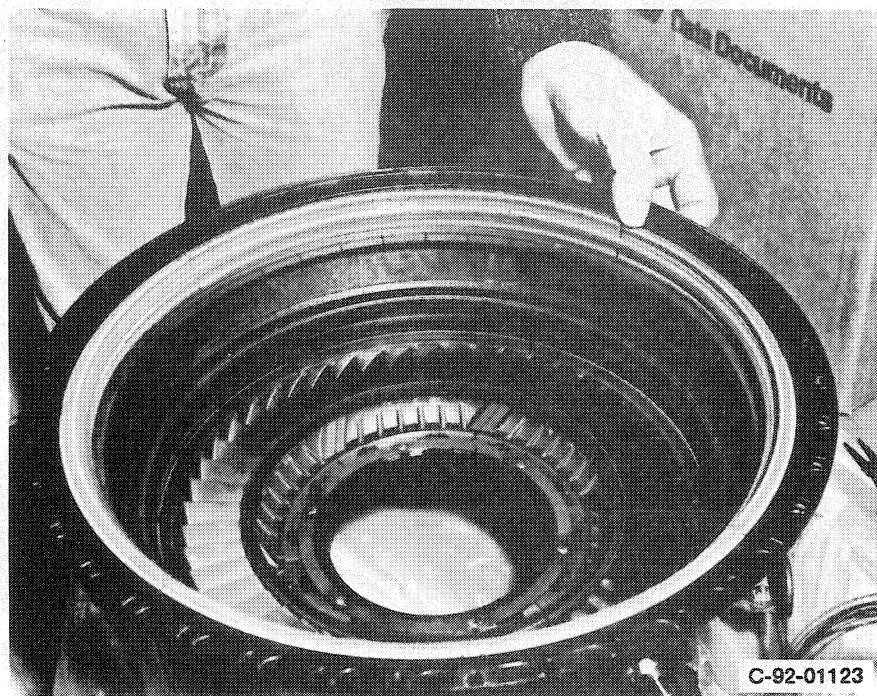
Figure 5.—Overview of installed brush seal and power turbine housing.

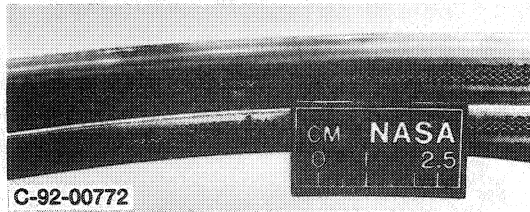
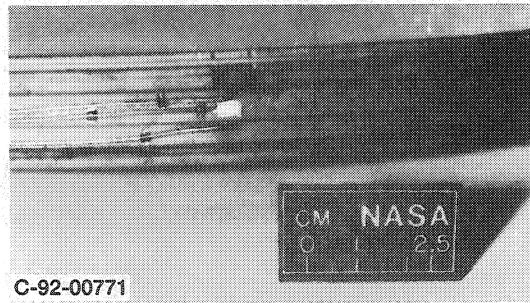
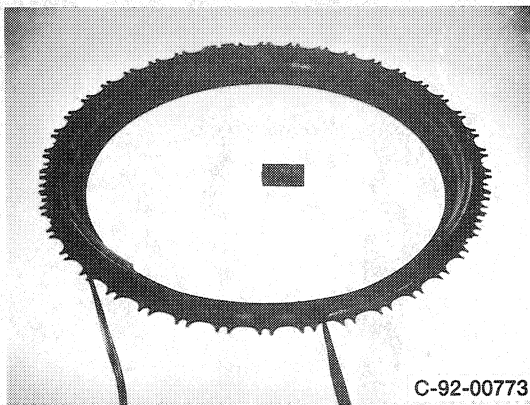
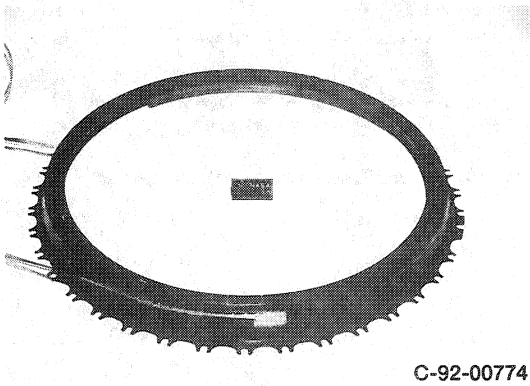
Figure 6.—Pressure tap and thermocouple locations on shroud seal.

(a) Pressure tap hole.

(b) Thermocouple mount and pressure tap lines.

(c) Shroud ring with three seal segments and instrumentation lines — downstream view.

(d) Shroud ring with three seal segments and instrumentation lines — upstream view.

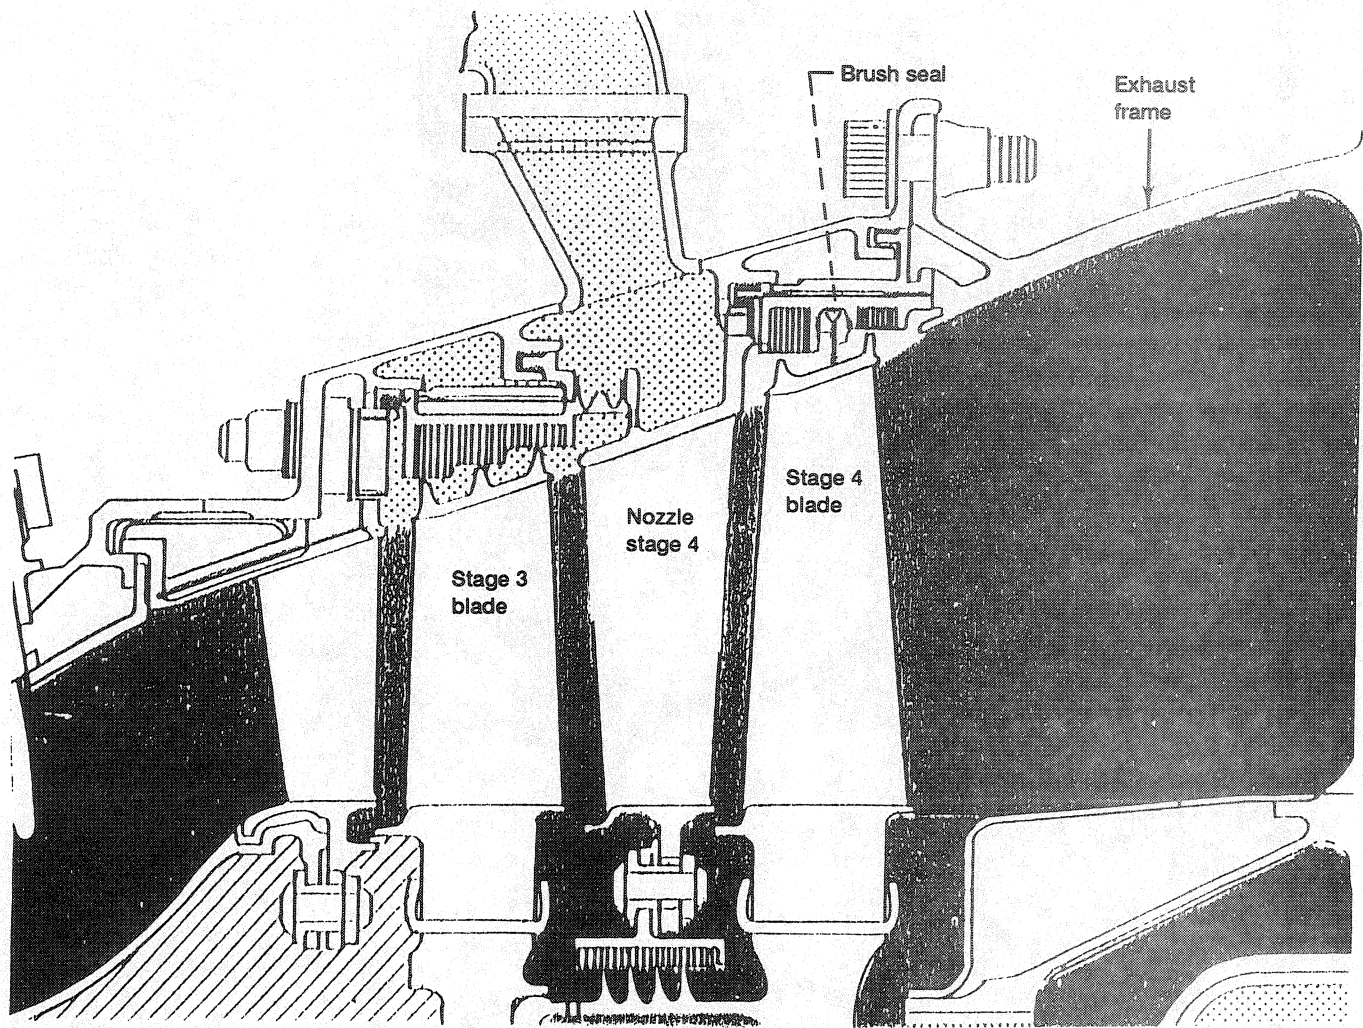
Figure 7.—Schematic of power turbine.

Assembly of the turbine with the shroud required forcing the brush past the upstream labyrinth tooth without any visual or instrumented guidelines; see figure 7 (power turbine). Forcing the brush over the labyrinth tooth spread the bristles axially into the upstream direction. This type of spreading alters the bristle packing configuration, but the extent of alteration and the degree of spreading are unknown. Post-test results indicated that perhaps two to three upstream bristle rows remained spread with possibly one downstream bristle row in disarray. Still the brush was resilient because the remaining rows appeared to be in position. The flexibility of a brush seal and the abuse it can withstand appear to be significant.

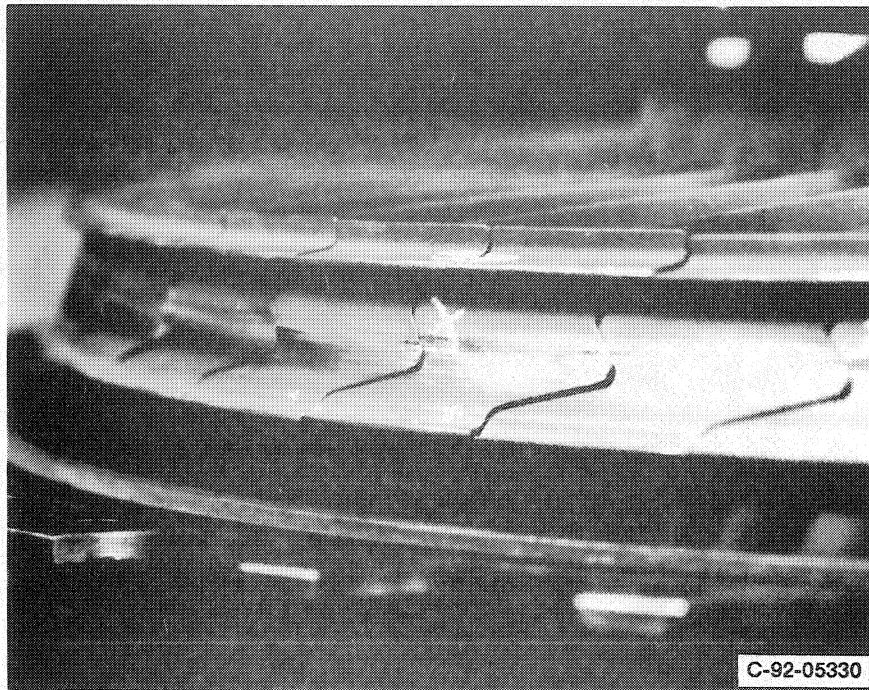
Figure 8.—Fourth-stage turbine after testing, showing polishing of leading edges.

Further assessment of figure 8 shows that the leading edges of the blade sets were polished. Some brush wear was noted and expected because René 80 is hard relative to the annealed Haynes 25 and the heat-sinking capacity of the brush is very small relative to that of the rotating blade sets. The surface irregularities at the rubbing interface can be seen. Although there was some evidence of material transfer, no metallurgical samplings or rotor measurements were taken because of the tight program schedules for the engine operations. This was a major error; however, if there comes a time when the rotor can be

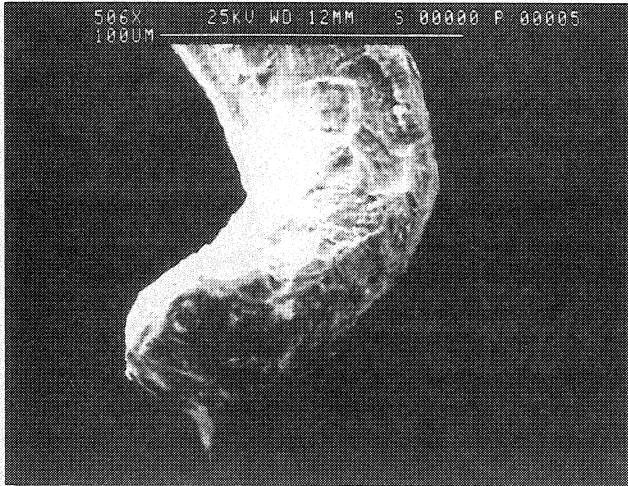
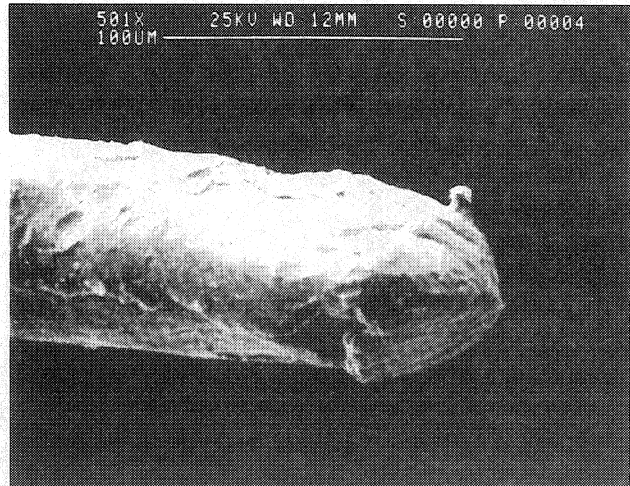
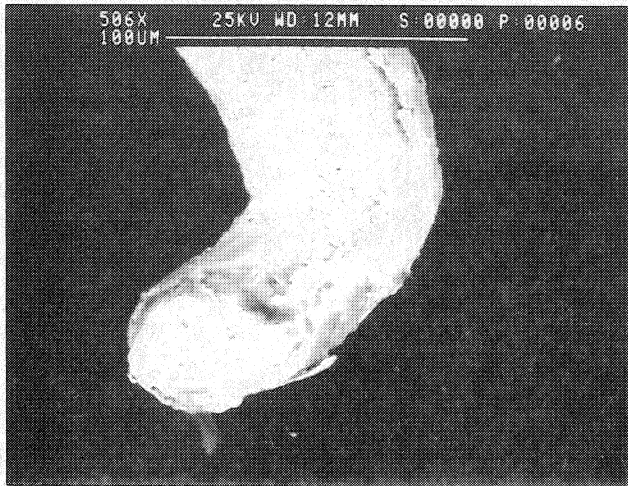
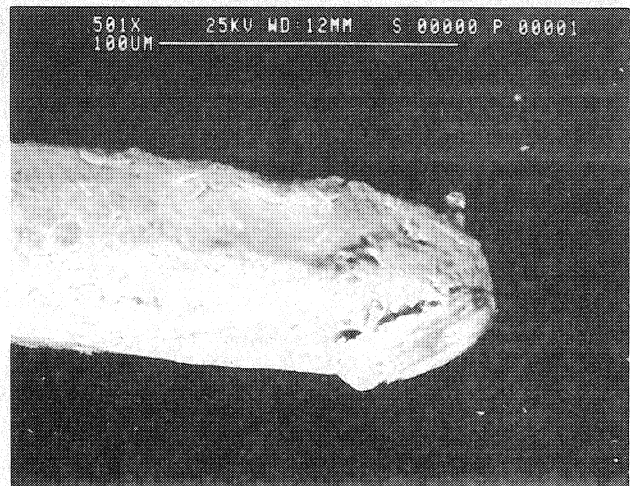
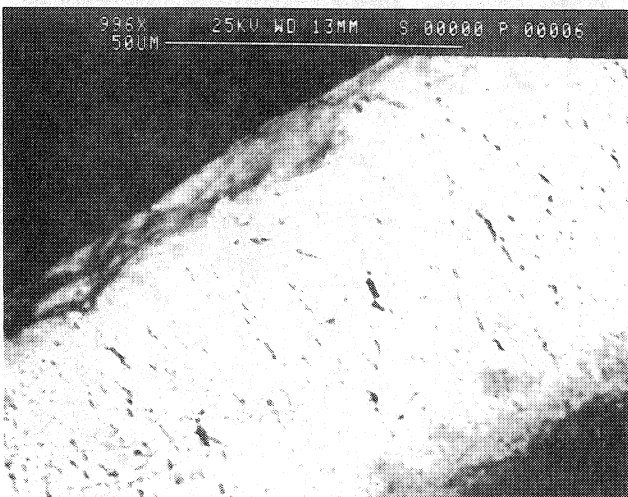
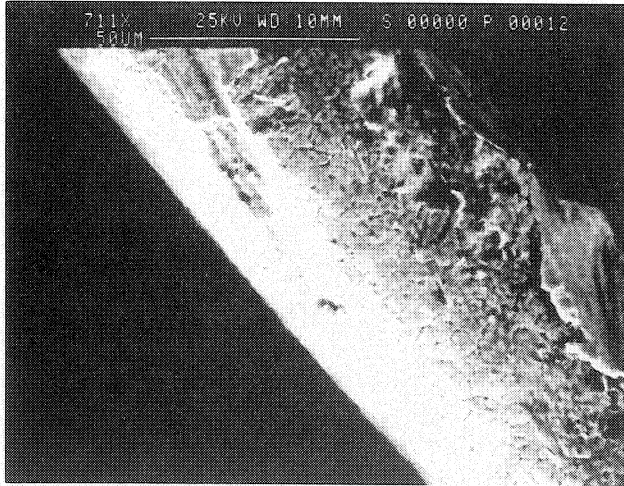
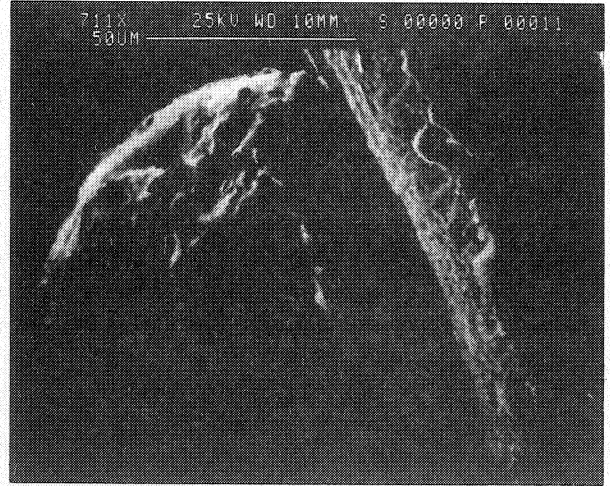
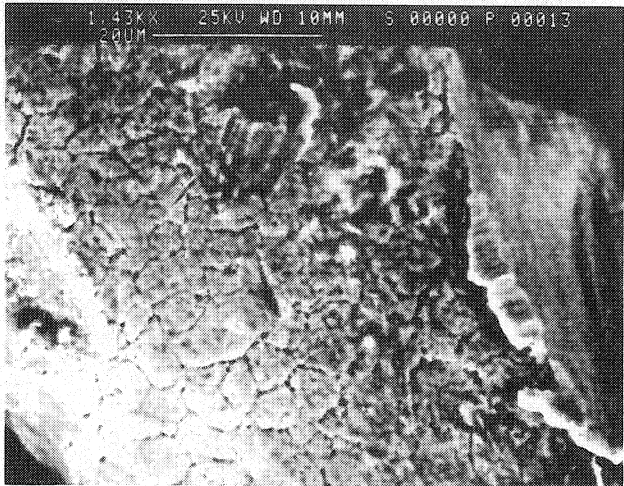
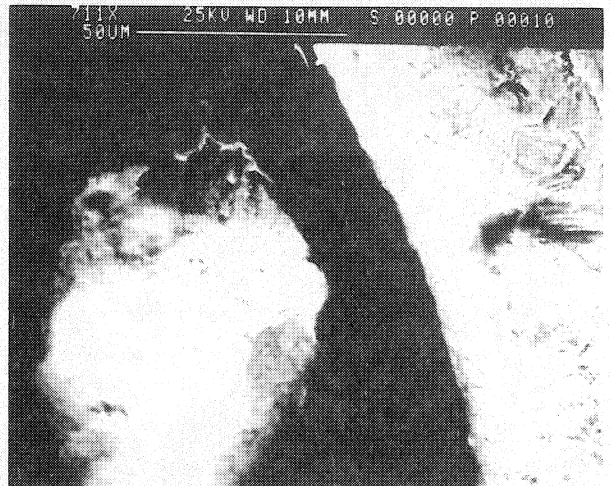
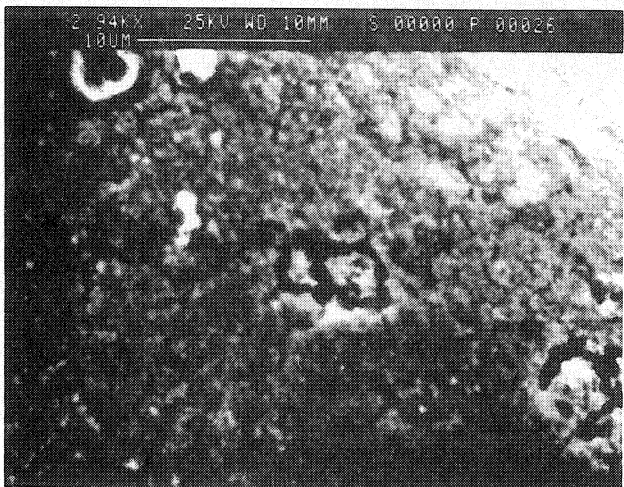
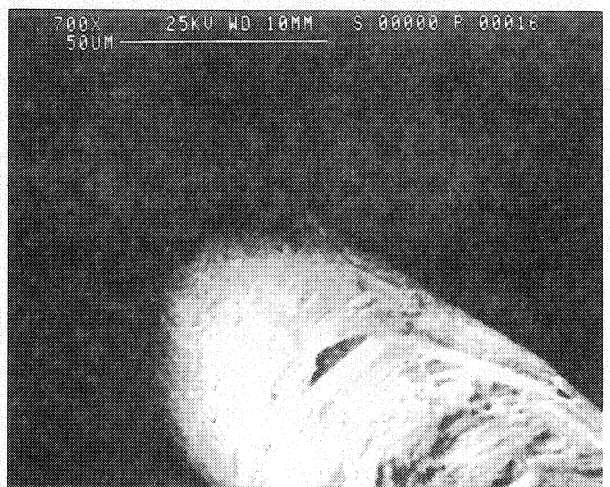
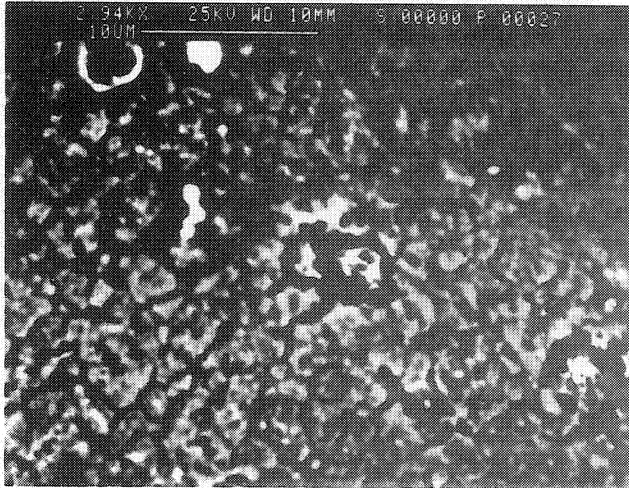
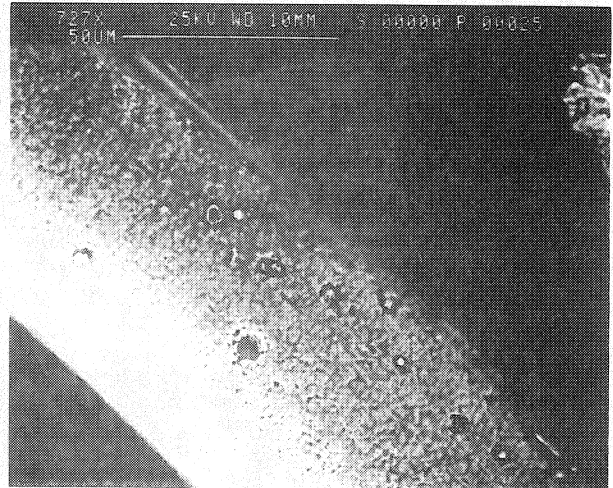
Figure 9.—Typical brush seal debris found in engine exhaust duct.

(a) Typical bristle tips.

(b) Surface features.

must be protected against initially high levels of debris generation. Analysis of these and other fragments showed severe oxidation with some degree of stiffness remaining. These fragments are not passive debris; they can cause damage to critical components. The only debris noted in the gear-tooth rotor study (ref. 3) was a "lubricant powder." Thus, surface speed, rotor roughness, and brush construction play a major role in determining the spectrum of debris generation.

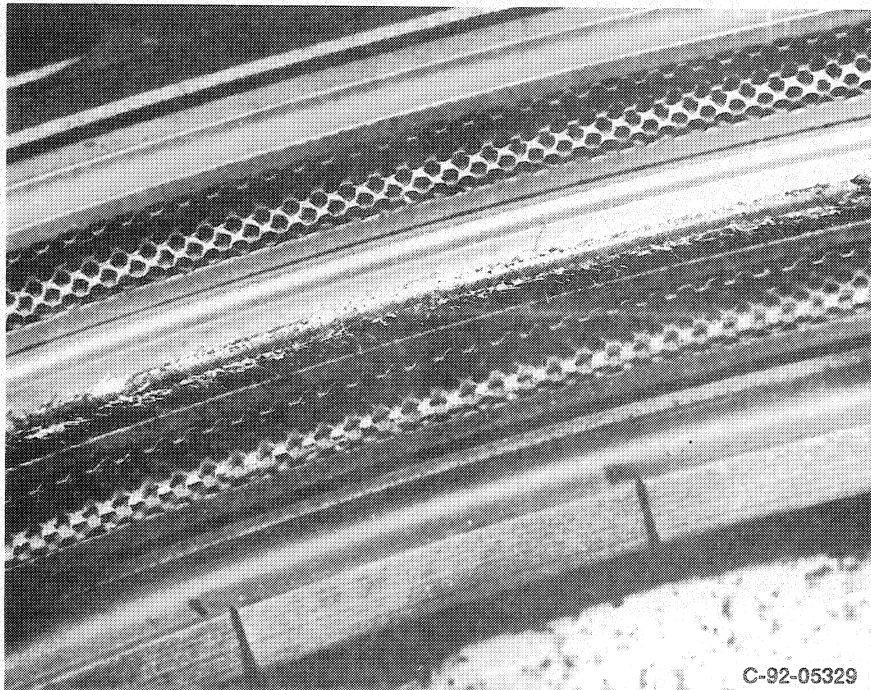
Figure 10.—Post-test view of brush seal showing bristle spreading and core of rubbed bristles.

Figure 10 illustrates bristle spreading after testing, with a central core of bristles rubbed (probably clip cut and worn to shape). Although the environment was hostile, the brush did not disintegrate, but bristle pullout could be noted in a few places. Some upstream bristles (two or three rows) show spreading and perhaps one row downstream (toward the exhaust). The remainder of the bristles show wear (or cutting plus wear). Detailed estimates of the bristle stubble heights are given in figure 11(a) as taken from the set of photographs in figure 11(b) corresponding to positions (joint, J+1, J+1.5, J+2, J+2.5, J+3, J+3.5, J+4, and J+4.5) shown in figure 11(a). The last two photographs in figure 11(b) correspond to the minimum stubble height, where the rotor actually rubbed the fence (position J+3); the view is looking toward the bristle stubbles to show the rubbed fence. Figure 11(c) shows wear track and fence rub, and figure 11(d) shows the joint wear track.

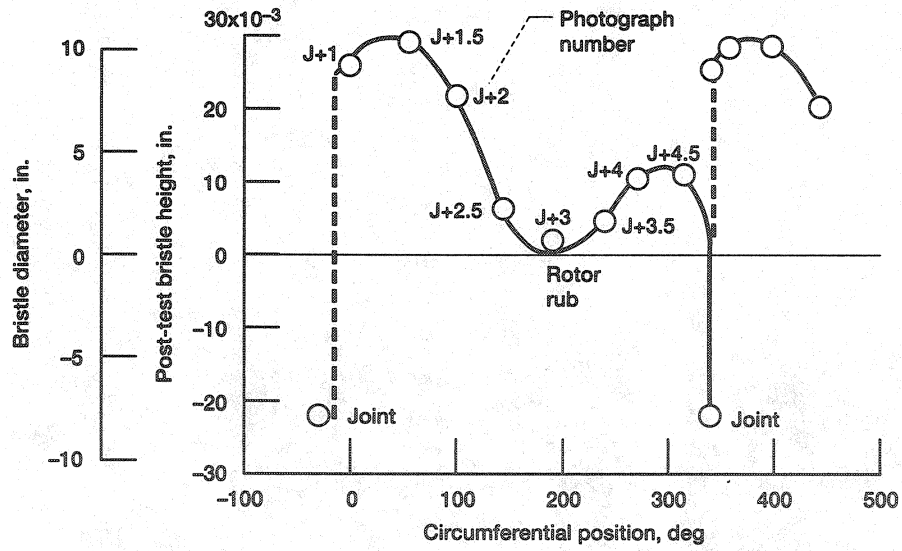
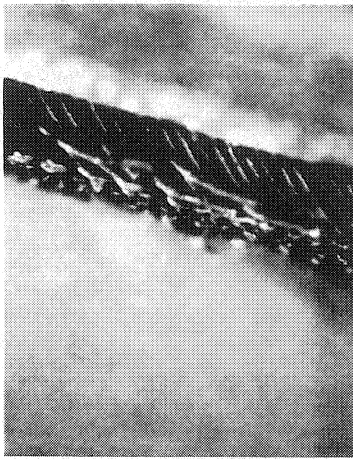
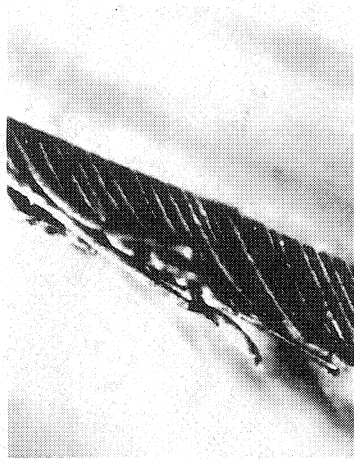
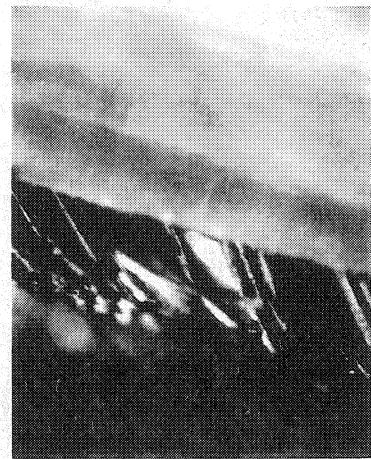
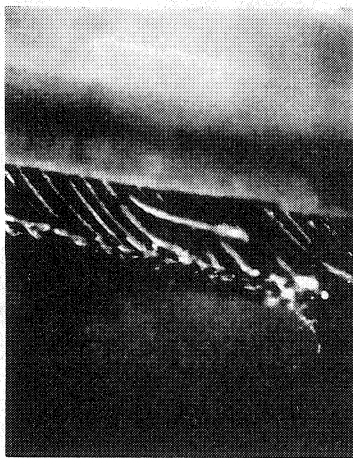
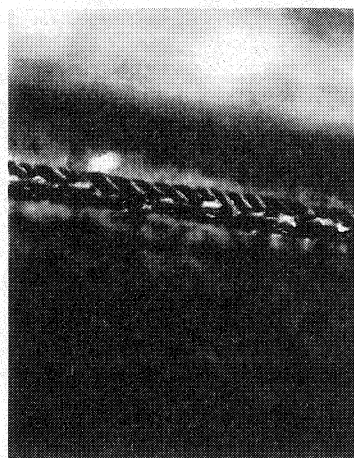
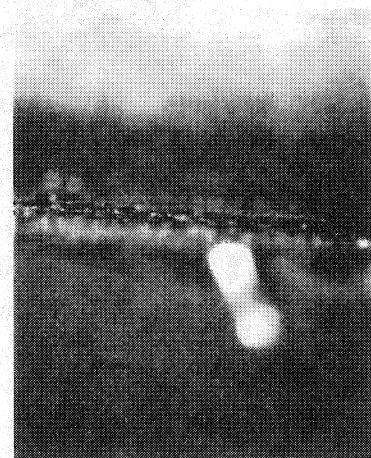
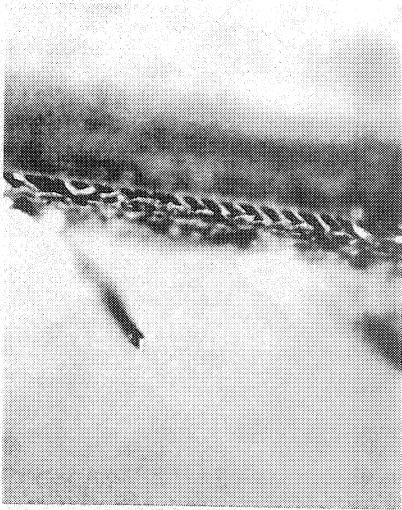
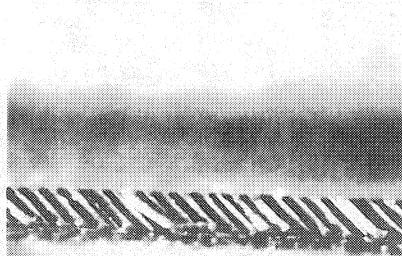
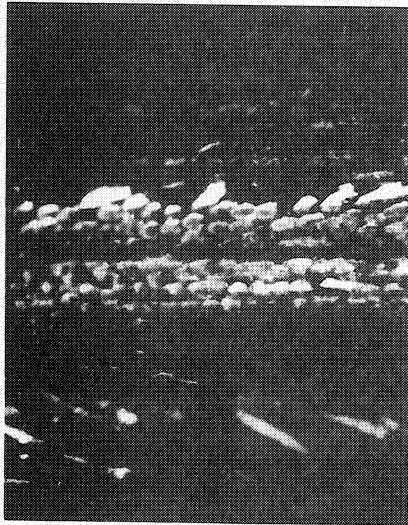
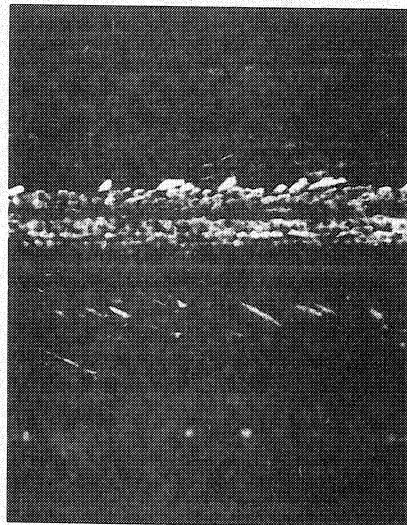
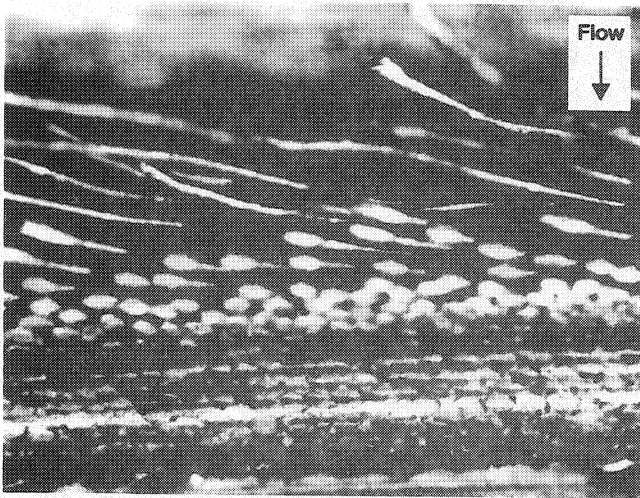
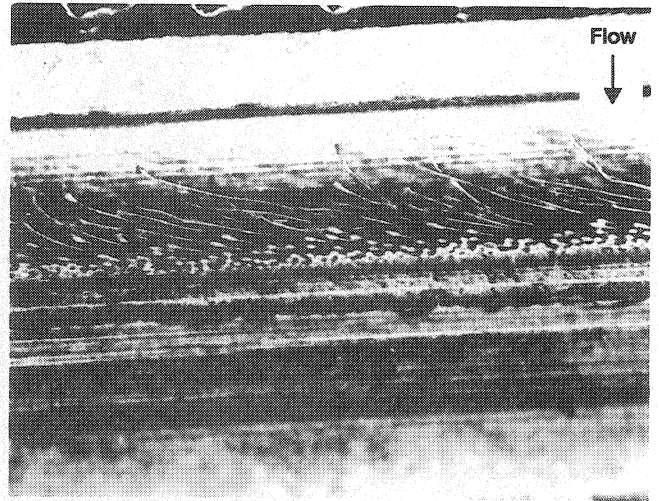
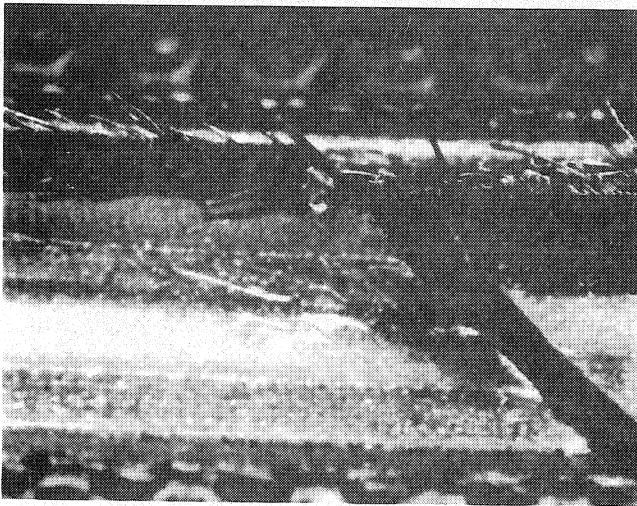
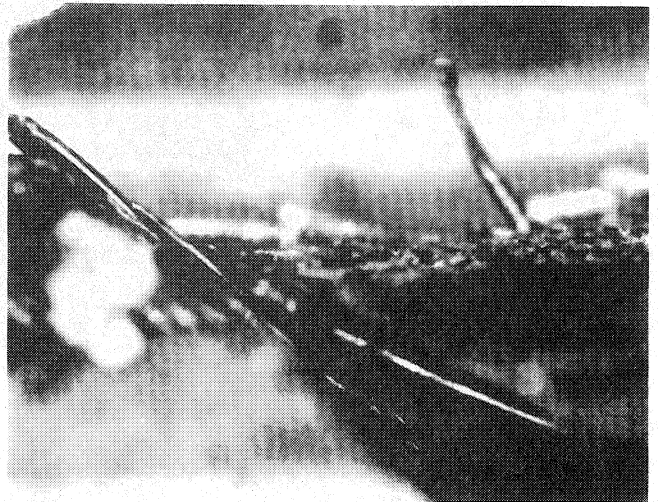
Figure 11.—Post-test bristle stub height and backing washer rub. Bristle diameter, 0.0028 in.

(a) Bristle height versus circumferential position.

(b) Bristles at backing washer.

(c) Wear track and fence rub.

(d) Joint wear track.

Details of the bristles (fig. 12) show an ingrained wear pattern that is characteristic of a high spot in the rotor which cuts a shallow groove as it wears in. Furthermore, the rotor ran eccentric with respect to the seal either during cycling or steady state or both. Plots of bristle measurements show rubbing of the seal ring at 180° to the pinned point and a step across the joint where the end of the split seal rubbed the rotor.

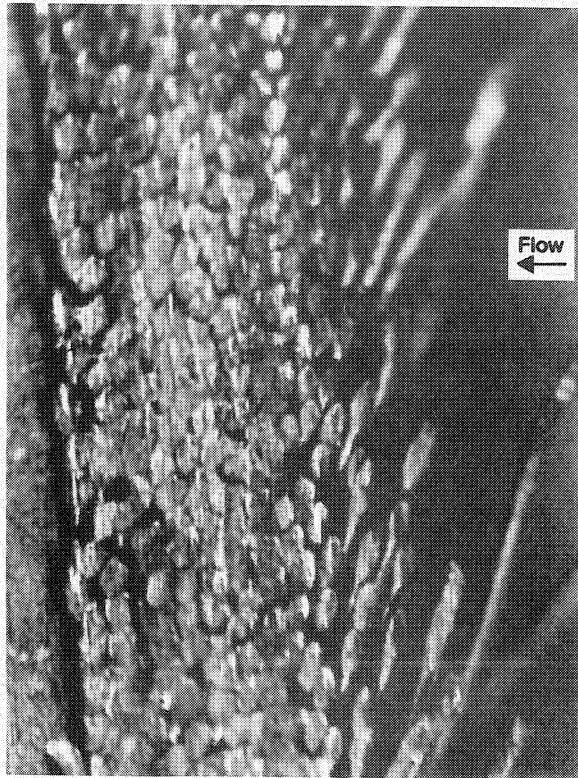
Figure 12.—Details of brush seal wear pattern.

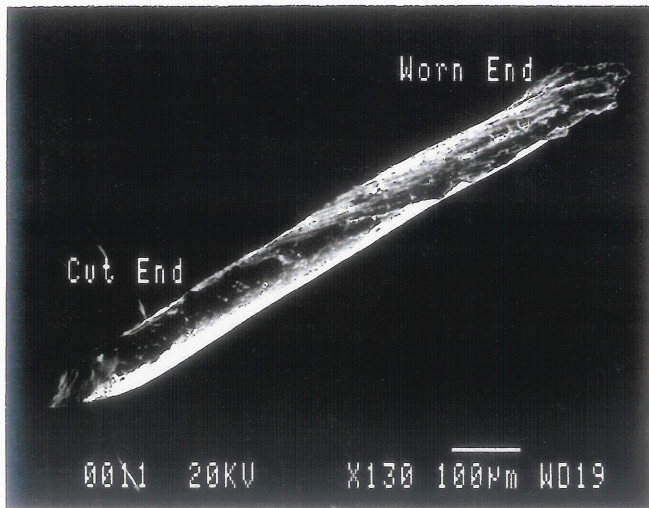
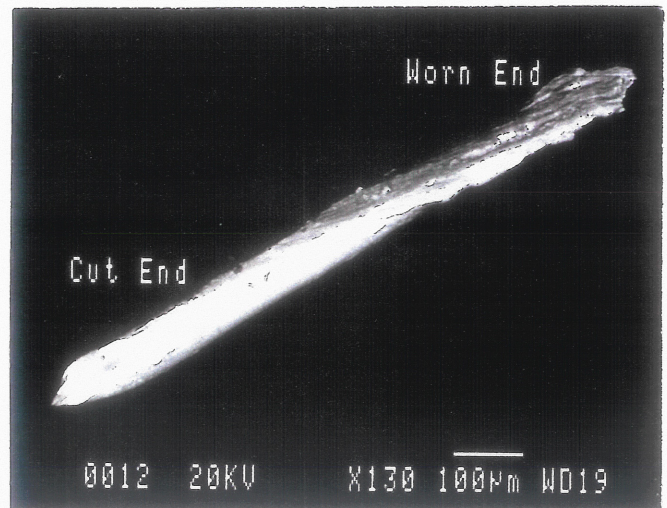
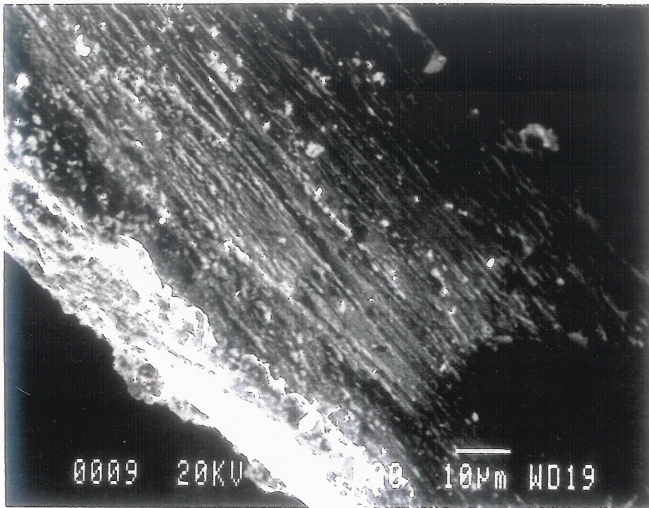
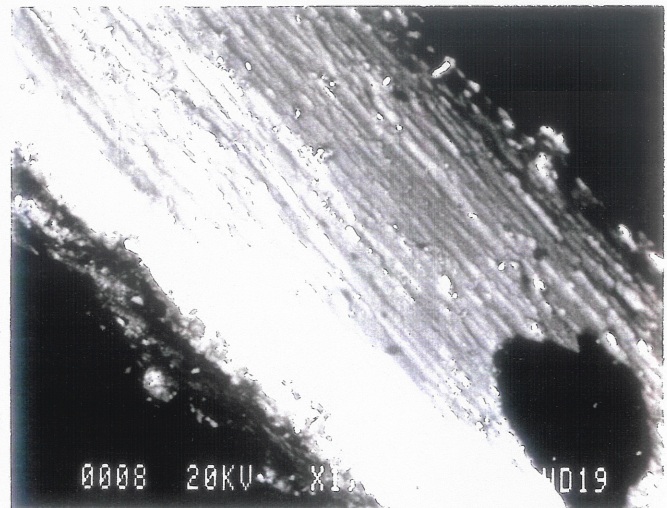
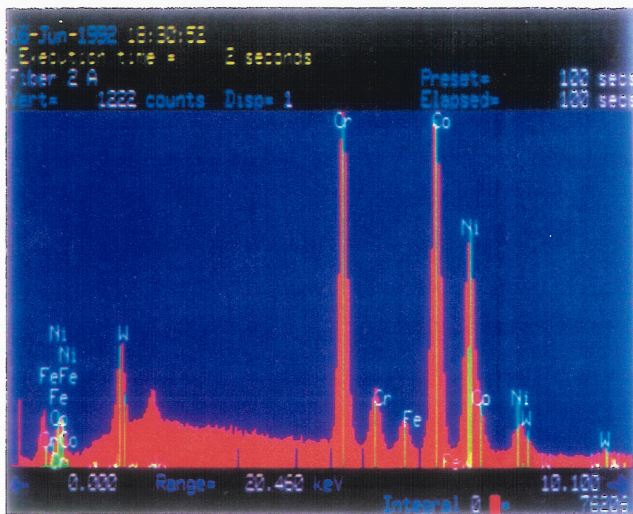
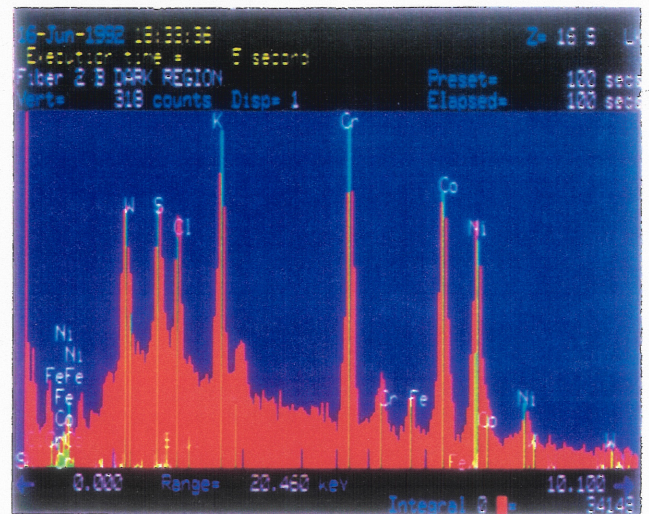
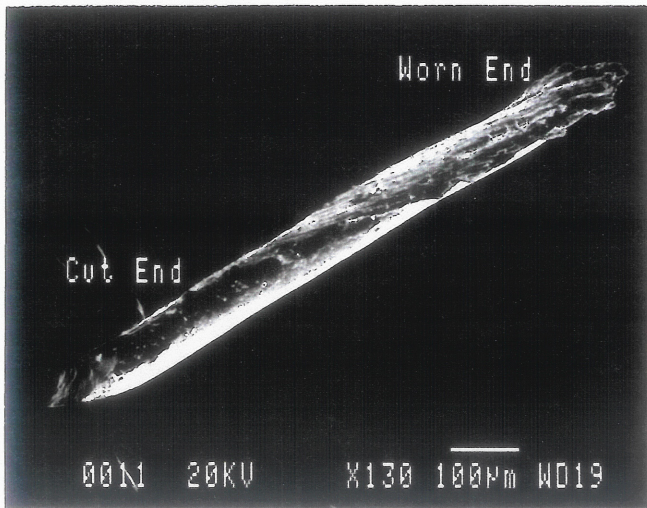
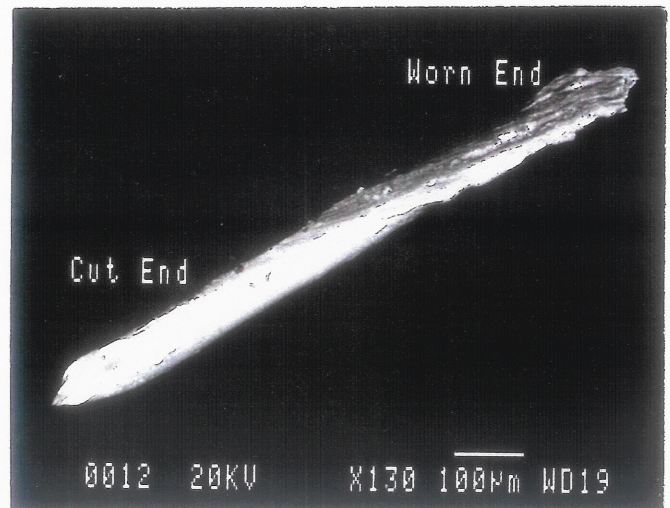
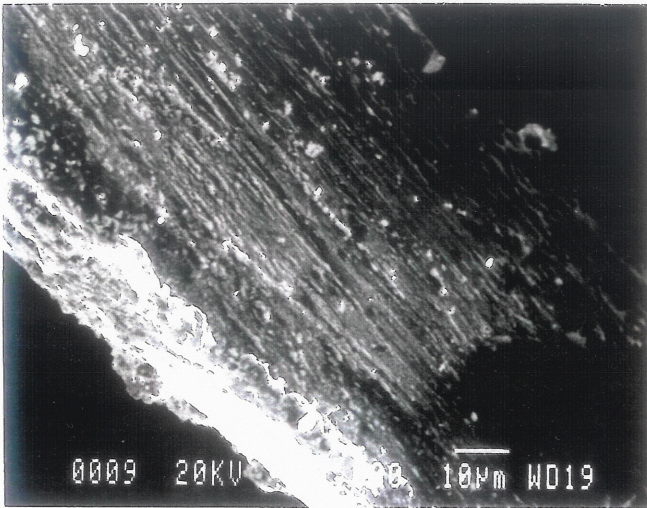
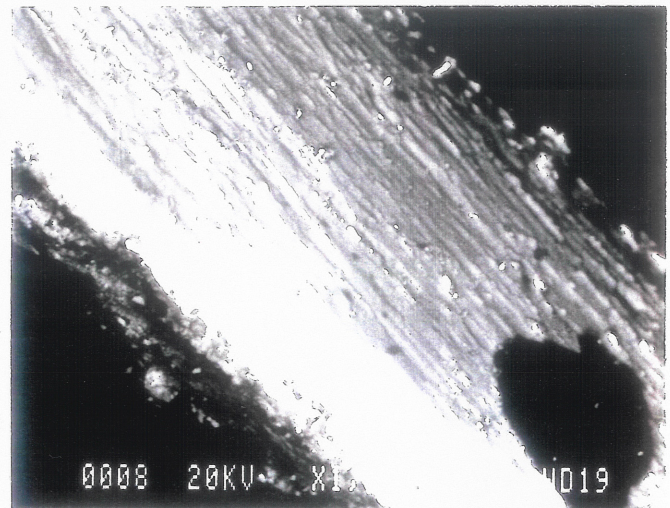
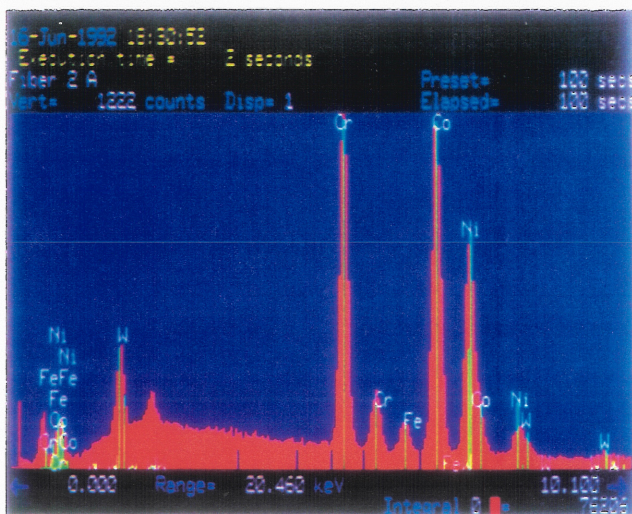
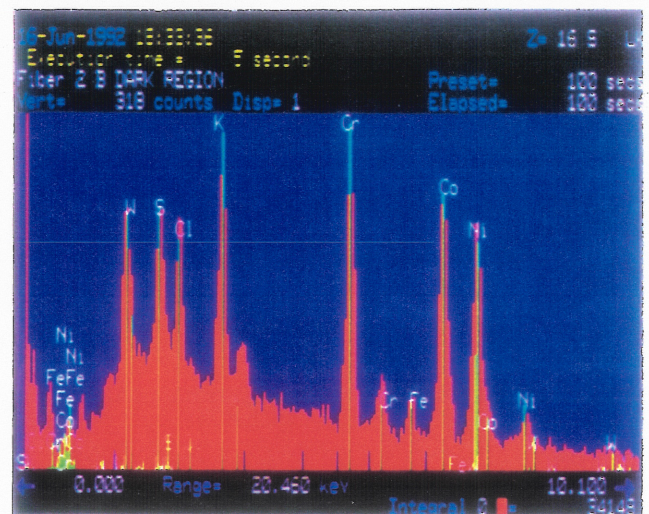
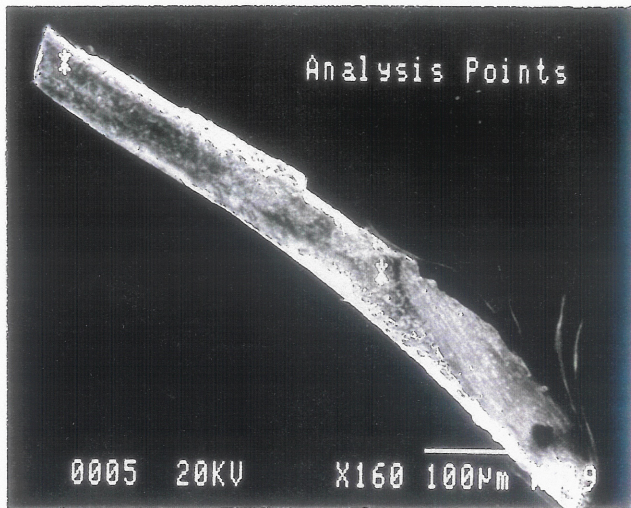
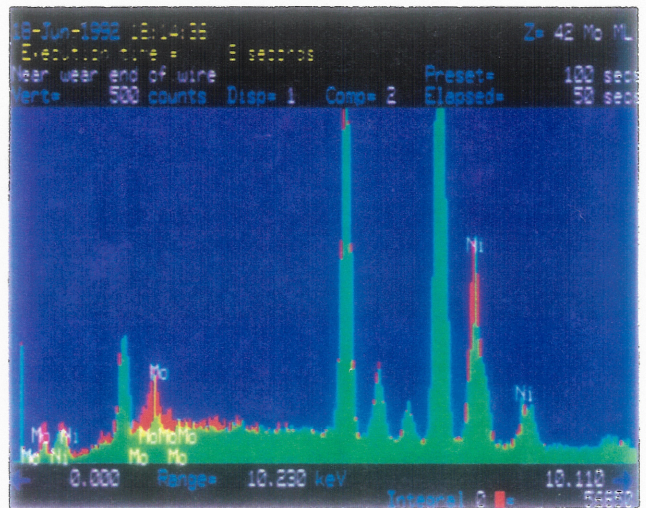
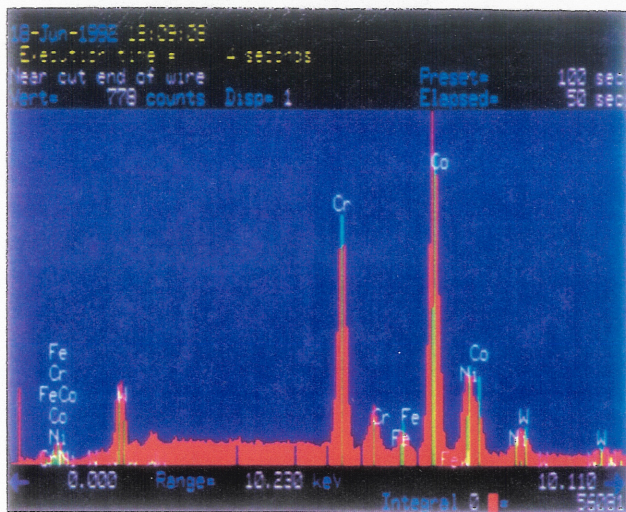
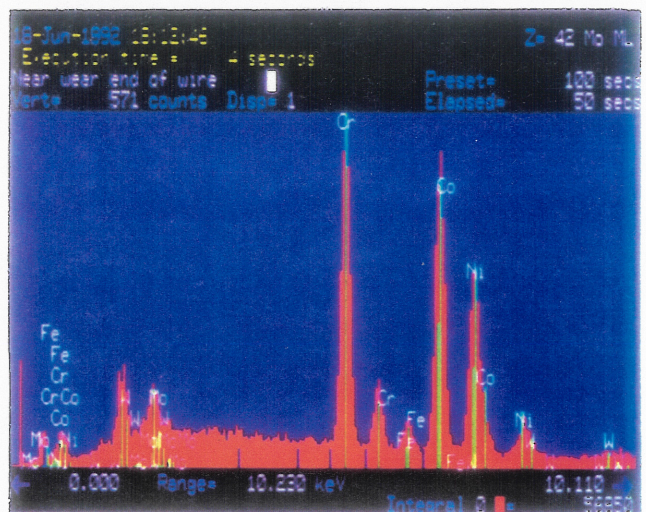
Figure 13.—Post-test metallographic results for single bristle.

(a) Bristle 1 spread away from wear track.

(b) Analysis of bristle 1.

(c) Bristle 1 at increased resolution.

Metallographic results (fig. 13) illustrate some material migration along the bristle and material transfer both from and to the surface. Material smears seem to be in line with a softer material rubbing a harder material even to the point of melting. Thus, one would conclude that the interface became very hot, but the interface followed the classic Block slider problem, where the penetration depth (radial) is very small. Thus, the thermal effect at the interface appeared to be topical, wearing the brush bristles until line contact with the rotor and smear transfer of both materials occurred. Such evidence is presented in figure 14, for an individual bristle that was clipped from the brush. The clipped end was removed from the interface, and the worn end is representative of interface materials. There are material smears, oxidized spots, and apparent pits. It is not clear how the irregularities of the interface affected these results, but it is clear that materials were transferred.

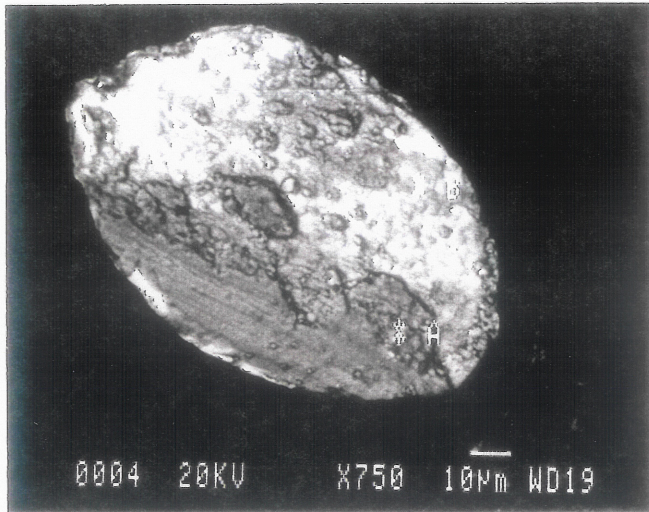
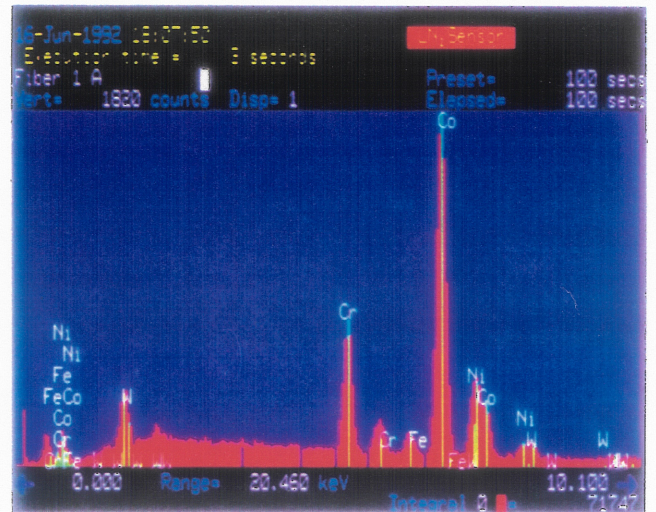
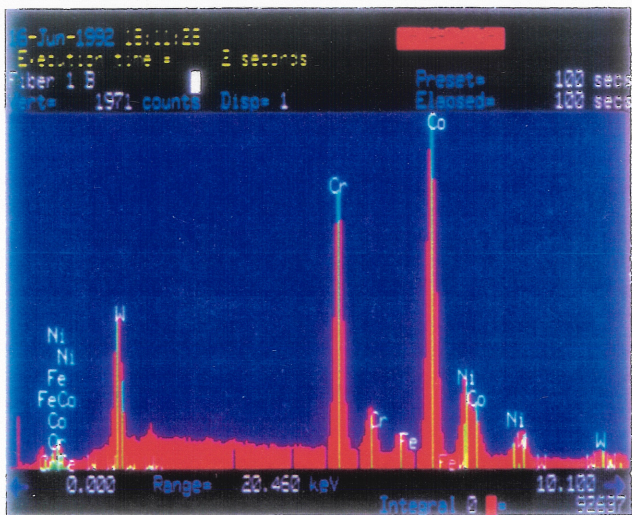
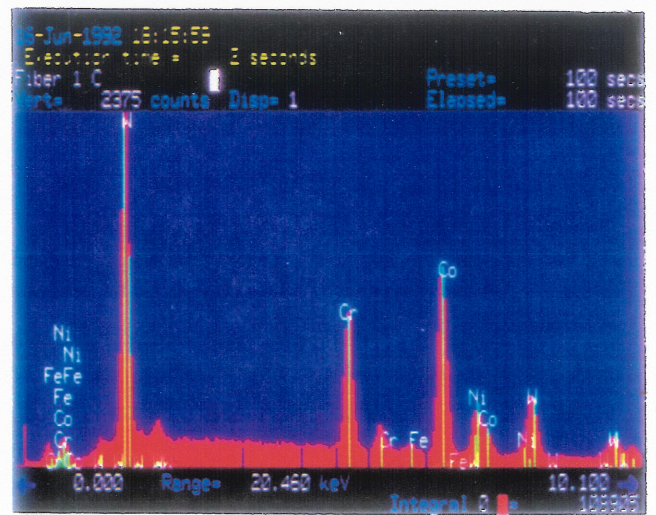
Figure 14.—Post-test metallographic results for bristle tip from wear track.
