Deformation Mechanisms of NiAl Cyclicly Deformed
Near the Brittle-to-Ductile Transformation Temperature

NASA Grant #NCC3-116

Final Report December 17, 1992

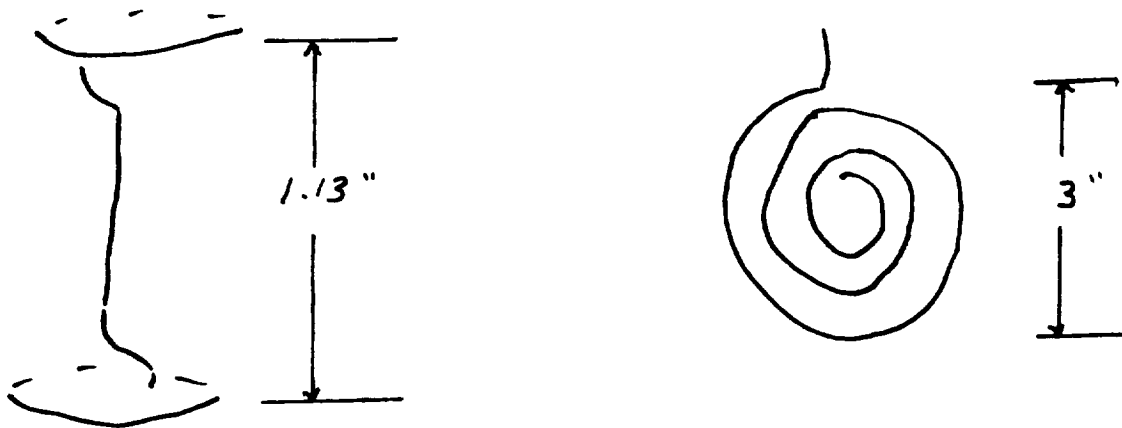
Figure 3.4 - Induction coil design (a) front and (b) top views.
