**MATERIALS SIG QUANTIFICATION AND CHARACTERIZATION
OF SURFACE CONTAMINANTS**

Russ Crutcher
Boeing Defense and Space Group
Kent, Washington

ABSTRACT

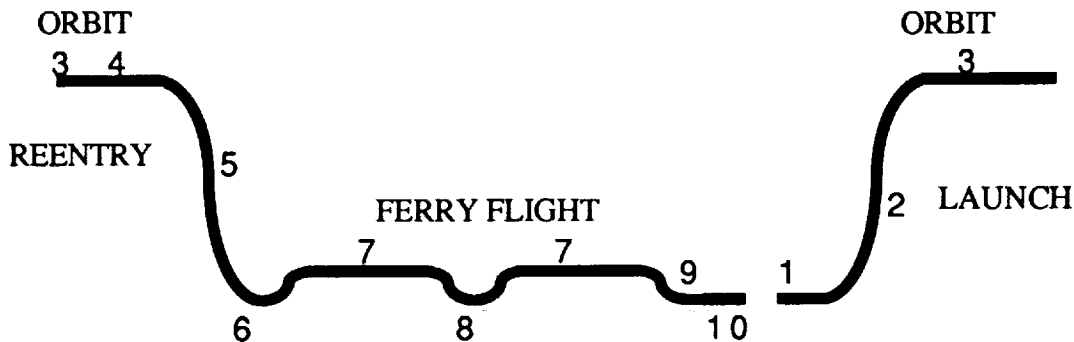
Contamination Exposure History of LDEF

1. Condition of LDEF prior to launch: >MIL-STD-1246B, level 1000C for many trays.
2. During launch particulate contaminants are redistributed and Shuttle Bay debris is added.
3. Contaminants are modified and new contaminants are generated in the orbital environment.
4. Grappling jars particles and films free; some may have relocated on LDEF.
5. During reentry particles and brittle molecular contaminant films relocate.
6. The shuttle is exposed to the Edwards environment, accumulation of natural dusts.
7. High humidity, high gas flow velocities, thermal and pressure stresses occur.
8. HEPA filter fibers appear on tapelifts after exposure to new filters.
9. Ground operations prior to SAEF-2 include many manipulations to LDEF in complex environments.
10. SAEF-2 exposure.

LDEF has been exposed to a variety of discrete environments over its lifetime. The prelaunch environment was a time when the new surface of trays, clamps, and the superstructure of LDEF were exposed to assembly debris, skin flakes, hair and fiber, insects, minerals, etc. The remnants or modified forms of these materials show the effects of exposure to all subsequent LDEF environments. The launch phase exposed LDEF to materials characteristic of the Shuttle Bay. These included bay liner materials, tile fiber and debris, and a variety of other contaminants common in the Shuttle bay but not unique to the bay. The launch environment is characterized by decompression, vibration, and a general acceleration force of about three times normal gravitation. These effects promote the migration of larger particles in the bay toward vents and toward surfaces that are normal to and face the acceleration vector. Once in orbit the environment is dominated by the orientation of the satellite with respect to the ram vector and atomic oxygen, to the thermal and ultraviolet light exposure, and to micrometeorite and debris impacts. Position four below marks the effects of grappling and docking operations. The first significant, although very low, acceleration loading after nearly six years in orbit occurred when the grapple arm attached to LDEF. Numerous objects, from as large as solar cell panel samples to small flakes of aluminum foil, began drifting from LDEF. Some relocation of materials from one LDEF surface to another probably occurred at this time. Reentry and landing exposed the orbitally degraded surfaces of LDEF to turbulent repressurization, acceleration and vibration loading, and to the reactive atmospheric gases, including water vapor. It also provided an environment in which cross contamination with the Shuttle Bay could occur. On the ground the Shuttle was exposed to natural minerals and other common airborne materials. The ferry flights exposed LDEF to decompression, repressurization, thermal cycling, and high humidity. Intervening stops during the ferry flight exposed LDEF to other contaminants. Once at Kennedy the ground operations prior to SAEF-2 exposed LDEF to a variety of particulate contaminants that were free of the effects of orbital exposure. Organic fibers, pollen grains, and insect debris were among the most obvious new contaminants. In SAEF-2 exposure to these types of materials continued with abraded floor materials, more pollens, skin flakes, and disassembly debris being added. The subject of this presentation is an overview of the changes in the contaminant distribution and character from grappling (4) to the final handling in SAEF-2 (10).

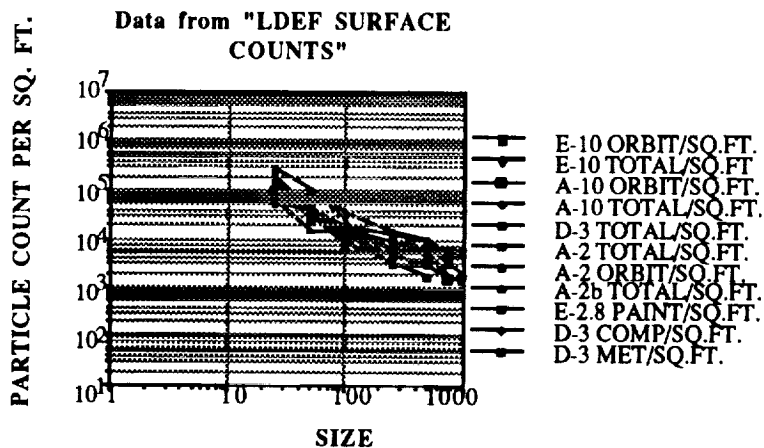
Particle Counts From LDEF Surfaces, Total Counts of all Particles and Counts Of Those Particles Present During Orbit.

The upper graph illustrates that the analyses of the particle population from Teflon surfaces, composite surfaces (D-3 COMP), metal surfaces (D-3 MET), and painted surfaces (E-2.8 PAINT) all seem to be within the same order of magnitude.

On trays A-2, A-10, and E-10 particle counts were made on selected areas to determine the cleanliness of the surface in orbit, the migration of particles present in orbit during recovery operations, and the cleanliness as received from SAEF-2. The surfaces counted for each of these trays were silver backed Teflon. The particles present in orbit could be identified by the silhouette of the particle on the surface, indicating that the surface had been protected during its orbital exposure. For the leading edge trays exposed to a high fluence of atomic oxygen (A-10 and E-10) the silhouette was a small area of surface not eroded to the same extent as immediately adjoining areas. For tray A-2 the silhouette was the area protected from the brown returning molecular contaminants. All of the particles present during orbit were indicated by the term "Orbit". Some of the particles present in orbit were still present when the sample was analyzed. These were particles that had a silhouette of themselves on the surface beneath them. Such particles were indicated as "Fixed" particles. The count of particles actually present on the surface as received from SAEF-2 was indicated by the term "Total". The total count after SAEF-2 was from about two to four times the number of particles present on the surface during orbit.

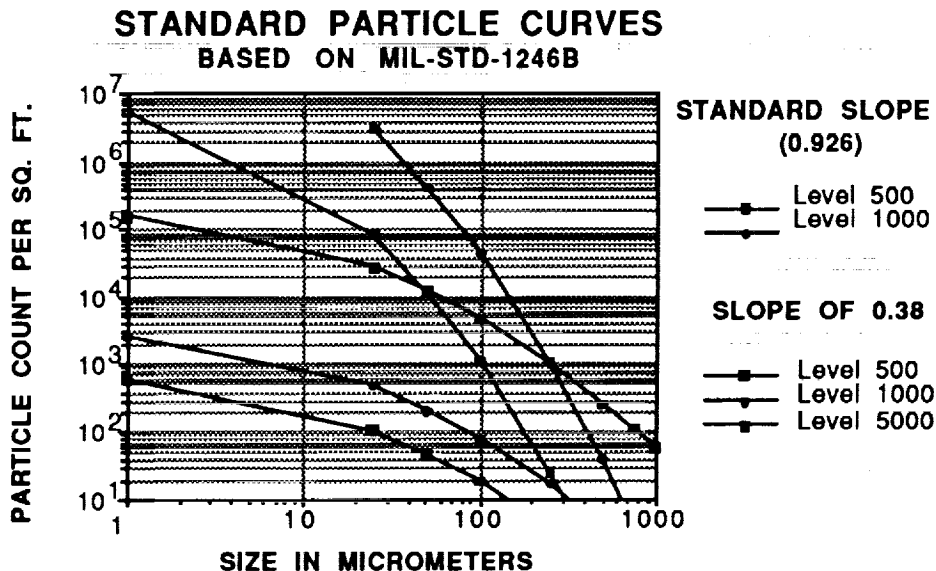
MIL-STD-1246B establishes cleanliness levels based on a particle size distribution assumed to be linear when the log of the cumulative number of particles greater than a specified diameter is plotted by the square of the log of the diameter. The standard further establishes the slope of the resultant line to be 0.926.

When identifying a cleanliness class using MIL-STD-1246B some arbitrary sized particle must be selected to establish the level if the particle distribution curve does not have a slope of 0.926. A particle distribution with a slope of 0.38 and one particle per square foot greater than 5000 micrometers could be assigned a cleanliness level of 1000 for particles less than 250 micrometers or a level 500 based on particles smaller than 50 micrometers.

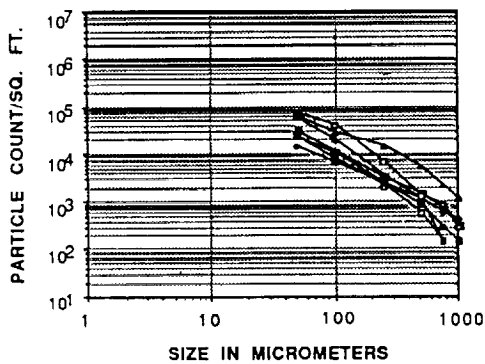
SHUTTLE BAY, EDWARDS

These charts are based on the results of tapelift samples from the Shuttle Bay and the Transportation Canister collected when LDEF was located within each respective container. The particle count distribution by size curves for the Shuttle Bay and for the Transportation Canister are much more shallow than the 0.926 slope used for the MIL-STD-1246 curves. The Shuttle Bay samples collected in the OPF are very close to a slope of 0.38. All of the particle count data for LDEF is shown in graphical form. The graphical format is used because the particle distribution is not conducive to the assigning of a MIL-STD-1246B cleanliness level. The significance of a list of numbers is also less informative than seeing the shape of the distribution. Unusual distributions such as that in the pre-transportation Transportation Canister sample are easily seen in a graphical format.

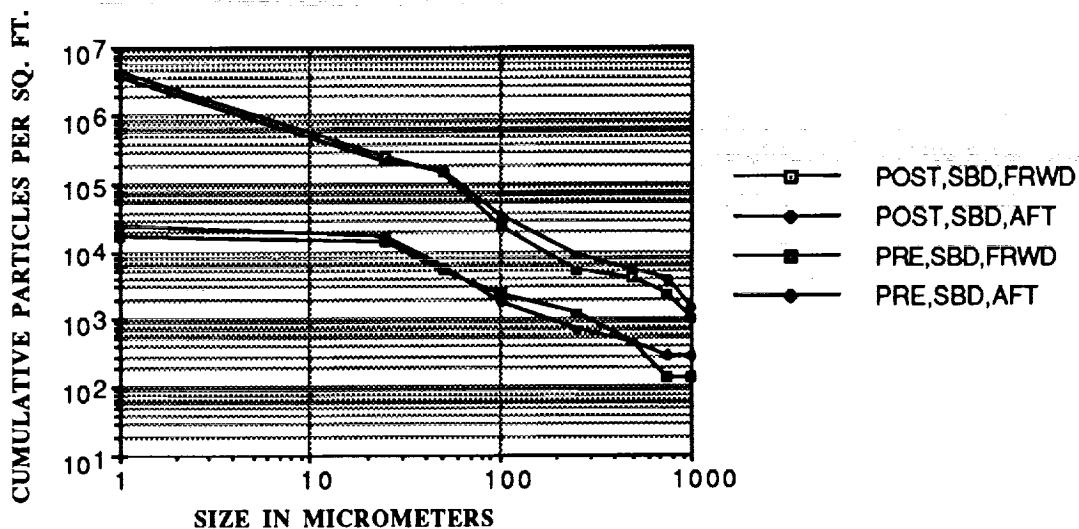
**TAPELIFT COUNTS FROM THE TRANSPORTATION
CANISTER BEFORE AND AFTER TRANSPORT OF LDEF**

The Transportation Canister was relatively clean prior to transporting LDEF from the OPF to the O&C building based on tapelift samples collected from the floor of the Canister. Most of the particles were small metal fragments. Many of these were in a line as a result of scratches on the surface of the Canister floor. Some of these fragments were bound together with an organic binder. Skin particles, paper fiber, clean room wiper residue, starch grains, sand grains, and vinyl flooring residue were also present. After transporting LDEF the particle count increased by nearly an order of magnitude or more. The second set of lifts were collected from approximately the same location as the first set. LDEF debris was a major reason for the increase in the number of particles but other sources also made a significant contribution. The LDEF debris was identifiable as very thin metal foils, Kapton particles, and fine ash particles. These materials accounted for over half of the increase. The balance was spray paint residues, paper fibers, calcite, starch, soil particles, pine pollen, and rust. The size distribution of the LDEF debris ranged from submicrometer to millimeters in greatest dimension. The non-LDEF debris was predominantly between five and one hundred micrometers with some of the fibers exceeding the millimeter range in length. The proportion of LDEF debris to other contaminants was smaller than had been expected. This may have been due to much of the more easily removed LDEF debris having been already removed by the earlier activities or having been moved to locations on LDEF where they were stable with LDEF in the fixed, row 12 top, configuration. The accumulation of more contaminants on the Canister floor not directly attributable to LDEF suggests that the upward facing surfaces of LDEF would receive contaminants from the Canister cover. These contaminants would include paper fibers, pollens, etc. The two plots of the particle size distribution before transporting LDEF are very close to one another, as are the two plots for the samples collected after transportation. This would seem to indicate that this was not a localized effect but was representative of what occurred during transport.

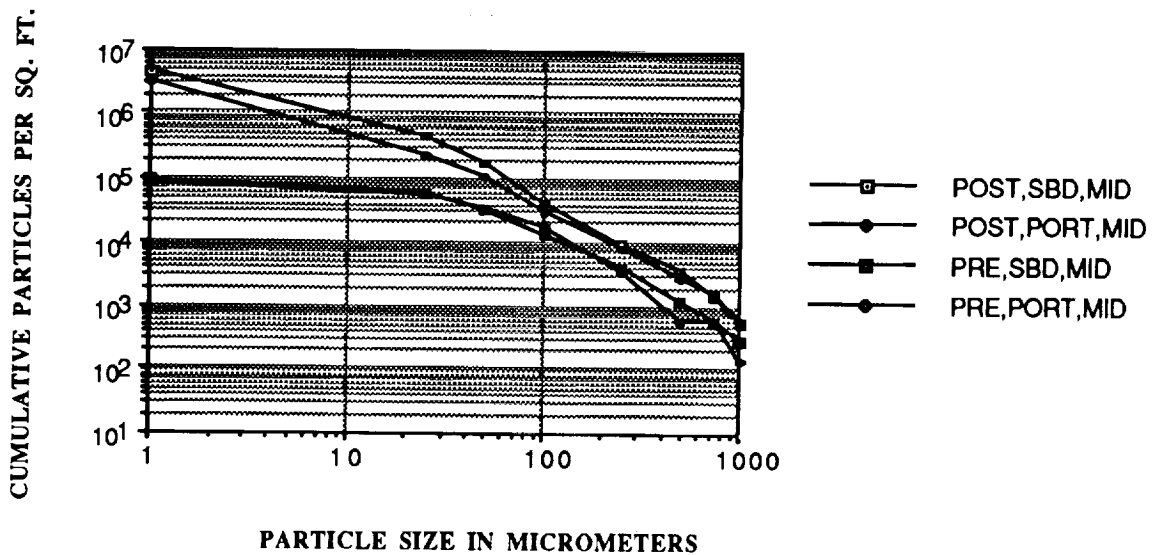
TAPELIFT COUNTS FROM THE LATS BEFORE AND AFTER TRANSPORTATION OF LDEF TO SAEF-2

The LATS was not nearly as clean as the Transportation Canister before the transport of LDEF. Tapelift samples collected from the port and starboard sides of the LATS floor near the middle of LATS had particle counts that were a factor of ten greater than was found on the pre-transport Transportation Canister for particles smaller than one hundred micrometers.

After transport of LDEF the particle size distribution curves for the LATS samples were nearly the same as the post-transport samples from the floor of the Transportation Canister. The contribution from LDEF however was much less. Less than a third of the increase was due to LDEF particles. Cleaning residues, spray paint residues, pollens, insect parts, paper and clothing fiber, and black foam particles were more common. The LATS activities probably contributed more new contaminants to LDEF than did the Transportation Canister.

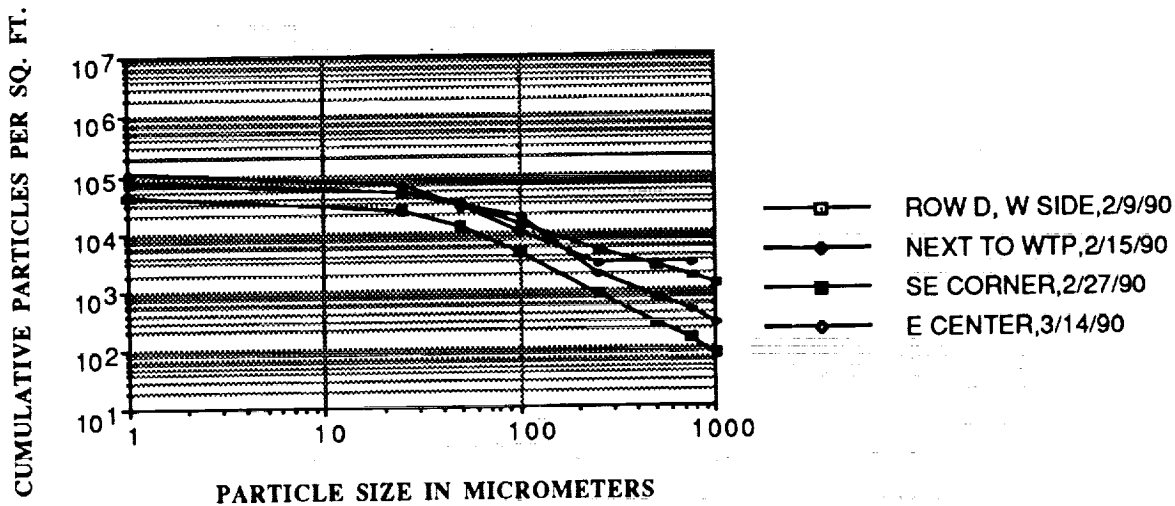
SUMMARY OF LATS PARTICULATE CLEANLINESS BASED ON TAPELIFT SAMPLES

The floor of the LATS was cleaned regularly (daily) to reduce the opportunity for the mechanical transport or lofting of debris to LDEF. The tapelift samples were collected at midday on the days noted. The surfaces sampled were areas of low traffic. The sample collected on the fifteenth of February was taken adjacent to one of the fallout pads. These samples indicate a relatively low cleaning efficiency and a rapid sedimentation rate.

The fallout pad data should be lower than the tapelift results in that the fallout pad collects only fallout and not mechanically transferred debris, but the difference in these two plots indicates that the fallout pad data grossly underestimates LDEF's exposure. Considering only the one hundred micrometer particles the fallout pad results summed for the entire exposure interval of the open trays, Jan. 30 to Feb. 21, would amount to less than a thousand (MIL-STD-1246B, Level 500).

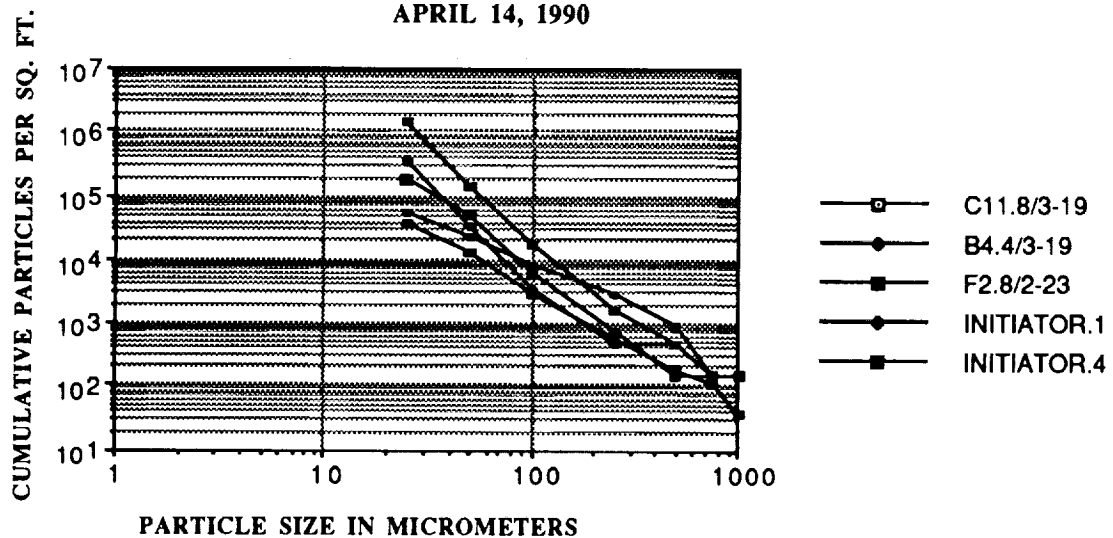
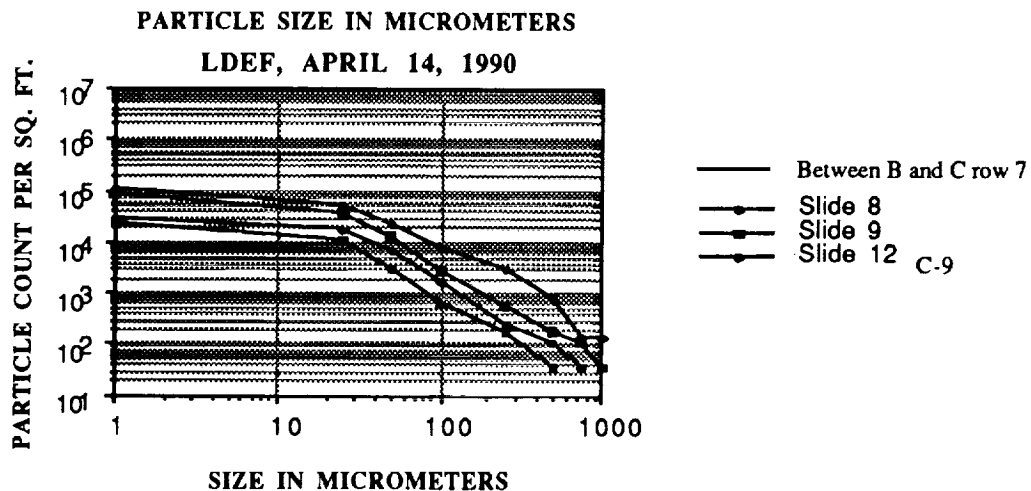
**TAPELIFT DATA FROM LDEF SURFACE COLLECTED
APRIL 14, 1990**

Tapelifts were collected from the surface of LDEF that had been covered with tray clamps prior to the removal of the trays. The legend indicates the tray clamp under which the sample was collected and the date on which that clamp had been removed (for example, the first entry below indicates the sample was collected from under the eighth tray clamp of tray C-11. This clamp had been removed with the tray on the 19th of March and the surface had been exposed to the SAEF-2 environment until the sample was collected on the 14th of April). It had been anticipated that the particle distribution would reflect the duration of SAEF-2 exposure. This was not the case. Although high particle counts were seen the type of particle was biased toward manufacturing and assembly residues and not so much toward the typical SAEF-2 debris. The particle population under clamp 8 of tray F-02 was about the same as that under clamp 4 of tray B-04 even though the F-02 area had been exposed in SAEF-2 for nearly three weeks longer. All of the samples from under the tray clamps were more contaminated than the tray surfaces or the other exposed surfaces of LDEF. This suggests that the tray clamps retained contaminants that were removed from other surfaces following integration. Surfaces not protected by tray clamps (INITIATOR samples and those shown in the lower chart) are nearly an order of magnitude cleaner. The contaminants on these other surfaces are also different indicating populations of the type seen on the tray surfaces.

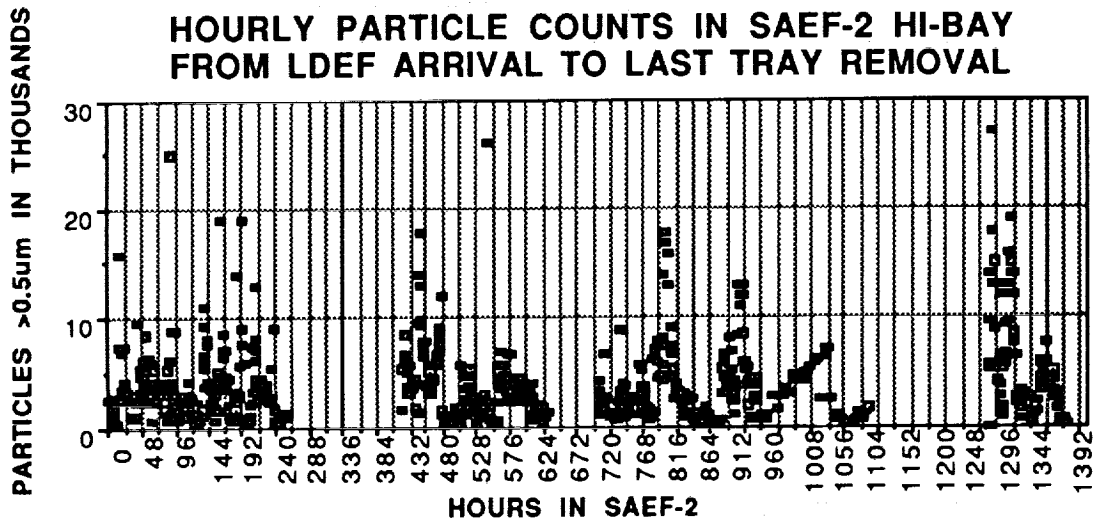
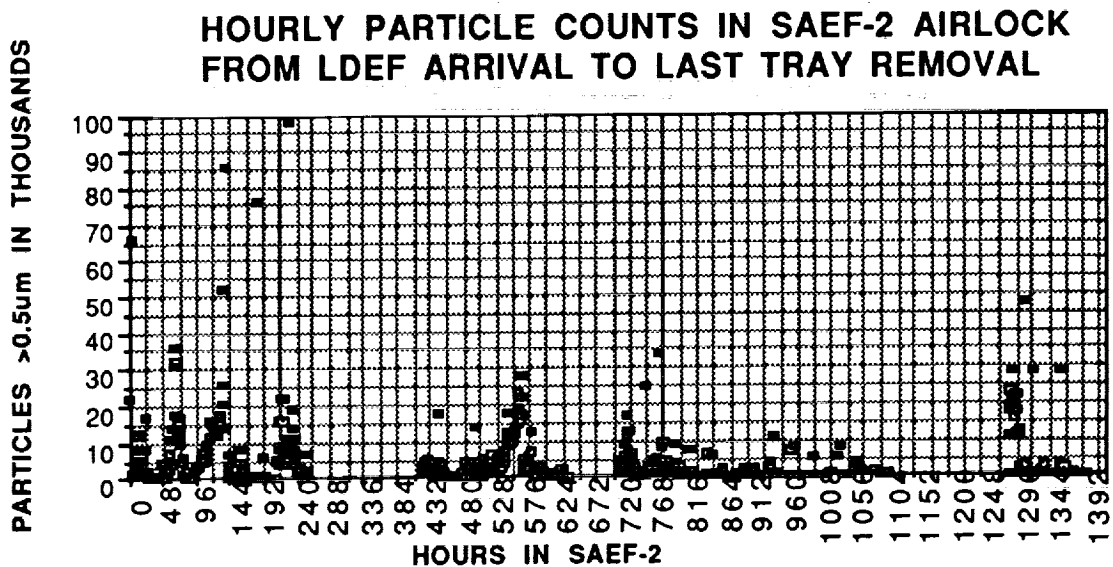
AIRBORNE PARTICLE COUNTS $>0.5 \mu\text{m}$ FOR THE SAEF-2 CLEANROOM HIGH BAY AND THE EQUIPMENT AIRLOCK

The graphs below show the particle count at each hour mark recorded during LDEF's exposure to the SAEF-2 environment. The hourly counts in the High Bay cleanroom never exceeded thirty thousand. Individual counts on one occasion exceeded one hundred thousand but that was a transient condition associated with the moving of a scaffold that was above and adjacent to the particle counter. This event lasted only a few minutes and the airborne particle count dropped back well below one hundred thousand before the next hour mark. The scaffolding was moved periodically but it was normally closer to LDEF and didn't significantly disturb the particle counter. In the Airlock the particle counts were typically higher. When materials were entering the Airlock from outside the count would exceed one hundred thousand. The particle count would recover generally within an hour. The airborne particle counts indicated that the air being supplied to SAEF-2 was being effectively scrubbed by the HEPA's. In a conventional non-laminar flow cleanroom with a single sensor mounted ten feet high on the wall relatively little information is gathered with regard to the larger particle population (five micrometers and greater).

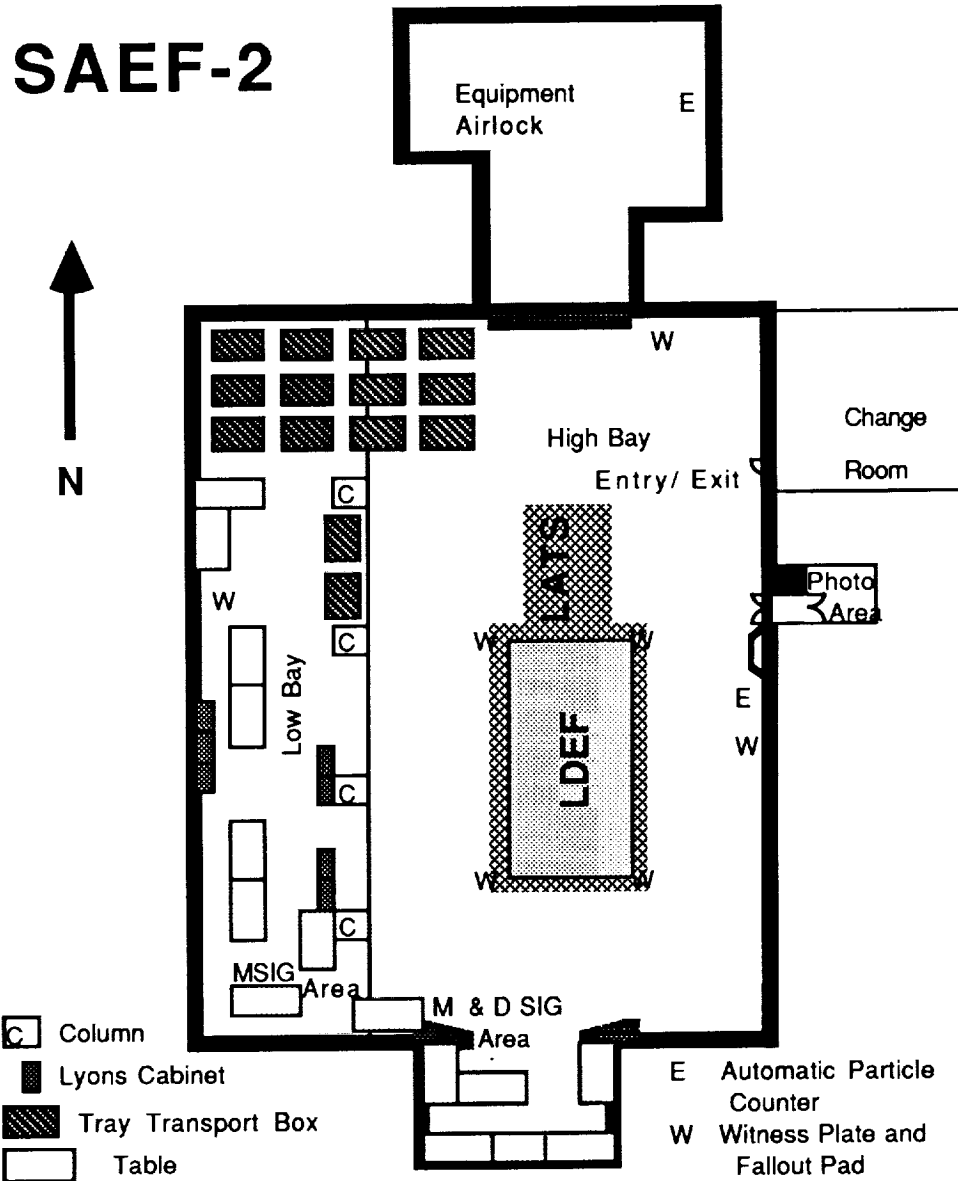
SAEF-2 FLOOR PLAN WITH LDEF ON LATS

The locations of the wall mounted airborne particle monitors and the floor or LATS bed fallout pads are shown in this illustration.

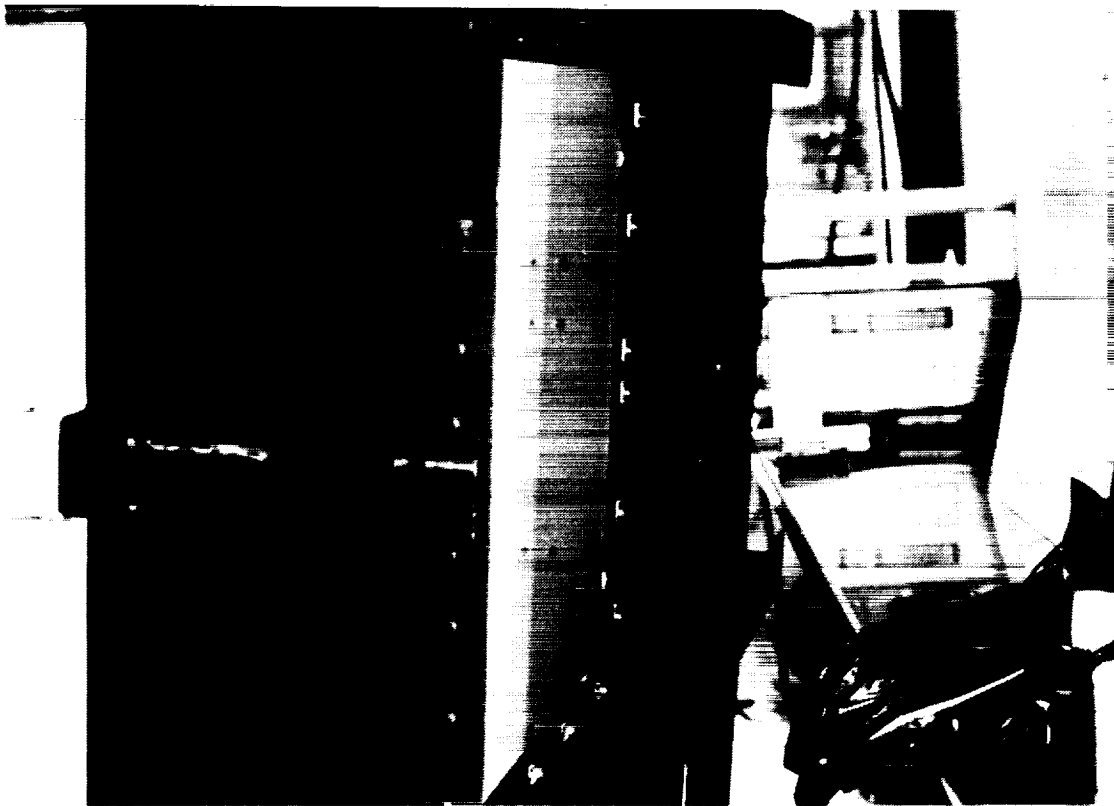
MOLECULAR FILM DEPOSITED ON INTERIOR SIDE OF TRAY F-06

Molecular films were visually detected either by the brown discoloration seen on light surfaces or the thin film interference colors caused by them on black surfaces. This photograph illustrates the interference color effect* seen on the ram facing side panel of tray F-06. Each red band beginning with the brown-red near the edge just before the first blue band corresponds to a thickness of approximately 100 nanometers (0.1 micrometers) added to the film's thickness. Notice the continuation of the pattern on the next brace.

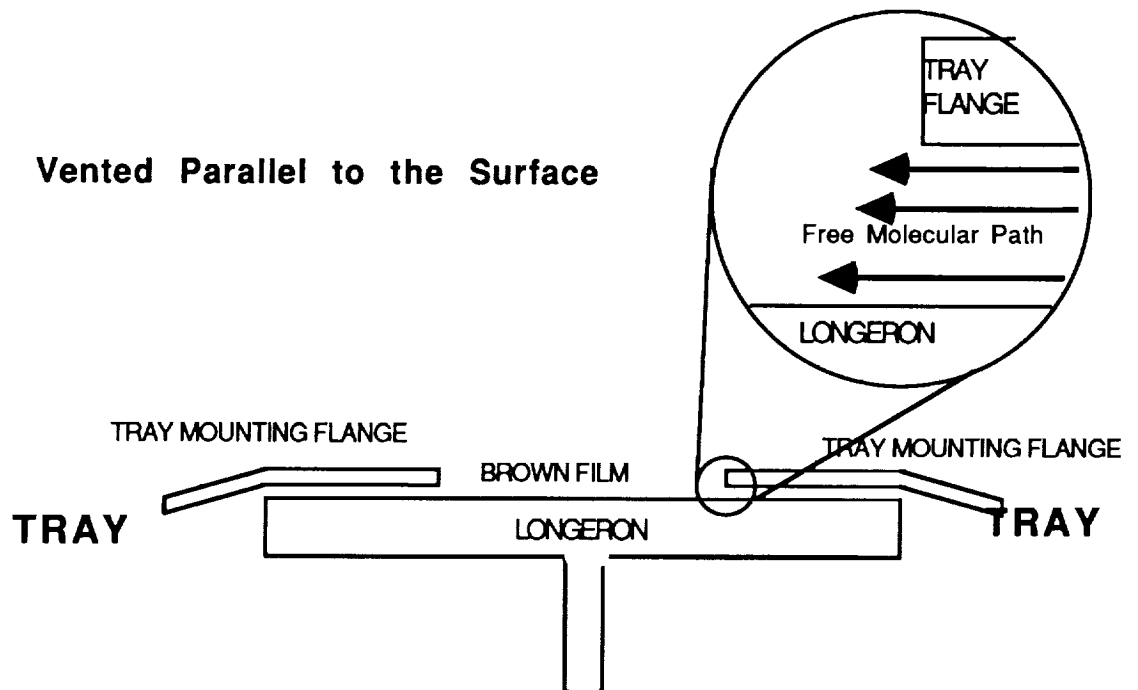
VCM Vented Parallel to the Surface

Many of the vent paths on LDEF consisted of narrow openings between parallel plates of metal. The edge of the trays are an example of such a path. Molecules escaping from the interior along such a path would tend to parallel the surface of LDEF. Any encounter with another molecule would have a fifty percent probability of directing the molecule toward the surface of LDEF. This may help explain the relatively high deposition efficiency exhibited by the exterior surface of LDEF.
