NASA Technical Memorandum

NASA TM - 108373

HUBBLE SPACE TELESCOPE THERMAL CYCLE TEST REPORT FOR LARGE SOLAR ARRAY SAMPLES WITH BSFR CELLS (Sample Numbers 703 and 704)

April 1992

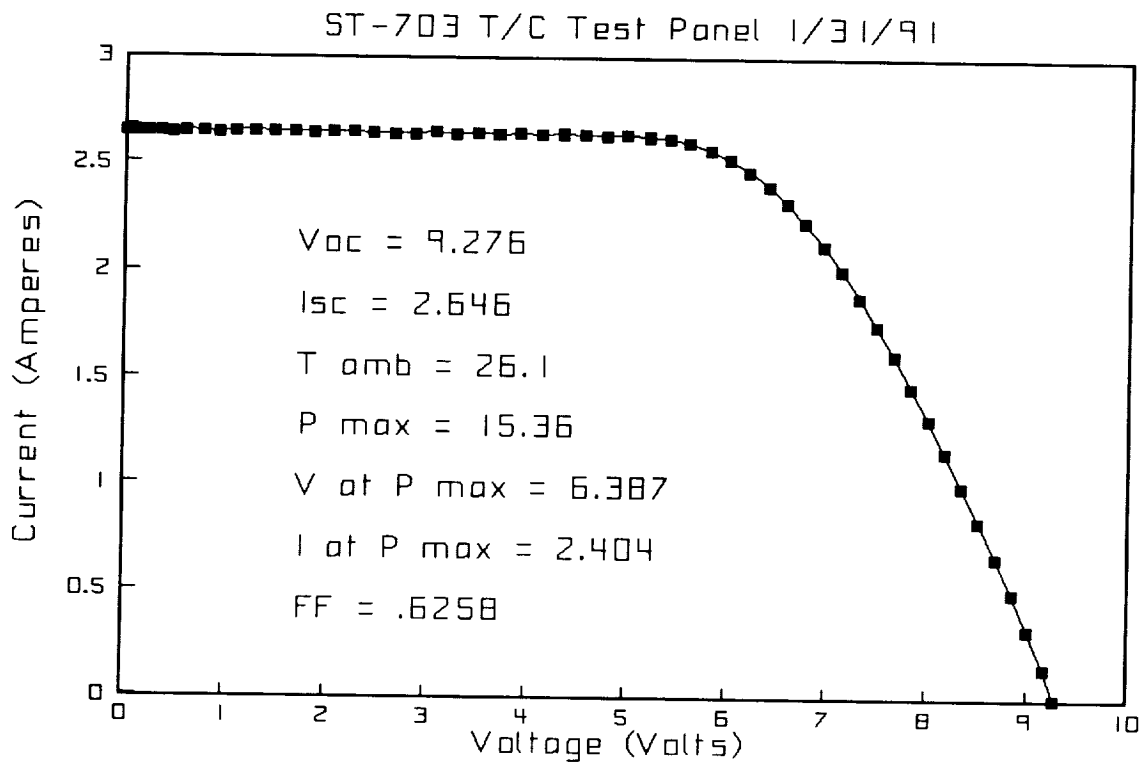
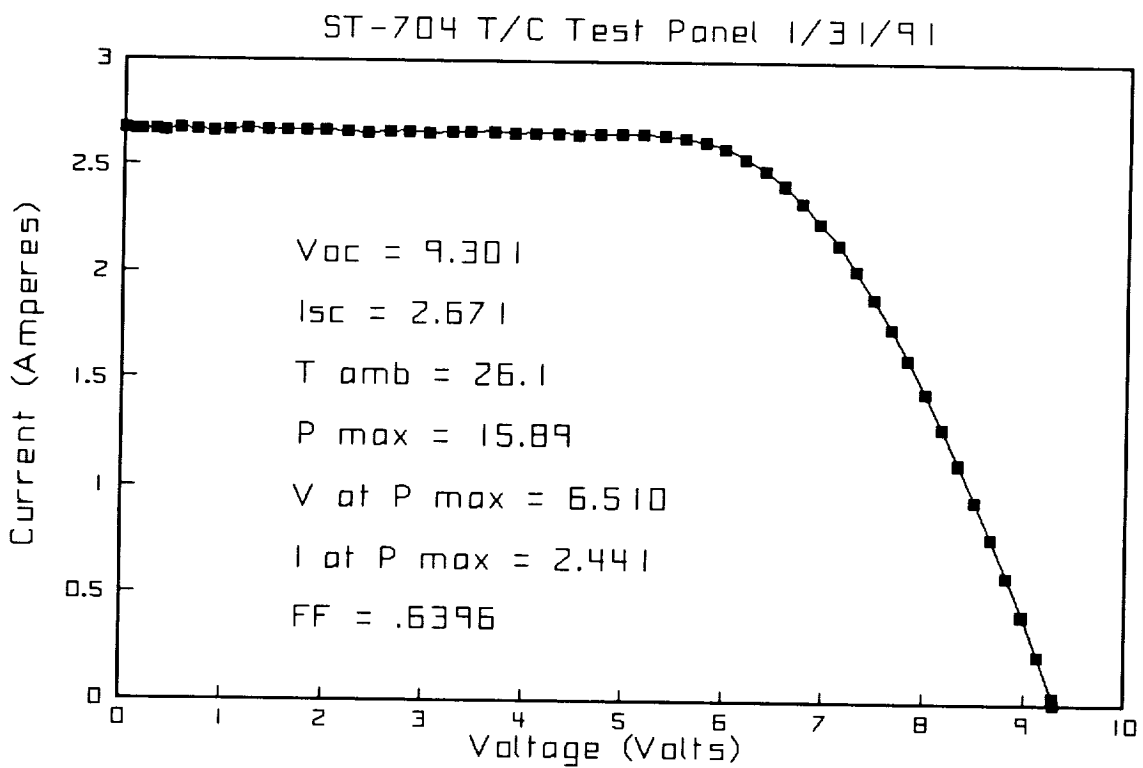
Figure 12. Electrical performance of modules 703 and 704 after 30,000 cycles.

Electrical performance data taken from the modules after 30,000 cycles revealed no degradation in the maximum power of either module since the last check at 22,469 thermal cycles. However, both modules showed slight increases in maximum power performance; 0.5 percent for module 703 and 0.3 percent for module 704 (fig. 12).

Electrical performance tests performed on both modules periodically during the test showed no degradation of the electrical power output of either module. Overall, from the initial test at 0 cycles to the final test after 30,000 cycles, there was an increase of output power of 1.0 percent for module 703 and 1.1 percent for module 704. At least part of this increase can be attributed to a software update and recalibration of the LAPSS between the initial test and the second test at 16,761 cycles. The remainder of the output power increases are within the calibration tolerance of the LAPSS.
