Compression of Thick Laminated Composite Beams With Initial Impact-Like Damage

(NASA-CR-190573) COMPRESSION OF THICK LAMINATED COMPOSITE BEAMS WITH INITIAL IMPACT-LIKE DAMAGE Interim Report No. 90, Jan. 1990 - Dec. 1991 (Virginia Polytechnic Inst. and State Univ.) 169 p

***Compression of Thick Laminated Composite Beams With
Initial Impact-Like Damage***

Prepared for: Mechanics of Materials Branch
National Aeronautics and Space Administration
Langley Research Center
Hampton, VA 23665-5225

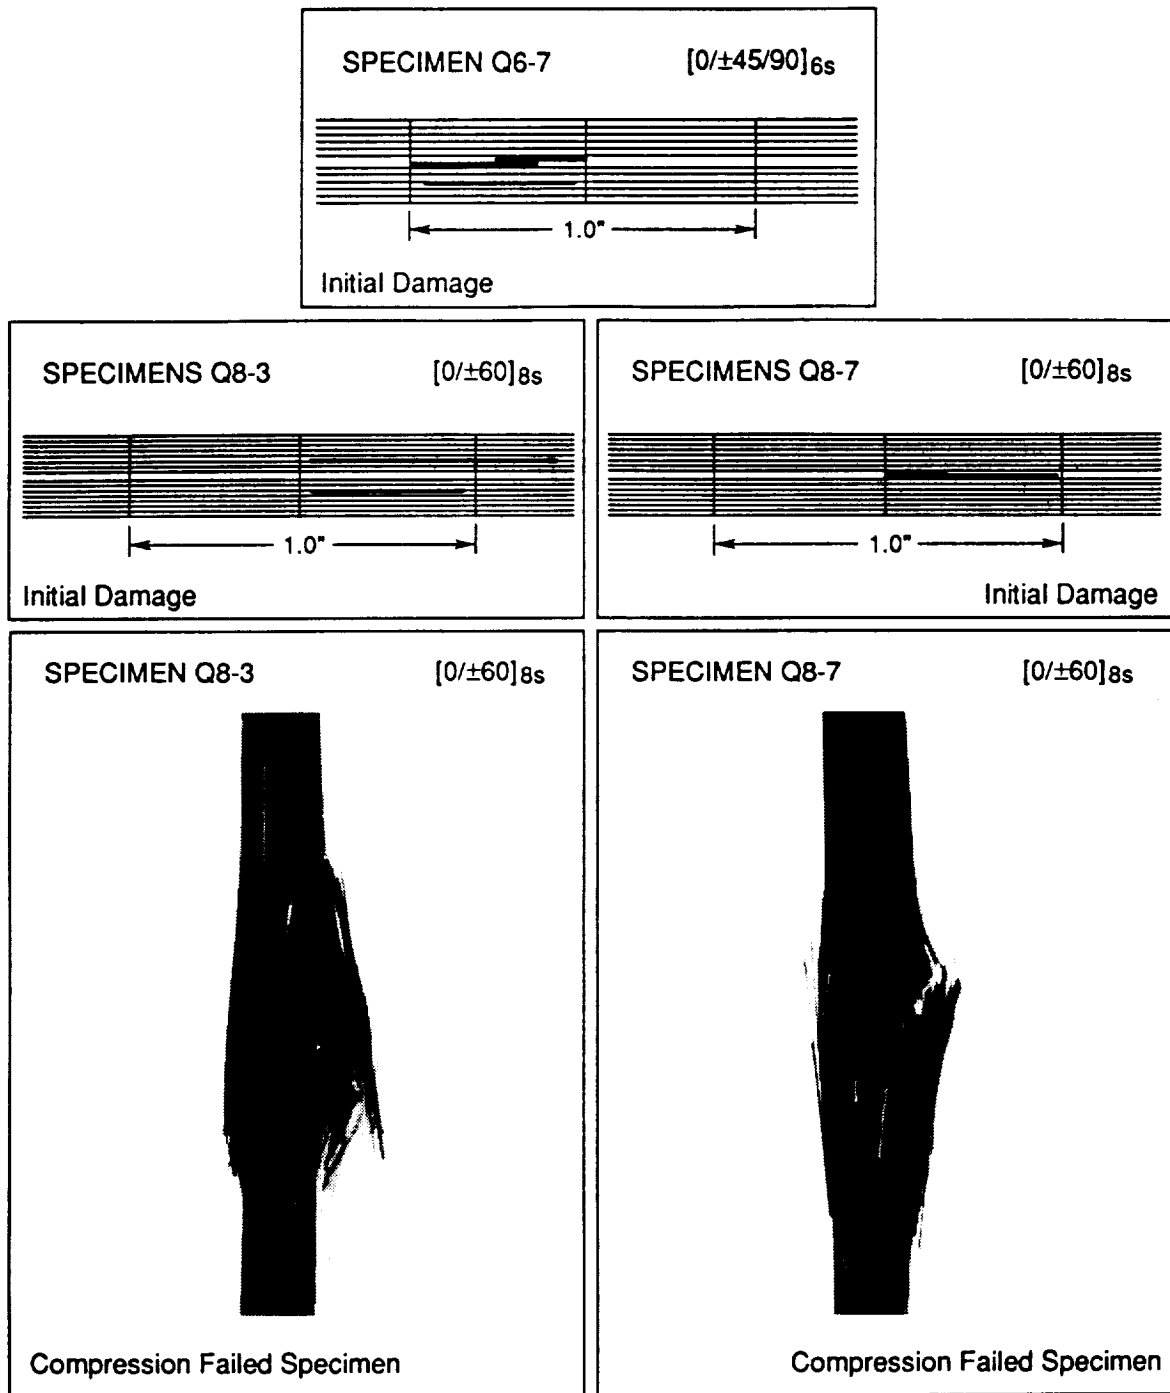
Figure 4.14 - Initial damage and failed specimens for isolated delaminations, $[0/\pm 45/90]_{6s}$ and $[0/\pm 60]_{8s}$

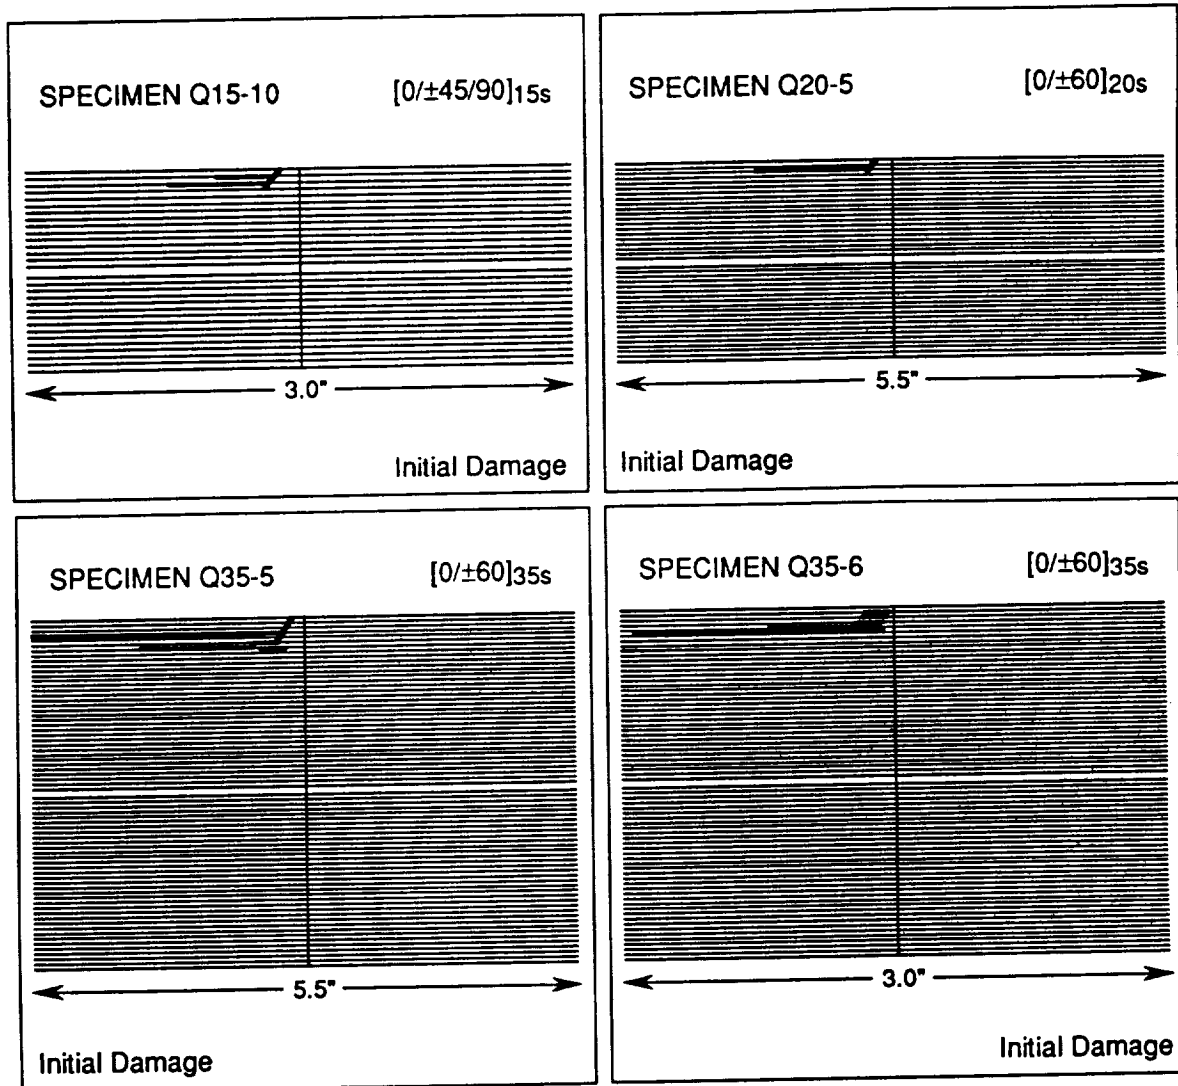
Figure 4.24 - Initial damage and failed specimens for unbalanced damage near the surface, $[0/\pm 60]_{20s}$, and $[0/\pm 60]_{35s}$
