**NASA**  
**Technical**  
**Paper**  
**3014**

# Graphite/Epoxy Composite Adapters for the Space Shuttle/Centaur Vehicle

Harold J. Kasper  
and Darryl S. Ring

## Summary

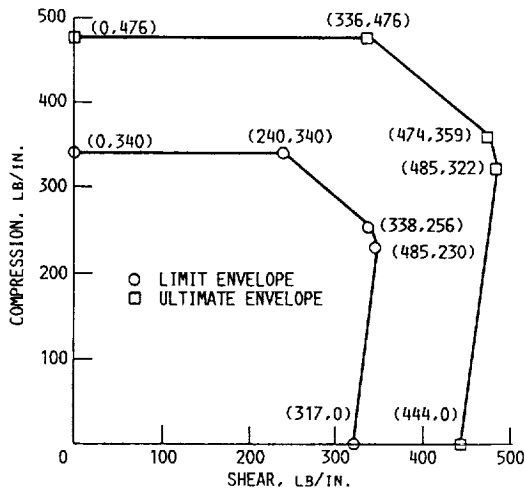
Figure 14.—G-Prime vehicle forward adapter design loads (panel FA3).

Table IV shows the results of the McAir panel tests. All load points were achieved on the design envelopes shown in figures 14 and 15 before loading the panels to failure. The test

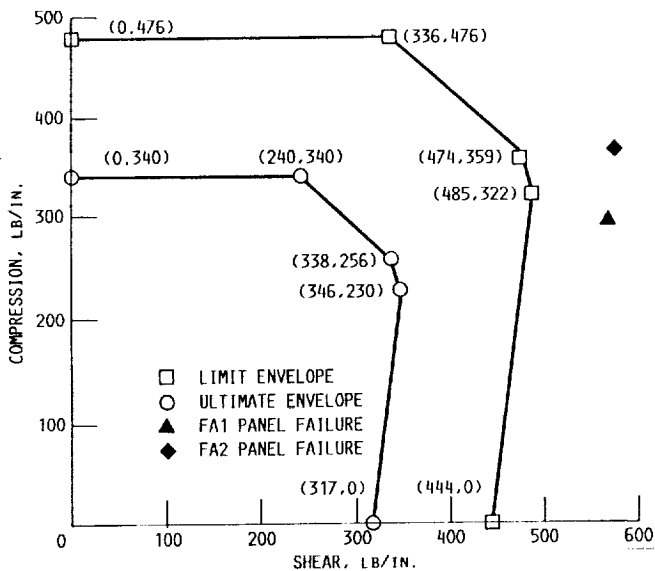
Figure 22.—Failure loads for forward adapter panels FA1 and FA2 compared with design load envelopes.

compression/shear failure loads fell outside their respective ultimate design envelopes. These loads are plotted in figures 22 and 23 to show their relationship to the design envelopes.

Failure of the test panels usually occurred in the fastener region. The corrugated construction was inherently weak in transmitting a smooth shear flow from a corrugation into its single fastener. Shear flow through the corrugation ends caused a local bending moment that resulted in a tear-out force in the fastener region. The original design used round washers under the fastener heads and caused a cutting action which resulted in premature failures in earlier adapter test panels. Square washers which reduced the effect of the tear-out action were used on test panels AA5 and AA6 and were finally incorporated into the aft adapter design. Although forward adapter panels FA1 and FA2 were tested successfully with round washers, square washers were incorporated into the forward adapter design to provide an additional margin of safety.

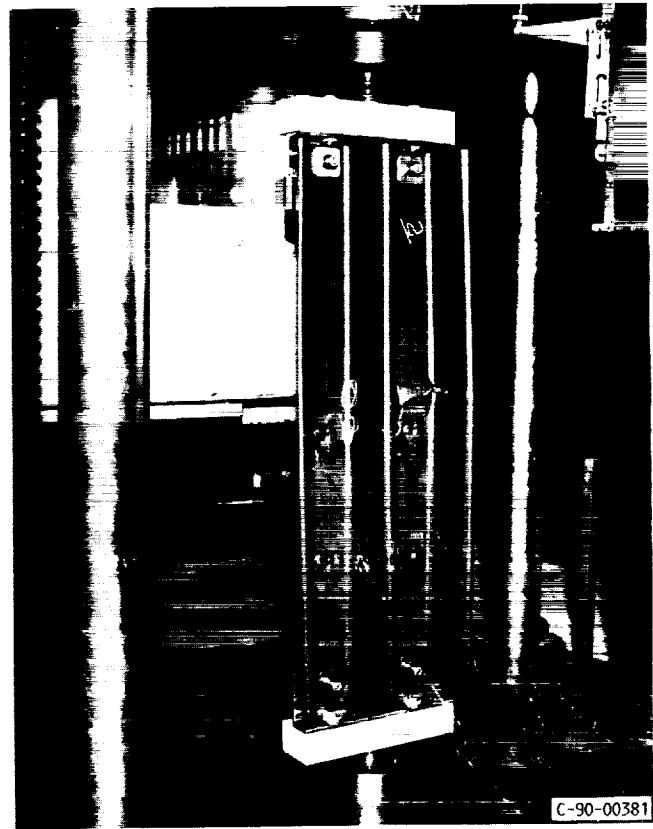
Figure 27.—Damage tolerance compression test specimens.

The damage tolerance/repair test plan consisted of two phases. Phase I was the compression testing of damaged, undamaged, and damaged and repaired corrugated test specimens at room temperature and at  $-423$  °F. Nine two-corrugation, 17-in.-long specimens similar to the one shown in figure 27 were tested. Five specimens were tested at room temperature and four at  $-423$  °F. Two of the room-temperature specimens had no damage, two had invisible impact damage, and one had damage that was repaired with a patch. The specimens tested at cryogenic temperature consisted of one with no damage, two with invisible impact damage, and one with a repaired damaged area. The damaged and undamaged room-temperature specimens were tested first to failure. This was done to establish a baseline. The cryogenic test specimens were tested to failure inside a cryostat, and the results were compared with the ambient results to determine if any correction factor should be applied to the phase II McAir damage tolerance tests, which are discussed later in this section.

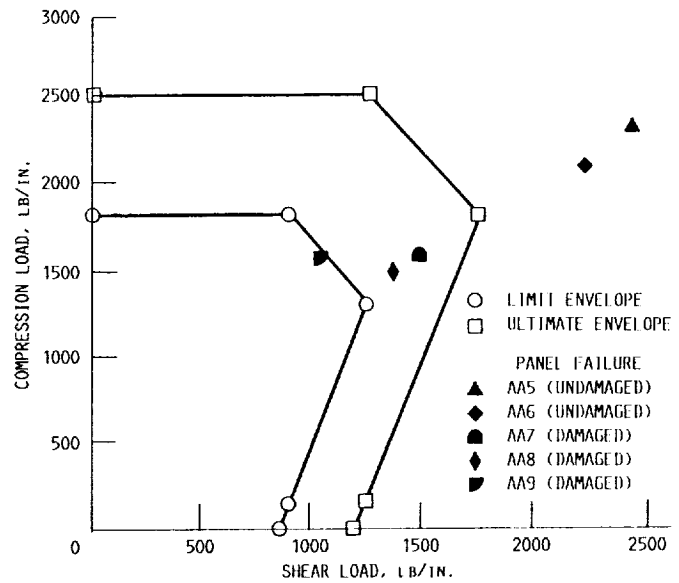
Figure 29.—Static failure loads for G-Prime McAir aft test panels.

The aft adapter damaged specimen failed at a combined static load which was less than that prescribed by the ultimate design load envelope, as shown in figure 29. The design margin of safety for the aft adapter was approximately one-half that of

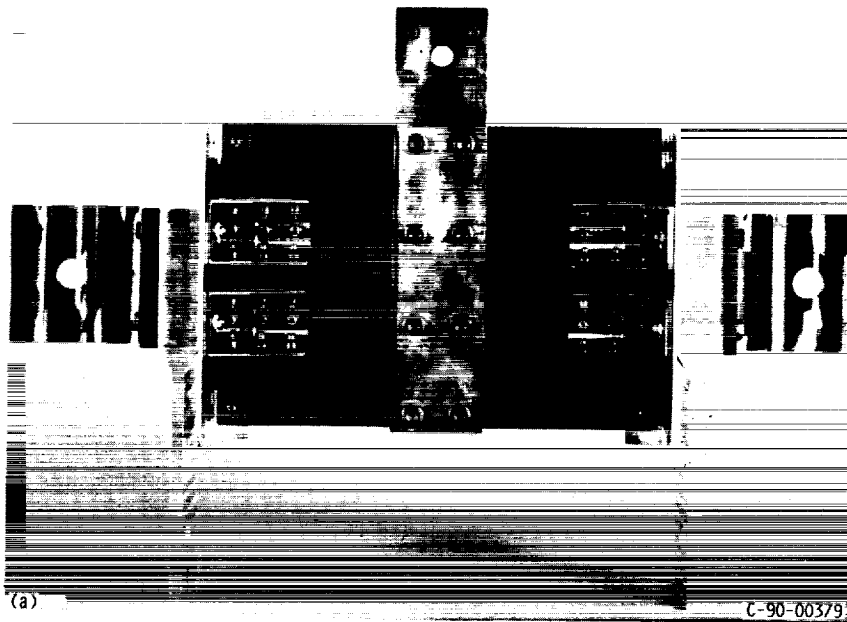
(a) Specimen.  
(b) Schematic.

Figure 33.—Short-beam hardpoint combined load test specimen and schematic (dimensions in inches).
