**METEOROID AND DEBRIS SPECIAL INVESTIGATION GROUP
DATA ACQUISITION PROCEDURES**

SUMMARY

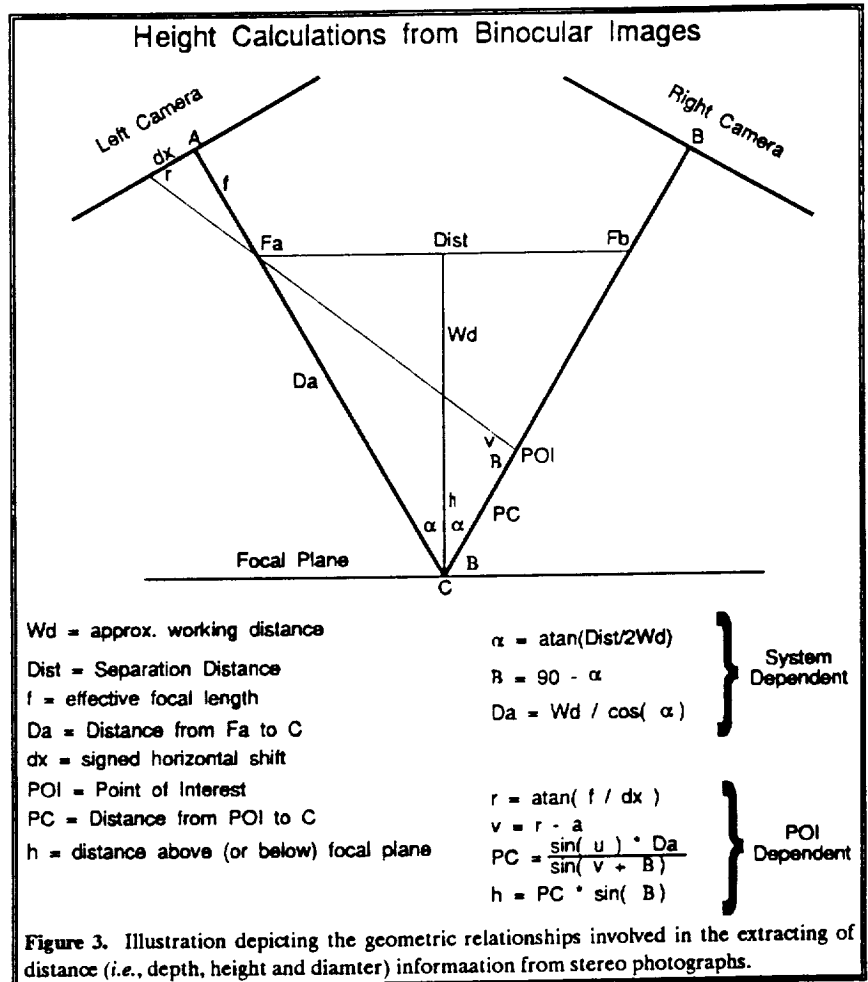
Figure 3 is a simplified diagram of the geometry involved in calculating the height of a point based on the parallax observed in a pair of binocular images. The parameters Wd , $Dist$, and f remain constant for a data collection system and can be determined empirically using calibrated features (i.e., objects of a known height and depth). The height of each point of interest (POI) is then calculated based on the difference in X position between the two views. Note that Figure 3 has the POI projected onto the center of the field of view on the right camera for simplicity.
