**NASA Technical Memorandum 104106**

**CAPABILITIES OF THE THERMAL ACOUSTIC FATIGUE APPARATUS**

**S. A. CLEVENSON  
E. F. DANIELS**

**FEBRUARY 1992**

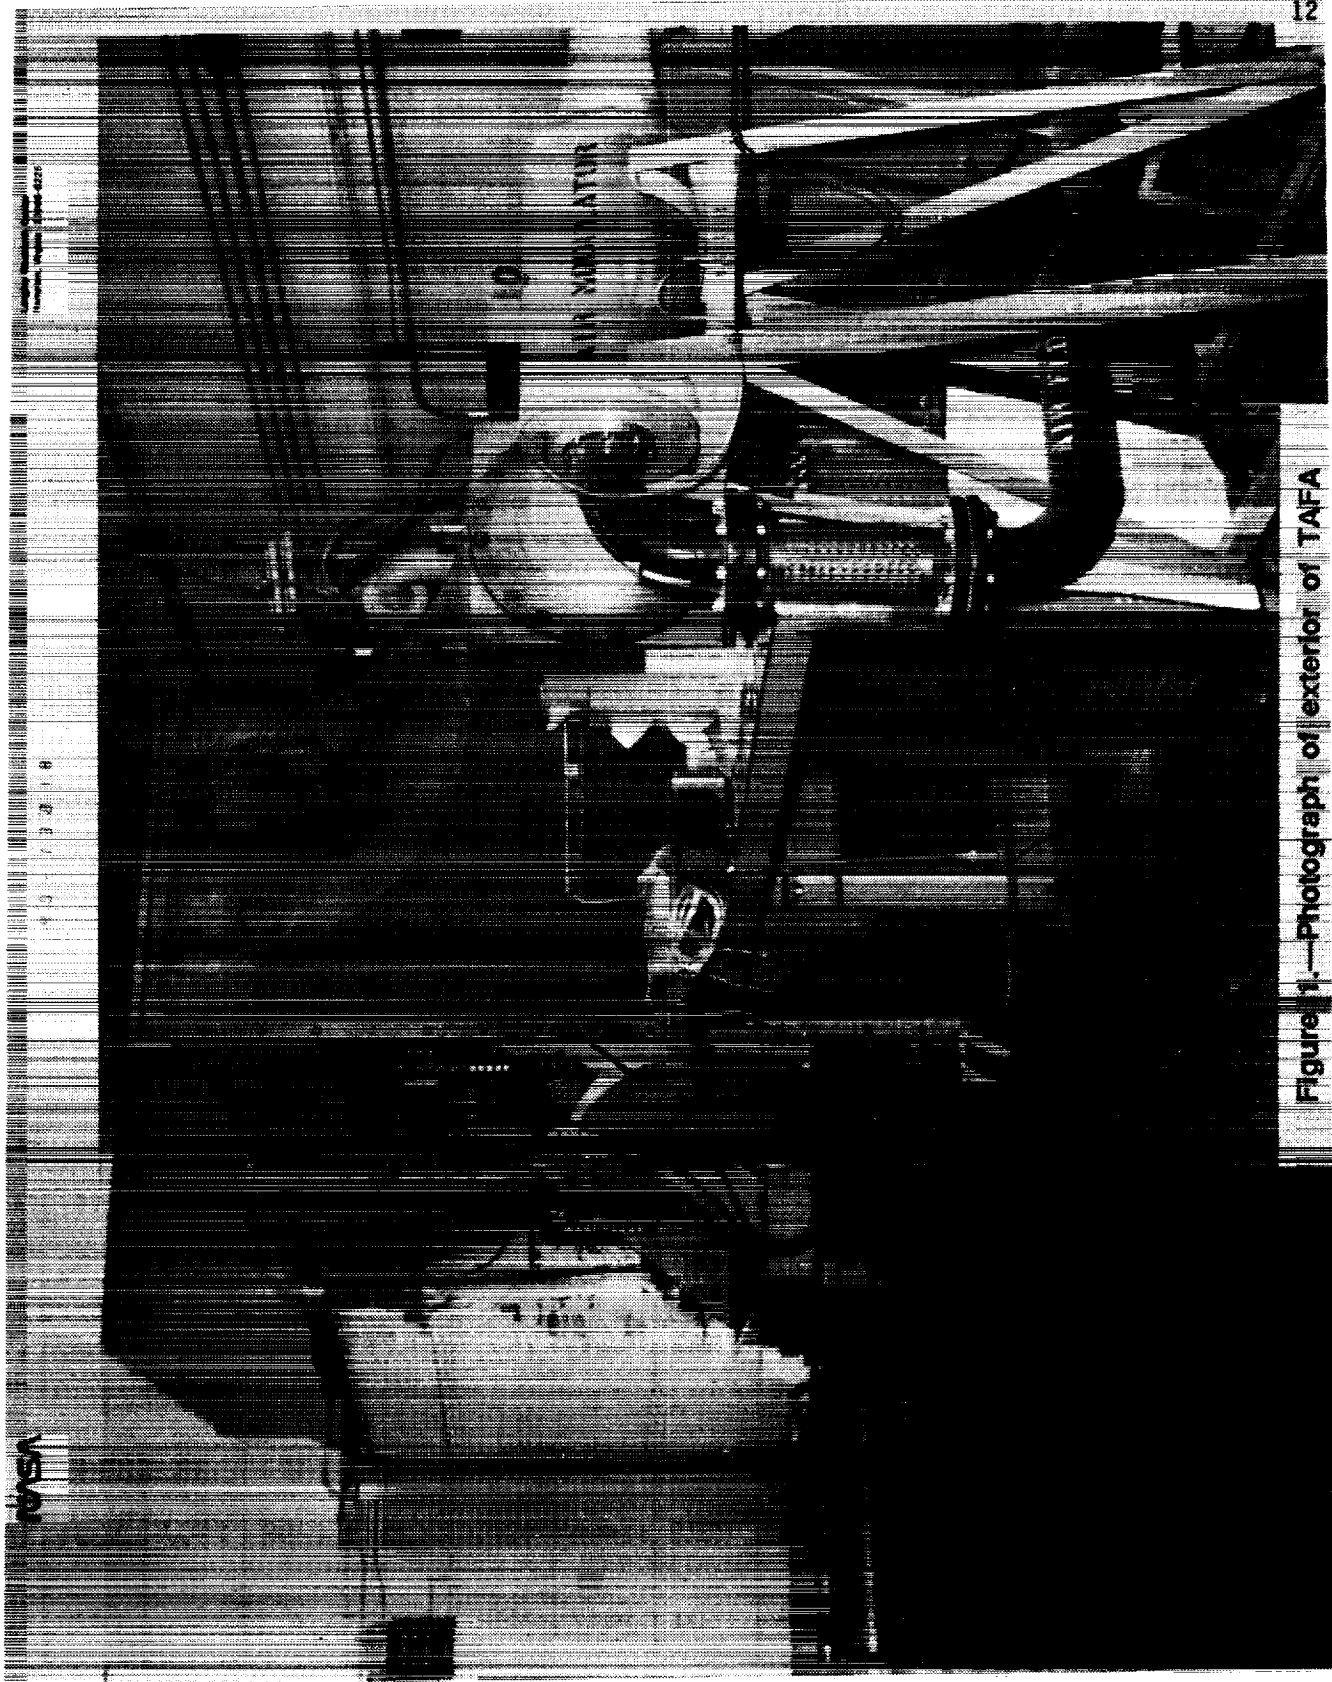
Figure 1.—Photograph of exterior of TAFPA

Acoustic capabilities. - The Thermal Acoustic Fatigue Apparatus (TAFE) is a grazing incidence, high-intensity noise apparatus with capability of sound pressure levels from 125 to 168 dB, both sinusoidal and random, in the frequency range of 40 to 500 Hz (figure 1). The noise source is two 30,000-watt acoustic modulators (Wyle Model WAS 3000) using filtered pressurized air. The sound is coupled to the 6-foot
