NASA Technical Memorandum 105355

# Properties Data for Opening the Galileo's Partially Unfurled Main Antenna

Kazuhisa Miyoshi and Stephen V. Pepper  
*Lewis Research Center*  
*Cleveland, Ohio*

February 1992

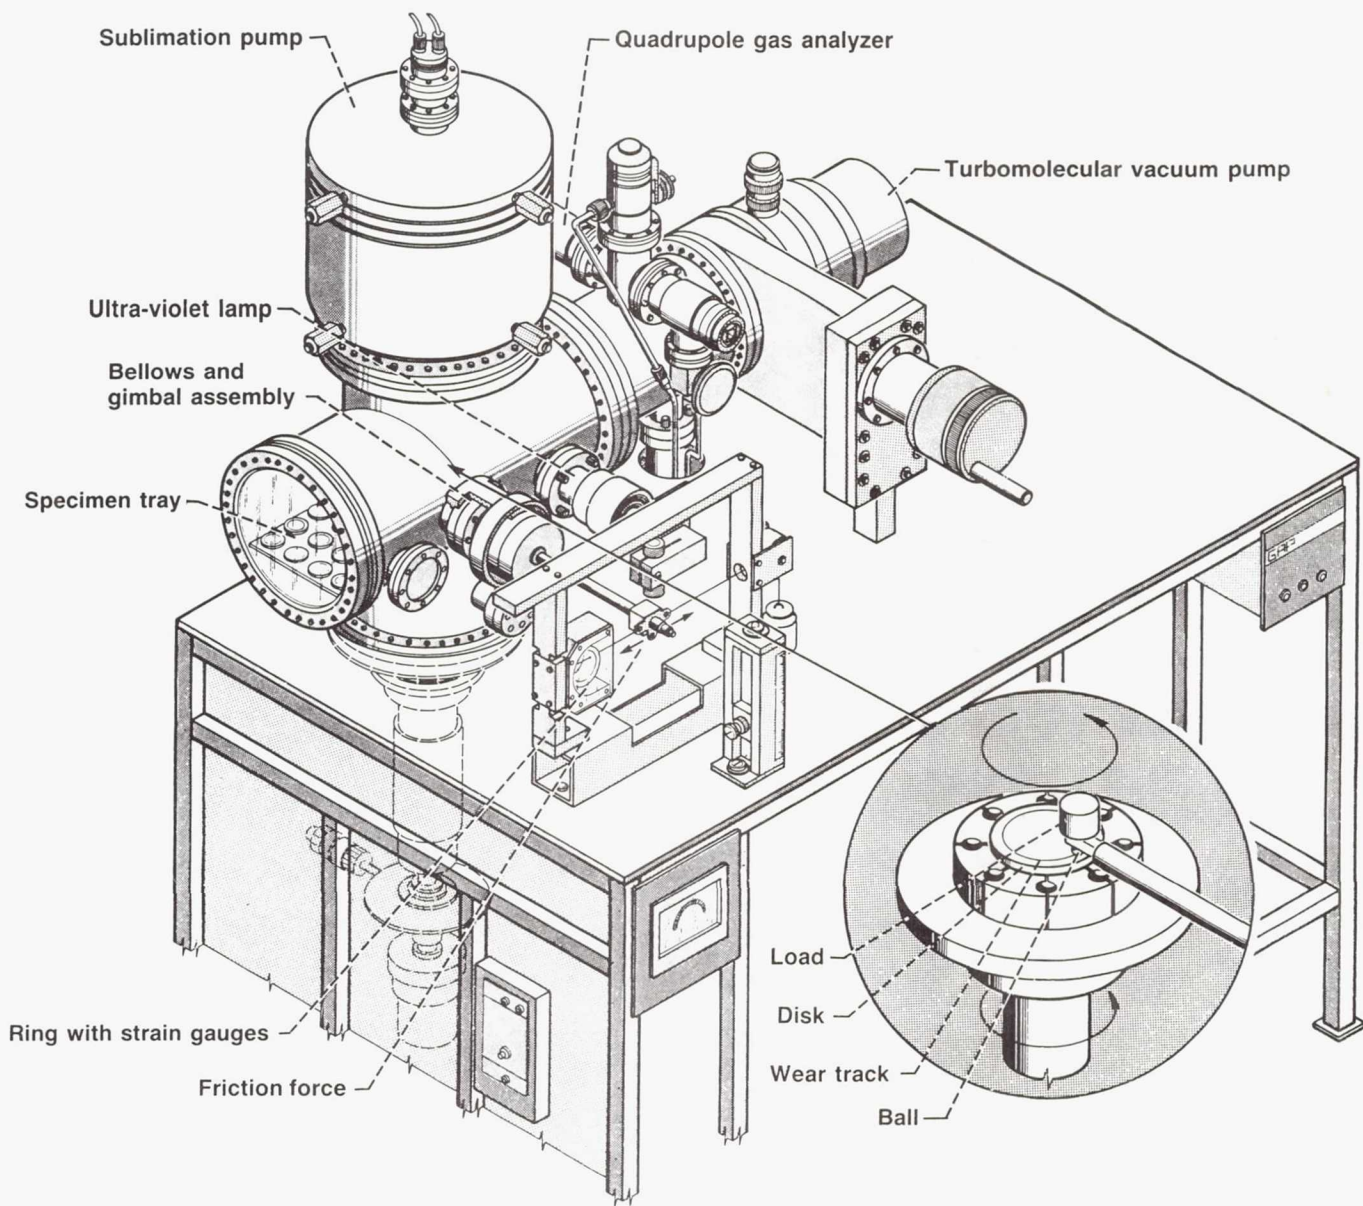
Figure 1.—Vacuum friction apparatus.

The tribometer (vacuum friction apparatus) is shown in figure 1 (ref. 2). The apparatus consists of a pin-on-disk assembly mounted in an ultrahigh vacuum chamber, a drive system, and a friction force measuring system (also shown in fig. 1). All components within the vacuum chamber are compatible with oxidizing, inert, or reducing gases.

The disk specimen is mounted on a shaft that is driven by a gear motor connected to a rotary feedthrough with a ferrofluidic seal. The drive assembly provides rotation at various speeds, which are regulated by a dc-motor speed controller. During disk rotation, the pin scribed a circular wear track on the flat surface of the disk. The bellows assembly permits rotation at various track diameters. The pin specimen is mounted in a holder attached to one end of a stainless-steel beam. The beam is welded into a bellows assembly which is gimbal mounted to the vacuum-chamber wall. The gimbal mounting permits deadweight loading of the pin against the disk surface. At right angles to the deadweight loading, the beam containing the pin can move in two directions in the horizontal plane. Movement of the pin (with the disk as it rotates) is restrained by a cable which is attached to a beryllium-copper ring. The ring contains four sets of strain gauges to measure the friction force between the pin and disk specimens. The friction force can be continuously recorded by a strip chart recorder or by a computerized data acquisition system during friction experiments.

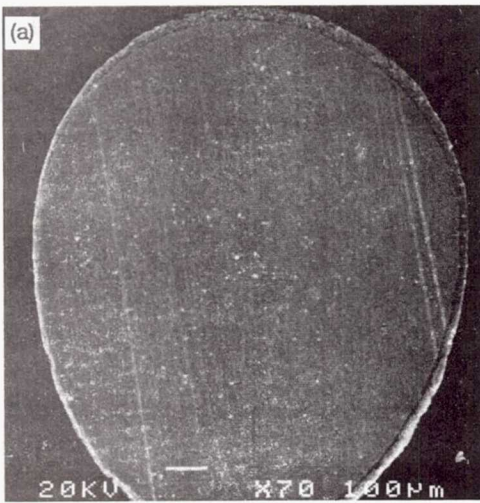
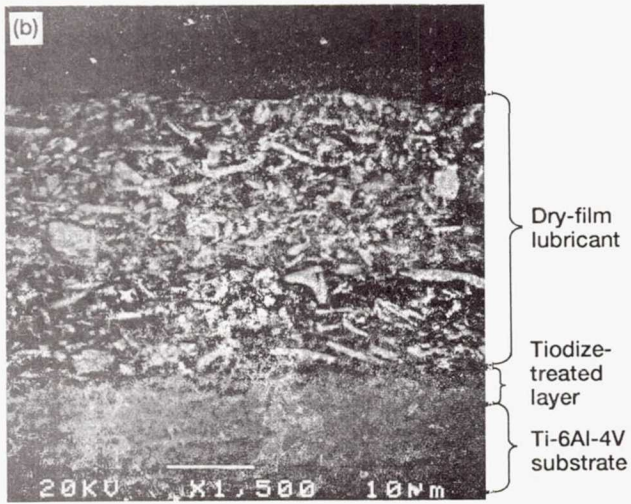
(a) Overview of pin.

(b) Details of dry-film lubricant, Tiodize treated layer, and Ti-6Al-4V substrate.

Figure 2.—Taper cross section of dry-film-lubricated Ti-6Al-4V pin at an angle of 45°.

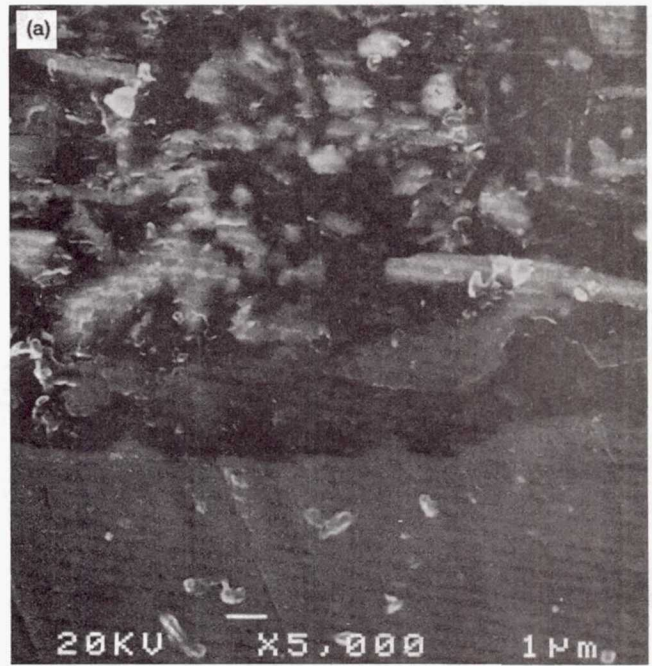
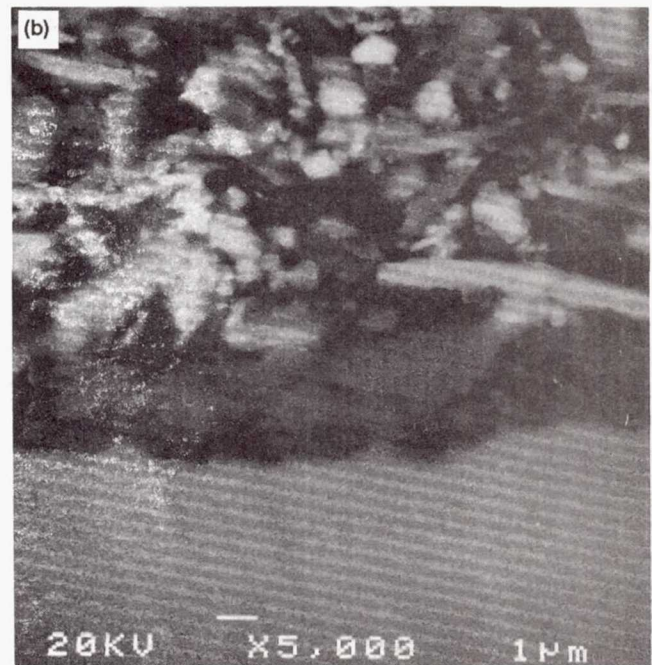
(a) Secondary electron image SEM.

(b) Backscatter electron image SEM.

Figure 3.—Structure of dry-film-lubricated Ti-6Al-4V pin.

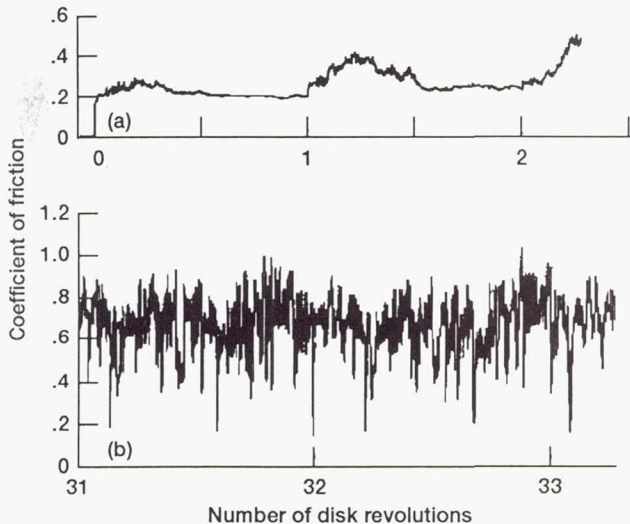
(a) At first and second revolution.  
 (b) At 31st and 32nd revolution.

Figure 4.—Friction trace for unlubricated Ti-6Al-4V pin sliding against Inconel 718 disk at 2.5 N in vacuum.

**Friction.**—Friction traces (plots of the coefficient of friction versus the number of disk revolutions) for the unlubricated system measured at 2.5 N are presented in figure 4. The traces for the first three or four disk revolutions are characterized by randomly fluctuating behavior, with only occasional evidence of stick-slip behavior (e.g., fig. 4(a)). The presence of oxides and contaminants on the surfaces of Ti-6Al-4V pin and Inconel 718 disk contributed to this relatively low coefficient of friction. Stick-slip behavior becomes dominant after five disk revolutions. The higher the number of disk revolutions, the greater the stick-slip behavior. The traces for 10 disk revolutions and above are primarily characterized by a continuous, marked stick-slip behavior, as shown by the representative section in figure 4(b). This type of friction is anticipated where strong metallic interactions occur at the interface due to the removal of the oxides and contaminants from the alloy surfaces by sliding action.

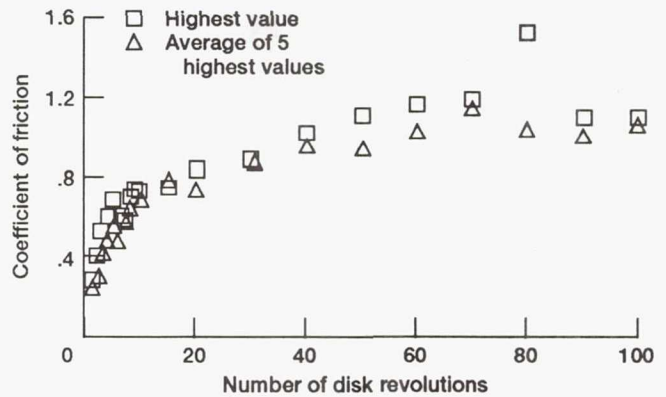
Figure 5.—Coefficients of friction for Ti-6Al-4V pin sliding against Inconel 718 disk as function of number of disk revolutions at 2.5 N in vacuum.

The coefficients of friction, calculated from the highest value and from the average value of the five highest values of friction within a given revolution, are presented in figure 5. Both coefficients of friction increased with increasing number of disk revolutions and reached equilibrium values (0.9 to 1.2) after 40 to 50 disk revolutions. The abnormally high coefficient of friction (1.45) at 80 disk revolutions is probably due to wear debris clogging the sliding interface.

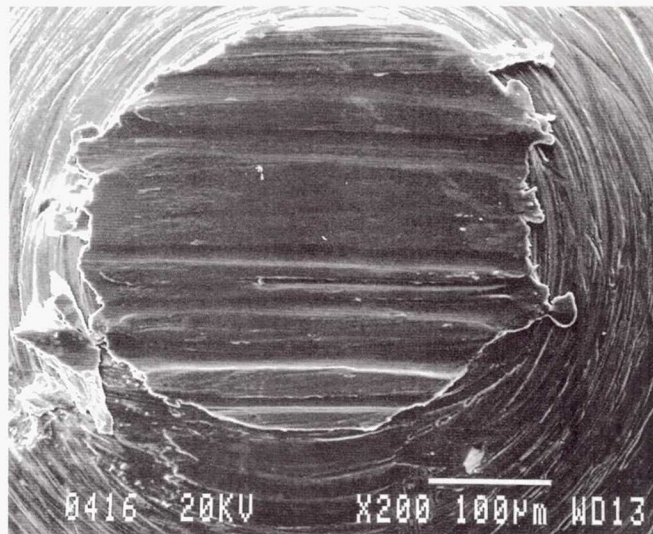
Figure 6.—Wear scar produced on unlubricated Ti-6Al-4V pin after sliding against Inconel 718 disk at 2.5 N in vacuum.

Wear damage.—Scanning electron microscope (SEM) photographs and energy dispersion x-ray analysis (EDX) spectra of the damage produced on the pin and on the disk after 100 disk revolutions at a load of 2.5 N are presented in figures 6 to 9. Figure 6 shows that substantial plastic deformation occurred on the pin. Large wear debris particles formed by plastic deformation and ductile fracture of the Ti-6Al-4V pin are present around the wear scar. Also, plastically deformed grooves and clogged wear debris are present on the wear scar of the pin. Closer SEM examination and EDX analysis of the wear debris showed it to be composed primarily of elements from the Ti-6Al-4V pin (fig. 7) and of small amounts of chromium, iron, and nickel from the Inconel 718 disk.

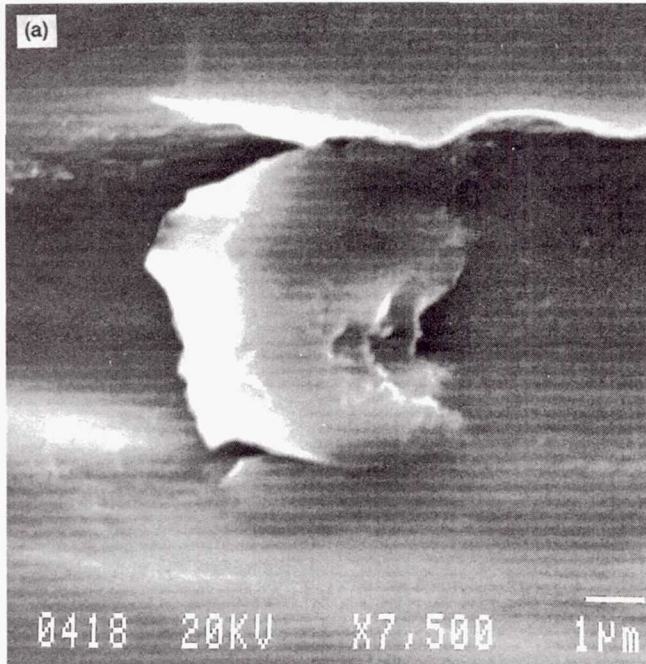
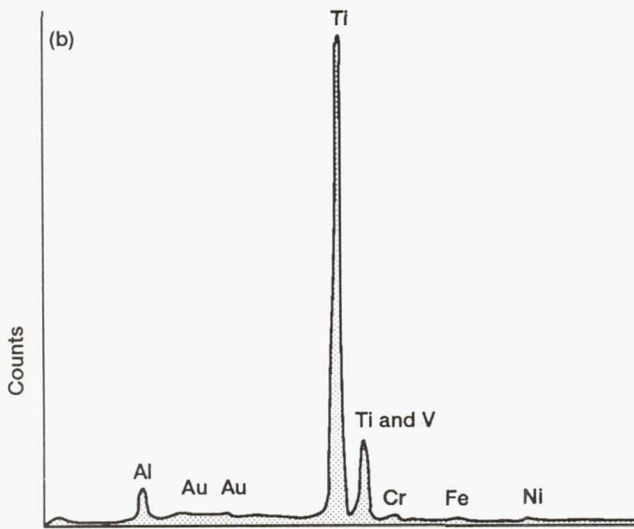
(a) Secondary electron image SEM of clogged wear debris.  
 (b) Spot EDX analysis of the clogged wear debris. The thin gold film used to reduce charging of the mount is responsible for the gold signal in the spectrum.

Figure 7.—Clogged wear debris on the wear scar of the pin.

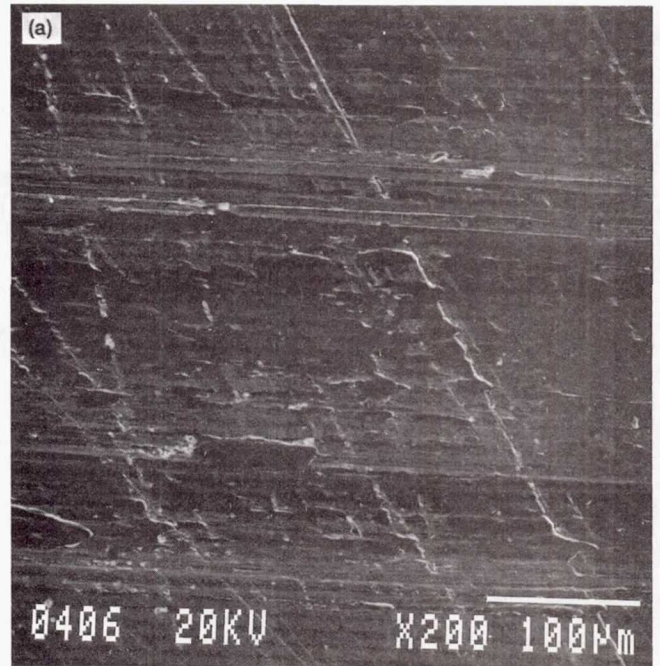
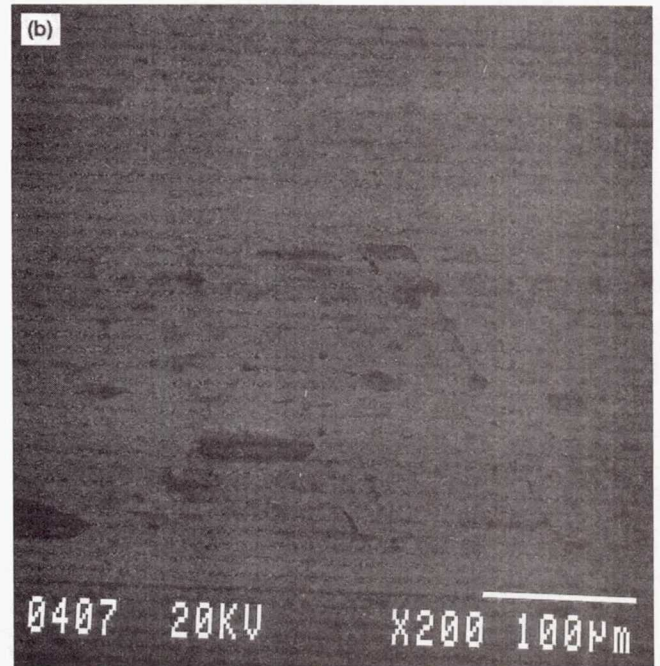
(a) Secondary electron image SEM.  
 (b) Backscatter electron image SEM.

Figure 8.—Wear track on Inconel 718 disk showing transfer patches of Ti-6Al-4V .

Figures 8 and 9 show the Ti-6Al-4V patches on the wear track of Inconel 718 disk. The transferred patches occupied a quite large area fraction of the overall wear track. Thus, the severe damage, often referred to as galling, occurred in the unlubricated Ti-6Al-4V to Inconel 718 contact in vacuum (refs. 3 to 5).

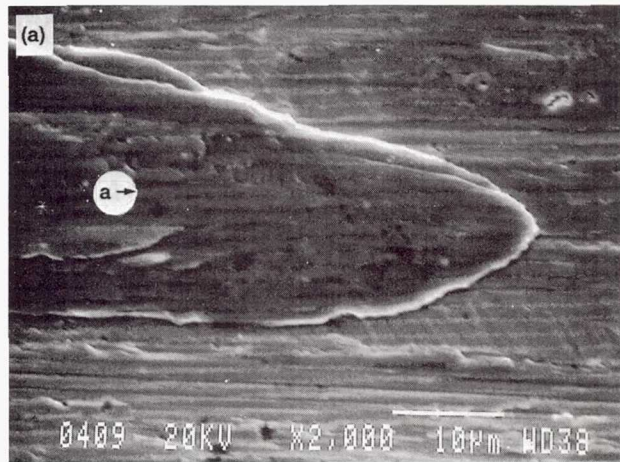
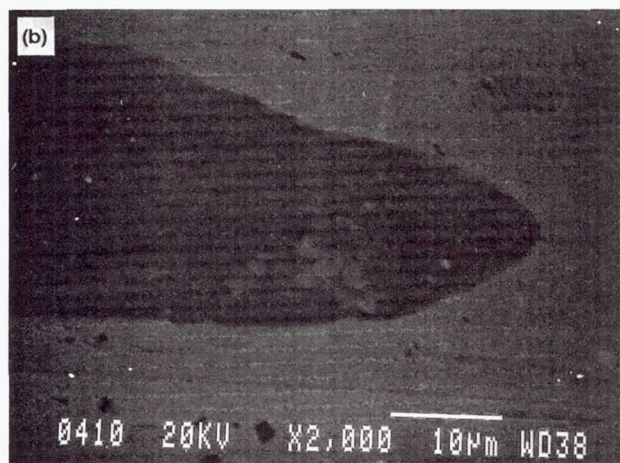
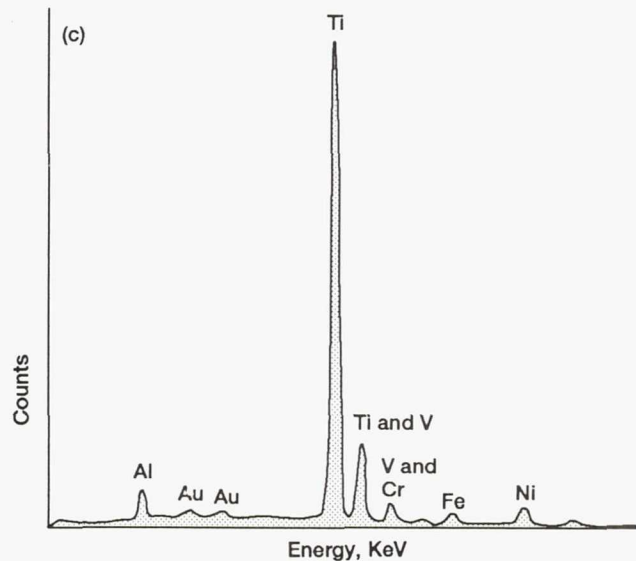
(a) Secondary electron image SEM.

(b) Backscatter electron image SEM.

(c) Energy dispersion X-ray analysis spectrum of transferred film on Inconel 718 disk. Data taken at point indicated in part (a). The thin gold film used to reduce charging of the mount is responsible for the gold signal in the spectrum.

Figure 9.—Large transfer patch of Ti-6Al-4V on Inconel 718 disk.

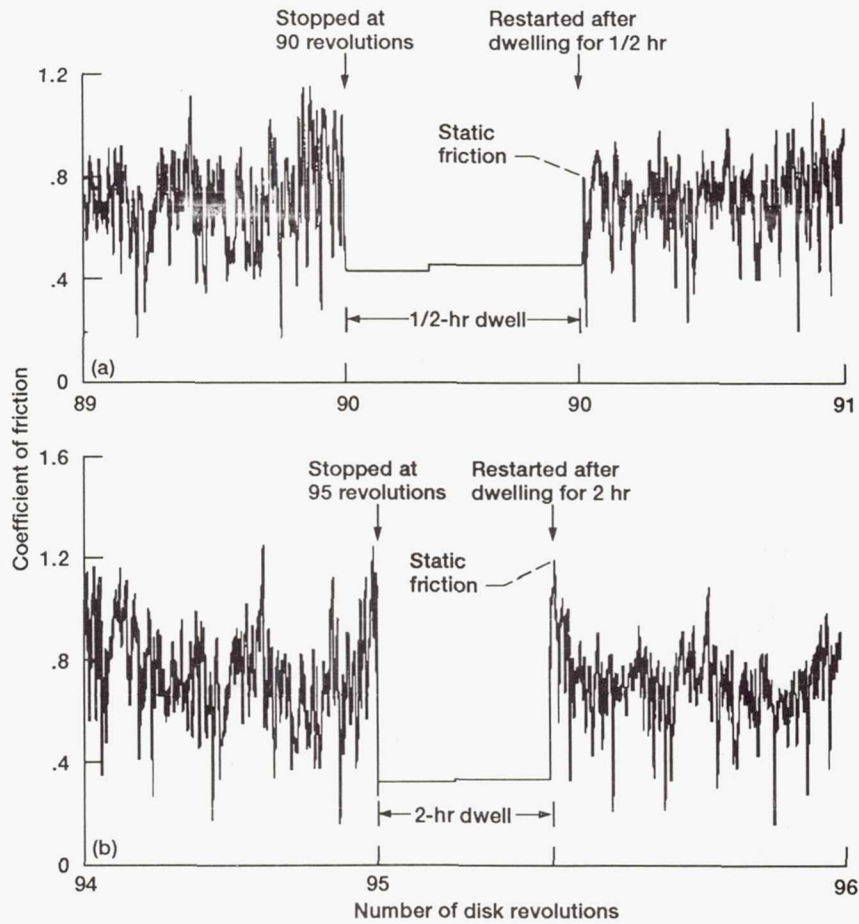
(a) Friction traces before and after dwelling for 1/2 hr.  
 (b) Friction traces before and after dwelling for 2 hr.  
 Figure 10.—Effect of dwelling on friction at 2.5 N in vacuum.

Figure 10 presents friction traces (coefficient of friction as a function of number of disk revolutions) for a Ti-6Al-4V pin in contact with Inconel 718 disk. At 90 disk revolutions (fig. 10(a)) and at 95 disk revolutions (fig. 10(b)), the sliding motion was stopped, and conditions were held for 1/2 hr and for 2 hr, respectively. After the dwell time, sliding was restarted. The traces clearly show that dwell time had almost no effect on the static coefficient of friction, which was similar before and after the dwell time.

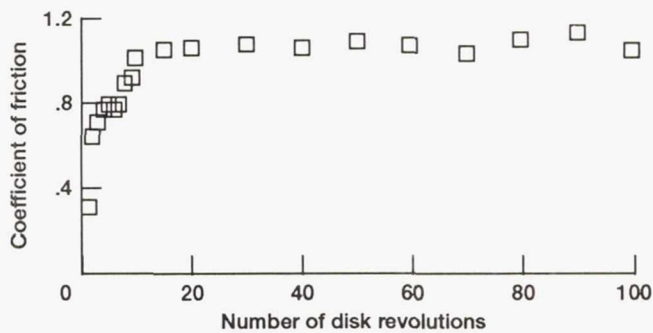
Figure 11.—Coefficients of friction (highest value) for unlubricated Ti-6Al-4V pin sliding against Inconel 718 disk as function of number of disk revolutions at 4 N in vacuum.

Effect of load.—Figure 11 presents the coefficients of friction measured at the load of 4 N. The coefficients of friction were calculated from highest value in friction traces. As might be expected, the friction behavior and the appearance of the galling was essentially the same as observed at 2.5 N.

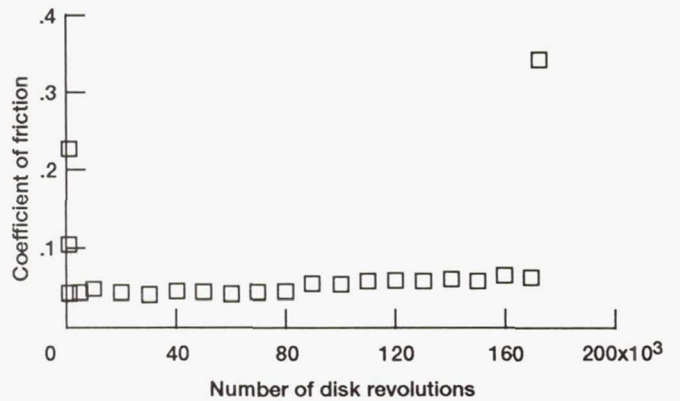
Figure 12.—Coefficients of friction for dry-film-lubricated Ti-6Al-4V pin sliding against Inconel 718 disk at 8.5 N in vacuum.

In vacuum, the coefficient of friction starts relatively high (0.23) but rapidly decreases and reaches an equilibrium value of about 0.04 (fig. 12). It remains constant for a long period of time. The friction trace fluctuated slightly with no evidence of stick-slip behavior (fig. 13). The sliding action finally caused the coefficient of friction to rapidly increase at 172 370 revolutions. Wear damage, which will be discussed later, caused the high friction at this stage.

Worn in vacuum.—At 172 370 revolutions of sliding contact in vacuum (fig. 12), the sliding motion was stopped because of high friction (0.36 or greater) caused by the wear damage. After holding conditions for about 18 hr, the sliding was restarted. The result is presented in figure 16(a). The coefficient of friction after rerun became much lower. Further, the coefficient of friction generally decreased to about 0.05 with increasing number of disk revolutions. This result suggests that the wear damage in vacuum, which caused high friction at 172 370, can self-heal when rerun in vacuum.

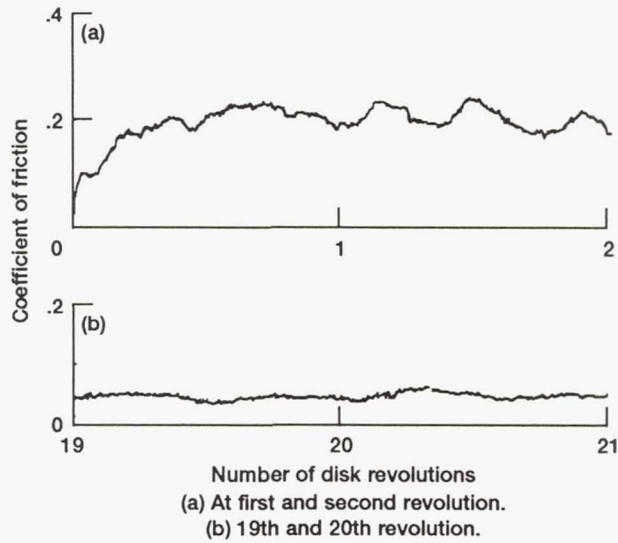
Figure 13.—Friction traces for dry-film-lubricated Ti-6Al-4V sliding against Inconel 718 at 8.5 N in vacuum.

Friction.—Sliding friction experiments were conducted with dry-film-lubricated (Tiolube 460) Ti-6Al-4V pins on Inconel 718 disks at a load of 8.5 N both in vacuum and in air. The results are presented in figures 12 to 14.

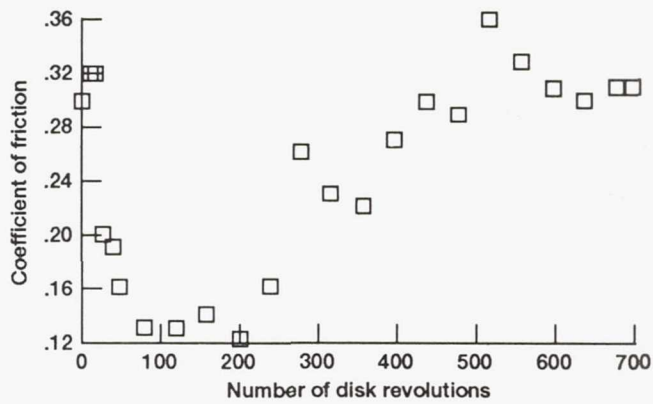
Figure 14.—Coefficients of friction for dry-film-lubricated Ti-6Al-4V pin sliding against Inconel 718 disk at 8.5 N in air.

In air, the coefficient of friction started high (approximately 0.30) in the first 23 revolutions, but decreased and reached an equilibrium value of about 0.1 (fig. 14). Continued sliding caused the coefficient of friction to increase at 270 revolutions. When the coefficient of friction reached an equilibrium value of about 0.3, the experiment stopped (at 700 disk revolutions). The friction trace with disk revolutions to 270 exhibited mild stick-slip behavior (as shown by the representative section in figs. 15(a) and (b)). After 270 disk revolutions, the friction trace exhibited greater stick-slip behavior (fig. 15(c)).

Worn in air and then rerun in vacuum.—After 700 disk revolutions in air (fig. 14), the worn surfaces were at rest, and loose wear particles on the Inconel 718 disk surface were blown off. Then the vacuum chamber was evacuated to  $10^{-7}$  Pa ( $10^{-9}$  torr). After dwelling for about 18 hr in contact, the sliding motion was restarted. The coefficients of friction for the pin and disk worn in humid air were much higher than those for the pin and disk worn in vacuum (as shown in fig. 16(a)). Further, the coefficient of friction generally increased with increasing number of disk revolutions.

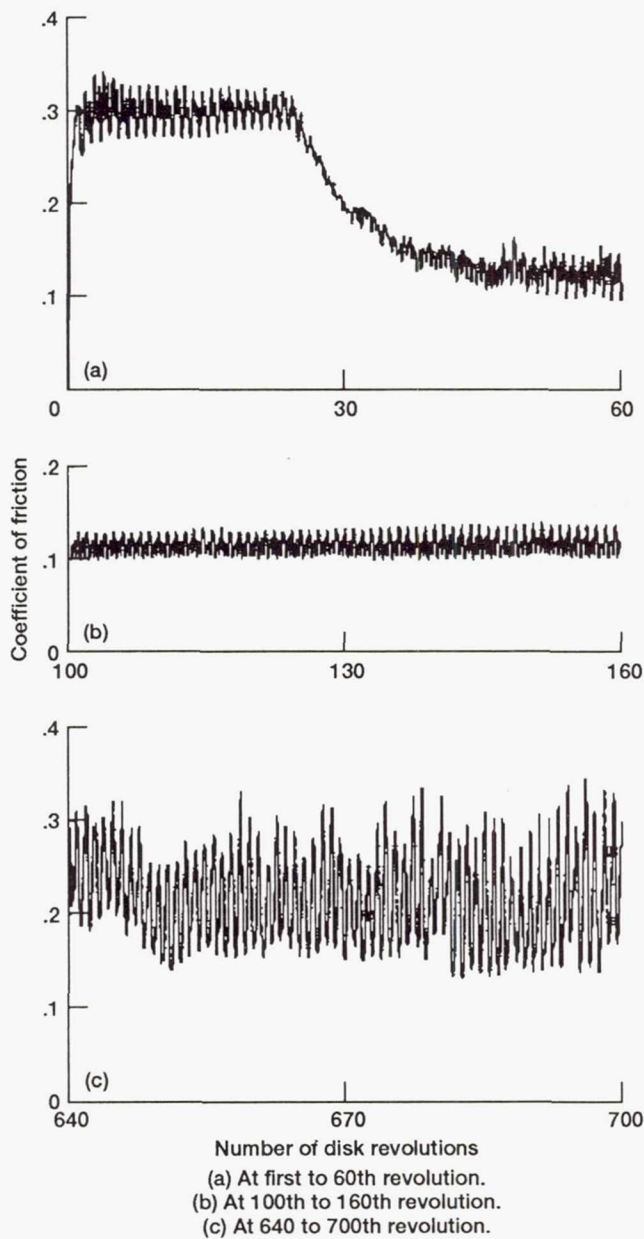
Figure 15.—Friction traces for Ti-6Al-4V pin sliding against Inconel 718 at 8.5 N in air.

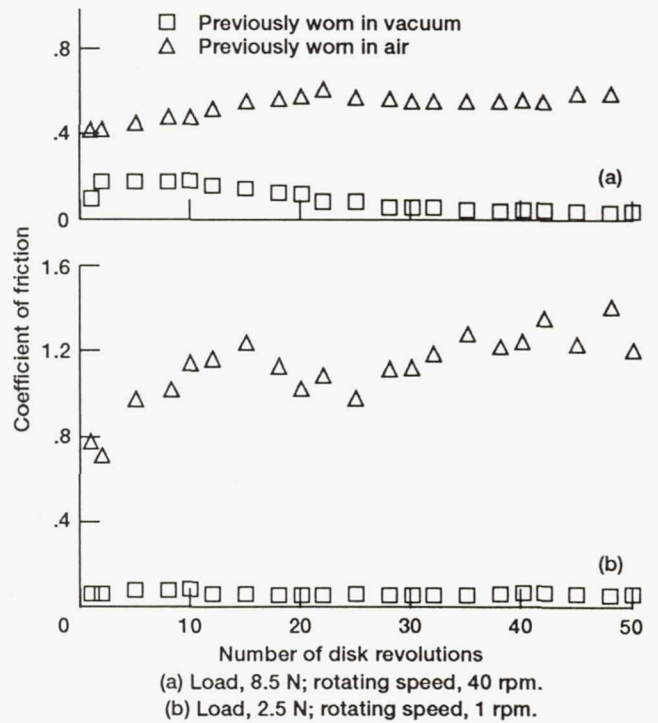
Figure 16.—Coefficients of friction for worn surfaces of dry-film-lubricated Ti-6Al-4V pin sliding against Inconel 718 disk when rerun in vacuum.

After 50 revolutions of sliding contact, the sliding motion was stopped, and the load was changed from 8.5 N to 2.5 N. Contact was maintained for 30 sec, and then sliding was begun at the new load. The changing load from 8.5 N to 2.5 N did not affect the coefficient of friction, as shown in figure 16(b).

After 50 revolutions of sliding contact in vacuum, the sliding motion was stopped, and the load was changed from 8.5 N to 2.5 N. Contact was maintained for 30 sec, and then sliding was begun at the new load. The coefficient of friction continued to increase with increasing number of disk revolutions (fig. 16(b)).

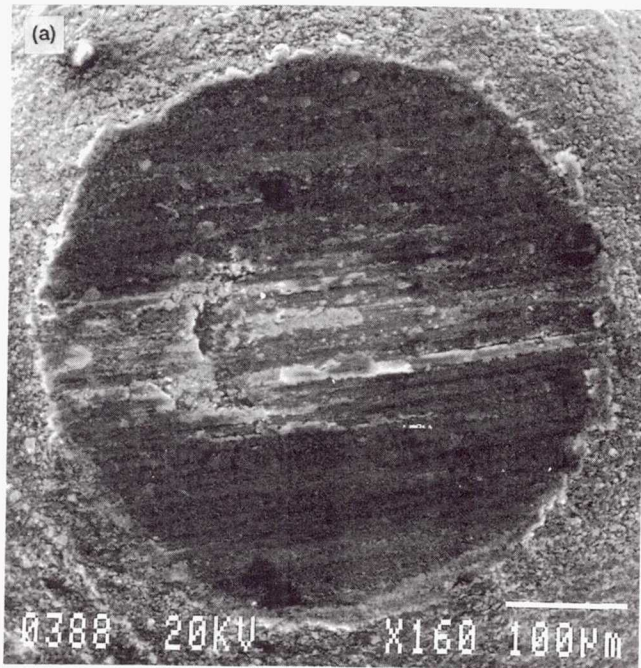
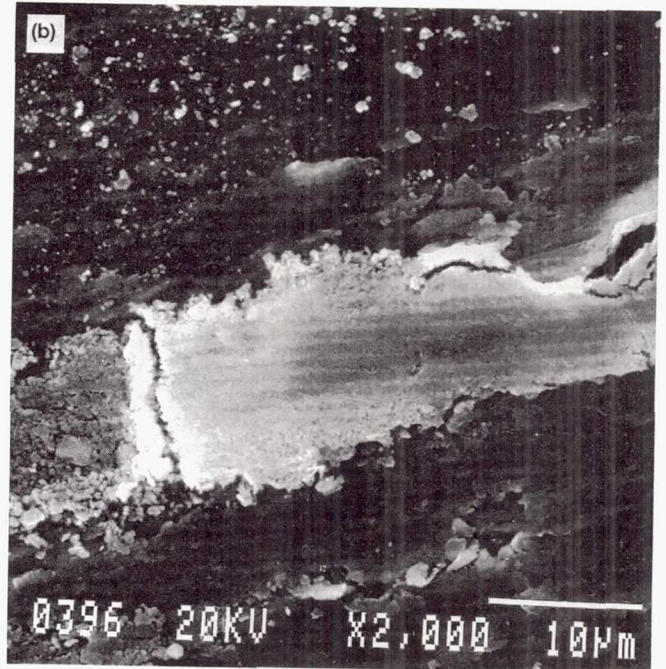
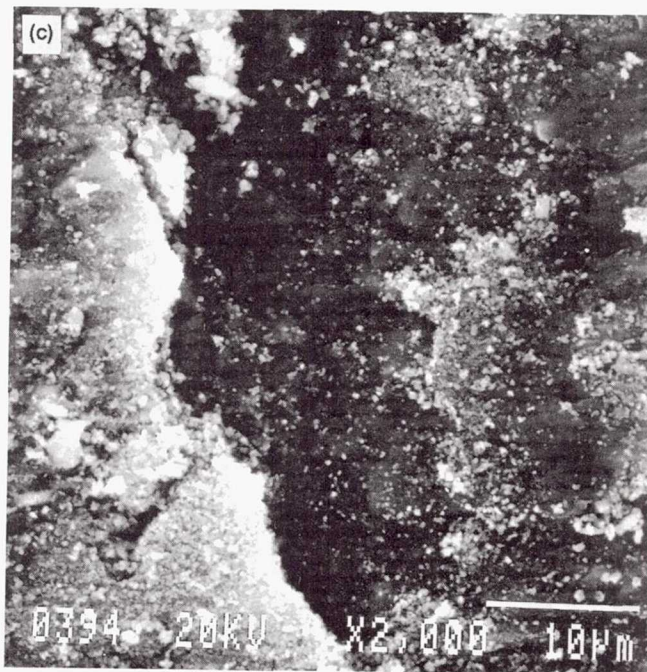
- (a) Low magnification overview showing relatively smooth surfaces at upper and lower areas of wear scar with spalling and tearing center.
- (b) Surface smearing and tearing at the center of wear scar resulting in separation of particles from surface in form of flakes.
- (c) Spalling at the center of wear scar.

Figure 17.—Wear scar produced in dry-film-lubricated Ti-6Al-4V pin after sliding against Inconel 718 disk in vacuum.

Worn in vacuum.—SEM photographs of the worn surfaces of the dry-film-lubricated Ti-6Al-4V pin sliding against Inconel 718 disk in vacuum show surface smearing, tearing, and spalling of the dry-film lubricant (figs. 17 to 20). This type of wear damage, which results from fatigue of the dry-film lubricant, is often referred to as spalling (refs. 3 to 5).

Figure 17(a) shows the relatively smooth burnished surfaces in the upper and lower regions of the wear scar and the rougher surface at the center of the scar. Closer SEM examination and EDX analysis of the wear damage at the center of the wear scar showed that the flake-like wear debris (fig. 16(b)) resulted from surface smearing and tearing of the dry-film lubricant. EDX analysis of the flake-like debris indicated that it mainly contained the elements of the  $\text{MoS}_2$  lubricants. Figure 17(c) shows a crater (dark area) where fragments of the dry-film lubricant were removed and the Ti-6Al-4V substrate was exposed. The EDX analysis of the crater indicated that it mainly contained elements of the Ti-6Al-4V.

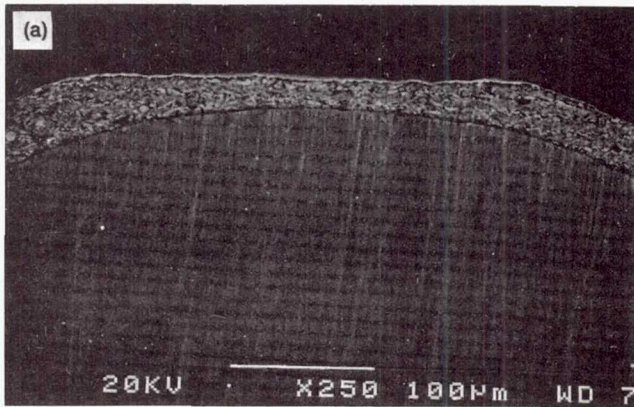
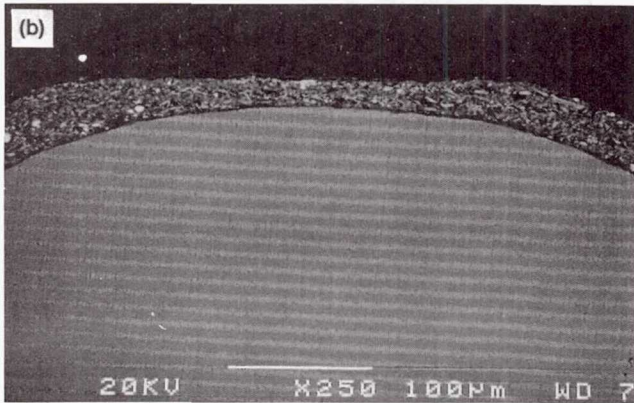
(a) Secondary electron image SEM.  
 (b) Backscatter electron image SEM.

Figure 18.—A taper cross section of the worn surface of dry-film-lubricated Ti-6Al-4V pin at angle of 45° to the worn surface.

Figures 18 and 19 show a taper cross section of the worn surface of the dry-film-lubricated Ti-6Al-4V pin at an angle of  $45^\circ$  to the worn surface. The cross-section SEM photographs clearly indicate that most of the dry-film lubricant remains even after about 170 000 revolutions in vacuum. The film thickness of the remaining lubricant is about 15  $\mu\text{m}$ . Close SEM examination reveals dense, amorphous-like material in the area right underneath the worn surface (fig. 19 (a)).

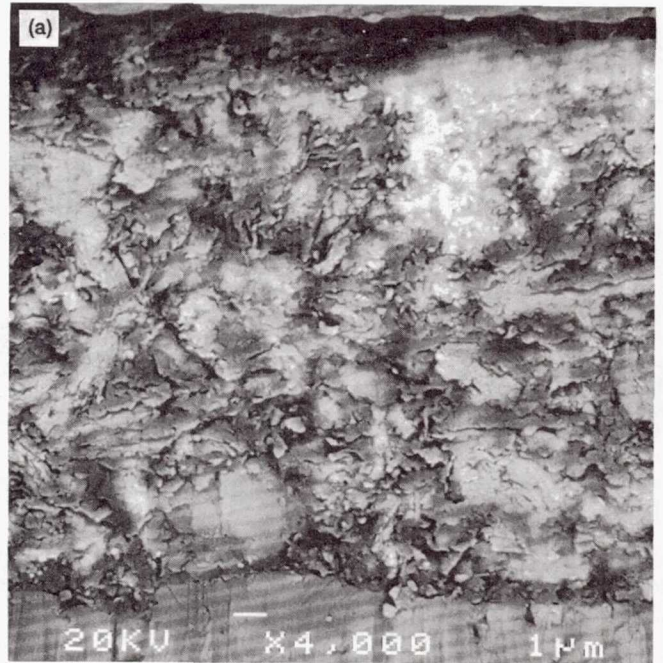
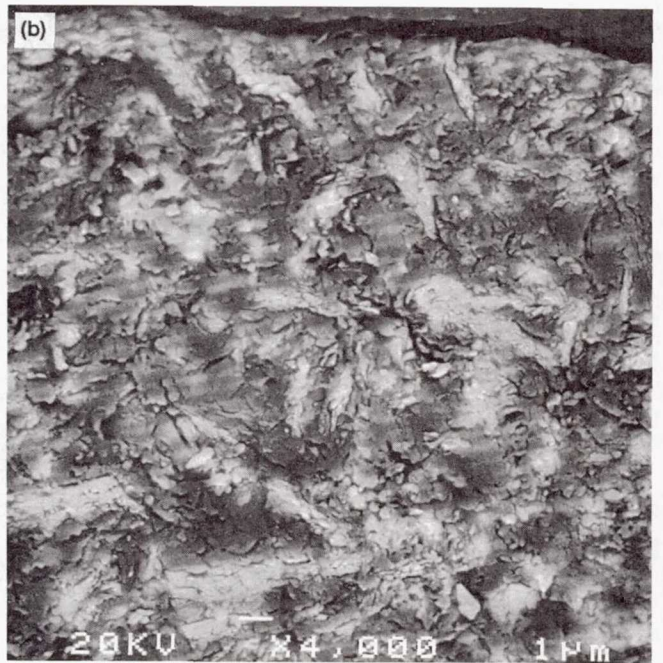
(a) Cross section of worn surface.  
 (b) Cross section of the as-coated area of dry-film-lubricant.

Figure 19.—Comparison of microstructures. Backscatter electron image SEM.

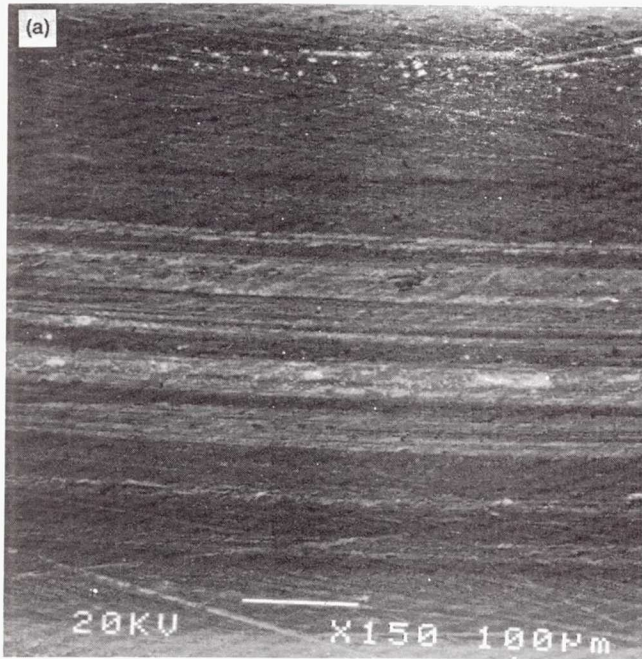
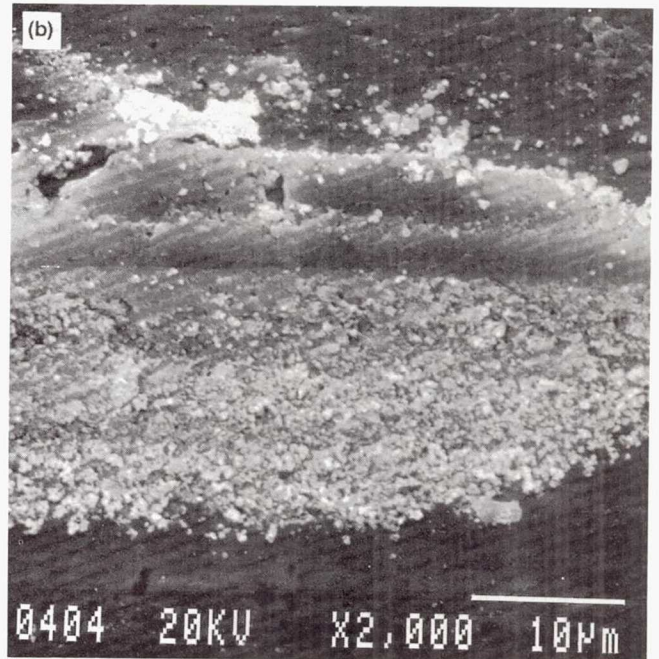
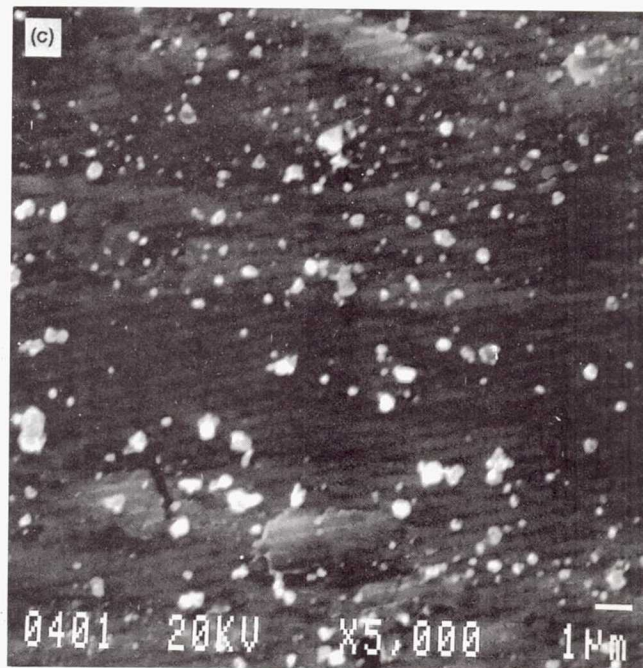
- (a) Low magnification overview of wear track.
- (b) Detailed view showing transfer patches at center of wear track.
- (c) Detailed view showing powder-like wear debris of dry-film lubricant.

Figure 20.—Wear scar produced on Inconel 718 disk after sliding against dry-film-lubricated Ti-6Al-4V pin in vacuum.

Figure 20(a) shows the relatively smooth track of the Inconel 718 disk with transferred patches of the dry-film lubricant observed (even in the low magnification view) mainly at the center of the wear track. Closer SEM examination of the center and upper regions of the track shows the transferred wear particles to be in the form of flakes and powders (fig. 20(b) and (c)).

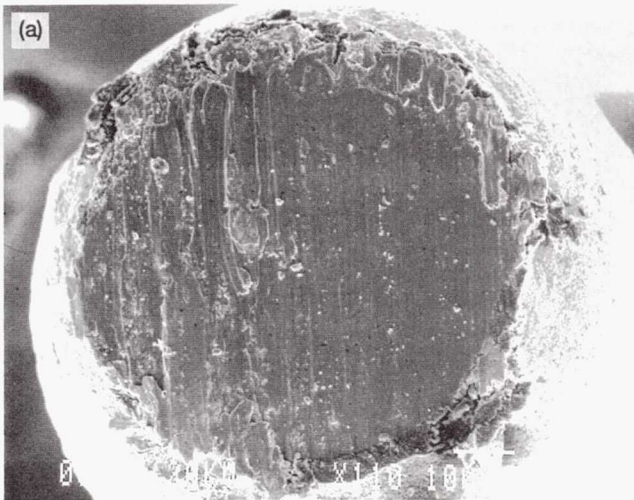
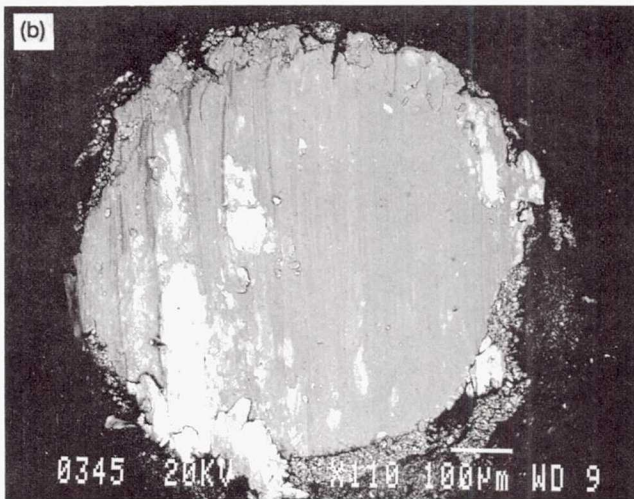
(a) Secondary electron image SEM.  
 (b) Backscatter electron image SEM.

Figure 21.—Wear track produced in dry-film-lubricated Ti-6Al-4V pin after sliding against Inconel 718 disk in air and then rerun in vacuum.

Worn in air and rerun in vacuum.—Scanning electron micrographs of the worn surfaces of the dry-film-lubricated Ti-6Al-4V pin and Inconel 718 disk run in air for 700 disk revolutions and then rerun in vacuum for 100 disk revolutions are shown in figures 21 to 27. Figure 21 shows that both plastic deformation and ductile fracture occurred in the dry-film-lubricated Ti-6Al-4V pin. The backscatter photograph (fig. 21(b)) reveals three different materials: (1) the light areas in the photomicrograph show where the transfer patches from the Inconel 718 disk stayed on the Ti-6Al-4V pin, (2) the grayer areas show the Ti-6Al-4V substrate with no dry-film lubricant present, and (3) the salt and pepper-like areas around the edge of wear scar show the dry-film lubricant. In addition to the major elements of Inconel 718, the transfer patches also contained elements such as molybdenum and sulfur from the lubricant (fig. 22(a)). On the other hand, the gray areas contained only the elements of Ti-6Al-4V (fig. 22(b)).

Thus, the worn surface of the pin and disk first run in humid air and then rerun in vacuum was completely different from that of the pin and disk run only in vacuum. The surface worn in humid air (figs. 21 and 23) exhibited galling accompanied by the severe surface damage and extensive transfer of the Ti-6Al-4V to the Inconel 718, or vice versa.

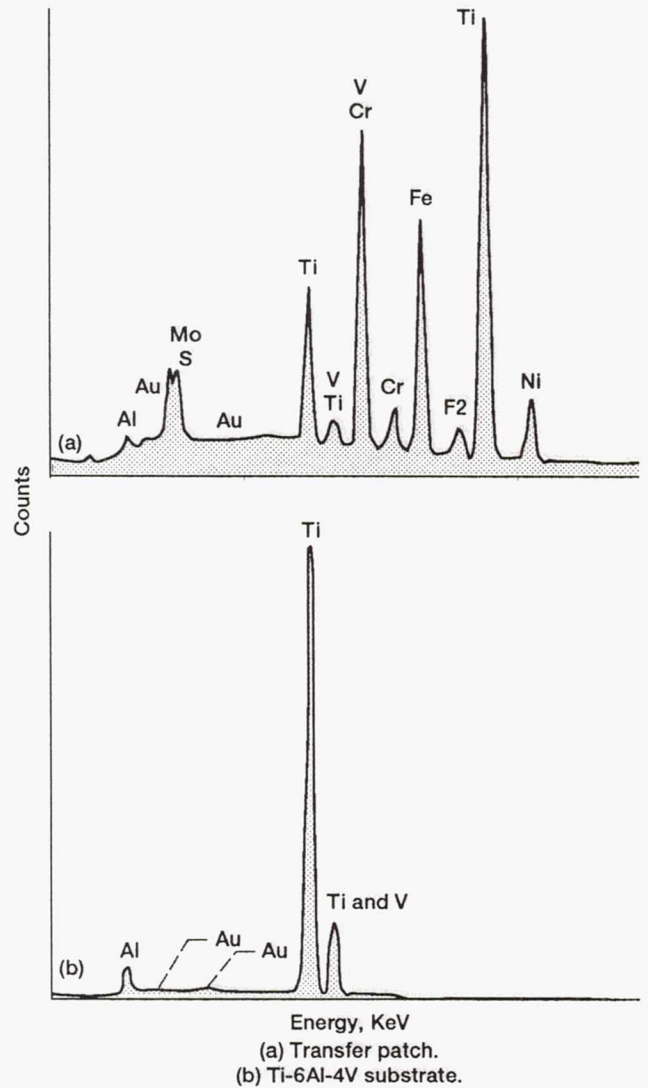
Figure 22.—EDX analysis of wear scar produced in dry-film-lubricated Ti-6Al-4V pin after sliding against Inconel 718 disk in air and then rerun in vacuum. The thin gold film used to reduce charging of the mount is responsible for the gold signal in the two spectra.

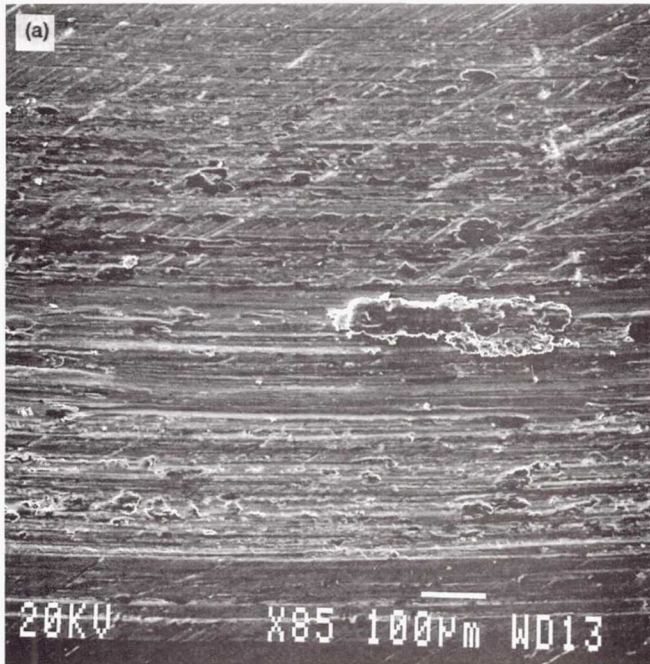
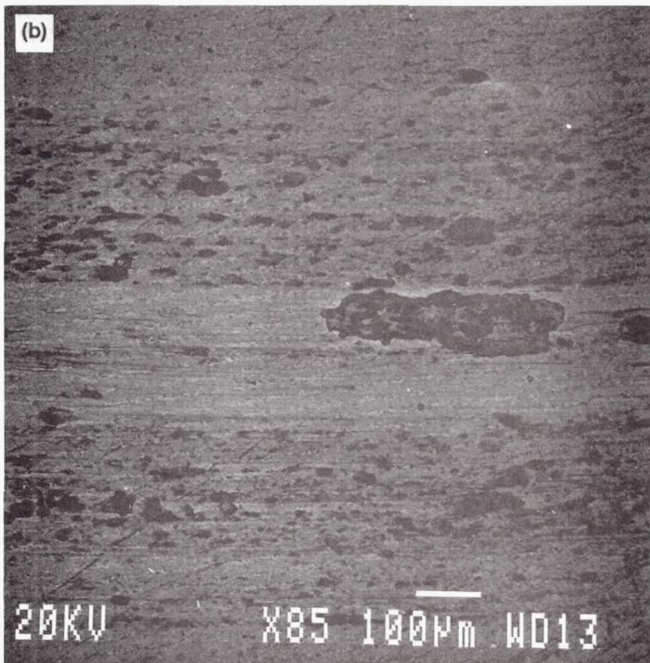
(a) Secondary electron image SEM.  
 (b) Backscatter electron image SEM.

Figure 23.—Wear track produced in Inconel 718 disk after sliding against dry-film-lubricated Ti-6Al-4V pin in air and then rerun in vacuum.

The large patches seen on the wear track of the Inconel 718 disk of figure 23 are also apparent in the backscatter photomicrograph of figure 23(b), which indicated the dark areas to be the transfer patches from the Ti-6Al-4V. Further, the EDX analysis (fig. 24(a)) of the transfer patch shows that it mainly contained elements of the Ti-6Al-4V with a small amount of elements from the dry-film lubricant. The rest of the areas in the wear track contained relatively smaller amounts of elements from the Ti-6Al-4V and dry-film lubricant (fig. 24(b)). Closer SEM examination (fig. 25) of the wear track reveals extensive plastic shearing of the Inconel 718 disk.

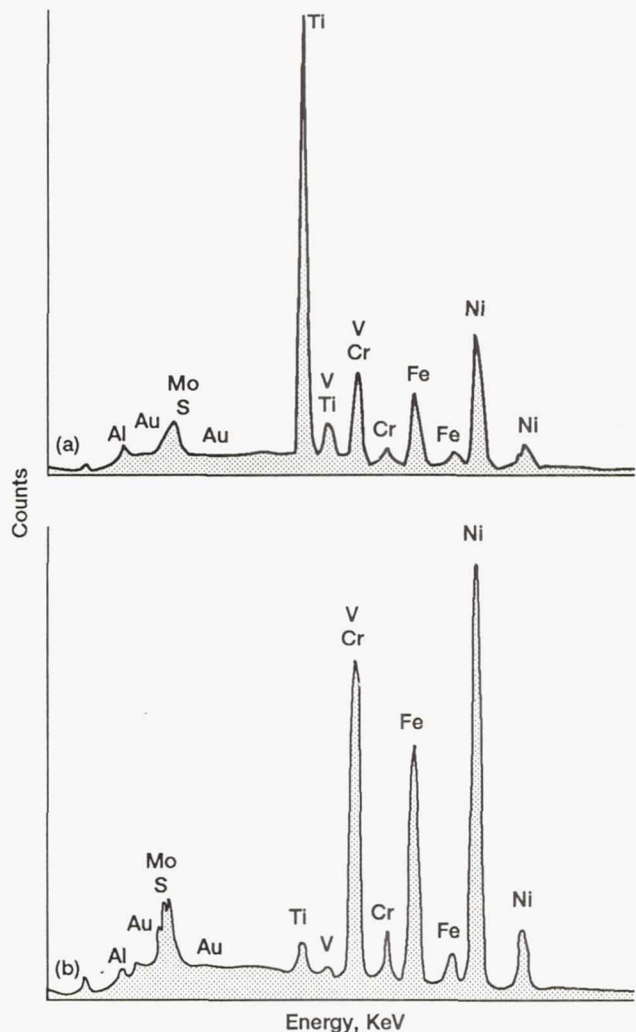
(a) Transfer patch of Ti-6Al-4V.  
 (b) Smear area.

Figure 24.—EDX analysis of wear track produced in Inconel 718 disk after sliding against dry-film-lubricated Ti-6Al-4V pin in air and then rerun in vacuum. The thin gold film used to reduce charging of the mount is responsible for the gold signal in the two spectra.

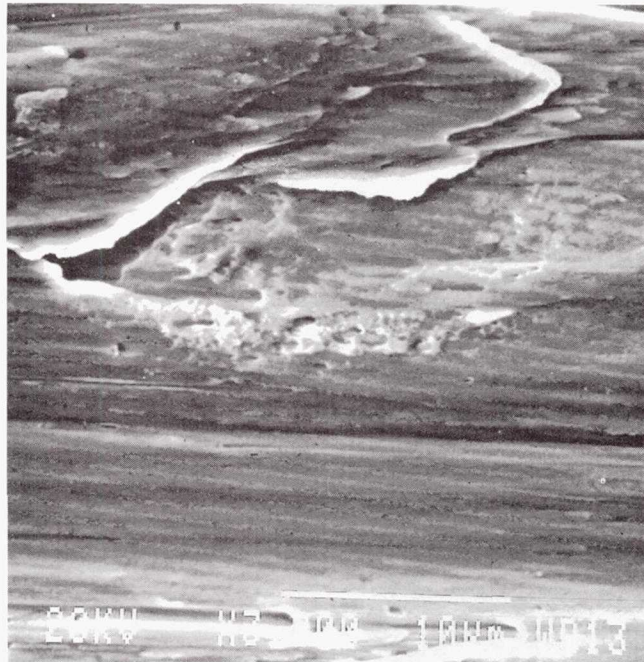
Figure 25.—SEM photomicrograph of wear track showing extensive plastic shearing in Inconel 718 disk after sliding against dry-film-lubricated Ti-6Al-4V pin in air then rerun in vacuum.

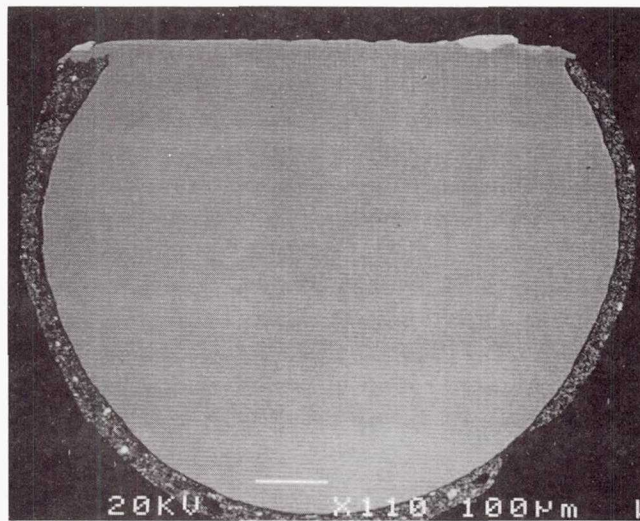
Figure 26.—A taper cross section of the worn surface of the dry-film-lubricated Ti-6Al-4V pin at an angle of 45° to the worn surface. Overview (backscatter electron image SEM) showing extrusion out of the wear scar, transferred patches of Inconel 718, and no presence of the dry-film lubricant on the worn surface.

Figure 26, a taper cross section of the worn surface of the dry-film-lubricated Ti-6Al-4V pin shows clearly that the dry-film lubricant is not present on the worn surface. Further, in the overview photomicrograph, extrusion out of the wear scar and transferred patches of Inconel 718 are also well defined because of effective atomic number contrast. In figure 27 plastic deformation of the Ti-6Al-4V (extrusion out of the wear scar) and local solid-phase welding between Ti-6Al-4V and transfer patch of Inconel 718 (often referred to as scuffing) were well defined by the backscatter electron image SEM.
