NASA Technical Memorandum 105355

# Properties Data for Opening the Galileo's Partially Unfurled Main Antenna

Kazuhisa Miyoshi and Stephen V. Pepper  
*Lewis Research Center*  
*Cleveland, Ohio*

February 1992

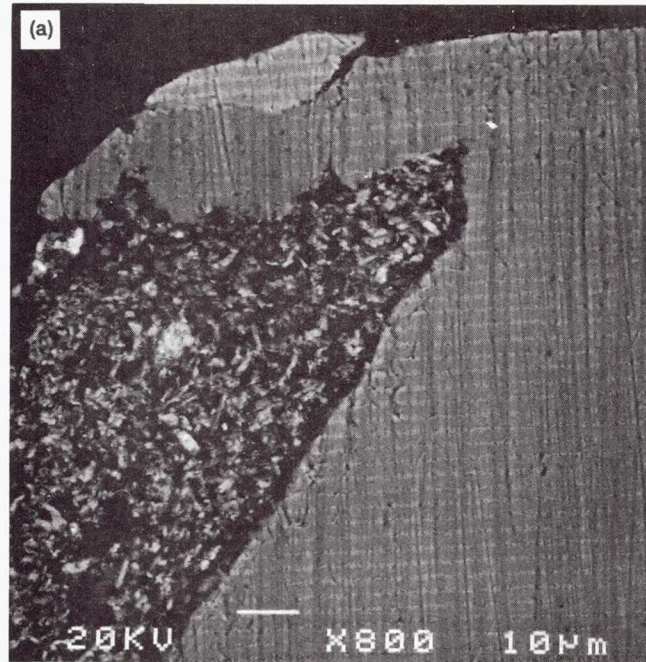
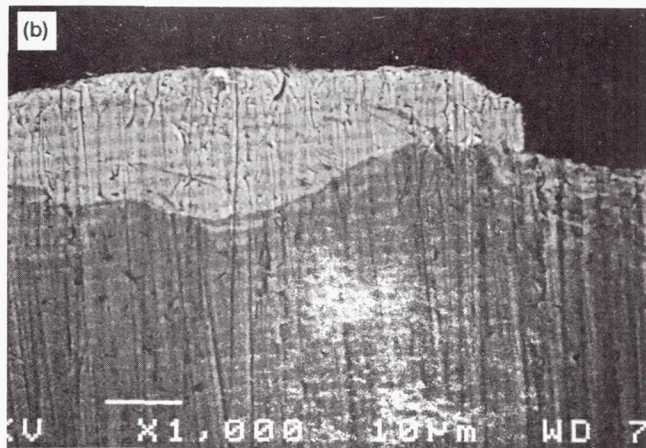
(a) Backscatter electron image SEM showing extrusion out of the wear scar.

(b) Backscatter electron image SEM showing a transferred patch of Inconel 718 on the worn surface of Ti-6Al-4V pin.

Figure 27.—A taper cross section of the worn surface of the dry-film-lubricated Ti-6Al-4V pin.

Figure 26, a taper cross section of the worn surface of the dry-film-lubricated Ti-6Al-4V pin shows clearly that the dry-film lubricant is not present on the worn surface. Further, in the overview photomicrograph, extrusion out of the wear scar and transferred patches of Inconel 718 are also well defined because of effective atomic number contrast. In figure 27 plastic deformation of the Ti-6Al-4V (extrusion out of the wear scar) and local solid-phase welding between Ti-6Al-4V and transfer patch of Inconel 718 (often referred to as scuffing) were well defined by the backscatter electron image SEM.
