NASA TM - 103559

THE EFFECTS OF MULTIPLE REPAIRS ON INCONEL 718 WELD MECHANICAL PROPERTIES

By C.K. Russell, A.C. Nunes, Jr., and D. Moore

December 1991

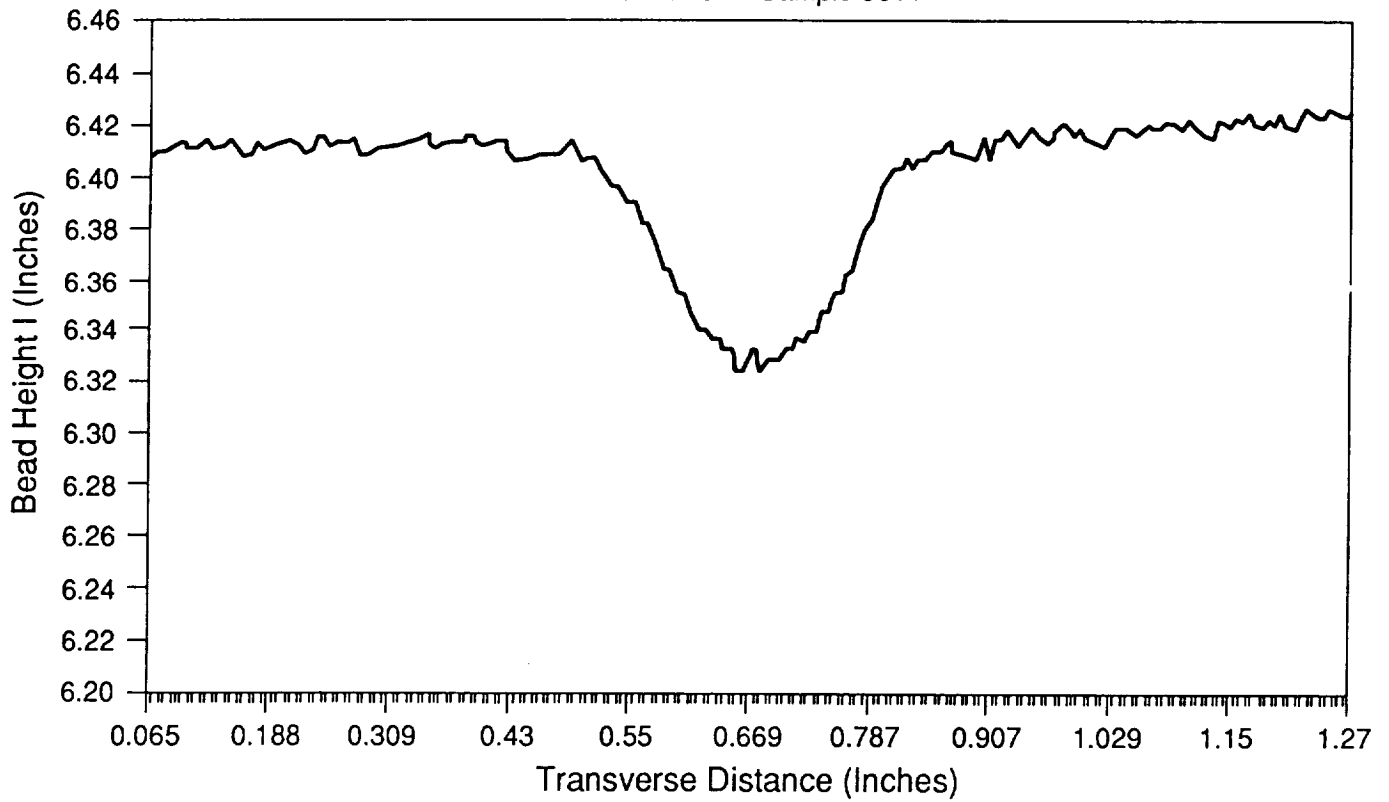
Figure 1. Weld bead profile measurement.

Weld Repair Program
Weld Root Profile — Sample 9811
