LEO MICROMETEORITE/DEBRIS IMPACT DAMAGE*

Paul M. Stella
Jet Propulsion Laboratory
California Institute of Technology
Pasadena, CA 91109

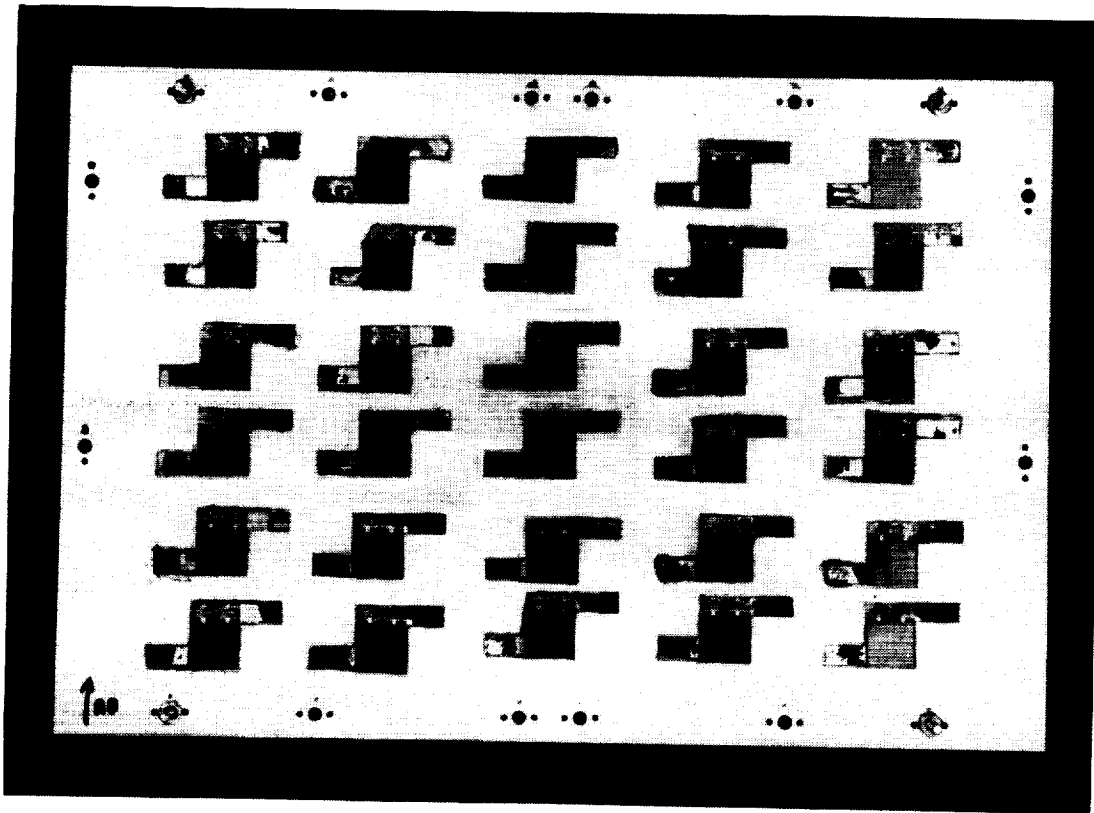
Observation of the recovered test plate revealed a number of obvious changes (Figure 2). All exposed (uncovered by adhesive or encapsulant) tab surfaces darkened (black and dark blue) from the original shiny silver appearance. In many cases, the darkened silver tab surfaces showed signs of stress by the formation of platelets, much like dried mud in texture. The dark surface material is readily removed by gentle mechanical abrasion revealing a shiny, albeit rough, surface underneath. In some areas, it appeared that the original surface had flaked off. The resultant surface region was slightly lower than the surrounding regions and the color was less dark -- more gray than blue/black -- suggesting less exposure time to the pertinent environment.

As might be expected, the least disturbed cover system was that of the conventional microsheet platelet. Encapsulant behavior varied widely, with some materials appearing to have been essentially removed. In those cases, the cell grid lines darkened, probably through interaction with the space environment. In other cases, although encapsulant materials degraded, becoming embrittled for example, the cell grid lines were still protected sufficiently that they remained shiny. Areas of the aluminum plate appeared stained, most likely due to environmental interactions (atomic oxygen and/or UV) with the residue of materials used in assembly.

Figure 2. JPL SAMPLE Plate After Retrieval

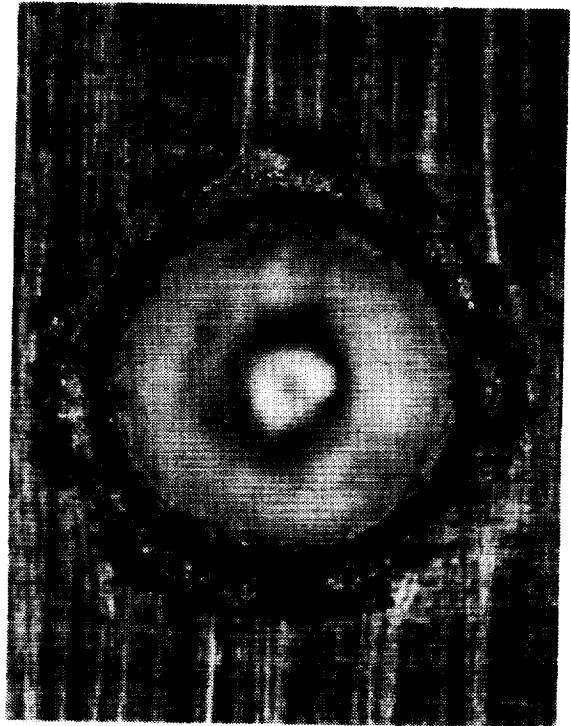
Survey of the plate reveals a large number of impact craters, predominantly in the aluminum plate, ranging in size from 0.05 mm (Figure 3) to 1 mm (Figure 4) in diameter. Most impacts appear to be normal to the plate (circular crater), although a small number of elongated craters indicate off normal incidence. The physical appearance of these impacts is discussed in the following section.

Since the majority of the test plate area consists of the uncovered aluminum mounting plate, the majority of impacts are located in the plate. These are generally similar visually, and typified by the example in Figure 4. The impact has formed a circular crater with a surrounding ridge ejected out from and over the plate surface. The crater bottom is crystalline in appearance, unlike the scratched and machined plate surface, showing evidence of melting and resolidifying. This crater pattern was observed for all sizes from 1mm diameter on down. Of the 157 impacts observed (over the entire test plate/sample surface), seven were 0.5mm or larger. Depth measurements of the seven indicated a crater depth (measured from crater bottom to top of surrounding ridge) ranging from one-half to one-third the crater diameter. Only a few craters were noted with an elliptical shape that might be attributable to an impact with a particle with a large non-normal velocity component.

Figure 4. Largest crater ~1mm
diameter

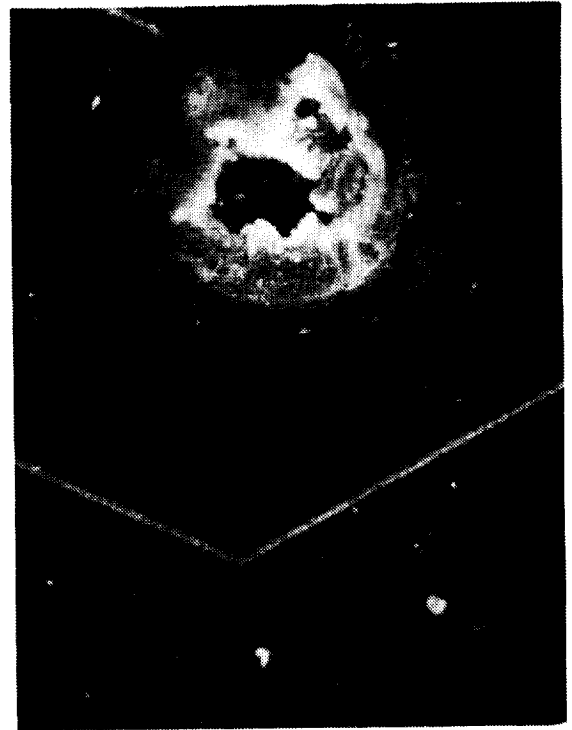
The appearance of impacts with a relatively thick polymer cell cover, such as Teflon FEP, shown in Figure 6, is remarkably similar to

the above-described silver-plated Invar tab. For Teflon, the incident particle readily penetrates and impacts the silicon cell below. The impact with the silicon has generated gases which, in turn, lift the Teflon away from the cell and blow out the central area. The flexible Teflon, unlike the rigid silver metallization, settled back somewhat onto the cell surface. A light colored ring can be observed around the blowout region, corresponding to an area of Teflon/silicon delamination, where physical contact has been recovered, if not adherence. It is clear that the Teflon provides essentially negligible protection against the high energy impacts. Again, due to the small damage area, cell power degradation may not be significant. It is intended to examine for any impact/cell power loss correlation in subsequent electrical performance tests.

Figure 6. Teflon cover (~0.3 mm
diameter hole)

Although polymer-type covers may look attractive for low cost cell protection and may someday be suitable for protection against U.V. and low energy protons, there is negligible ability to shield against debris/micrometeorite impacts. If these impacts are cell degrading, then more robust covers, such as the standard fused silica or microsheet materials may be required at these low altitudes.
