NASA Technical Memorandum 104490

Sliding Wear of Self-Mated Al_2O_3 -SiC Whisker Reinforced Composites at 23-1200 °C

**SLIDING WEAR OF SELF-MATED Al_2O_3 -SiC WHISKER REINFORCED
COMPOSITES AT 23 TO 1200 °C**

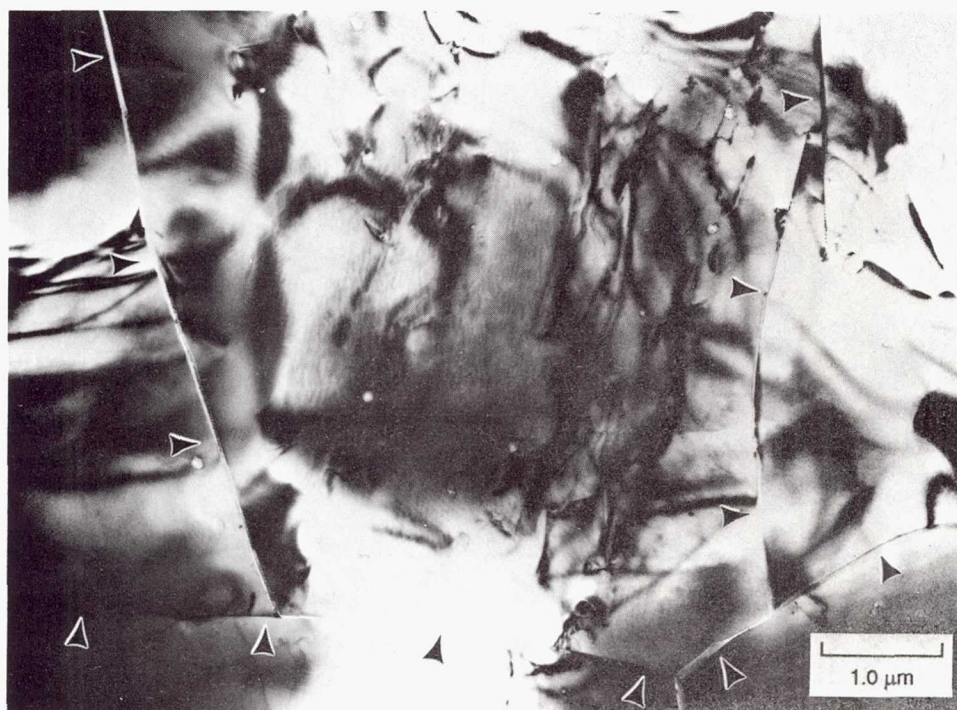
Figure 9.—TEM image of 600 °C wear surface shows extensive microcracking of material. Cracks inclined to surface are not as obvious as those seen "edge on" in micrographs. Arrows have been used to make the full extent of cracking obvious. Dislocations are visible in heavily microcracked regions. Several dislocations are visible in central region of micrograph.

TEM images of the 600 °C wear surface showed severe microcracking. A high dislocation density was invariably found in microcracked regions. (See Fig. 9.) Grains further removed from the microcracked regions contained few if any dislocations.

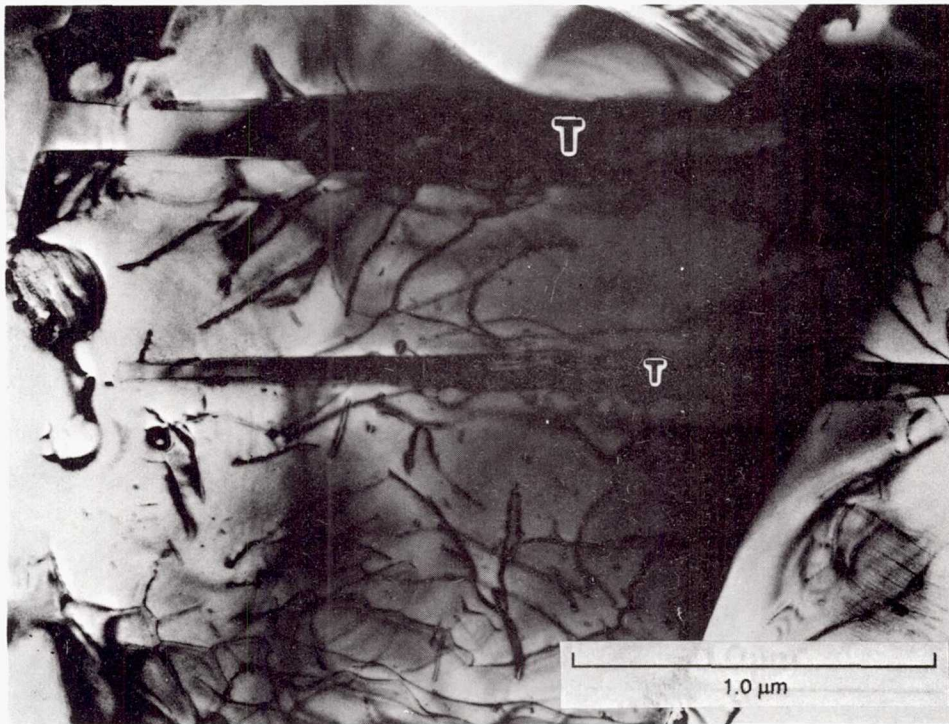
Figure 13.—TEM image of Al₂O₃ grain. Single dislocations and dislocations are visible as well as two twin lathes which extend horizontally across the micrograph (labeled "T").

Regions containing healed microcracks invariably have dislocations visible under the appropriate diffraction conditions. In addition to microcracks, healed cracks, and dislocations, twinning was observed in a few grains, Fig. 13. Even at elevated temperatures, the microstructural changes observed were quite surface specific. Grains which were further away from the sliding interface (~ 1 mm) appear unaffected.
