TRANSFER ORBIT STAGE
MECHANISMS THERMAL VACUUM TEST
Scott T. O'Leary
Martin Marietta Astronautics Group

ABSTRACT:

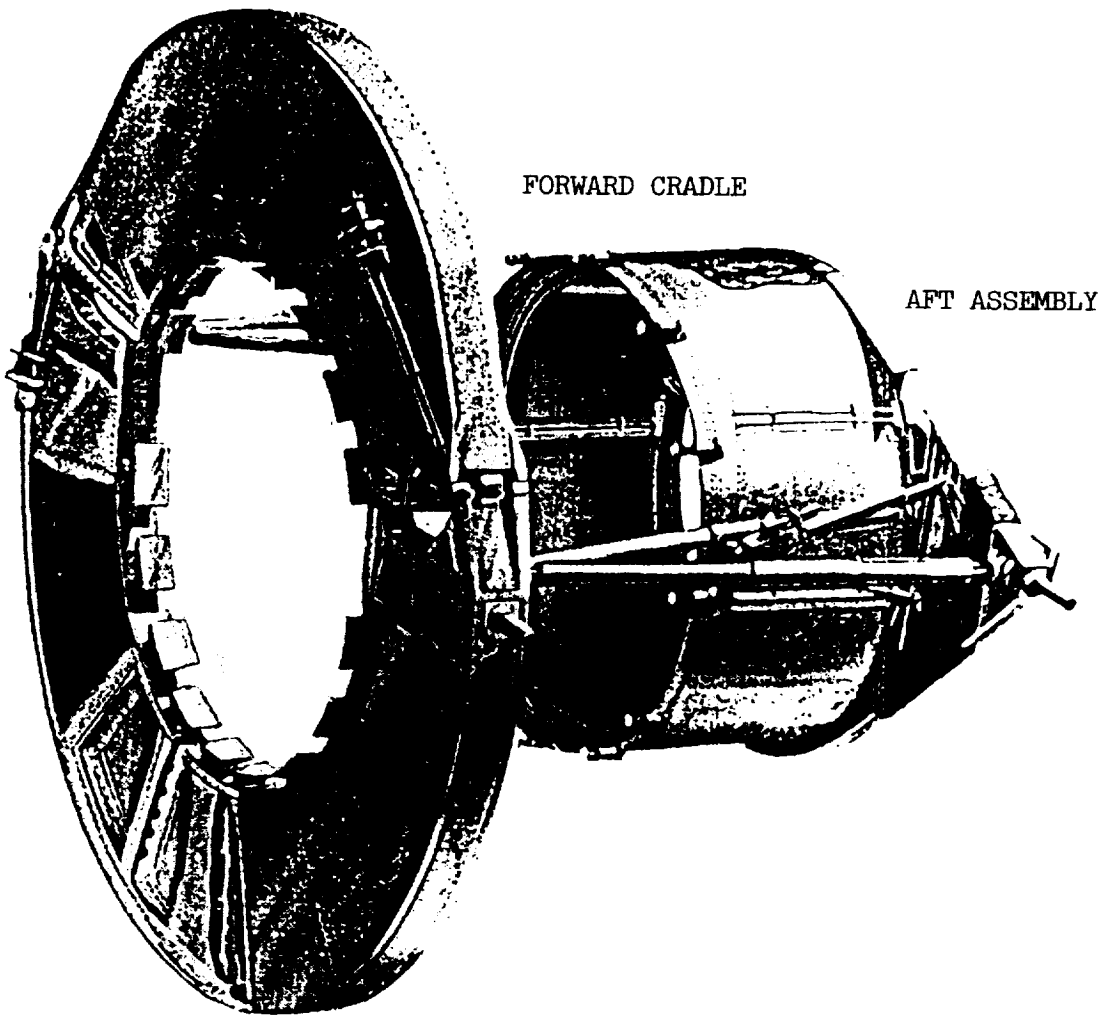
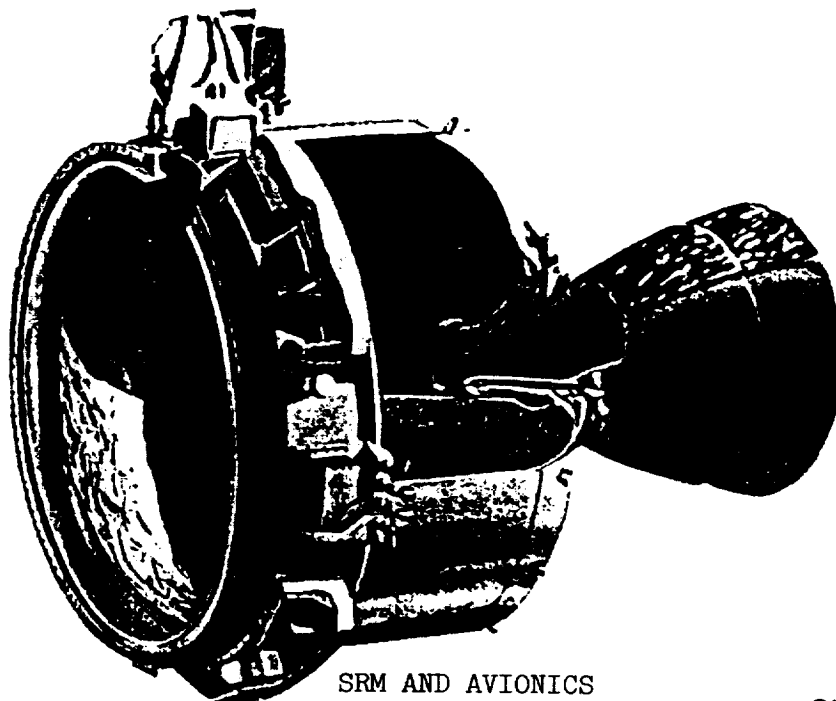
Figure 1.

FORWARD CRADLE

AFT ASSEMBLY

MECHANISM ASSEMBLY

SRM AND AVIONICS

The TOS system uses mechanical actuators to open a forward cradle and tilt the aft assembly which holds a satellite and TOS SRM and avionics package (figure #1). Tests were conducted on the TOS system at ambient temperature and pressure conditions, and worst case cold at vacuum. The TOS Mechanisms test had five primary objectives:

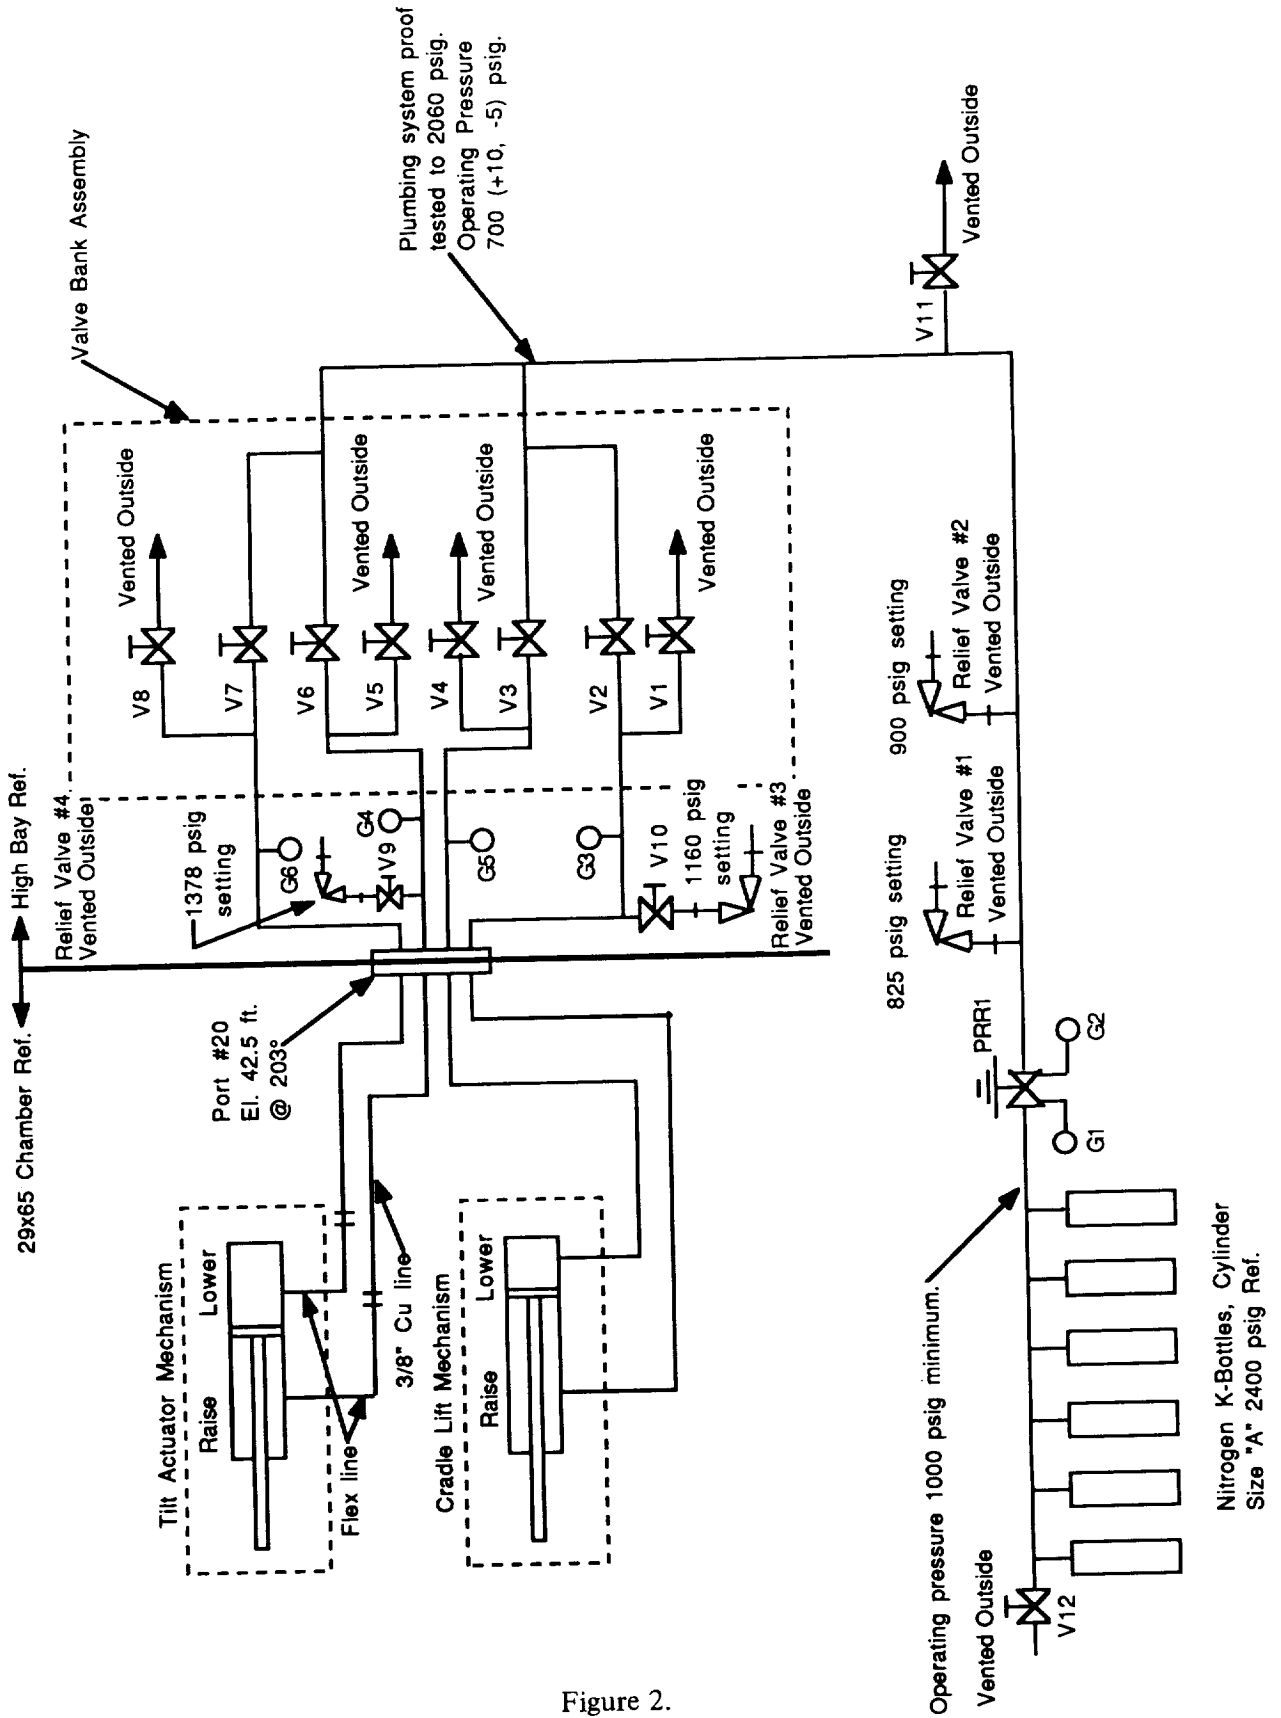
Figure 2.

LIFT AND TILT ASSEMBLY PLUMBING AND VALVING

The pneumatic actuators were operated manually by adjusting hand valves which were located on a system valve bank assembly (figure #2). This proved to be a simple and effective method of operating the actuators.

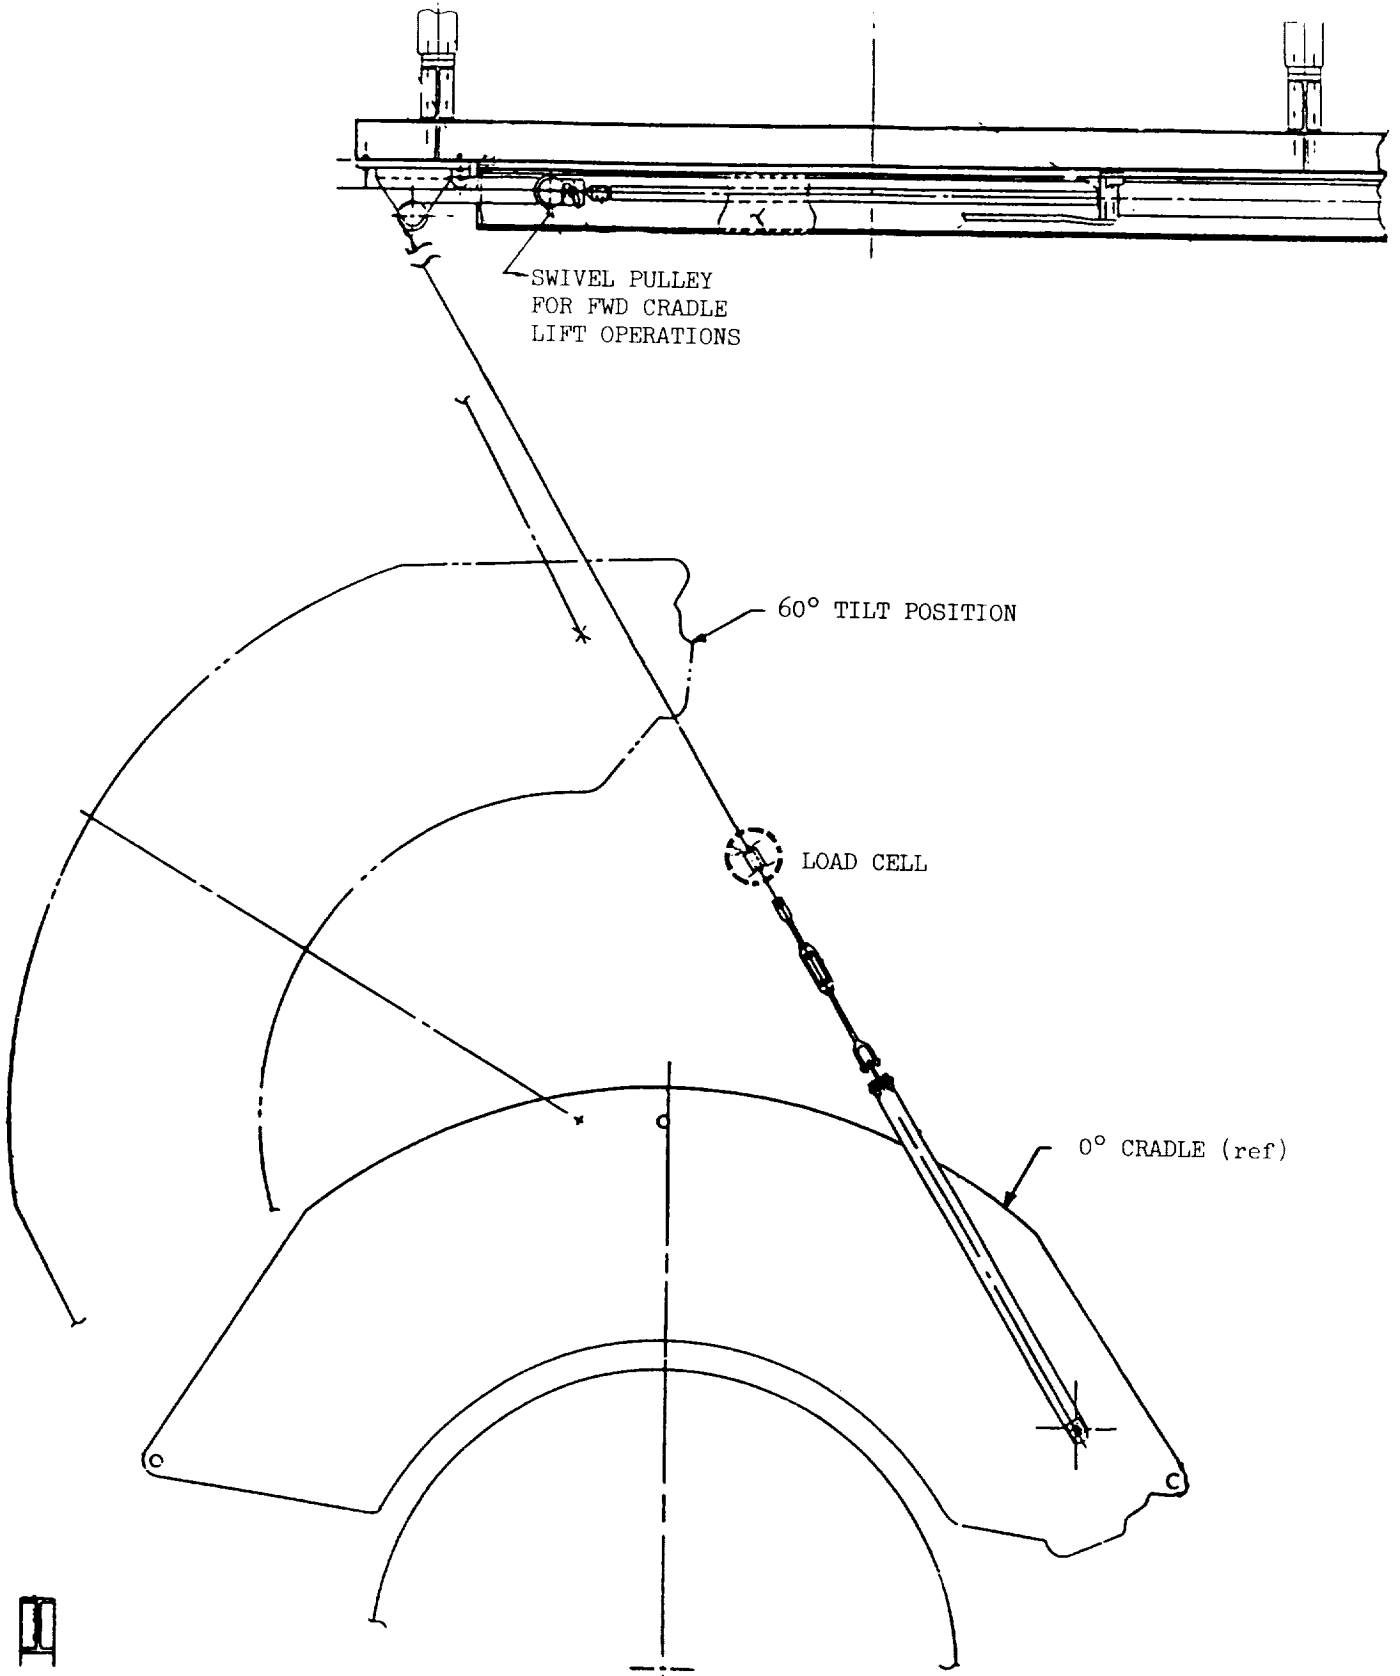
Figure 3. Forward Cradle Lift

A full system verification was performed with the actuators on the support assembly. During checkout, a frictional binding problem in the actuators was discovered. To reduce the side loading on the piston, a swiveled pulley was attached to the end of the actuator piston, allowing it to rotate freely (figure #3). The bolts which mounted the pneumatic actuator to the support structure were loosened 1/4", to allow the actuator to float, thus reducing the torsion acting on the actuator. The tilt actuator was hung vertically and pinned at one end which allowed it to move freely (figure #4). This setup reduced the friction sufficiently to allow the hardware to be moved in a smooth manner.

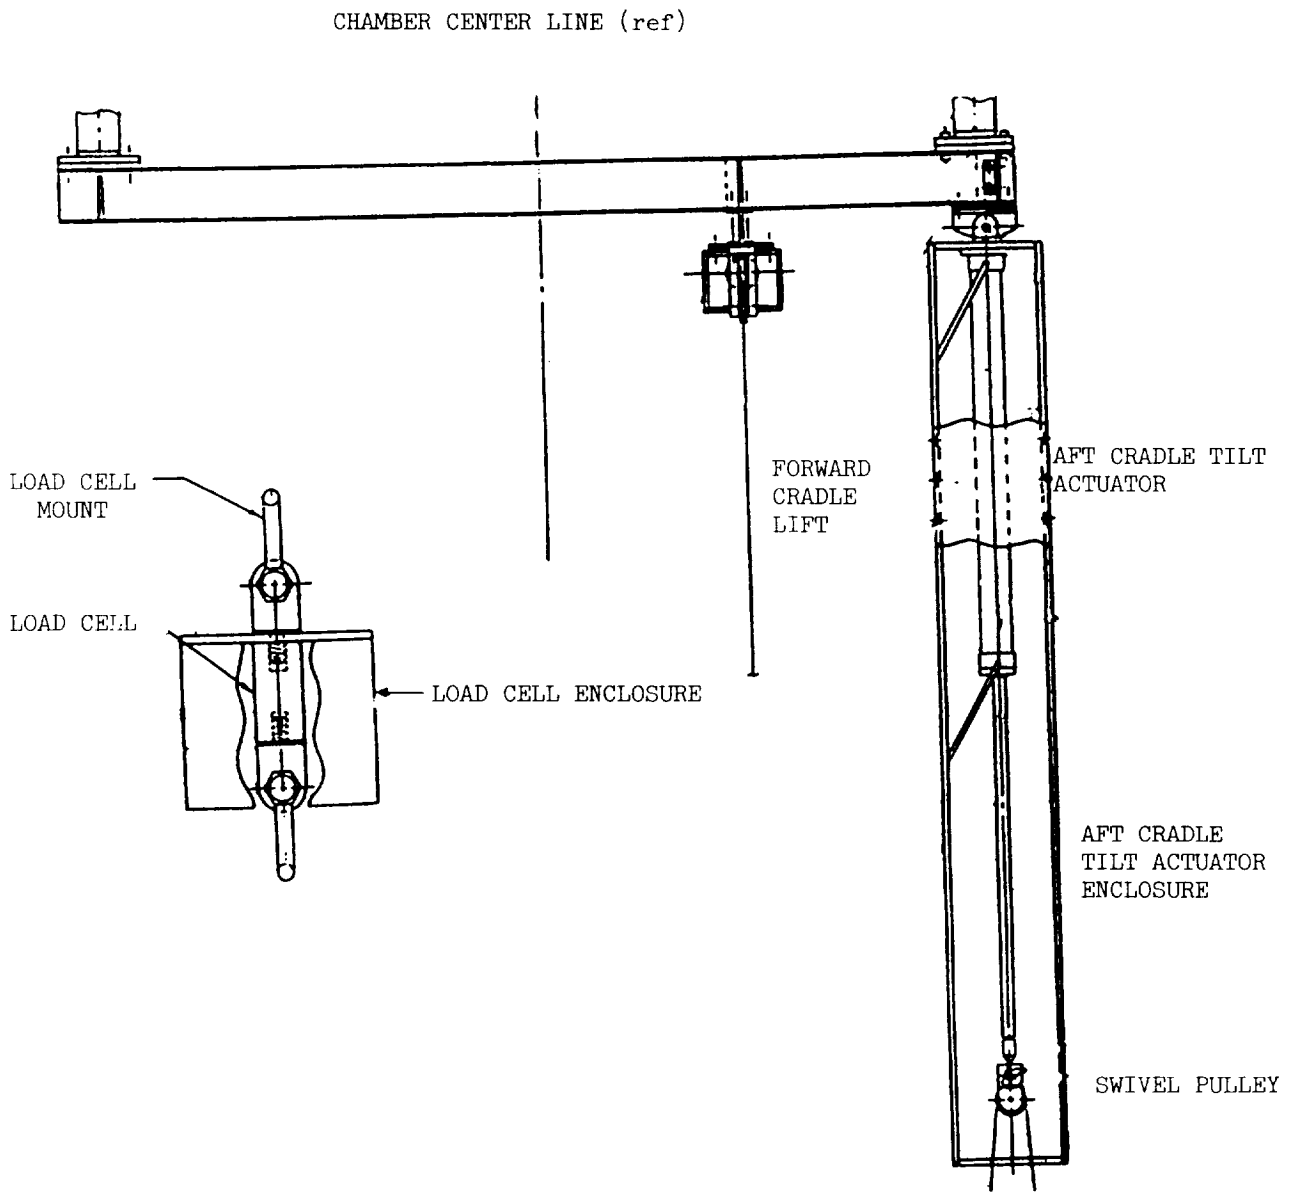
Figure 4. Aft Cradle Tilt Actuator

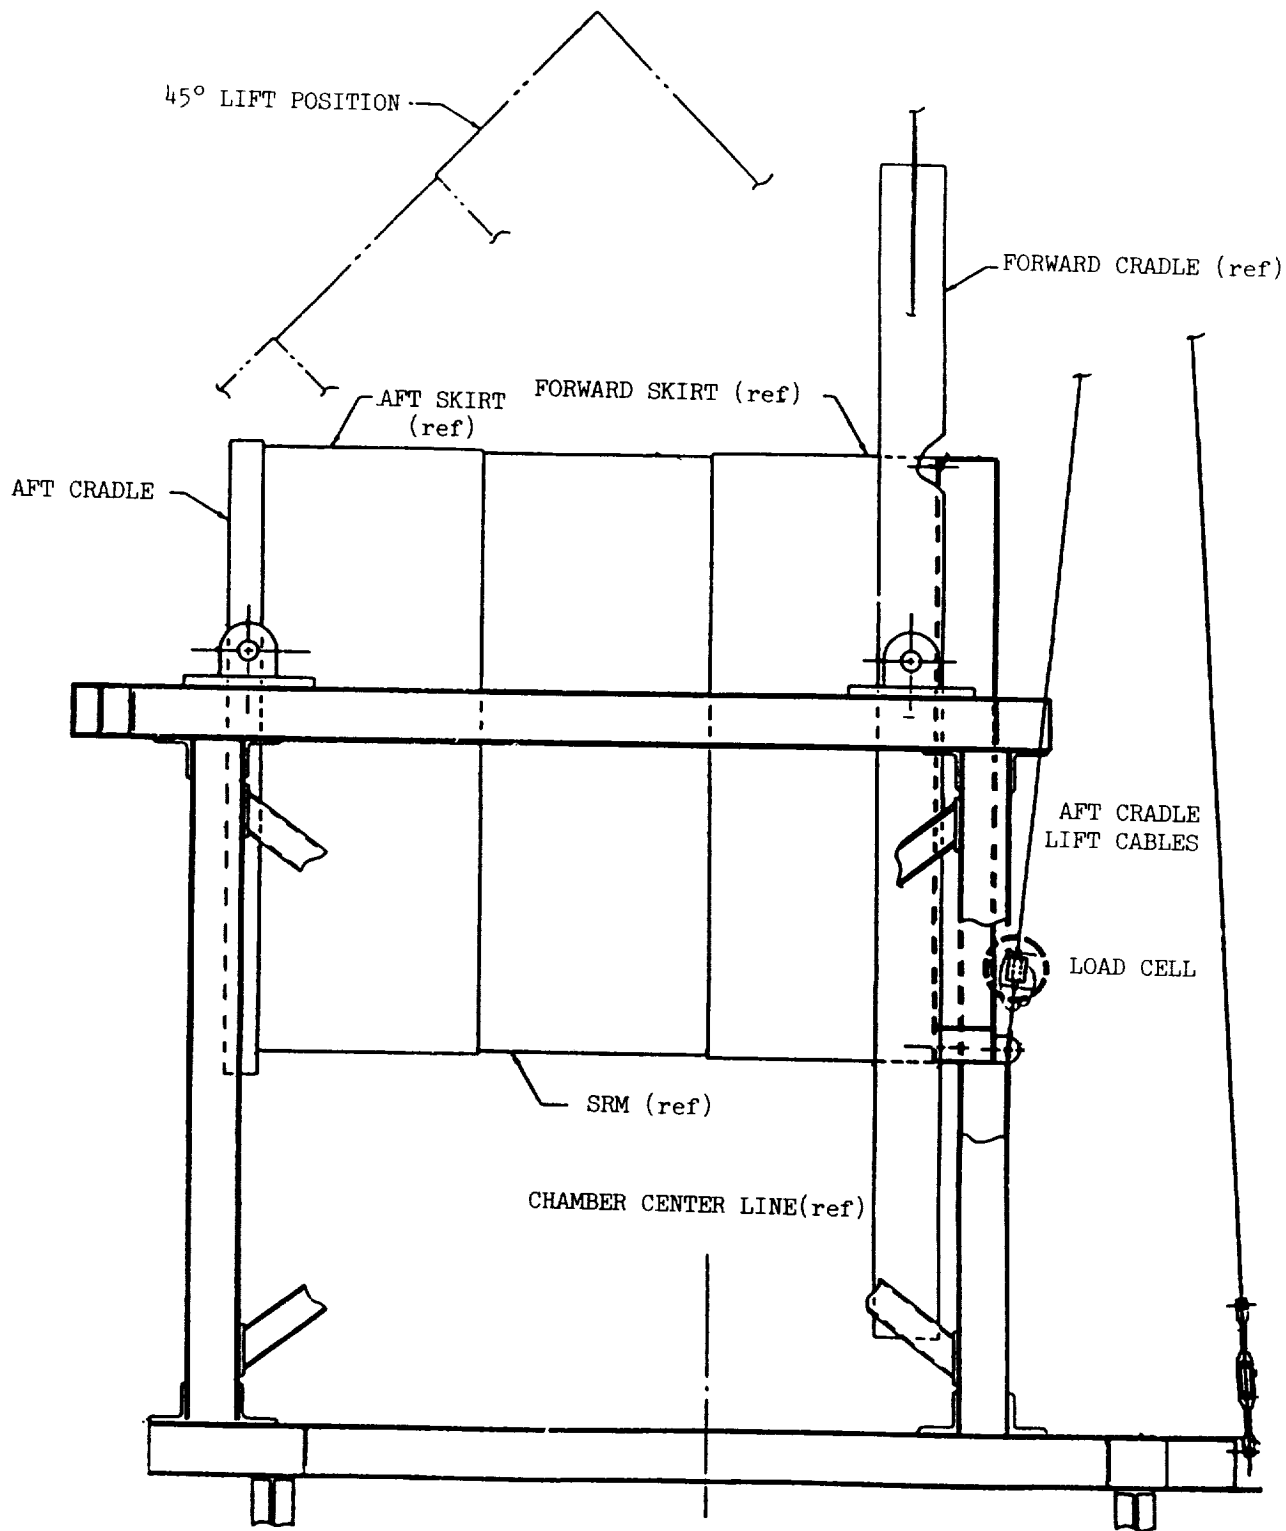
Figure 5. TOS in Chamber

The TOS was mounted horizontally in its support structure in the thermal vacuum chamber (figure #5). The forward cradle flight hinge actuators and the aft cradle flight tilt actuators, two each, were disconnected so they could be operated without exceeding their zero g design limitations. The shuttle interface harness was configured in a flight like manner to simulate harness stiffness during rotation. Pneumatic actuator lifting interfaces were installed on the vehicle and the lift cables and instrumentation connected. MLI was not installed on the top section of the forward cradle for two reasons, first to help induce temperature gradients between the forward and aft sections of the forward cradle, secondly, eliminate MLI interference with the lift fixture.
