NASA Technical Memorandum 101731

Monitoring Techniques for the X-29A Aircraft's High-Speed Rotating Power Takeoff Shaft

David F. Voracek

December 1990

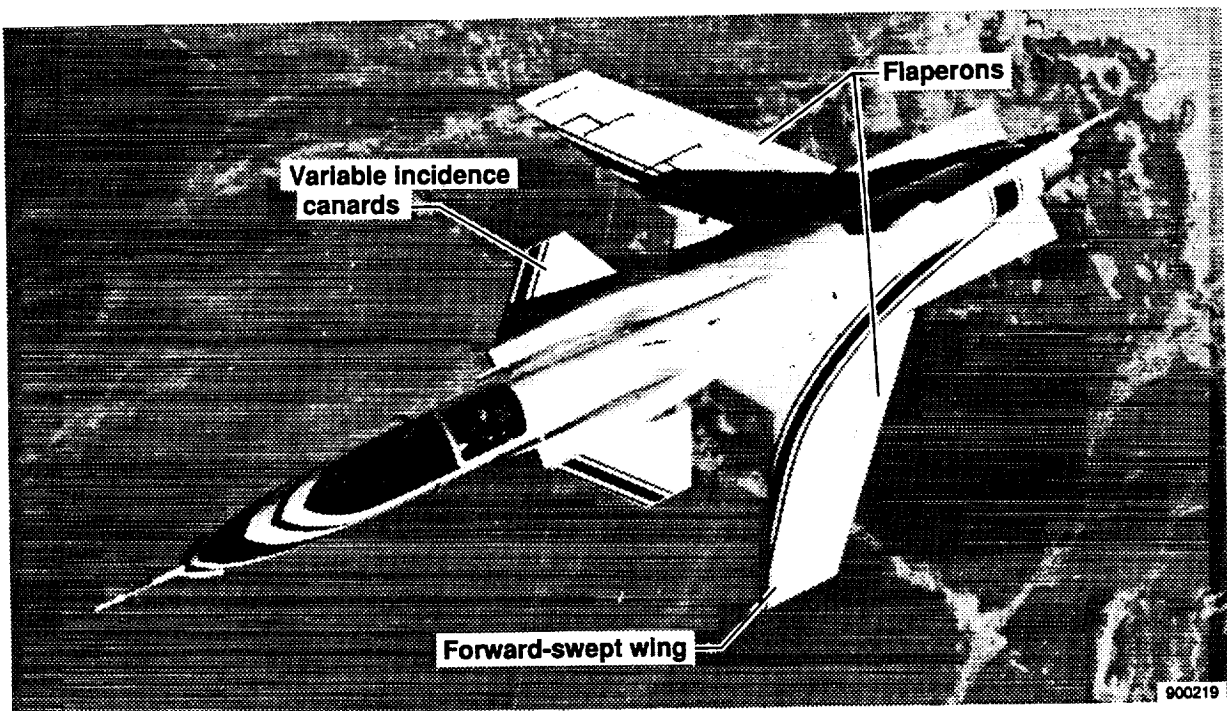
Figure 1. The X-29A forward-swept-wing aircraft.

The X-29A aircraft (fig. 1) incorporates many new technologies, the most evident of which is the forward-swept wing. The wing employs aeroelastic tailoring of advanced composite wing skins designed to avoid structural divergence and to ensure structural integrity within the flight envelope. Double-hinged trailing-edge flaperons provide both aerodynamic camber and roll control. The variable incidence canards, along with the wings and flaperons, operate together to achieve minimum trim drag. The vehicle is unstable longitudinally, with a negative static margin of 35 percent of the mean aerodynamic chord at subsonic speeds, and it is neutrally stable at approximately Mach 1.4. The flight control system includes triply redundant digital computers that provide the information to safely fly the aircraft.

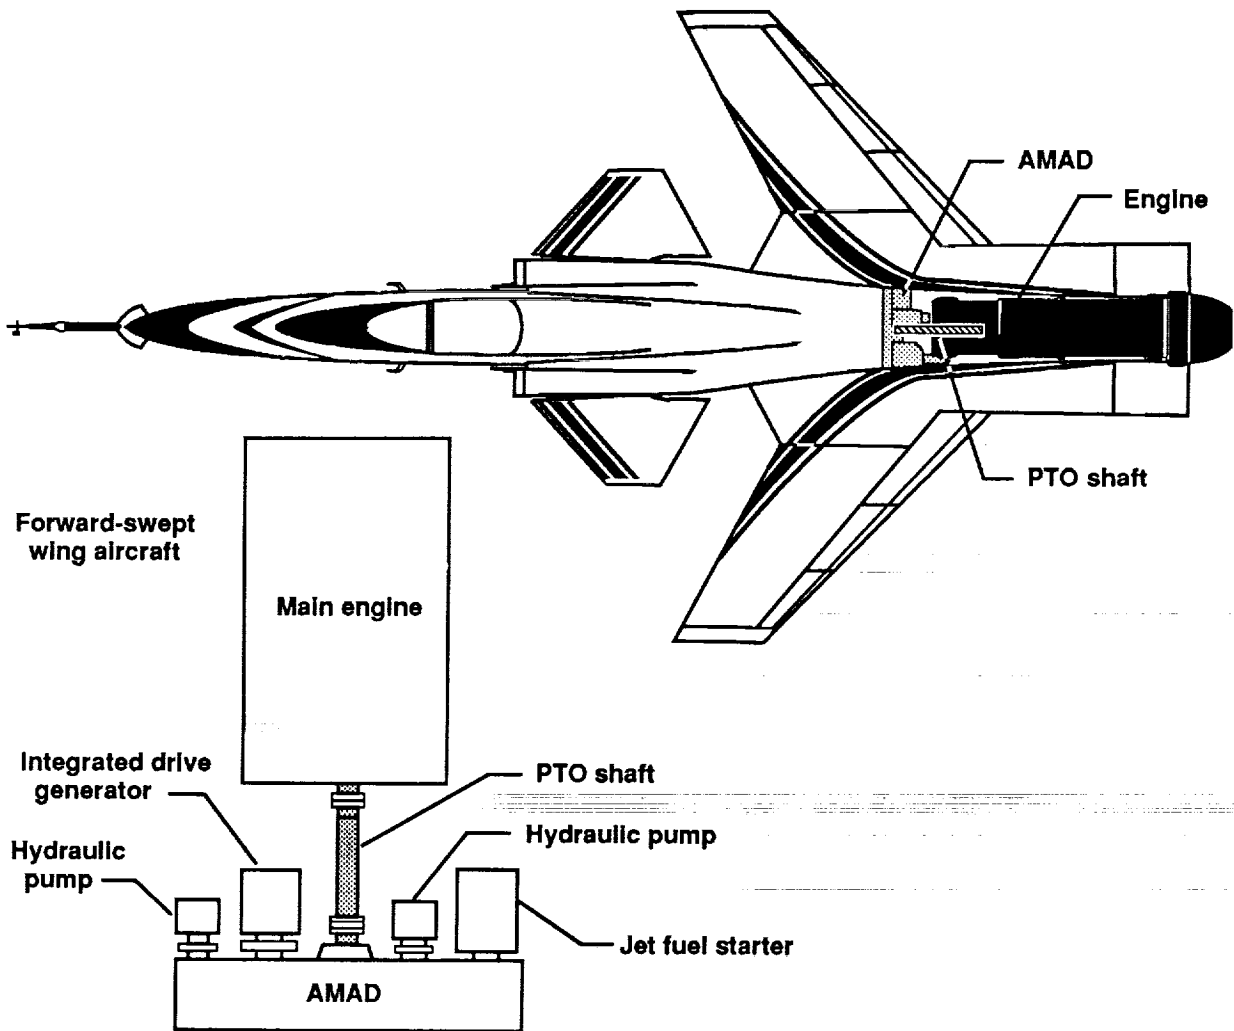
Figure 2. PTO shaft and AMAD.

The engine starting and secondary power subsystems incorporate the engine start system and the PTO shaft. The engine start system consists of a jet fuel starter system and an AMAD. Figure 2 shows an enlargement of the mounted accessories of the AMAD which consist of a starter, two hydraulic pumps, and an integrated drive generator. The PTO shaft is the direct mechanical link between the engine and the AMAD as shown in figure 2.

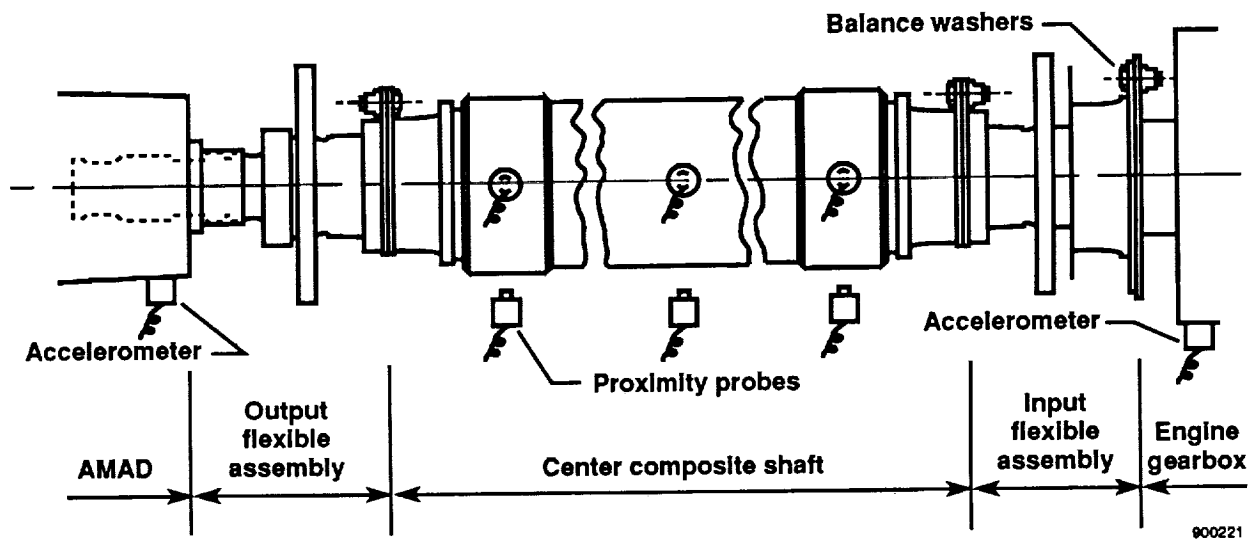
Figure 3. PTO shaft subsystem.

The PTO shaft subsystem consists of the following five subassemblies (fig. 3):

The first section, the AMAD, powers the two hydraulic pumps and the integrated drive generator, which supplies aircraft hydraulic and electrical power. The second and fourth sections, the output and input flexible assemblies, are designed to absorb any axial loads that the shaft may experience. They also provide a centering ball design which prevents the shaft from "whipping" in case of failure.⁽²⁾ The third section, the center composite shaft, transmits the rotary power between the AMAD and the main engine in two modes. In the first mode, the engine starting-motoring mode, power is transmitted through the AMAD to the main engine gearbox which is geared to the main engine high-pressure compressor spool. In the second mode, the accessory drive mode, power is transmitted from the main engine gearbox to the AMAD to drive the AMAD-mounted accessories.

The high rotational speeds between 0 and 16,810 rpm of the X-29A PTO shaft require a high degree of dynamic balance between its subassemblies to prevent destructive vibrations and harmonics. The gearbox, AMAD, and composite shaft components of the assembly are balanced dynamically as a unit during manufacturing. The following table shows the balanced component matrix for two AMADs, three PTO shafts, and three engine gearboxes. Washers were used to balance the PTO subsystem and were mounted under the bolts connecting the engine gearbox to the input flexible assembly as shown in figure 3.

The engine ground run check of the PTO shaft was conducted on each aircraft before the first flight of the day to see if the shaft vibration levels were within the limits. The shaft vibration levels were measured by one accelerometer located on the AMAD and another accelerometer located on the engine gearbox (fig. 3). The accelerometer signals were telemetered to a ground station, where they were band-pass filtered from 160 to 315 Hz to eliminate noise. The acceleration data were routed to a strip chart and to a spectrum analyzer to find the vibration levels.

The ground and flight limits established by the engine and airframe manufacturers were based on the allowable limit radial loads for the engine gearbox duplex bearings. Initial engine ground runs were accomplished with the PTO shaft instrumented with proximity probes (fig. 3) to establish a relationship between the shaft deflection and the engine bearing loads. This relationship was established because the accelerometer used for flight and ground monitoring was located on the engine gearbox assembly. The AMAD limits were developed in a similar procedure also based on the gearbox duplex bearing loads. The recommended acceleration limits, which were established by analysis and ground testing for the gearbox, consist of 2.7 *g* at 80 percent (227 Hz) of the engine speed during the engine ground runs and a 6.0-*g* limit during flight. The limits for the AMAD are shown in figure 5.

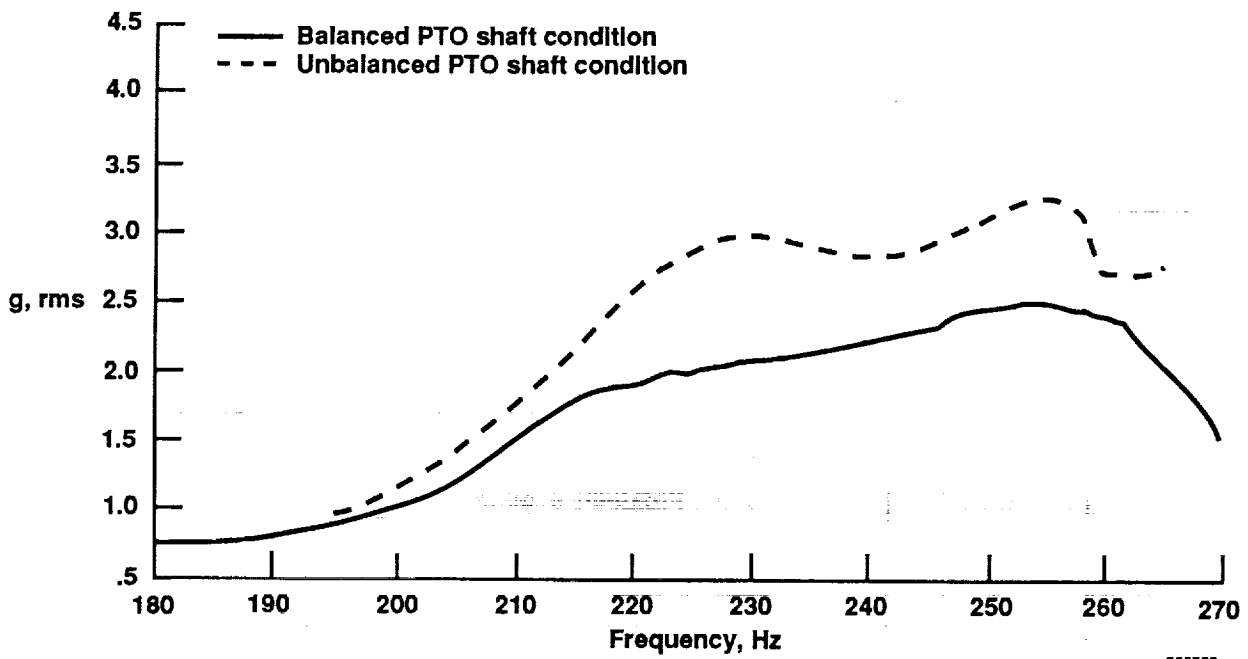
Figure 4. Effect of an unbalance on PTO shaft vibration levels.

During the initial evaluation of the PTO shaft, engine runs were performed with the PTO shaft in both a balanced condition and in an out-of-balance condition. These tests determined the effect of a known shaft unbalance on the gearbox vibration levels. In figure 4, the unbalance increased the vibration levels throughout the operating rpm range.

The real-time flight test monitoring of the PTO shaft vibration characteristics was the main method used to assess the vibration levels of the shaft. The monitoring used the same equipment and methods of the engine ground runs. Vibration levels were measured using the accelerometers located on the AMAD and engine gearbox during flight throughout the operating speed range of the PTO shaft. Using a strip chart and a spectrum analyzer, the vibration levels were determined, tabulated, and compared with nominal balanced data (fig. 4) to determine PTO shaft performance.

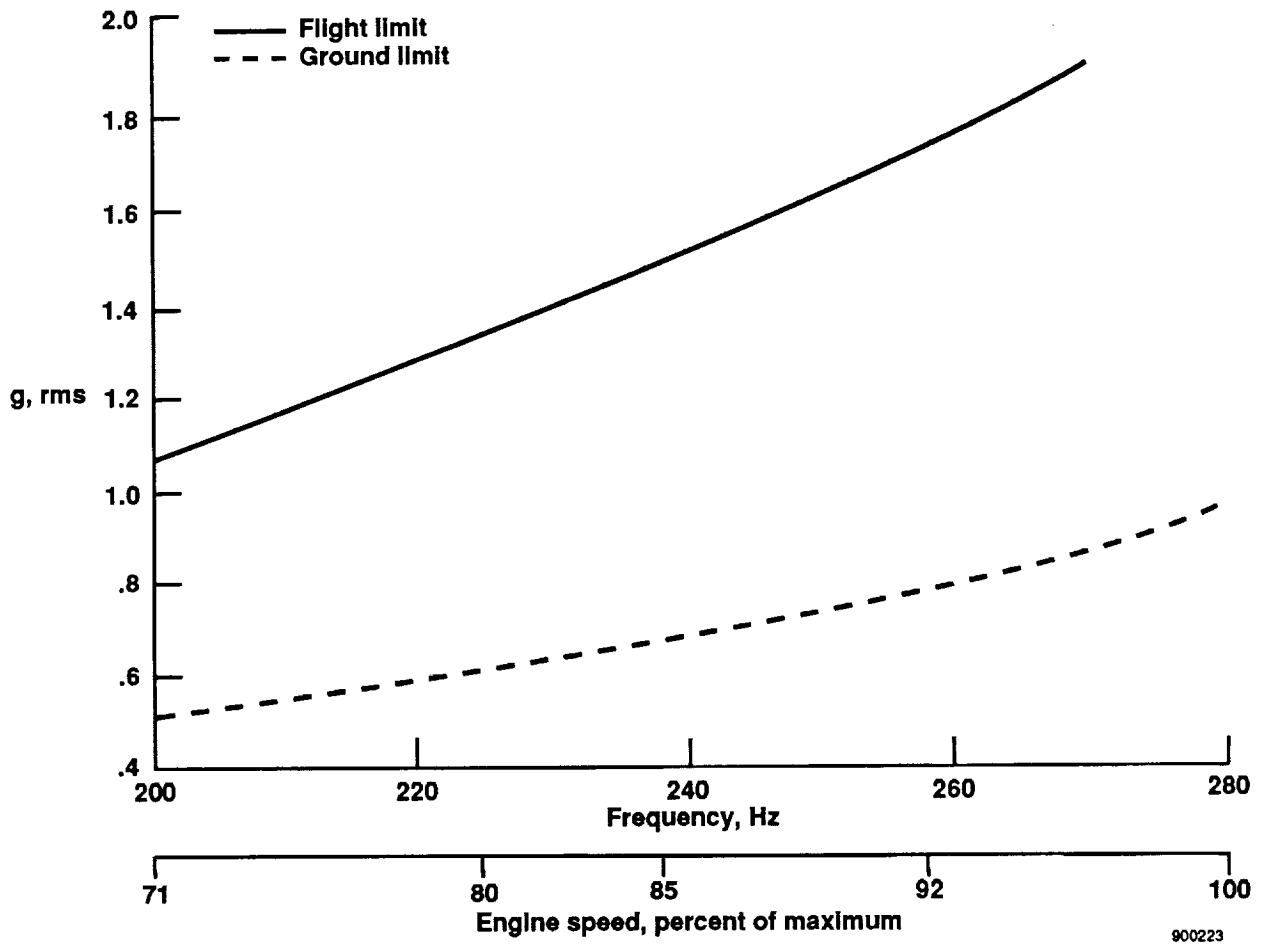
Figure 5. The X-29A AMAD vibration limits.

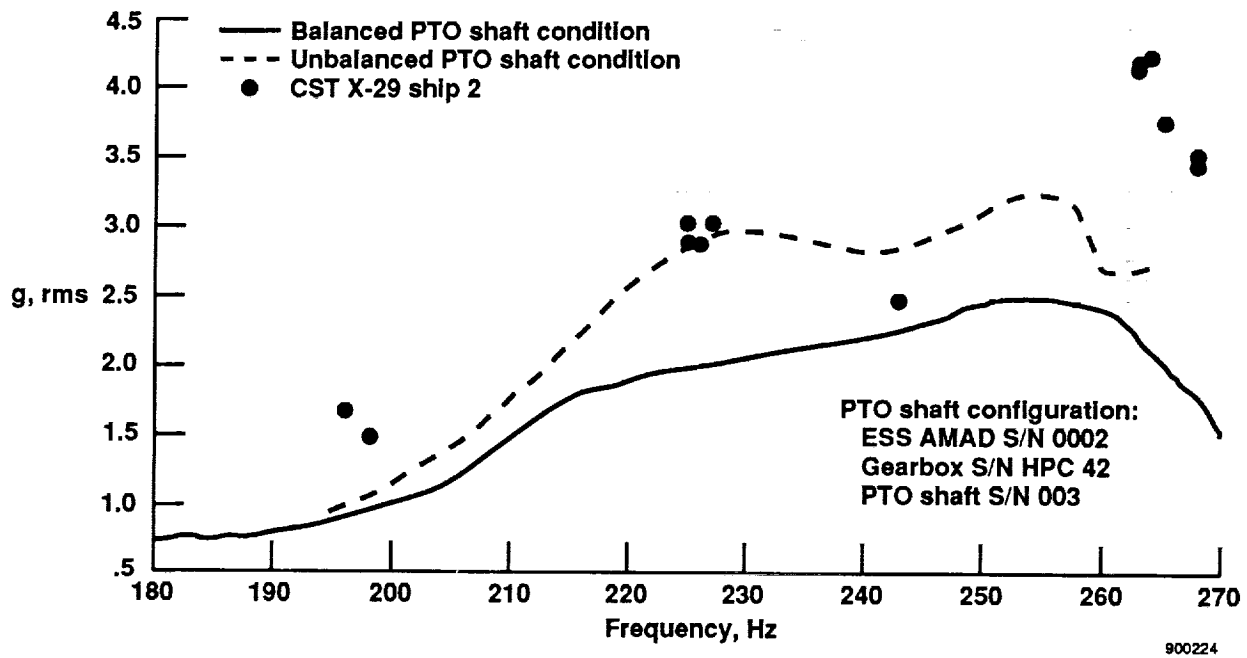
Figure 6. Combined systems test gearbox acceleration data.

During the course of the X-29A program, a complete check of all systems including instrumentation, aircraft, and control room operation was conducted. This complete check is called a combined systems test (CST). The gearbox and AMAD data compiled for the second X-29A aircraft during its initial CST are shown in figures 6 and 7. The higher acceleration levels of the gearbox and AMAD indicate an unbalanced shaft installation.

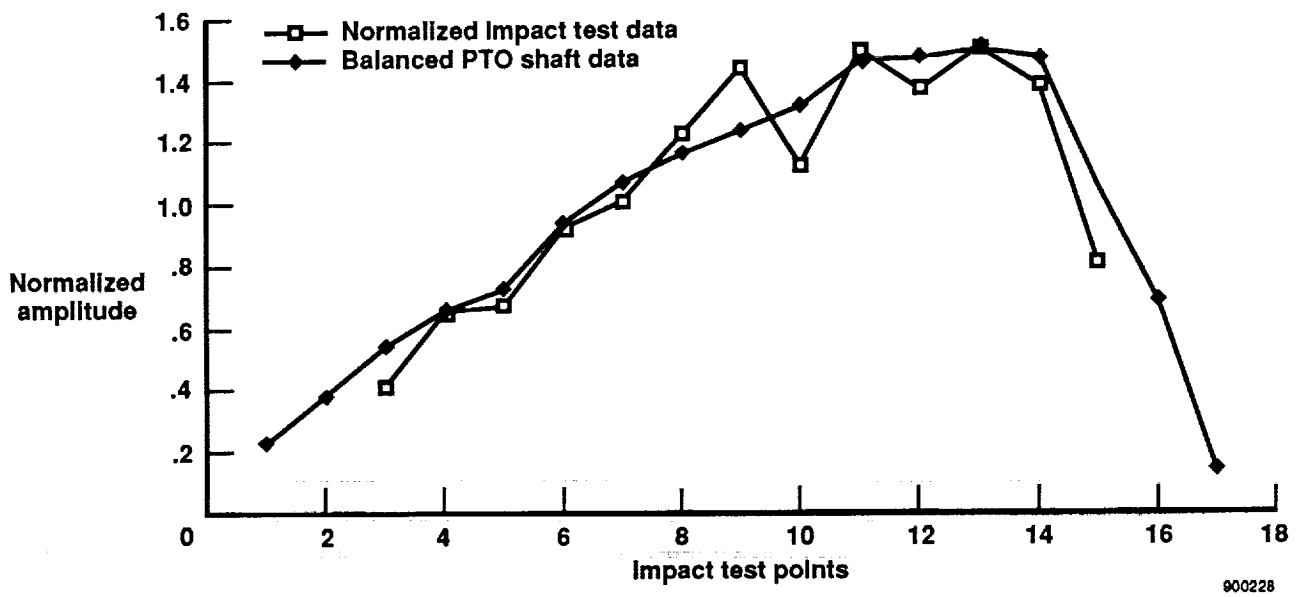
Figure 10. PTO shaft mode shapes comparison.

A shaft GVT was then performed to verify the structural integrity of the PTO shaft. The GVT test of the installed shaft measured the frequency of the PTO shaft mode and compared the data with previously measured data of a balanced PTO shaft. From the response signatures, the vertical and lateral mode frequencies were found to be 362 Hz and 353 Hz, respectively. Both responses are above the design criteria of 300 Hz. The normalized mode shape for the vertical mode is shown in figure 10 along with the mode shape from a known balanced PTO shaft. The data obtained from the GVT closely follow the mode shape of the balanced shaft. The GVT data indicate that the PTO shaft was not damaged and that a problem exists in the installation, or that the shaft assembly itself was unbalanced.

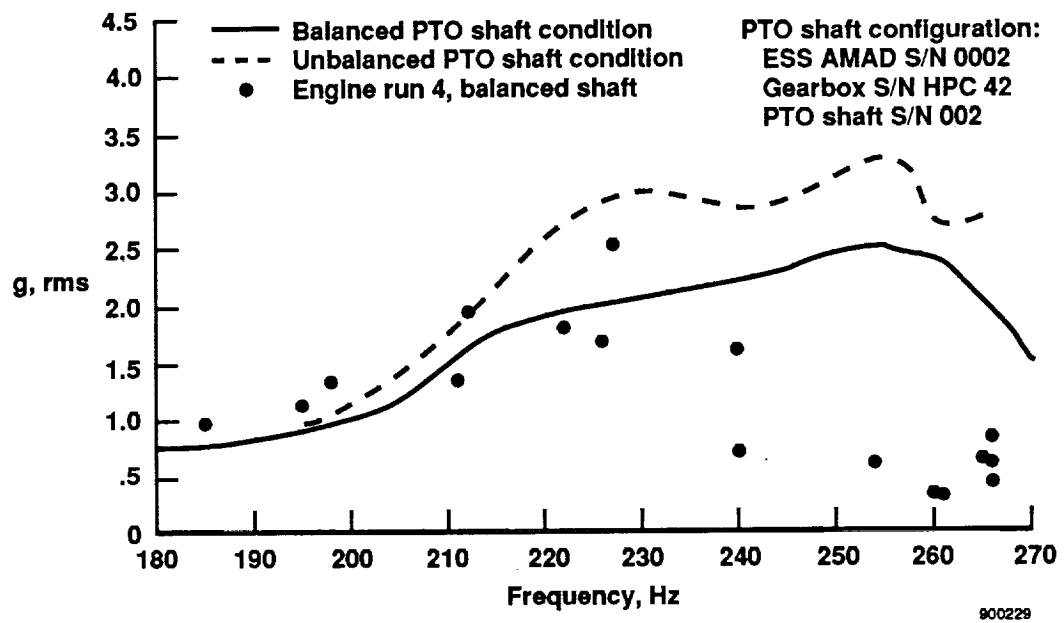
Figure 11. Gearbox engine run data after PTO shaft change.

In lieu of rebalancing the current configuration (PTO shaft S/N 003, gearbox S/N HPC 42, and AMAD S/N 0002), it was decided to change to PTO shaft S/N 002, which had also been balanced with the current gearbox, and AMAD, as shown previously in the table. This PTO shaft was installed on the X-29A aircraft, and another engine run was performed. The data in figures 11 and 12 show a reduction in the vibration levels of the gearbox and AMAD, respectively. The reduction in vibration levels indicates that the configuration was installed correctly and was balanced.

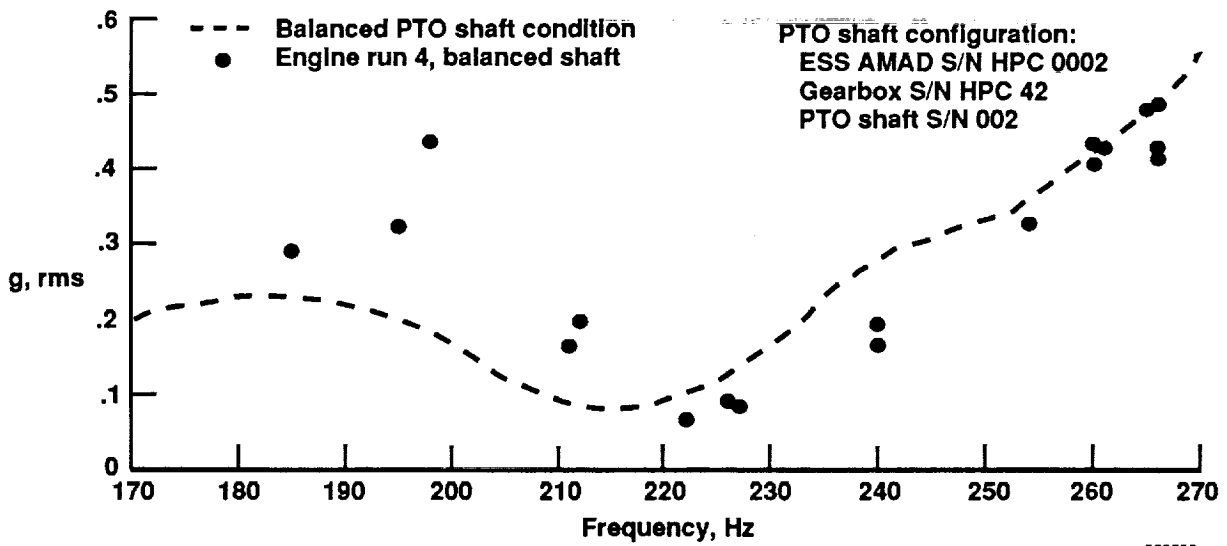
Figure 12. AMAD engine run data after PTO shaft change.

The data in figures 9, 12, and 13 show that as the frequency of the PTO shaft approached 200 Hz, the amplitude of the vibration increases. The AMAD strip chart trace in figure 14 shows that the signal from the AMAD accelerometer resembles a sine wave with a calculated frequency of approximately 0.40 Hz. This frequency was termed the beat frequency or frequency difference of two closely spaced modes of vibration. The second trace in figure 14 shows the engine speed in percent of the maximum speed. Interestingly, as the engine speed approached approximately 71 percent or 200 Hz, the amplitude of the beat increases confirmed the plotted acceleration data.

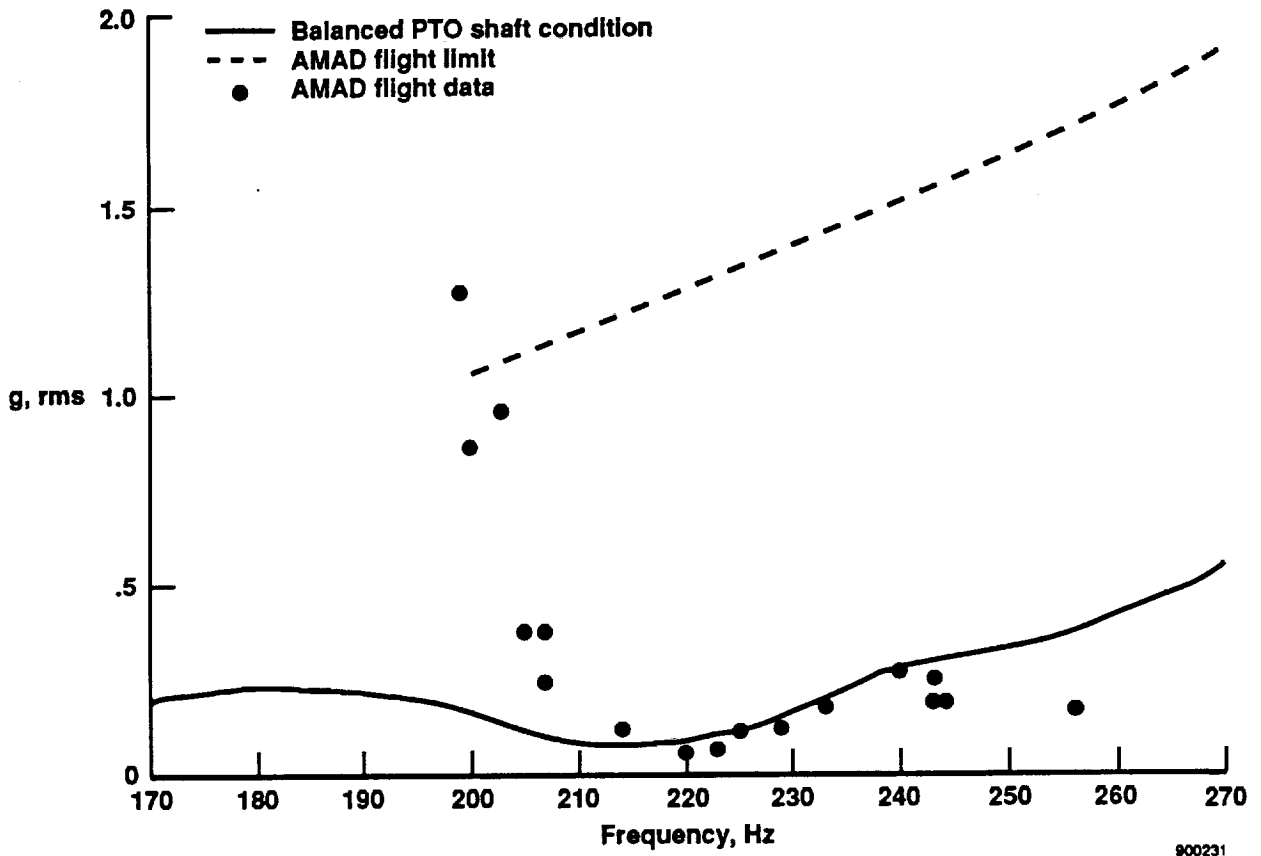
Figure 13. The X-29A AMAD vibration data, ship 2, flight 1.

The AMAD vibration limit was exceeded during the initial flight of the second X-29A aircraft. This occurred at approximately 199 Hz, which corresponds to an engine speed of just under 12,000 rpm or a frequency of 200 Hz (fig. 13). At frequencies above 200 Hz, the AMAD vibration levels were within the established limits. The gearbox data showed no unusual trends and did not exceed any limits. The data indicated that the PTO shaft was balanced and that another unbalance existed in the AMAD.

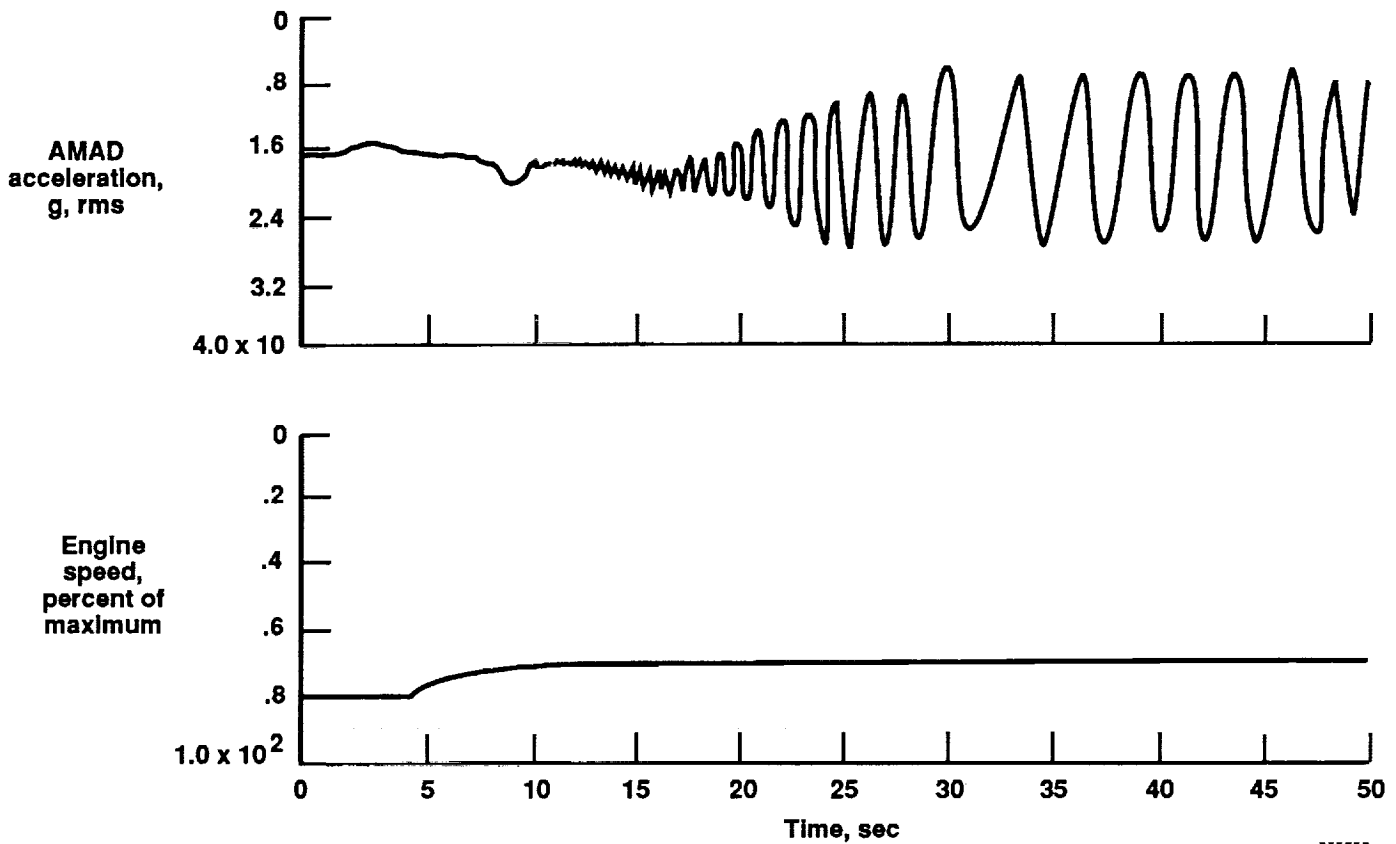
Figure 14. AI IAD vibration and engine speed time history.

As the engine speed trace in figure 14 confirms, the higher AMAD vibration levels occur when the engine compressor speed is in the range of 71 percent of the maximum operating speed of 16,810 rpm, the flight idle speed of the X-29A aircraft. Figure 16 shows that a high vibration level could only occur below 10,000 ft and Mach 0.6. These conditions would most likely occur during the takeoff and landing of the X-29A aircraft.

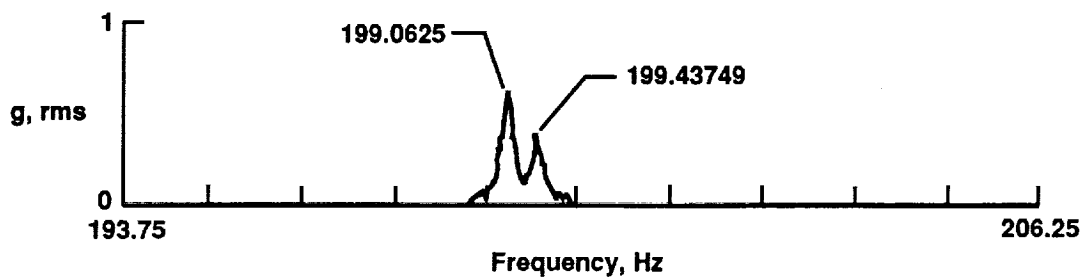
Figure 15 AMAD accelerometer power spectrum.

The power spectrum of the AMAD accelerometer in figure 15 zoomed in at approximately 200 Hz, confirming the presence of two closely spaced modes. The frequency difference calculated from the power spectrums indicated about the same frequency difference as the strip chart trace.
