NASA
Technical
Paper
3071

Compression Behavior of Graphite-Thermoplastic and Graphite-Epoxy Panels With Circular Holes or Impact Damage

Dawn C. Jegley

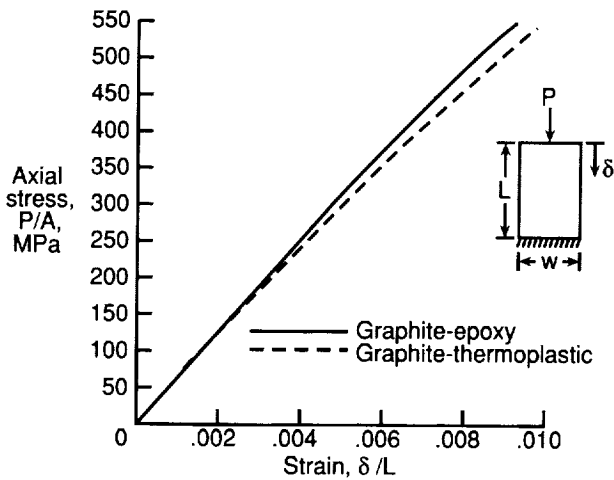
Figure 2. Compression stress-strain behavior for control specimens E1-1 and T1-1 with stacking sequence $[(\pm 45)_2/0_4/90/\pm 45/0_2/90]_s$. A is cross-sectional area.

Control specimens (those without holes or impact damage) were constructed with each stacking sequence studied. Control specimens made from graphite-epoxy and graphite-thermoplastic materials with stacking sequence $[(\pm 45)_2/0_4/90/\pm 45/0_2/90]_s$, designated E1-1 and T1-1, respectively, in table II, buckled prior to failure. Moiré fringe patterns indicate that control specimen E1-1 buckled into three half-waves while control specimen T1-1 buckled into one half-wave at about 70 percent of the failure load. The stress-strain relationships for these control specimens are shown in figure 2. The slope of these curves indicates that the prebuckling stiffness of specimen E1-1 (which is 5 percent thicker than specimen T1-1) is about 8 percent higher than the prebuckling stiffness of specimen T1-1 even though they have the same stacking sequence. A change in slope (stiffness) in the stress versus strain curve indicates the onset of buckling. A slight reduction in stiffness at buckling can be seen in figure 2 at a stress of about 400 MPa. Both control specimens E1-1 and T1-1 failed near a clamped edge.

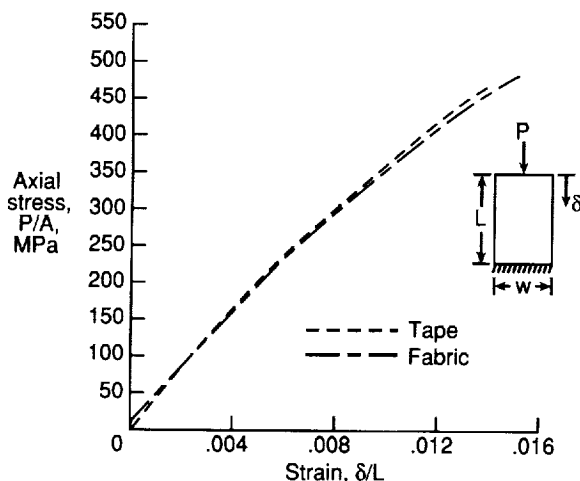
Figure 3. Compression stress-strain behavior for control specimens T2-1 and F2-1 with stacking sequence $[(\pm 45)_3/0_2/90/(\pm 45)_2/0/90]_s$. A is cross-sectional area.

Control specimens with stacking sequence $[(\pm 45)_3/0_2/90/(\pm 45)_2/0/90]_s$ made from graphite-thermoplastic tape and woven fabric, designated T2-1 and F2-1, respectively, buckled into three half-waves immediately prior to failure near a clamped edge. The stress-strain relationships for control specimens of types T2 and F2 are shown in figure 3. Since these specimens contain 69 percent $\pm 45^\circ$ plies, their stress-strain relationships are nonlinear, indicating nonlinear material properties. The slope of the curves indicates that the difference in prebuckling stiffness of the two specimens is approximately the same. The fabric specimen failed at a higher stress and strain than the tape specimen.

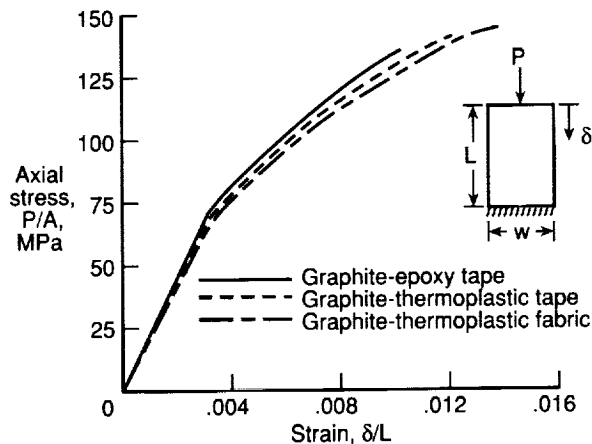
Figure 4. Compression stress-strain behavior for control specimens of types E5, T5, and F5 with stacking sequence $[(\pm 45)_2/90]_s$. A is cross-sectional area.

All previously mentioned specimens contain 28 or more plies. These relatively thick specimens display a different behavior than specimens containing significantly fewer plies. To compare relatively thin specimens, graphite-epoxy tape, graphite-thermoplastic tape, and graphite-thermoplastic fabric specimens (designated as specimen types E5, T5, and F5, respectively) with stacking sequence $[(\pm 45)_2/90]_s$ were studied. The stress-strain relationships for the control specimens of specimen types E5, T5, and F5 are shown in figure 4. The fabric specimen is about 12 percent thinner and about 10 percent less stiff than the tape specimens. The control specimens of specimen types E5, T5, and F5 buckled into four half-waves of approximately equal wavelength then failed at midlength of the specimen (along a nodal line). Each specimen carried load well into the postbuckling range. Failure strain for the graphite-epoxy control specimen was 35 percent and 20 percent lower than the failure strain for the graphite-thermoplastic fabric and tape specimens, respectively. The graphite-thermoplastic fabric specimen had the highest failure strain, 0.0138. The change in stiffness in the stress-strain curve indicates that buckling occurred in all three specimens at a stress of approximately 75 MPa. The prebuckling stiffness in the graphite-epoxy specimen is about 10 percent higher than the prebuckling stiffness in the graphite-thermoplastic specimens. The postbuckling stiffness in the graphite-epoxy specimen is about 25 percent higher than the postbuckling

stiffness in the graphite-thermoplastic specimens. The shear stiffness of a graphite-thermoplastic 0° lamina is 15 percent lower than the shear stiffness of a graphite-epoxy 0° lamina. Since this $[(\pm 45)_2/90]_s$ laminate is 88 percent $\pm 45^\circ$ plies, the graphite-thermoplastic specimens have lower laminate stiffnesses.

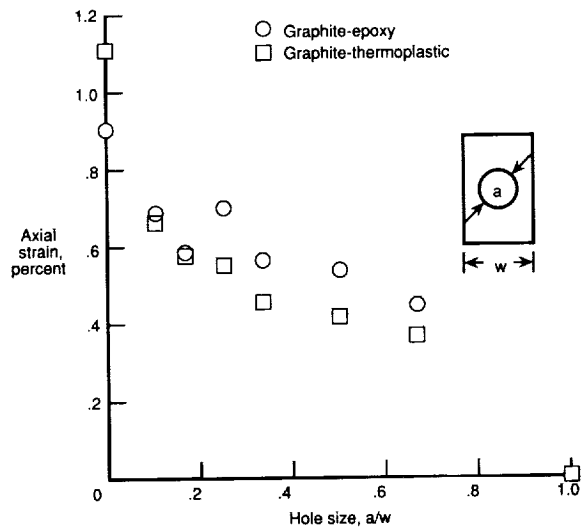
(a) Failure strain as a function of hole size.

Figure 6. Results for specimens with stacking sequence $[(\pm 45)_2/0_4/90/\pm 45/0_2/90]_s$.

Failure characteristics. The effect of hole size on failure strain is shown in figure 6(a) for graphite-epoxy and graphite-thermoplastic specimens with stacking sequence $[(\pm 45)_2/0_4/90/\pm 45/0_2/90]_s$ (specimens of types E1 and T1). Specimen geometry, failure stress, and failure strain are shown in table II for all specimens of types E1 and T1 tested.

All specimens of types E1 and T1 with holes failed through the hole and exhibited no buckling behavior. Failure strain is 5 to 30 percent higher for specimens of type E1 than for specimens of type T1 with the same hole size. Failure of each specimen involved delamination between plies and laminate failure in transverse cracking across the specimen, as shown in the photographs of specimens E1-7 and T1-5 in figure 6(b). Failed fibers became wedged between other fibers during failure. The failure of the graphite-thermoplastic specimens at consistently lower stresses and strains than the graphite-epoxy specimens may be related to the lower shear stiffness of the AS4-PEEK material. However, since this $[\pm 45_2/0_4/90/\pm 45/0_2/90]_s$ laminate contains only 43 percent $\pm 45^\circ$ plies, matrix shearing is

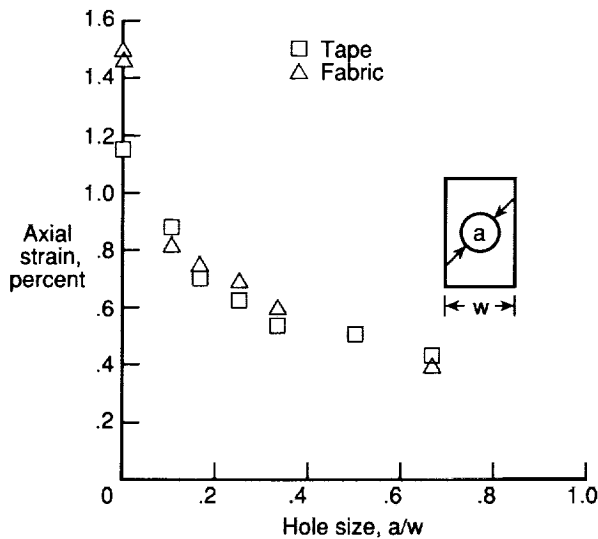
Figure 7. Failure strain as a function of hole size for graphite-thermoplastic specimens with stacking sequence $[(\pm 45)_3/0_2/90/(\pm 45)_2/0/90]_s$.

The effect of hole size on failure strain is shown in figure 7 for specimens with stacking sequence $[(\pm 45)_3/0_2/90/(\pm 45)_2/0/90]_s$ made from graphite-thermoplastic tape and graphite-thermoplastic woven fabric, designated as specimen types T2 and F2, respectively. Average specimen cross-sectional area away from the hole and the range of hole sizes considered are presented in table III. All specimens of types T2 and F2 with holes failed through the hole and exhibited no buckling behavior. Failure strains are almost identical for specimens of the same hole size for the two material forms, as shown in figure 7. C-scans made of specimens after failure indicate that no off-axis cracking occurred in any of the specimens of type T2 or F2. Some longitudinal cracking occurred in the specimens with large holes.

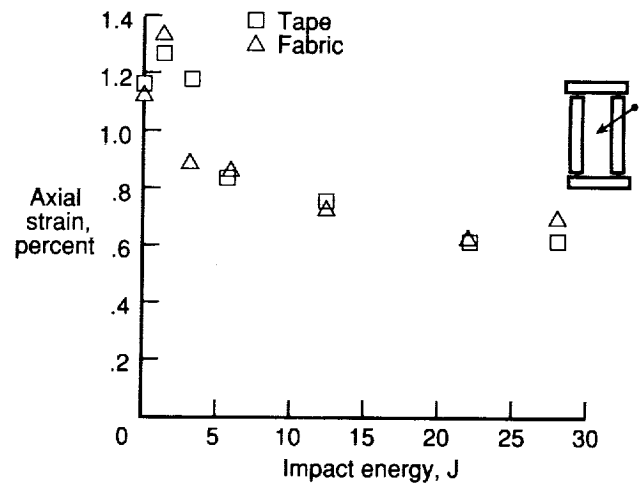
Figure 10. Failure strain as a function of impact energy for graphite-thermoplastic specimens with stacking sequence $[(\pm 45)_3/0_2/90/(\pm 45)_2/0/90]_s$.

The effect of impact damage on failure strain is shown in figure 10 for graphite-thermoplastic specimens with stacking sequence $[(\pm 45)_3/0_2/90/(\pm 45)_2/0/90]_s$ made from tape (specimens of type T2) and from woven fabric (specimens of type F2). The range of impact energies is presented in table III. All specimens subjected to impact speeds of 31 to 46 m/sec (impact energies of 1.4 to 3.3 J) buckled prior to failure. Specimens subjected to higher impact speeds did not buckle. Specimens impacted at 31 m/sec failed at one end of the specimen. The tape specimen impacted at 47 m/sec buckled into three half-waves then failed at a nodal line, away from the impact site. All other impact-damaged specimens failed at the impact site. The mode of failure in all specimens involved delamination and fiber breakage. The tape specimens exhibited more delamination than the fabric specimens because in the fabric specimens each pair of $\pm 45^\circ$ plies is woven together and cannot delaminate. Failure strains are almost the same for tape and fabric specimens, as shown in figure 10.

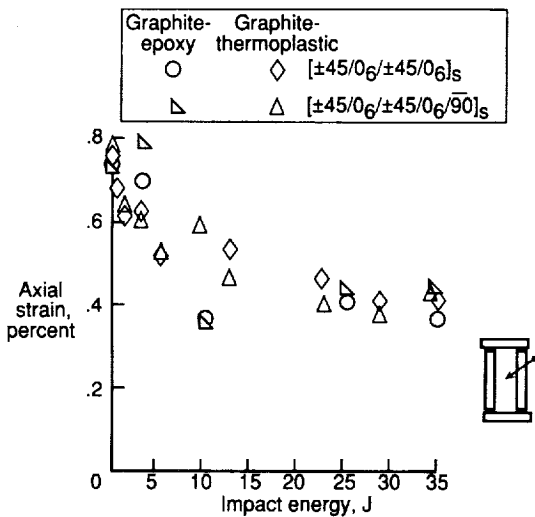
Figure 11. Failure strain as a function of impact energy for graphite-epoxy and graphite-thermoplastic specimens with stacking sequences $[\pm 45/0_6/\pm 45/0_6]_s$ and $[\pm 45/0_6/\pm 45/0_6/90]_s$.

To determine whether clustering many 0° plies in the center of a graphite-thermoplastic or a graphite-epoxy laminate influences the failure of specimens subjected to low-speed impact, graphite-thermoplastic and graphite-epoxy specimens made from tape with stacking sequences $[\pm 45/0_6/\pm 45/0_6]_s$ (specimen types T3 and E3) and $[\pm 45/0_6/\pm 45/0_6/90]_s$ (specimen types T4 and E4) are examined. The range of impact energies considered is listed in table III. No specimens of type T3 or T4 buckled prior to failure. Those impacted with energies less than 1 J failed near a clamped edge. Specimens of types E3 and E4 impacted with energies less than 3 J buckled prior to failing near a clamped edge. All other impacted specimens failed through the impact site. Delamination was the primary cause of failure. Transverse cracks formed across the specimen as the matrix failed. Despite the high percentage of 0° plies (75 percent), C-scans made after severe impact and compressive loading reveal no indication of longitudinal cracks as are described in reference 9 for failures of unidirectional laminates in graphite-thermoplastic specimens; however, longitudinal cracks are evident in the graphite-epoxy specimens. The effect of impact damage on failure strain is shown in figure 11 for the specimens of types T3, T4, E3, and E4.

There is no consistent difference between the failure strains of graphite-thermoplastic specimens of the two stacking sequences. The clustered 0° plies do not induce premature failure in graphite-thermoplastic specimens subjected to impact damage. Specimens of type E4 have slightly higher failure strains than specimens of type E3 but not a significant enough

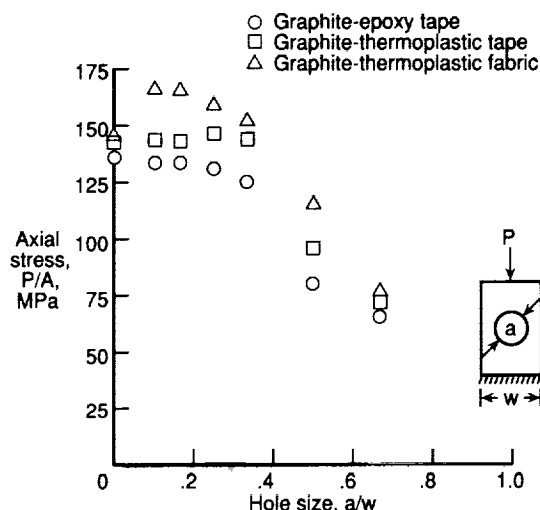
Figure 14. Failure strain as a function of hole size for specimens with stacking sequence $[(\pm 45)_2/90]_s$. A is cross-sectional area.

The effects of hole size on failure stress are shown in figure 14 for specimens with stacking sequence $[(\pm 45)_2/90]_s$ made from graphite-epoxy tape (specimen type E5), graphite-thermoplastic tape (specimen type T5), and graphite-thermoplastic fabric (specimen type F5). The range of hole sizes considered is presented in table III for all specimens of types E5, T5, and F5 tested. The specimens of types E5, T5, and F5 with holes buckled into three or more half-waves (often with different wavelengths) with one half-wave centered around the hole. Buckling became evident in moiré patterns at or below 40 percent of the failure load of the undamaged specimen in specimens with small holes. Buckling became evident in moiré patterns at less than 20 percent of the failure load of the undamaged specimen for specimens with large holes. The failure mode of all specimens involved delamination and transverse cracking. C-scans made after testing indicate that no longitudinal or off-axis cracking occurred in the graphite-thermoplastic specimens, but both types of cracks appeared in the graphite-epoxy specimens. The specimens with smaller holes failed at a nodal line in the top half of the specimen. Holes with $a/w < 0.4$ have almost no effect on failure stress for all three types of specimens. The graphite-epoxy specimens with $a/w < 0.4$ have 20 percent lower failure stresses than the graphite-thermoplastic specimens. The specimens with larger holes ($a/w > 0.4$) fail

through the hole. Failure stresses for graphite-epoxy specimens with larger holes are slightly lower than those for the graphite-thermoplastic specimens. The graphite-thermoplastic fabric specimens can withstand 10–20 percent higher stress than the graphite-epoxy specimens. The failure stresses of the graphite-thermoplastic tape specimens are 5–10 percent above those of the graphite-epoxy specimens.

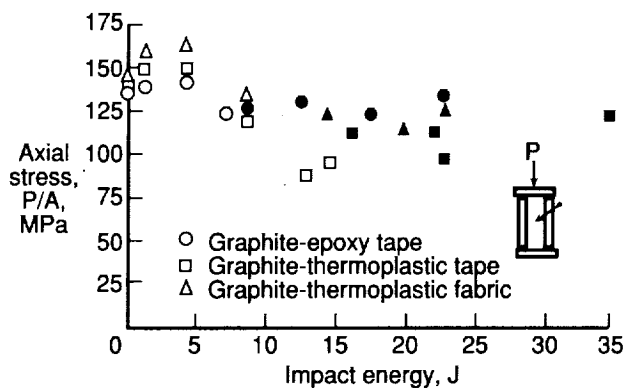
Figure 15. Failure stress as a function of impact energy for specimens with stacking sequence $[(\pm 45)_2/90]_s$ (open symbols represent cases when the impact projectile did not fully penetrate the specimen, filled symbols represent cases when the impact projectile did). A is cross-sectional area.

The effects of impact damage on failure stress are shown in figure 15 for specimens with stacking sequence $[(\pm 45)_2/90]_s$ made from graphite-epoxy tape (specimen type E5), graphite-thermoplastic tape (specimen type T5), and graphite-thermoplastic fabric (specimen type F5). The range of impact energies considered is presented in table III for all specimens of types E5, T5, and F5 tested.

A comparison of failure stresses for the three types of specimens, shown in figure 15, indicates that the graphite-thermoplastic fabric specimens withstand about 12 percent more stress than the graphite-epoxy specimens for impact speeds below about 61 m/sec (impact energy of 5.5 J). Graphite-thermoplastic tape specimens withstand 5 percent more stress than the graphite-epoxy specimens for impact speeds below 61 m/sec. However, the reduction in failure stress due to impact damage is larger in both types of graphite-thermoplastic specimens than in the graphite-epoxy specimens. This difference may be related to the amount of damage sustained when the impact projectile penetrates and passes through the specimens rather than bounc-
