NASA Contractor Report 185262
Aerojet 2459-56-1

Orbital Transfer Vehicle Oxygen Turbopump Technology

Final Report, Volume II—Nitrogen and Ambient Oxygen Testing

December 1990

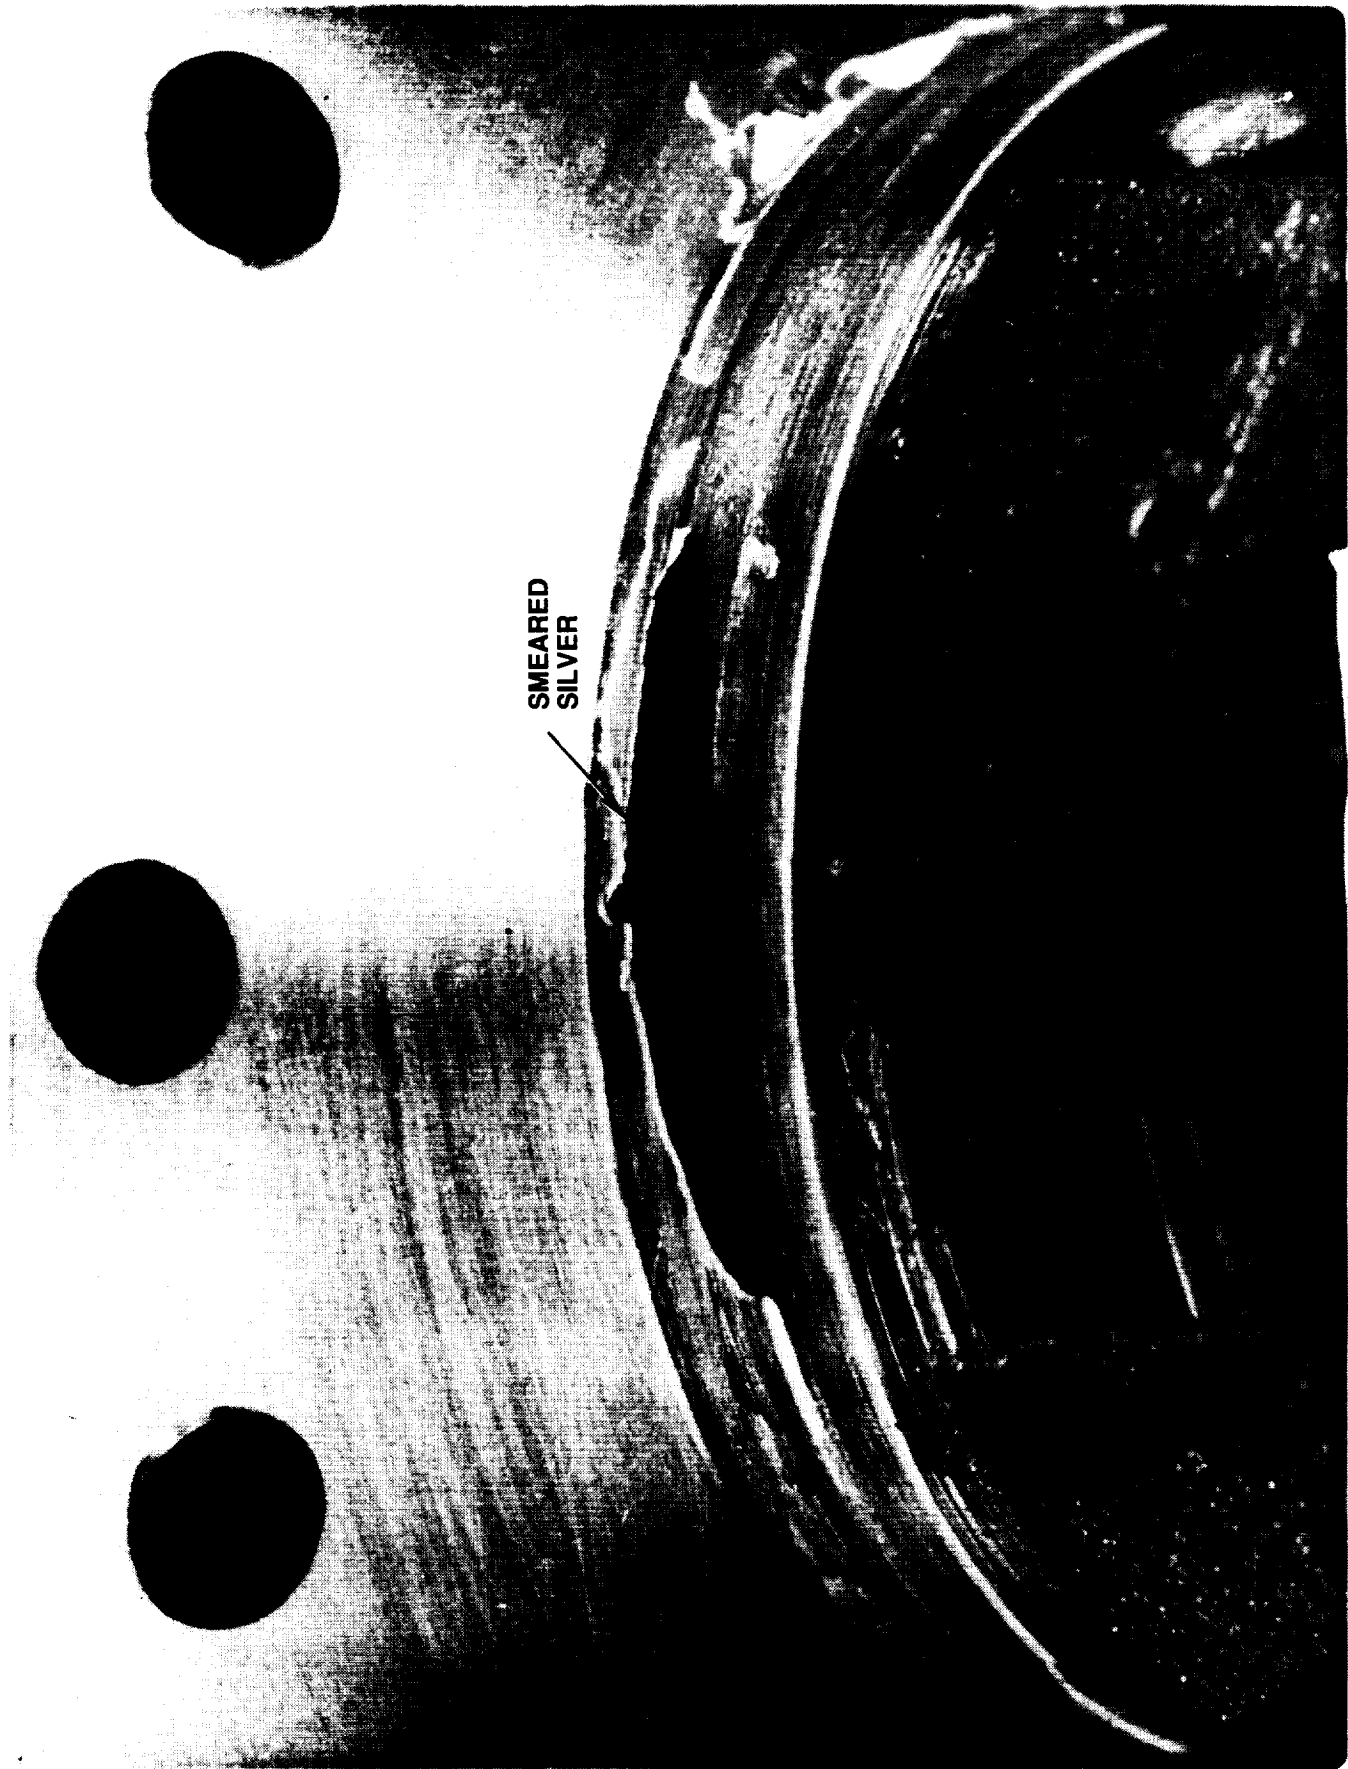
Figure 3.5-14. Pump Bearing Bore View Looking From the First Stage Impeller Side

Close up photos of the pump bearing from the first stage side, Figure 3.5-14, and from the second stage side Figure 3.5-15 show that the wear occurs at the first stage exit land. A significant portion of the silver plating on the exit land has been removed or smeared in the circumferential direction. An axial surface profile across the bearing bore between the four pockets is shown in Figure 3.5-16. From these profiles and the photos it is obvious that the predominant wear occurred on the exit land. The rest of the bore is close to original condition. It appears that once wear started on the exit land the debris moved circumferentially removing the silver plating. Mentioned earlier was the fact that a groove was carved in the chrome coating on the shaft. This would indicate a hard particle to wear a groove in the hard chrome surface. With this exit land worn the journal bearing flowrate will increase. Subsequent disassembly of the pump end bearing supply filter showed a ruptured filter element. In addition, the pressure drop on this filter was higher than the turbine end filter and also varied with time. The conclusion is that debris passed through the pump journal bearing.

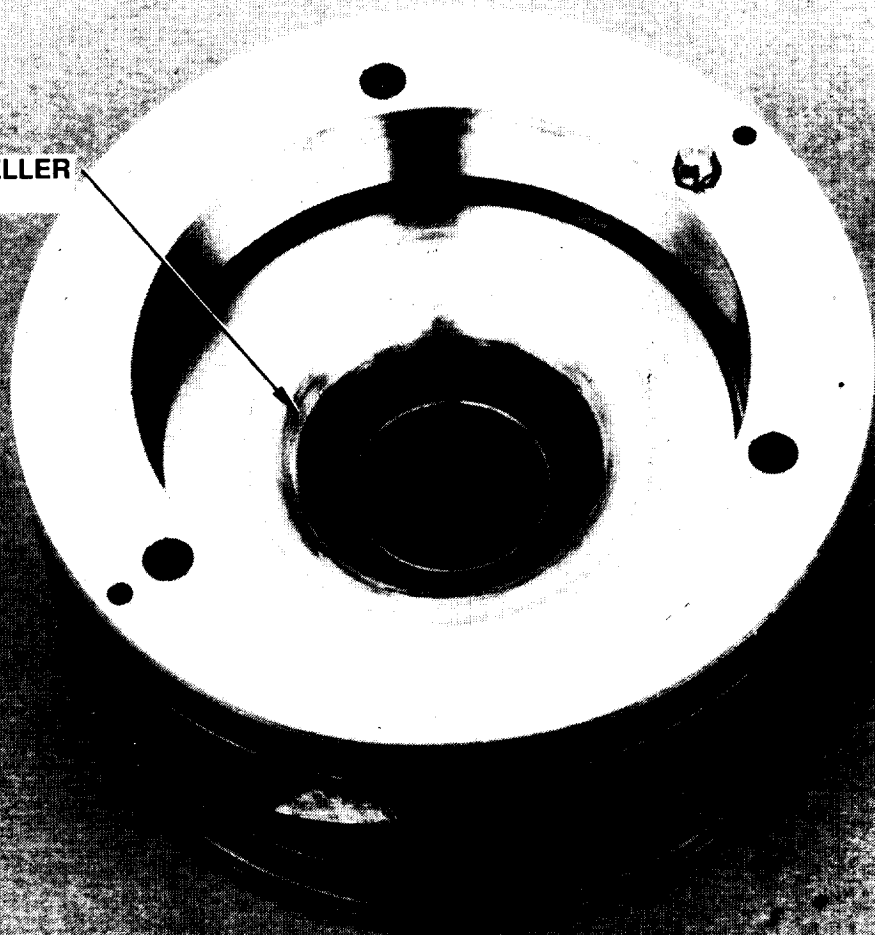
Figure 3.5-22. Second Stage Impeller Housing

The second stage impeller housing shown in Figure 3.5-22, is in excellent condition. Two things were found on this part. First, there was slight trace of dis-coloration in the pump inlet and a small amount in the bearing area. This sub-stance was a very thin tan powder (oxidation?). There was the same substance in the first stage diffuser passage but not in the crossover passages. Second, a small amount of impeller vane contact on the silver housing contour was experienced. This minute contact is shown close up in Figure 3.5-23. This contact occurred where the radial surface of the impeller housing contour enters the housing inner radius. This was the point of minimum clearance during the turbopump assembly and probably contacted during assembly.
