# Evaluation Of Thermal Sprayed Metallic Coatings For Use On The Structures At Launch Complex 39

Peter J. Welch  
Engineering Development Directorate  
Ground Support Office  
Materials Analysis Office  
Materials Testing Branch

MTB-1058-89

SUBJECT: EVALUATION OF THERMAL SPRAYED METALLIC COATINGS FOR USE  
ON THE STRUCTURES AT LAUNCH COMPLEX 39

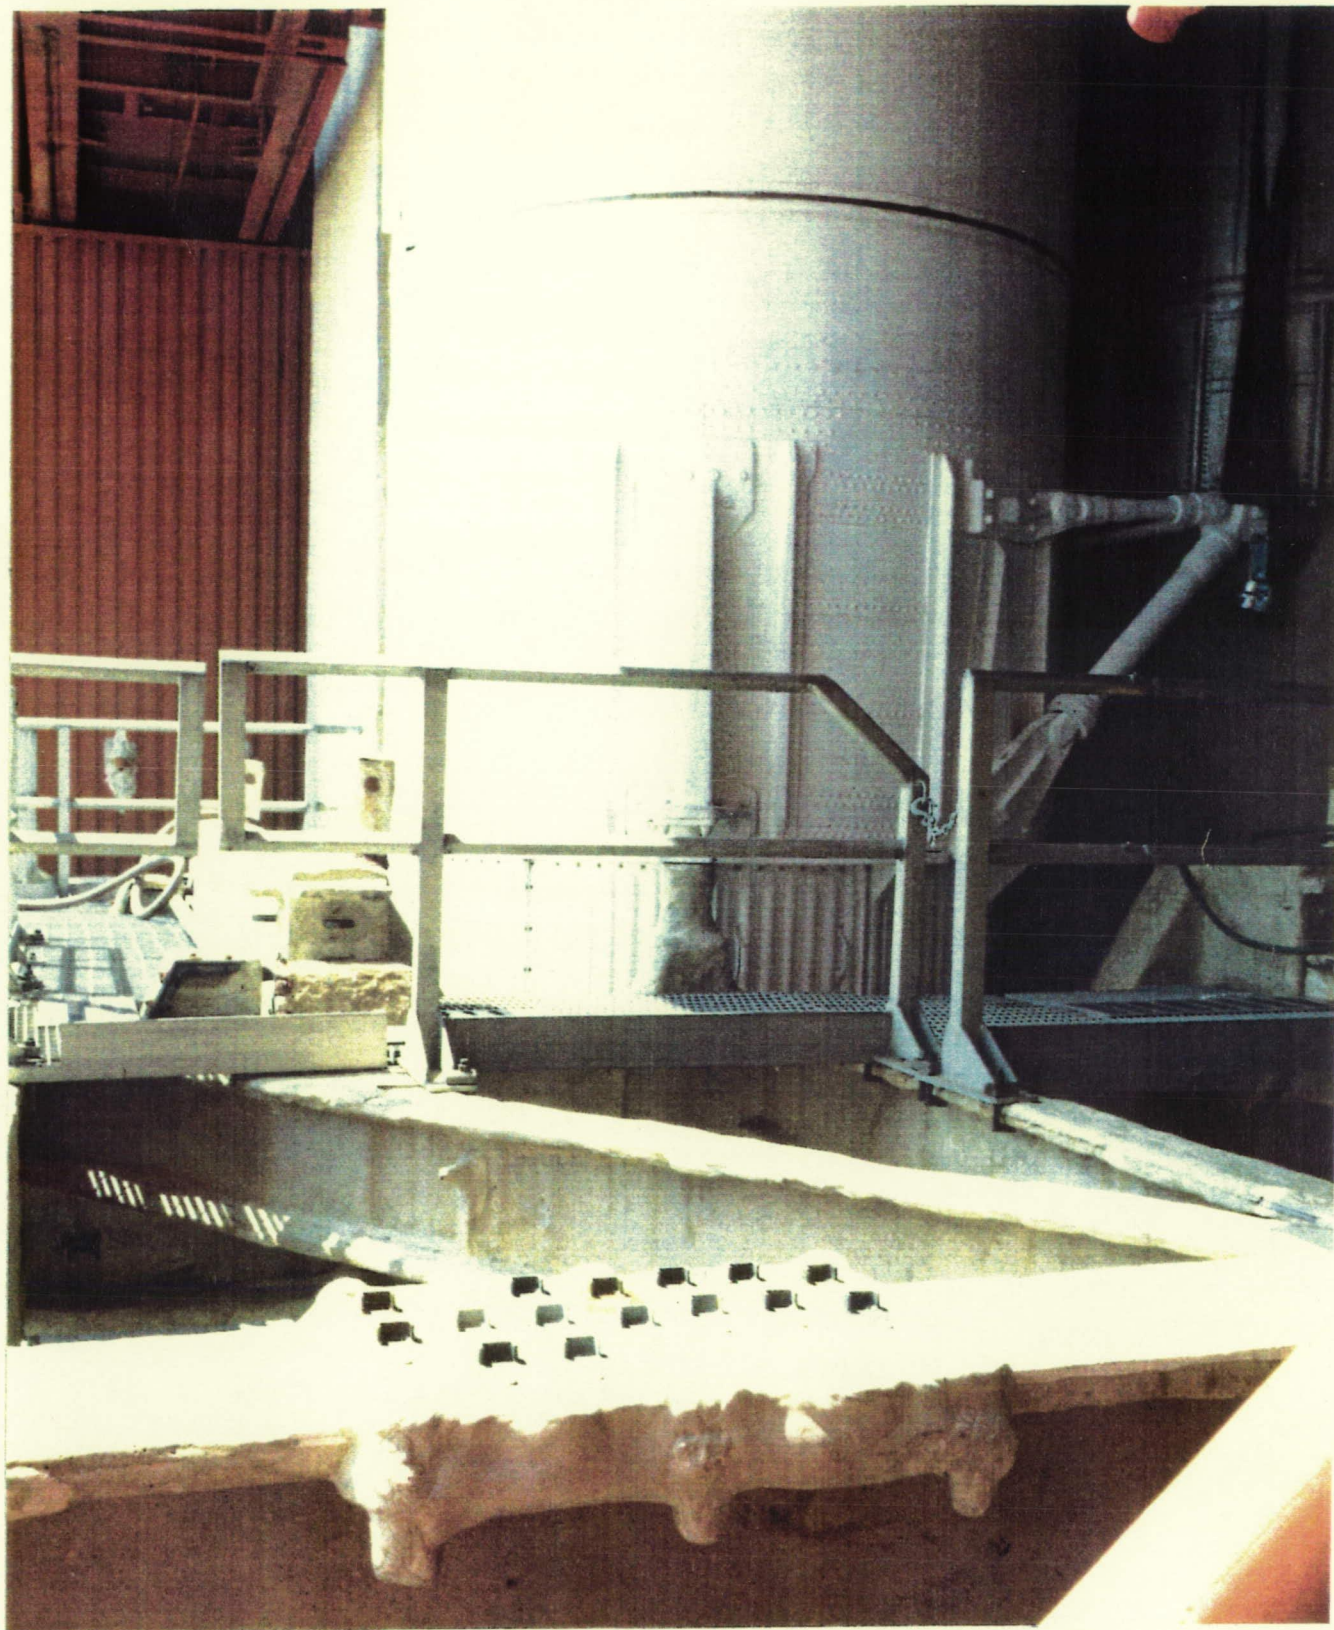
FIGURE 1

THE MOUNT PLATE WITH TSC COMPOSITE TEST PANELS IS SHOWN MOUNTED ON THE TITAN TRANSPORTER PRIOR TO THE TITAN LAUNCH ON SEPTEMBER 5, 1989.

- 2.1 Eleven new thermal spray coating (TSC) composite test panels, a strain isolation barrier, and 6 reference panels were secured to a mount plate which was attached to the Titan transporter at LC-40, at the same location described in MTB-781-88.
- 2.2 The mount plate was secured to the transporter several weeks before the Titan III launch on September 4, 1989, and returned to the MTB on September 7, 1989 (see Figures 1 and 2).
- 2.3 A group of TSC test panels were set out at the beach corrosion test site on April 15, 1987. Periodically the panels were rinsed with a slurry of Al<sub>2</sub>O<sub>3</sub> powder and HCl to simulate the effects of the SRB exhaust residue.

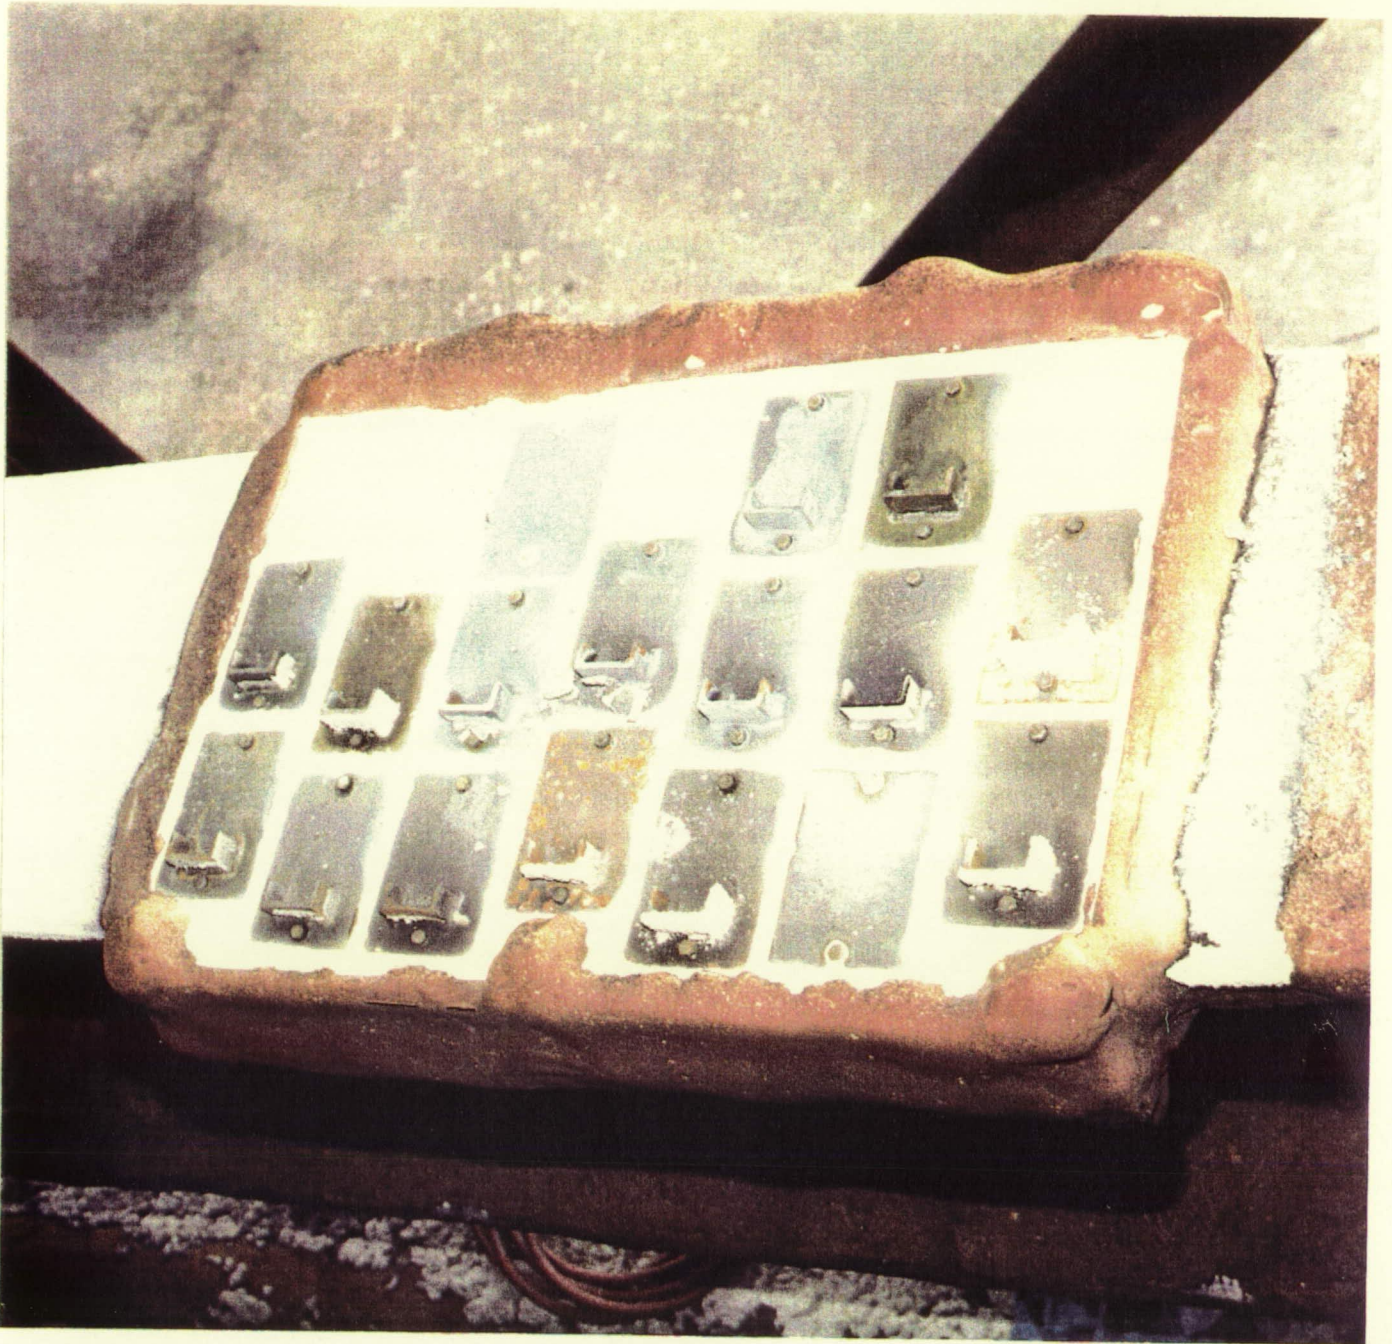
FIGURE 2

THE MOUNT PLATE WITH TSC COMPOSITE TEST PANELS IS SHOWN MOUNTED ON THE TITAN TRANSPORTER AFTER THE TITAN LAUNCH ON SEPTEMBER 5, 1989.
