FINAL REPORT

HYDROGEN INDUCED FRACTURE  
CHARACTERISTICS OF SINGLE CRYSTAL  
NICKEL-BASED SUPERALLOYS

Po-Shou Chen and Roy C. Wilcox

Prepared for  
George C. Marshall Space Flight Center  
Marshall Space Flight Center, Alabama 35812

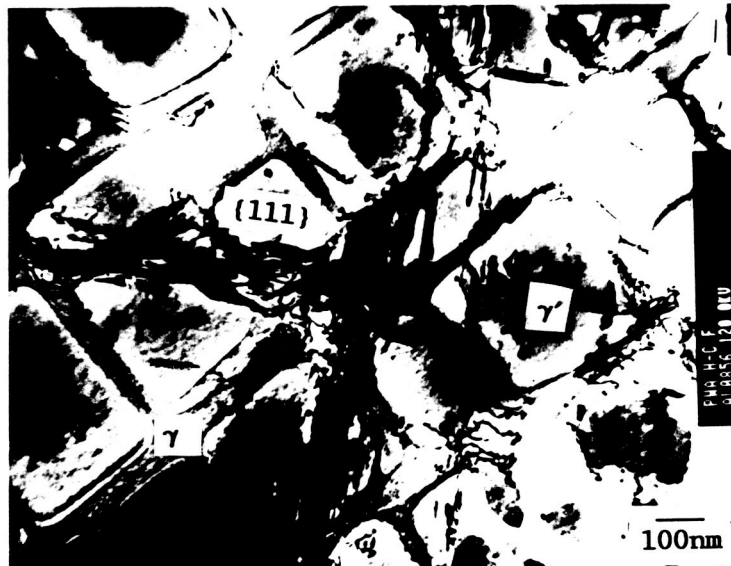
Figure 2. Bright field TEM micrograph with the foil normal parallel to the [100] stress axis showing intense bands lying on {111} planes

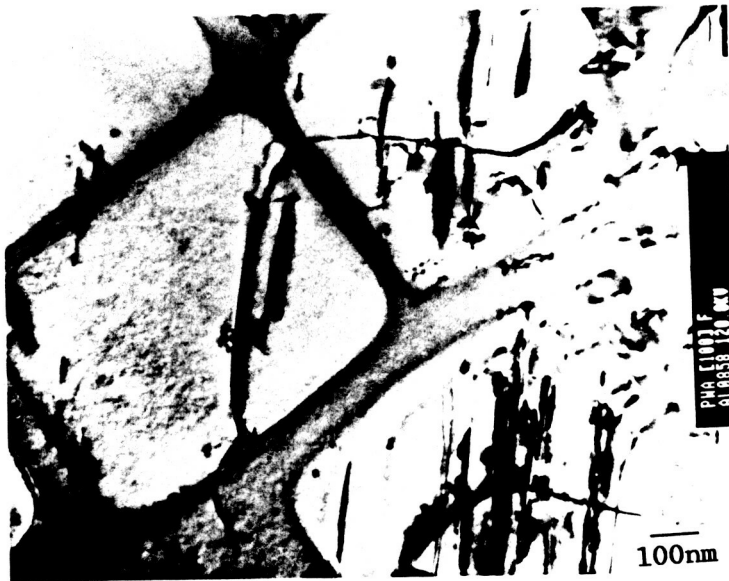
Figure 7. "V" shaped superdislocation.

Superdislocations with "V" shaped configuration were found in the  $\gamma'$  particles (Figure 7). This is a typical morphology of  $\{100\}$  type superdislocations [29]. In addition to  $[110]$  and  $[011]$  cracking on the  $\{111\}$  planes, microcracking along  $\{111\}$  slip planes within the  $\gamma$  matrix (Figure 8a) or along  $\{100\}$   $\gamma/\gamma'$  interfaces was detected (Figure 8b). This revealed that, in addition to the cracking cutting across both  $\gamma$  and  $\gamma'$  particles, cracking could occur in the narrow  $\gamma$  region on  $\{111\}$  planes or be deflected by  $\gamma'$  particles leading to interfacial cracking on  $\{100\}$  planes. In a previous study [4], the dislocation structure in helium charged specimens was similar to that found in the hydrogen charged specimens in this work. The primary differences were the formation of  $\{100\}$  type slip and cracking along the  $\gamma/\gamma'$  interface in an hydrogen atmosphere.

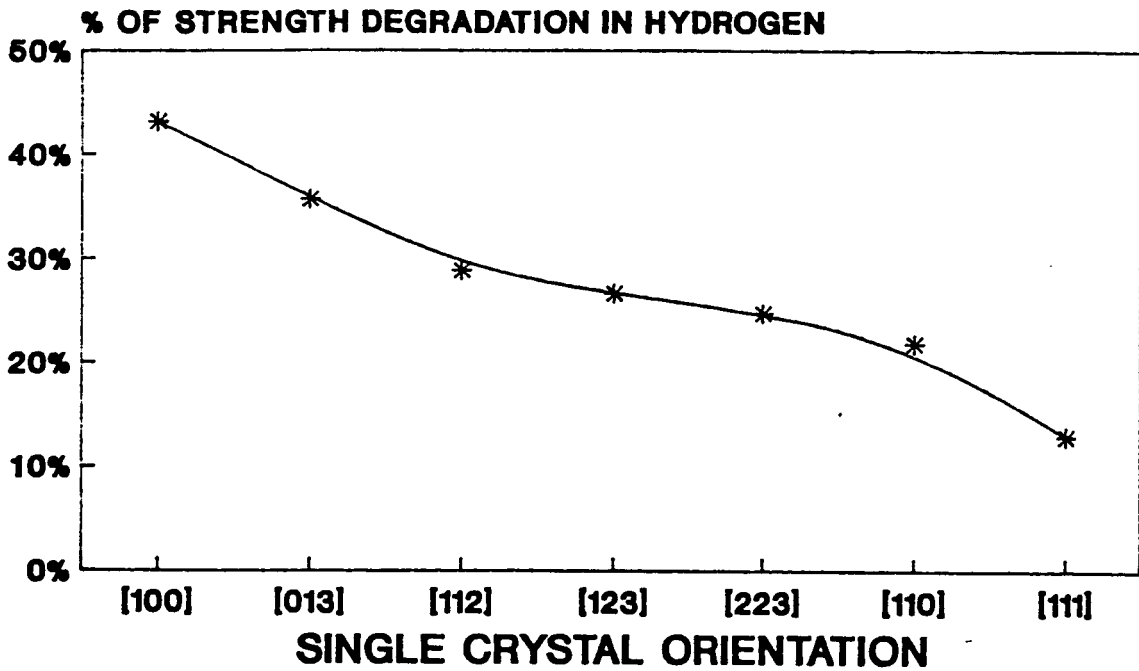
Figure 9. Tensile strength degradation in hydrogen of PWA 1480E as a function of the seven different orientations.

The larger the angle  $\phi$ , the lower the normal stress required to induce crack propagation on the (100) plane. The combined plot of Figure 9 and 10 is given in Figure 11. As shown in Figure 11, the amount of strength degradation had good agreement with the normal stress on (100) cleavage planes. This orientation dependence suggested that hydrogen-induced fracture occurred by cleavage on the (100) plane with the smallest angle between the normal to the (100) planes and the crystal axis. The fracture stress increased with increasing the angle  $\phi$  and fracture then occurred when the resolved normal stress to the (100) planes attained a critical value. In other words, the greatest degradation occurred in the [100] specimen because of the least applied fracture stress required to induce cleavage on the (100) plane. The microscopic observation of mismatch, misorientation, volume fraction and morphology of  $\gamma'$ , revealed no deviation between single crystal growth orientation [15]. Therefore, it can be concluded that cleavage fracture of the hydrogen charged nickel-base superalloy was mainly governed by (100) cleavage. The controlling factor of anisotropic strength degradation was the angle between the normal to the (100) planes and the tensile axis. In the specimen with the [100] orientation, the normal to the (100) plane was  $0^\circ$  to the tensile axis and this resulted in the

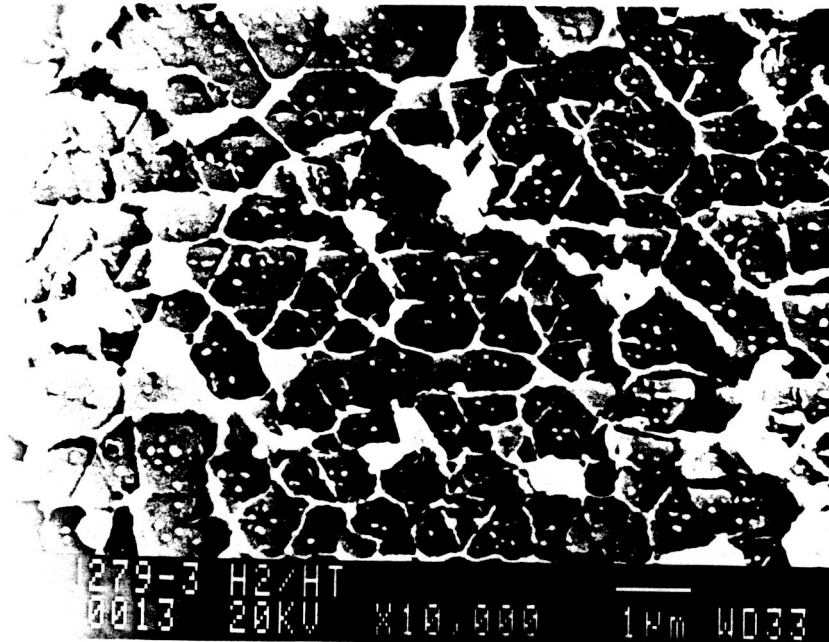
Figure 20. (a)  $\{111\}$  type of cleavage planes found in the  $[100]$  specimen near the notch area. (b) Fractograph taken at high magnification showing a triangular  $\gamma'$  network.
