# NASA Technical Memorandum 102608

THE UTILIZATION OF AN INFRARED IMAGING SYSTEM AS A  
COOLING SLOT BLOCKAGE DETECTOR IN THE INSPECTION OF  
A TRANSPIRATION COOLED NOZZLE

JANUARY 1990

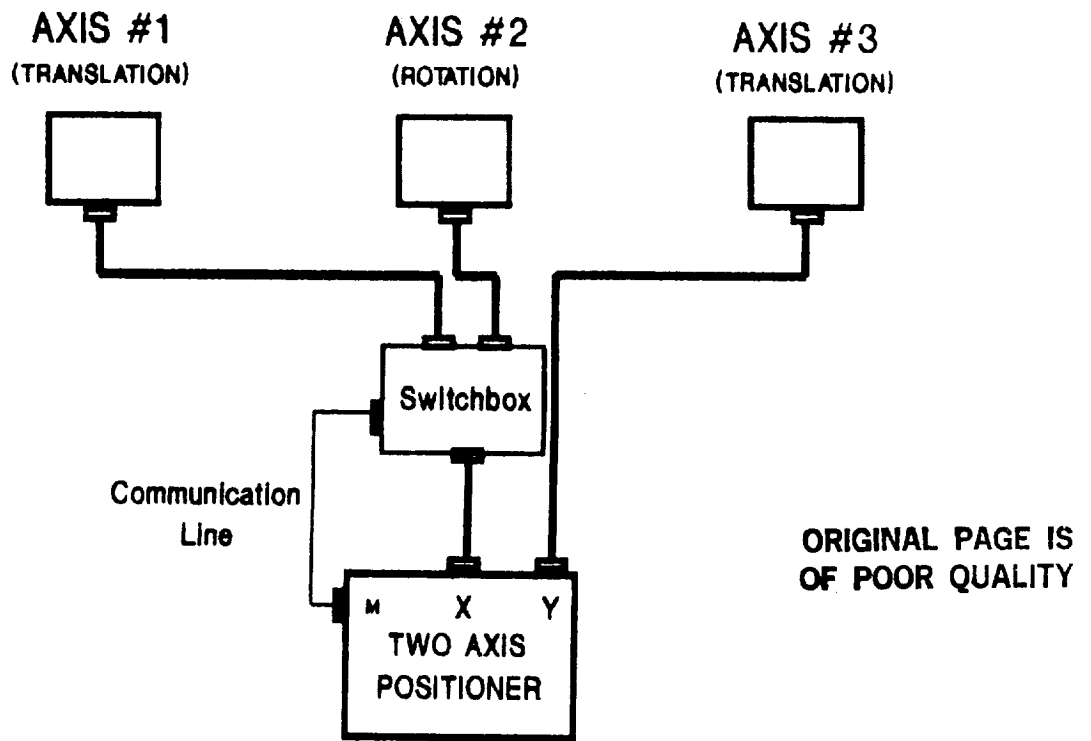
FIGURE 4. IMPLEMENTATION OF SWITCHBOX IN THE CONTROL OF THREE INDEPENDENT AXES

Precise motion control of a three degree of freedom system was not within the capabilities of the current positioning system. This led to the development of a device which would allow the two-axis positioner to control three independent axes. This was accomplished by having one

of the positioner's output ports control either of two positioning devices through a gated switch-type mechanism. Inserting this switchbox in series with one of the output ports would allow signals to be routed to either device depending upon the position of an electronically triggered multipole double throw switch (fig. 4). The switchbox could be controlled by the position controller through a 15 pin communication line or by the user through the manual operation of panel mounted switches. Further details on the design and operation of the switchbox are given in Appendix C. Figure 5 shows a circuit diagram of the switchbox.

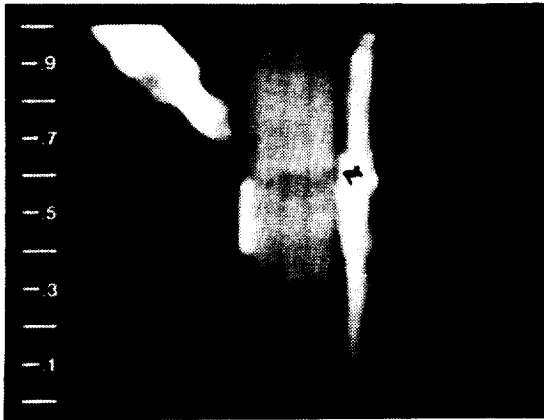
FIGURE 13.  
INFRARED IMAGE OF TEST MODEL SUPPLIED  
WITH 150°F AIR.

Figure 11 shows that both blocked and open slots were essentially undetectable with no air flow through them while at room temperature. Figure 12 shows that all slots were still practically undetectable with near ambient temperature air flow through them. Figures 13 and 14 show that the best open slot visibilities were obtained when air was supplied at temperatures greater than 77°F above ambient. Although cold nitrogen gas, from evaporated liquid nitrogen, as in figure 15, produced possibly larger contrast differences between the restricted and unrestricted slots, it caused considerable frost buildup on the surface of the specimen which was undesirable. While transient temperature change conditions seemed likely to enhance the imager's capability to detect blocked slots, results of the only such test attempted, shown in figure 16, did not demonstrate even as good an ability to detect slots as the steady state method. Dry air supplied at temperatures at least 77°F above ambient was determined to enhance slot visibility by the imager. Optimum air pressure and flow rate would have to be determined for each nozzle section during inspection.
