NASA Contractor Report 3996

Development of Pressure Containment and Damage Tolerance Technology for Composite Fuselage Structures in Large Transport Aircraft

CONTRACT NAS1-17740
AUGUST 1986

*Boeing Commercial Airplane Company
Seattle, Washington*

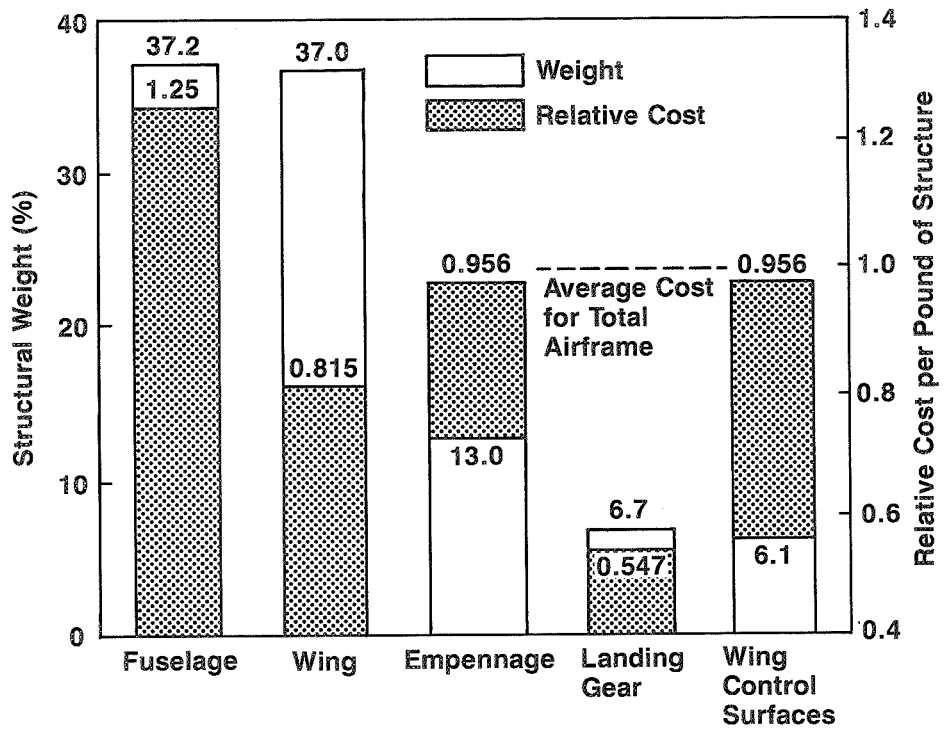
Figure 1. Typical Commercial Transport Component Weight Distribution and Relative Cost Breakdown

The wing and fuselage account for approximately equal fractions of aircraft structural weight, as shown in Figure 1. Also, as shown in Figure 1, the fuselage accounts for the greatest cost per pound of structure. Therefore, to maximize the benefits of composites application to large commercial and military transport primary structure, the fuselage also must be considered and investigated. In the recently completed Fuselage Study program, NASA contract NAS1-17417 (ref. 1), Boeing identified damage tolerance/pressure containment as a critical technology required for composite fuselage development. As shown in Figure 2, a majority of the fuselage is designed by pressure. Damage tolerance design features for pressure containment will influence a major portion of the shell structure.

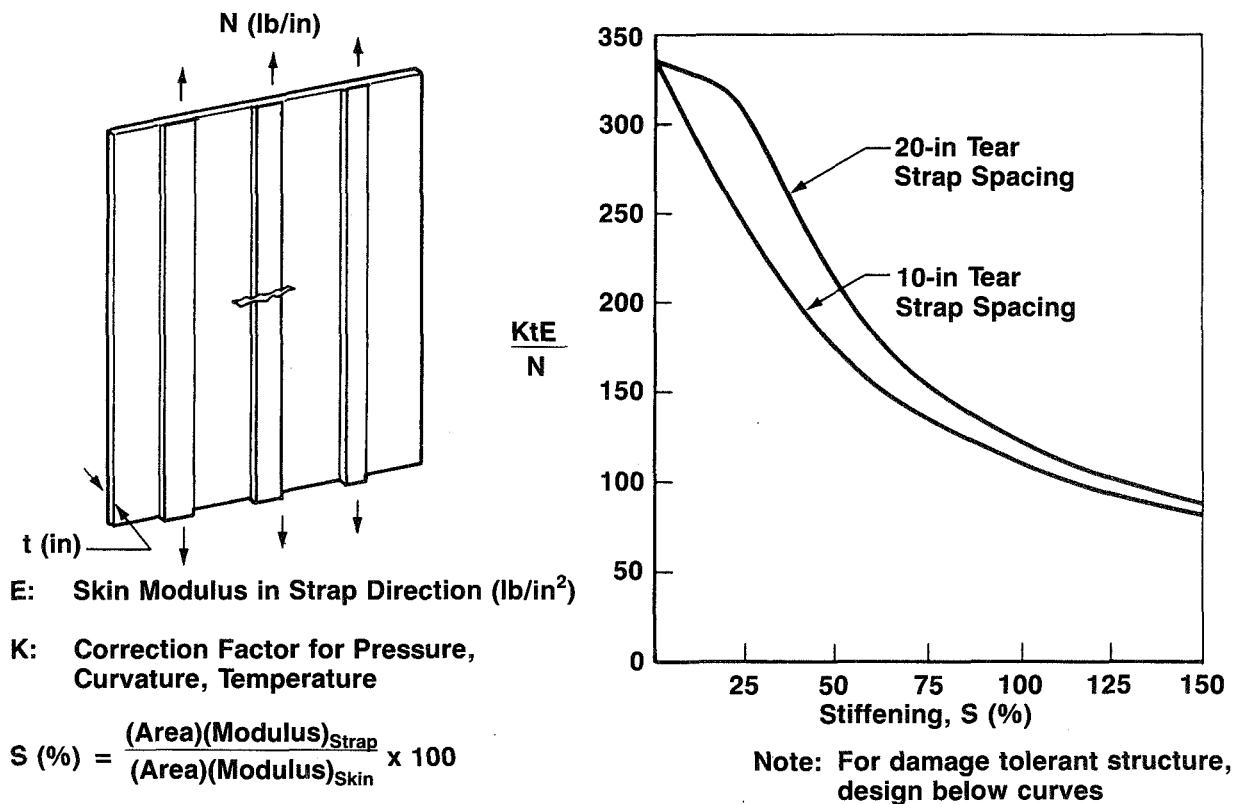
Figure 9. Tear Strap Design Curves

Boeing uses a 12-in damage criterion to demonstrate damage tolerance. This criterion allows damage to occur at any location in the skin and to completely sever a frame and/or a stringer. The damage is arrested at the next frame or stringer. Integrally co-cured tear straps are incorporated into the shell design to provide the arrest mechanism. Tear strap design curves, shown in Figure 9, were developed in NASA contract NAS1-17417 (ref. 1).

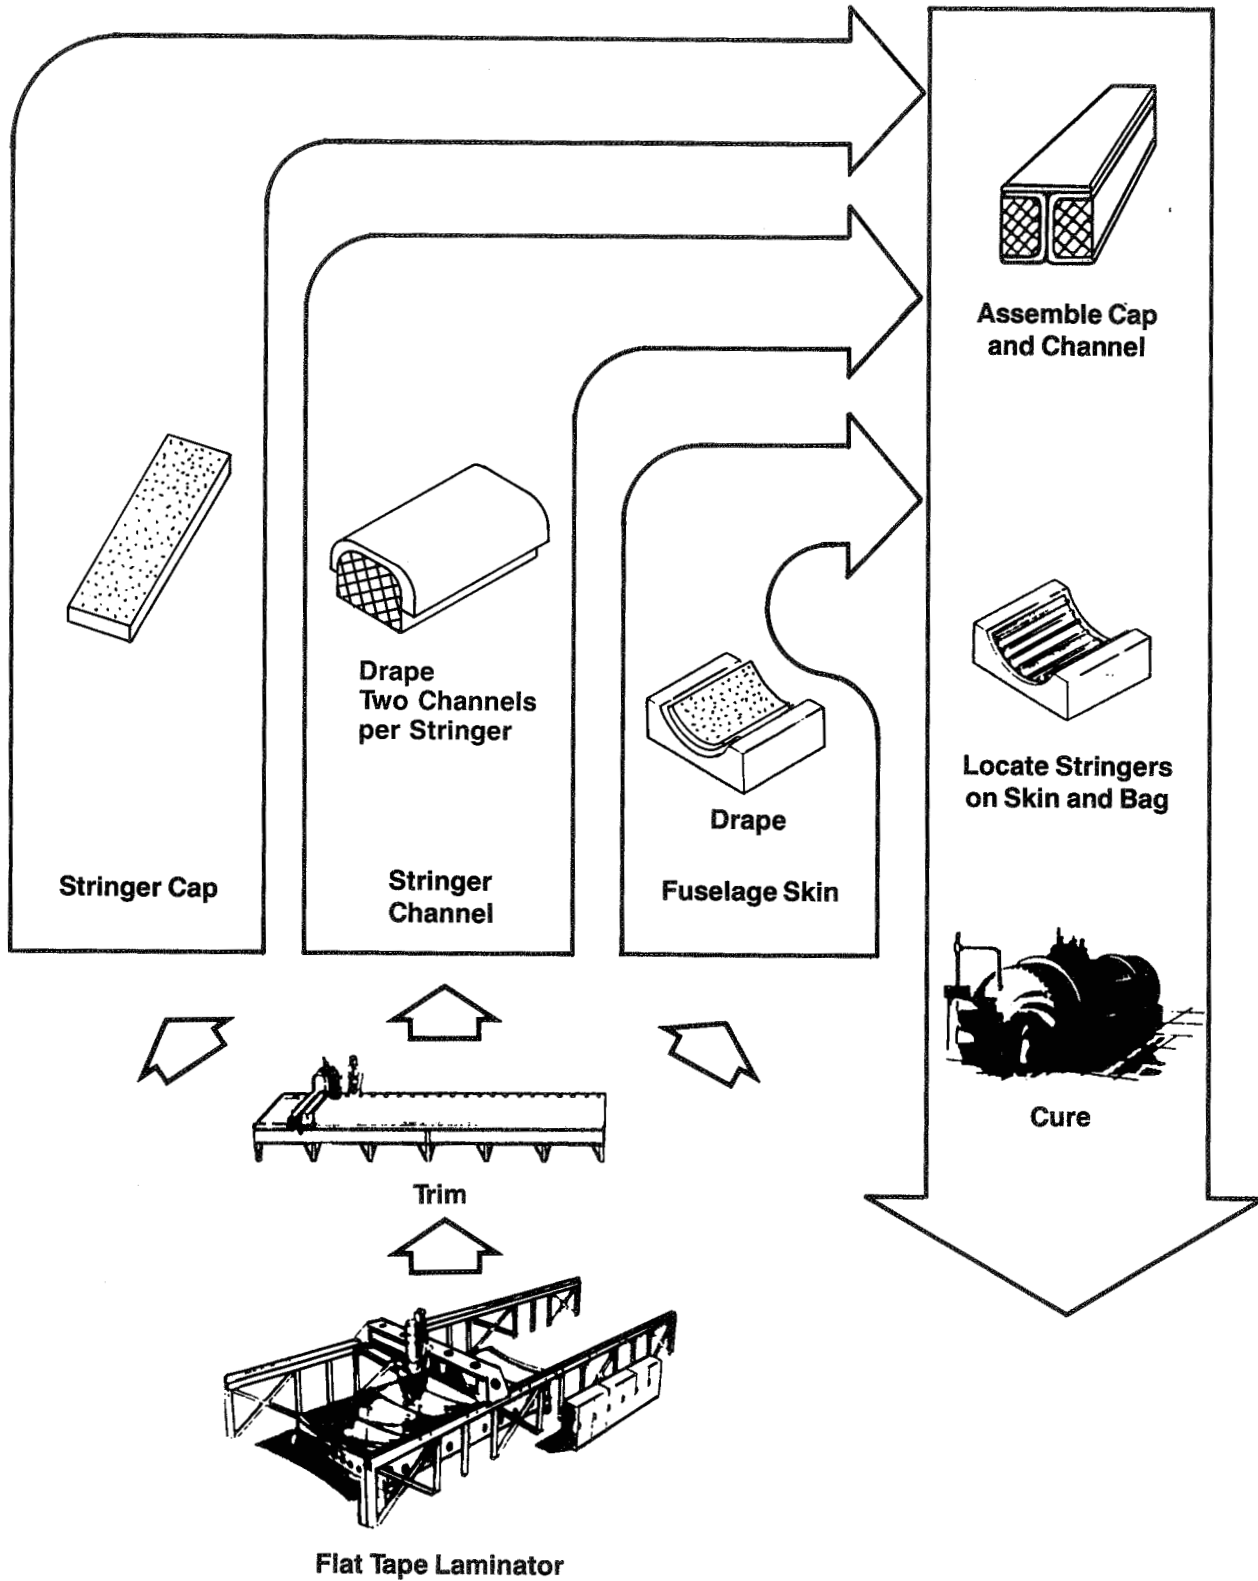
Figure 46. I-Stringer Panel Fabrication Flow

numerically controlled cutter. The stringer preplies are drape formed onto the layup mandrels, and the stringer halves and cap plies are assembled as shown in Figure 46. The skin panel is drape formed to the layup mandrel, and the stringer assemblies are located on the skin panel. A strip of precured graphite laminate is placed between the stringer and the skin laminate to provide a foundation for the stringer tool. This reduces localized pressures developed during cure and prevents the stringer from sinking into the skin laminate. The skin-stringer panel is then bagged and cured in an autoclave to produce an integrally co-cured stiffened panel. Graphite-epoxy material is used for the skin layup mandrel and the stringer mandrels to minimize thermal expansion differences. This procedure for fabricating I-section stringer stiffened panels has been validated on the LCPAS wing program (NAS1-16863) and the Air Force Damage Tolerance program (ref. 9) and has been successful for fabricating parts in this program.

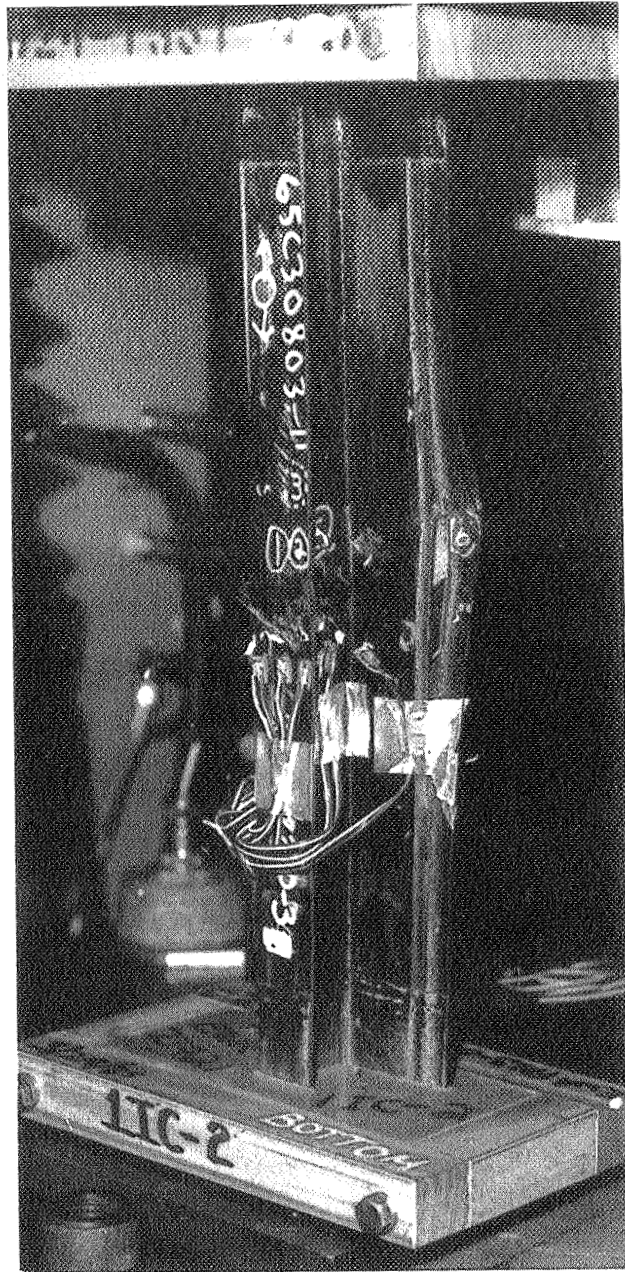
Figure 121. Local Buckling Mode and Failure Pattern of a Single Stringer Crown Crippling Element

$P = 23$ kips

Failed Crown Element
 $P_{Fail} = 23.7$ kips

TTU inspection prior to testing indicated that all three crown elements contained areas of low compaction at the skin-stringer interface. The amount of low compaction area per specimen, shown in Figure 120, varied from low (specimen 3C-1), to medium (specimen 3C-2), to high (specimen 3C-3). These crown elements, designed primarily for tension loads, were required to be capable of compression strains of 0.0025 in/in. All three elements failed above 0.006 in/in (0.0064 in/in average) and failed within 1 kip of each other (fig. 118). The free edge of the skin proved to be the critical area. The stringer section remained stable until the free edge of the skin buckled, precipitating the instability of the stringer skin flange. The free edge of the skin buckled at 0.0049 in/in, which was 23% higher than the predicted value of 0.004 in/in (fig. 119). Figure 121 shows the buckling mode and failure of one of the crown elements.
