NASA
Technical
Paper
2950

The Interlaminar Fracture Toughness of Woven Graphite/Epoxy Composites

Joan G. Funk
and Jerry W. Deaton

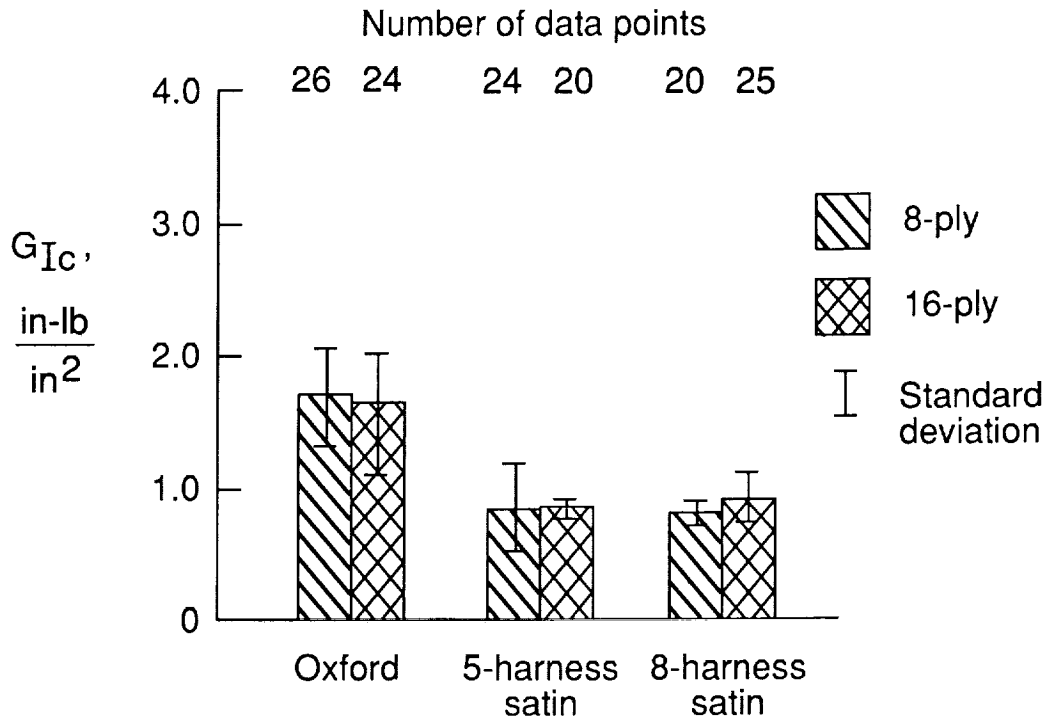
Figure 9. Values of G_{Ic} of the 8-ply and 16-ply folded-configuration laminates tested in the warp direction.

The G_{Ic} values for the 8-ply and 16-ply symmetric (folded) specimens of the oxford, 5-harness satin, and 8-harness satin weaves are shown in figure 9 for the specimens tested in the warp direction and in figure 10 for the specimens tested in the fill direction. Shown above each bar at the top of the figure are the number of data points for which G_{Ic} was calculated for the respective test configuration. The standard deviation is indicated by the range lines drawn through each bar. The results shown in figures 9 and 10 indicate that G_{Ic} was not dependent upon the thickness of the test specimens for either of the three weaves. Since G_{Ic} was not thickness dependent, the remaining laminates were evaluated with 16 plies only.

Folded configuration. The data shown in figures 9 and 10 indicate significant differences in G_{Ic} as a function of midplane fiber orientations relative to the longitudinal axis of the test specimen. The 16-ply data from figures 9 and 10 are compared in figure 11 along with the 24-ply unidirectional tape data from reference 12. The specimens tested in

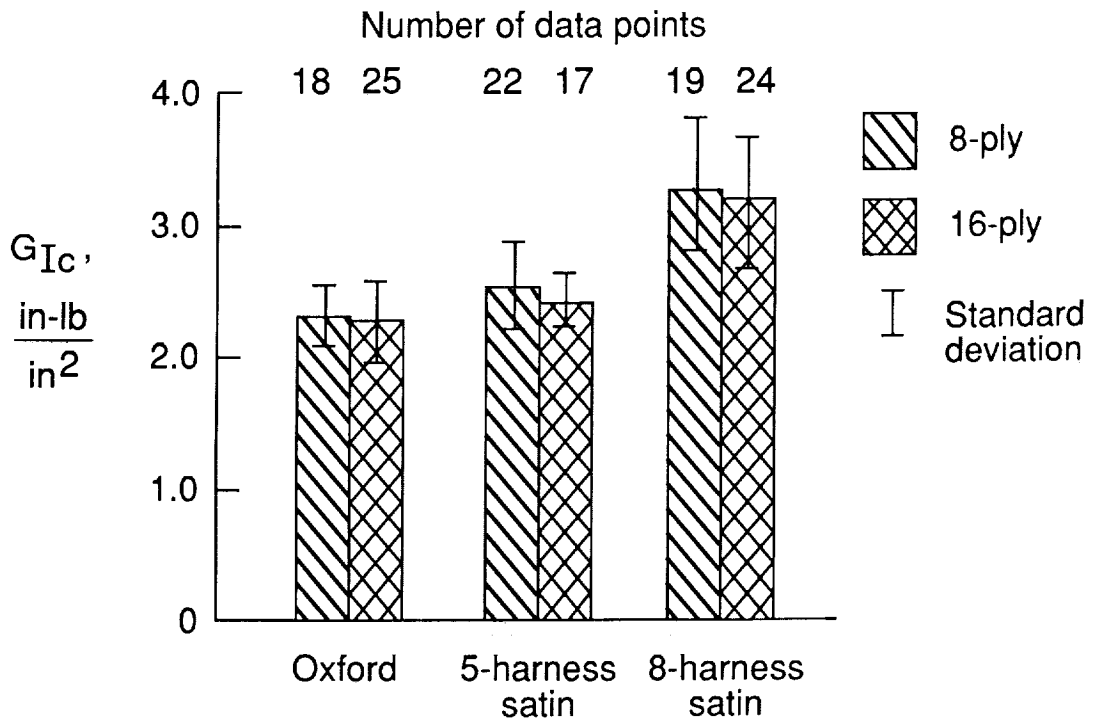
Figure 10. Values of G_{Ic} of the 8-ply and 16-ply folded-configuration laminates tested in the fill direction.

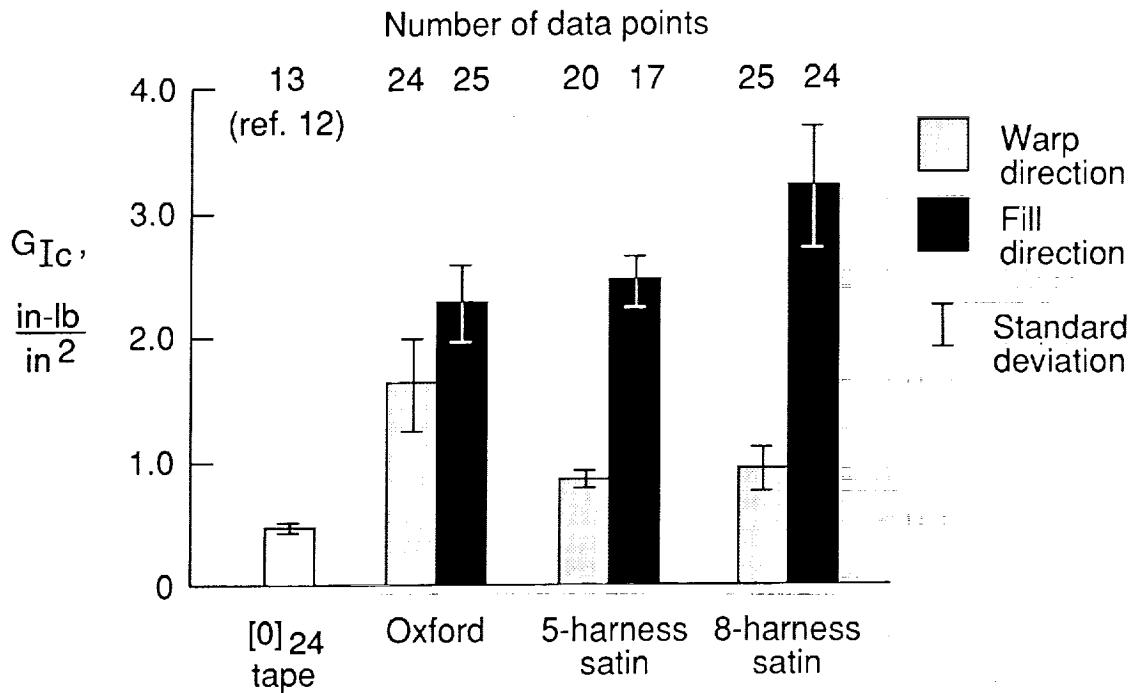
Figure 11. Values of G_{Ic} of the folded-configuration laminates in both the warp and the fill directions.

the fill direction consistently had a higher G_{Ic} than the specimens tested in the warp direction. The G_{Ic} value of the woven materials was two to eight times greater than that of the 0° unidirectional tape material. Detailed observations of the failure surfaces will be discussed and correlated with test direction in a subsequent section.

growth. (See fig. 11.) When the largest percentage of the fibers at the midplane were perpendicular to the direction of crack growth, the failure surfaces exhibited more fiber breakage. The additional energy required to break the fibers resulted in a higher G_{Ic} for these materials.
