NASA Technical Memorandum 102099

Arcjet Cathode Phenomena

Prepared for the
1989 JANNAF Propulsion Meeting
Cleveland, Ohio, May 23-25, 1989

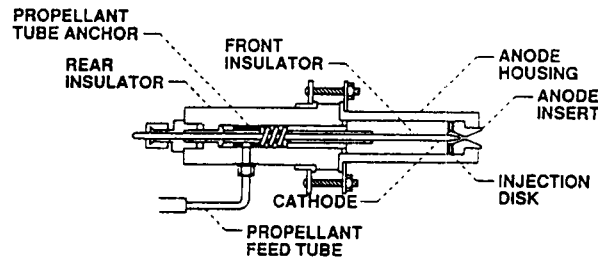
FIGURE 1. - CUTAWAY VIEW OF ARCJET THRUSTER.

Cathode materials comparison tests were conducted with a laboratory arcjet whose schematic is shown in Figure 1. This radiatively cooled thruster was designed to allow convenient and repeatable assembly. A 2% thoriated tungsten nozzle was used. The constrictor was 0.64 mm diameter by 0.41 mm long. The converging and diverging ends of the nozzle were conical with half angles of 30° and 20°, respectively. The anode cathode gap spacing was set by inserting the cathode into the thruster until contact was made with the anode and then withdrawing the desired amount. For the tests described herein, a gap of 0.58 mm was used. Gaseous propellant was injected tangentially into a cylindrical arc chamber just upstream of the nozzle. Gas entered through two 0.34 mm dia holes to form a vortex flow field.

In each arcjet test assembly the cathode was centered coaxially within the arc chamber by a boron nitride front insulator. Longitudinal grooves along the outer surface of the insulator allowed passage of propellant to the chamber injection holes and permitted regenerative preheating of the gas.

The thoriated tungsten nozzle, gas injector, and front insulator were all contained within an anode housing. Each component was positioned within the barrel of the housing and separated by graphite gaskets. The walls of the housing not only directed and preheated incoming propellant, but also served as a thermal radiator for the tungsten nozzle.

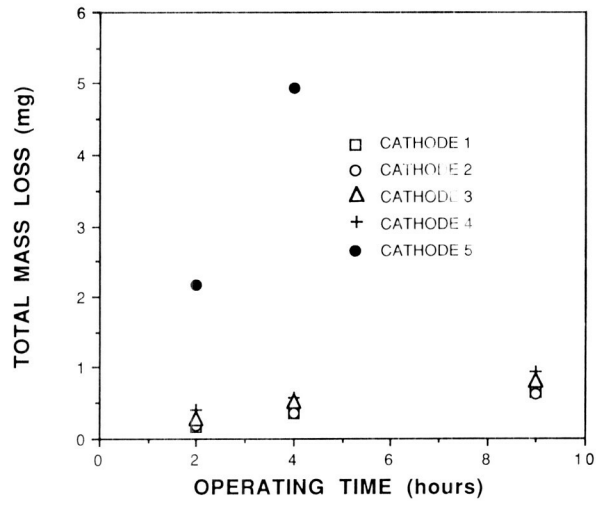
FIGURE 3. - CATHODE MASS LOSS VERSUS TIME.

Figure 3 also shows that the mass loss of the thoriated rhenium cathode is significantly higher than that of the other tungsten-based materials. For this sample the mass loss rate after 4 hours of operation was seen to be an order of magnitude above those measured for the tungsten-based cathode tips. The melting point of the 2% thoriated rhenium tip is expected to be 200 to 300 °C below that of 2% thoriated tungsten. As will be discussed in the next two sections, the thorium oxide likely does not play a significant role in the emission process and the observed mass loss rates can be explained solely by evaporation. If this is postulated, then the fact that the rhenium-based cathode displayed a mass loss rate significantly higher than that of the tip containing 25% rhenium implies that it must have been running at a higher temperature. This could be explained by the fact that rhenium has a significantly higher work function than does pure tungsten (5.1 versus 4.5 V). Further work would be necessary, however, to confirm the postulated difference in operating temperature between rhenium and tungsten tips. Evidence will be presented in a following section to show that the arc cathode attachment occurs from a small molten crater at the cathode tip and that the dimensions of this crater are nearly constant with time. This being the case, it is unlikely that the total erosion rate would decrease with time. This suggests that as the cathode erodes back to a nearly steady state configuration, the redeposition rate increases leading to a lower net erosion rate (i.e., a lower mass loss rate).

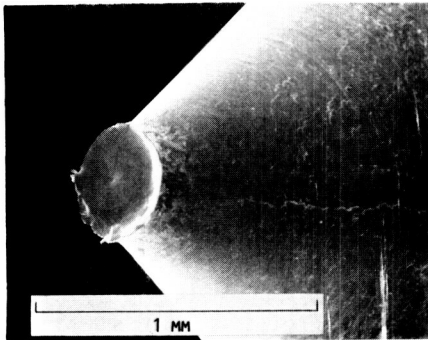
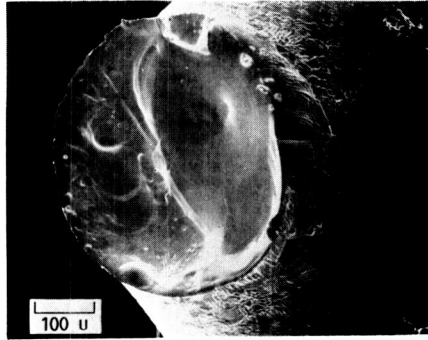
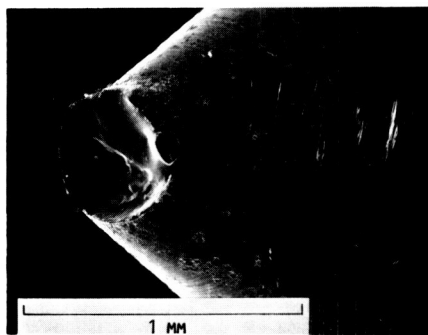
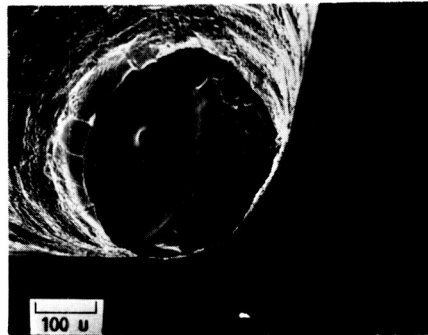
(A) TWO PERCENT THORIATED TUNGSTEN TIP AFTER TWO HOURS OF OPERATION. (70x).

(B) TWO PERCENT THORIATED TUNGSTEN TIP AFTER FOUR HOURS OF OPERATION. (150x).

(C) TWO PERCENT THORIATED TUNGSTEN TIP AFTER NINE HOURS OF OPERATION. (70x).

(D) SECOND TWO PERCENT THORIATED TUNGSTEN TIP AFTER TWO HOURS OF OPERATION. (150x).

FIGURE 4. - SEM PHOTOGRAPHS OF TUNGSTEN BASED CATHODE TIPS AT VARIOUS POINTS IN TESTING.

brevity, one of the 2% thoriated tungsten tips was chosen for detailed analysis and this is presented here. Figures 4(a) to (c) show a sequence of SEM photographs of the tip taken after 2, 4, and 9 hours of operation, respectively. For comparison, Figure 4(d) shows a SEM photograph of the second 2% thoriated tungsten tip after its first 2 hour run. From these photographs, it can be seen that the shape of the tips is very similar in each case. The arc appears to have originated from a small molten crater at the tip.

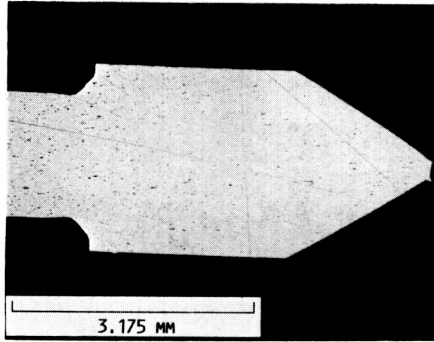
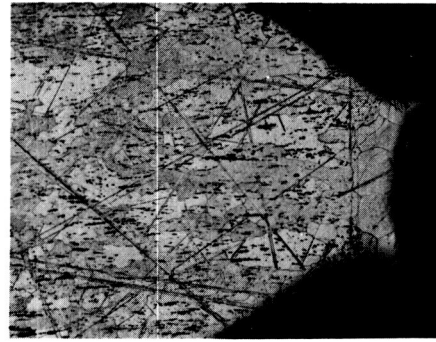
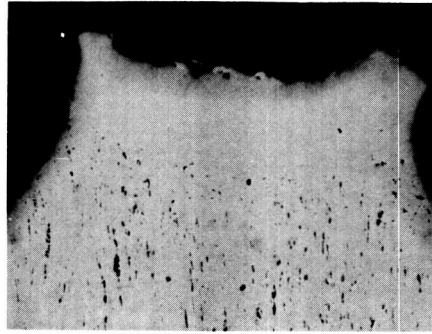
(A) POLISHED TIP (16x).

(B) POLISHED AND ETCHED TIP (100x).

(C) POLISHED TIP (200x).

FIGURE 5. - PHOTOMICROGRAPHS OF SECTIONED CATHODE TIP IN POLISHED AND ETCHED CONDITIONS.

At the conclusion of testing the cathode shown in Figures 4(a-c) above was sectioned, polished, and etched and then subjected to SEM analysis with both energy dispersive (EDS) and Auger spectroscopy. The entire tip in its polished condition is shown in Figure 5(a), and Figure 5(b) shows the tip after etching to bring out the grain boundaries. A number of the dark nodules observed were analyzed via EDS and found to be composed of thorium oxide. These were sintered cathodes so the presence of nodules was not unexpected. Figure 5(b) shows, however, that no nodules were present at the cathode tip. In fact, EDS showed no thorium oxide within 100 to 150 microns of the cathode tip. From the recrystallization pattern near the tip, this also appears to be the approximate depth to which the material was molten. Behind this area, the grain boundaries, though irregular, appear to be homogenous and unaffected throughout the bulk of the material as do the dark nodules. This suggests that operation does not cause gross changes in the bulk material and that there is little migration of thorium oxide toward the tip. A clearer view of this is shown in the photomicrograph of Figure 5(c) which presents a more magnified view of the region near the crater on the polished cathode tip shown in Figure 5(a). This photomicrograph shows that no thorium oxide nodules are present in the resolidified region near the crater. Thus, there is no indication that arcjet operation causes migration of thorium oxide toward the molten crater.

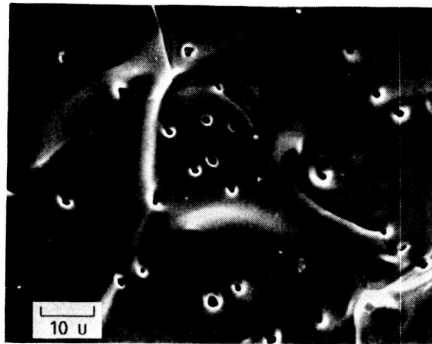
FIGURE 6. - RECRYSTALLIZED AREA OF CATHODE TIP WITH PITS (1200x).

During the course of the SEM photography, one final observation was made. Under high magnification a number of occlusions were observed on some of the cathode tips. An example of this is shown in Figure 6. This photograph was taken early in the test cycle and shows the resolidified region of the tip. A number of pits are seen and these are approximately one to two microns in diameter. This is approximately the same size as the thorium oxide nodules seen in the earlier photograph. It is likely that these pits were sites of thorium oxide nodules which vaporized due to the extreme temperature at the tip. This temperature must be at least the melting point of tungsten at which the vapor pressure of thorium oxide is greater than 1 torr.²¹

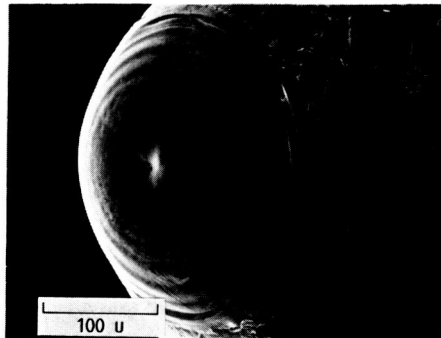
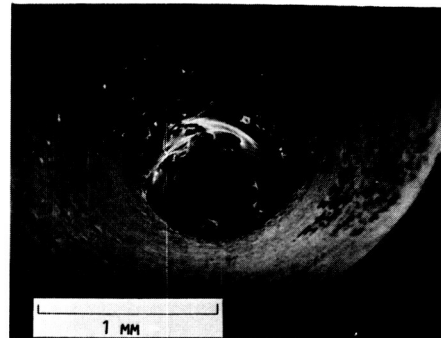
(A) AFTER TWO AND ONE-HALF MINUTES OF OPERATION.

(B) AFTER FOUR HOURS OF OPERATION.

FIGURE 7. - TWO PERCENT THORIATED RHENIUM CATHODE TIP.

2% Thoriated Rhenium. As described in a previous section, the 2% thoriated rhenium tip test was first terminated after only 2-1/2 minutes after excessive sparking was observed in the plume. An SEM photograph of the tip at this point is shown in Figure 7(a). From this it is obvious that a very extensive portion became molten very rapidly. The crater on the tip after 4 hours of operation shown in figure 7(b), is similar to those observed on other tips, but it does appear to be deeper as might be expected from the higher mass loss rate and operating voltage (indicating an increased arc length).

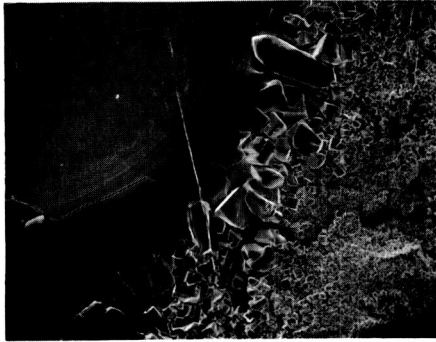
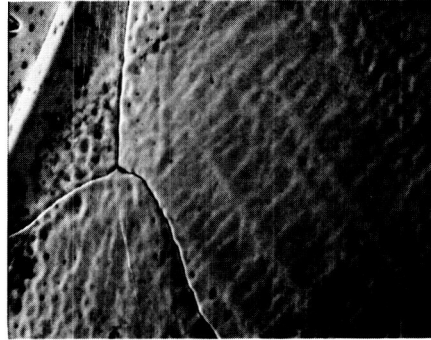
(A) NEAR BORDER OF MOLTEN AREA.

(B) MOLTEN (RECRYSTALLIZED) AREA.

FIGURE 8. - SEM PHOTOGRAPHS OF HAFNIUM CARBIDE TIP.

Hafnium Carbide. Hafnium carbide has recently been suggested as an alternate cathode¹² material because of its high melting point (ca 3890 °C) and low work function of about 3.5 V. Numerous attempts were made to run a tip ground from hafnium carbide. In an initial experiment with a slightly different tip geometry, the tip ran well for some time, but cracked on restart. Another tip cracked almost immediately on start up. Finally, in this study, a tip was run briefly without cracking. This was taken from the thruster for analysis. Visually the tip maintained its deep blue coloration except at the tip where its color had turned to gold. SEM photographs of this region showed that the tip had become molten. Different regions of this tip are shown in Figures 8(a) and 8(b) under high magnification. Figure 8(a) shows the border of the molten area. Large crystals seem to have formed right at the edge of this area. A region near the center of the molten area is shown in Figure 8(b). This appears to be resolidified with boundaries similar to those seen in the metal tips. Analysis of the composition in this region, however, indicated that a major chemical change had taken place as this area was found to now be composed of hafnium nitride. This suggests that a chemical reaction between the propellant and the hot cathode had taken place. While it may be possible to lessen or eliminate the stress cracking by using a hafnium carbide cermet, it is doubtful that this would change the tip chemistry and this probably means that hafnium carbide is not a viable cathode material.

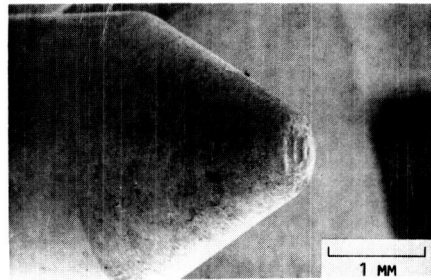
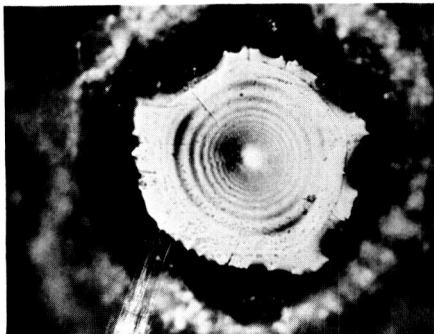
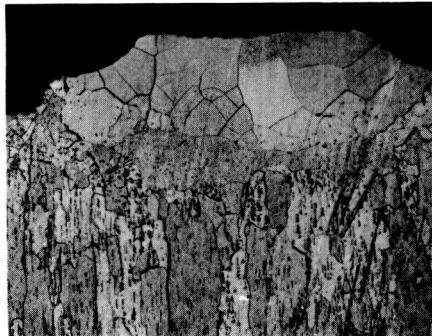
(A) SEM PHOTOGRAPH OF TIP.

(B) PHOTOMICROGRAPH OF ARC CRATER.

(C) PHOTOMICROGRAPH OF TIP AFTER SECTIONING AND ETCHING.

FIGURE 9. - CATHODE TIP FROM 100 HOUR CONTINUOUS TEST.

Different photographs of the cathode tip run in the 100 hour test are shown in Figure 9. The SEM photograph of the tip under low magnification (Figure 9(a)) shows that a small arc crater had

formed on the tip. A photomicrograph of this crater, taken looking straight at the cathode tip, is shown in Figure 7(b). The cathode crater observed is almost identical to those that have been observed in other arcjet tests.^{11,13} The tip, after sectioning, polishing, and etching is shown in Figure 9(c). As in the case of the short term tests, a resolidified area can be seen in the region of the cathode tip. The grain structure immediately behind (or underneath) this area does not appear different than that observed in the bulk. As in the shorter cathode tip tests, no thorium oxide nodules were seen in the region of the arc crater.

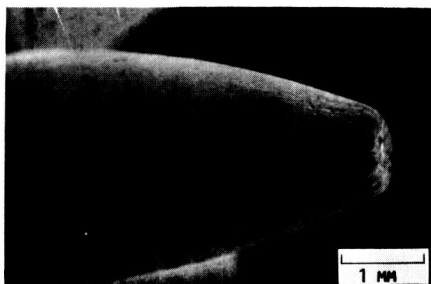
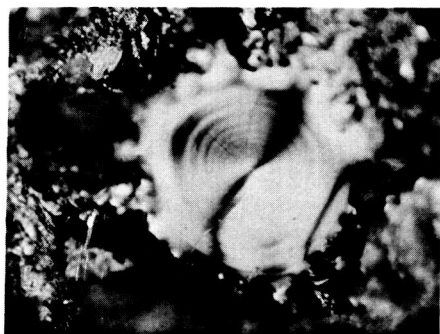
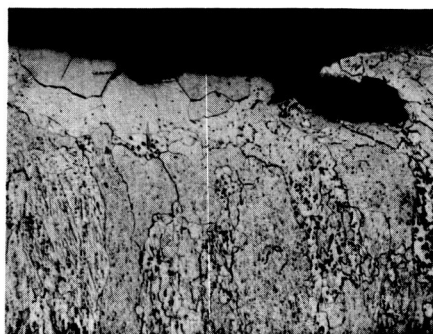
(A) SEM PHOTOGRAPH OF TIP.

(B) PHOTOGRAPH OF ARC CRATER.

(C) PHOTOGRAPH OF TIP AFTER SECTIONING
AND ETCHING.

FIGURE 10.- CATHODE TIP FROM 1000 HOUR CYCLIC LIFETEST.

Similar views of the cathode tip used in the 1000 hour/cyclic are presented in Figures 10(a) to (c). This tip was originally bullet-shaped¹¹ and polished, rather than ground with a straight 30° angle. From Figures 9 and 10 it can be seen that there is a significant difference between the final shapes of these two cathode tips. From Figure 9(a), the crater on the tip from the 100 hour test is raised slightly from the surrounding surface. Figures 10(a) and 10(b) show that the cathode crater in the case of the 1000 hour test was in a depression on the tip. The explanation for this difference is not clear. It is possible that the lifetest cathode was similar in appearance to that of the tip from the 100 hour test at the 100 hour point and future testing would be required to address this issue. The arc craters observed in both tests, however, were nearly identical in size and appearance. Measurements of these craters and a similar crater from an earlier test¹³ give diameters between 0.15 and 0.20 mm. All of these cathodes were initially 2% thoriated tungsten.

This issue is important in understanding arcjet life and one final difference was noted in the appearance of the two cathodes from the long term tests. As stated, the cathode from the long term lifetest was cycled and accumulated more than 500 starts. It was evident that surface melting had occurred over the entire tip including the area on the shoulder well behind the tip crater (see Figure 10(a)). This surface melting phenomenon was not as extensive in the case of the 100 hour continuous test in which a single start was performed. From this, it is postulated that the arc ignites upstream of the cathode tip and then is rapidly forced there by the gas flow as the tip heats to a temperature that can support the emission. This phenomenon may be due to the observed depletion of thorium oxide at the tip. This would suggest the continued use of 2% thoriated tungsten as the cathode material, rather than pure tungsten for ease in starting. Further experimentation would be required to provide a better understanding of this phenomenon.
