**Final Report** (NASA-CR-182127) AGT (ADVANCED GAS TURBINE)  
TECHNOLOGY PROJECT Final Report (Detroit  
Diesel Allison) 203 p C SCL 20E

# **Advanced Gas Turbine AGT Technology Project**

## **Final Report**

Allison Gas Turbine Division  
General Motors Corporation  
Indianapolis, Indiana 46206-0420

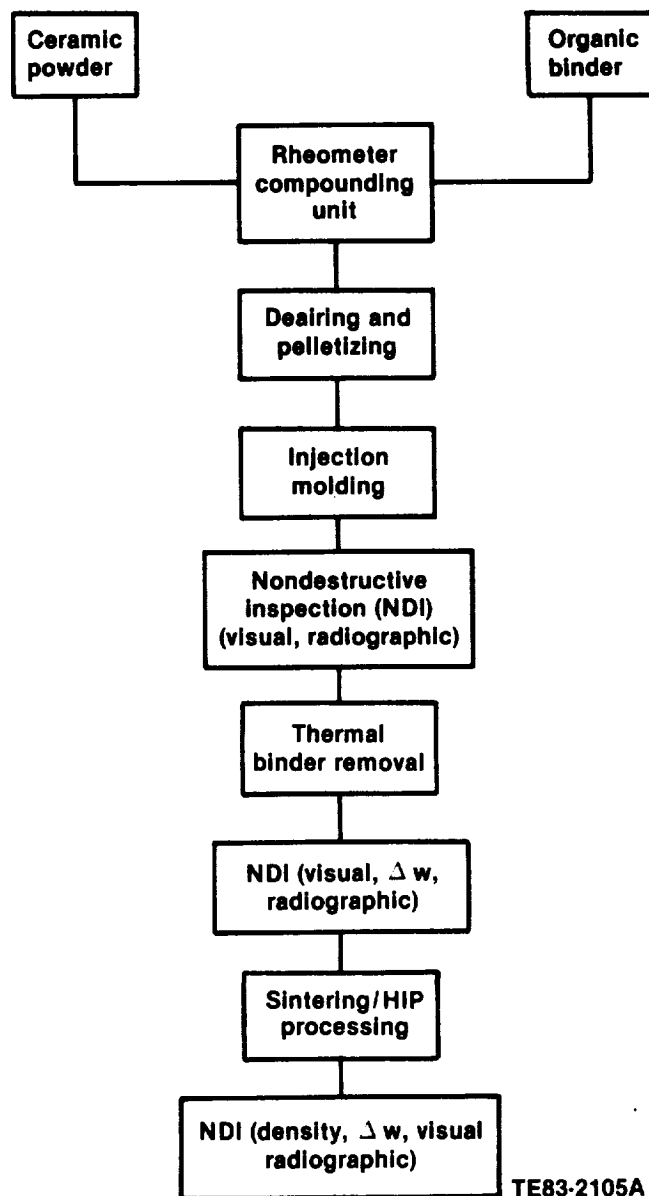
**Figure 15.** Process routing for GTE Laboratories injection-molded  $\text{Si}_3\text{N}_4$  turbine rotors.

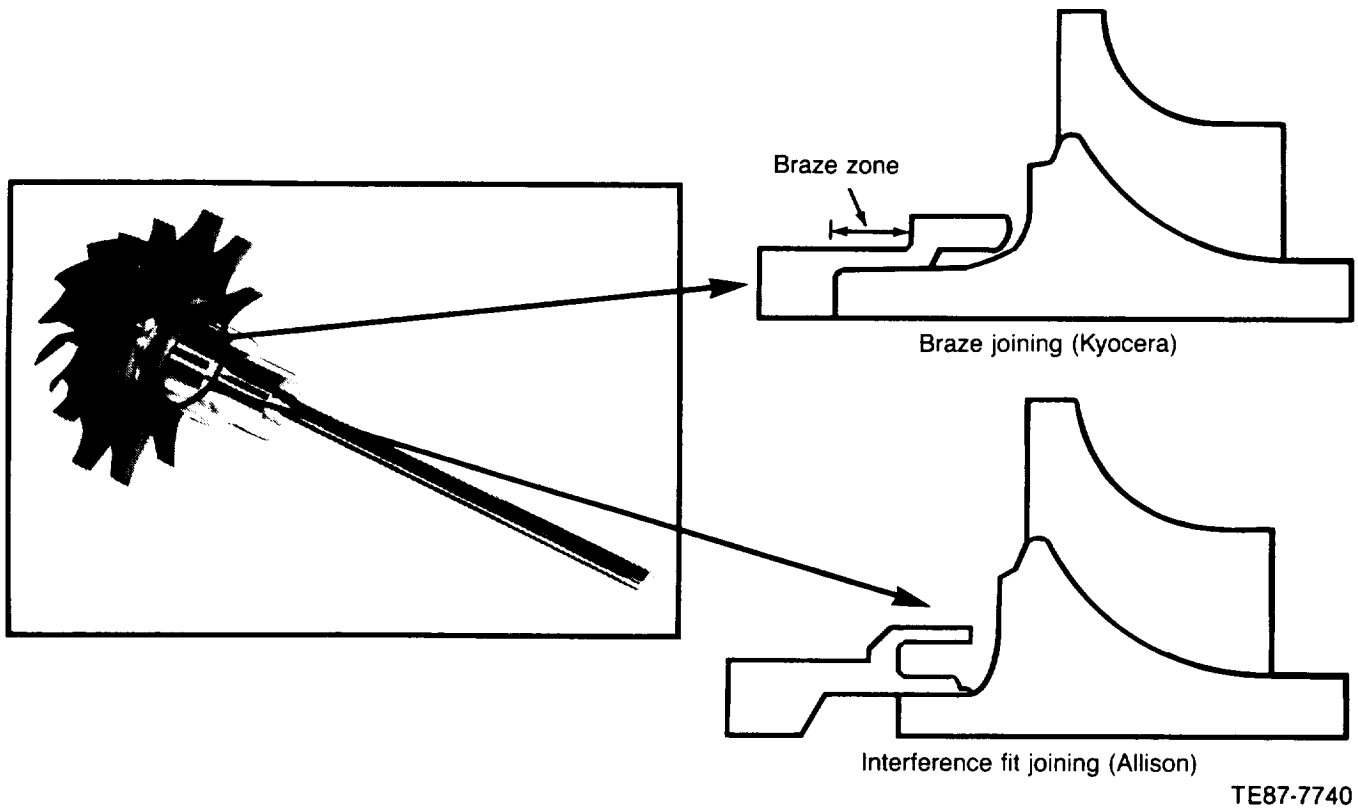
Figure 150. Braze and interference fit joining of metal gasifier shaft to  $Si_3N_4$ .

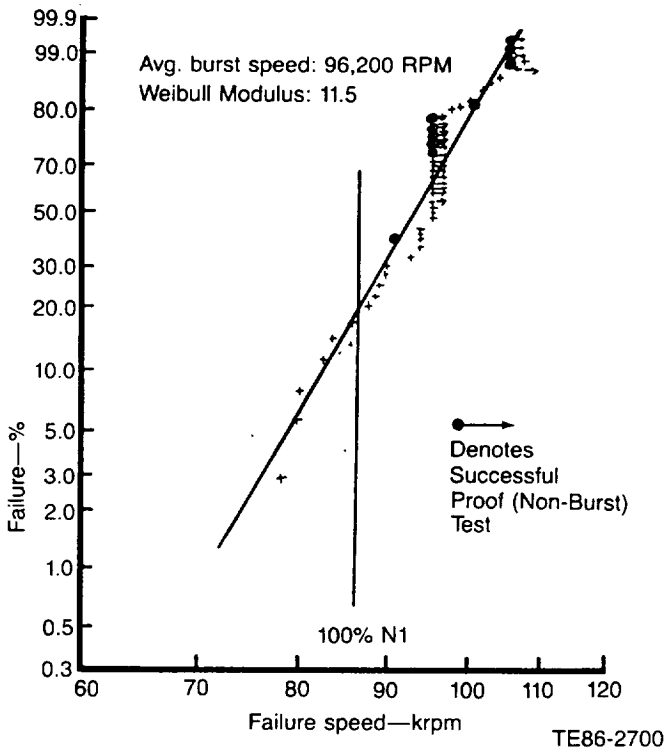
**Figure 157.** Cumulative probability of failure as a function of spin speed, Group 8 (1985) SiC gasifier rotors.
