NASA Contractor Report 180807

Thermal Barrier Coating Life Prediction Model Development

Final Report

R.V. Hillery, B.H. Pilsner, R.L. McKnight,
T.S. Cook, and M.S. Hartle
GE Aircraft Engines
Cincinnati, Ohio 45215

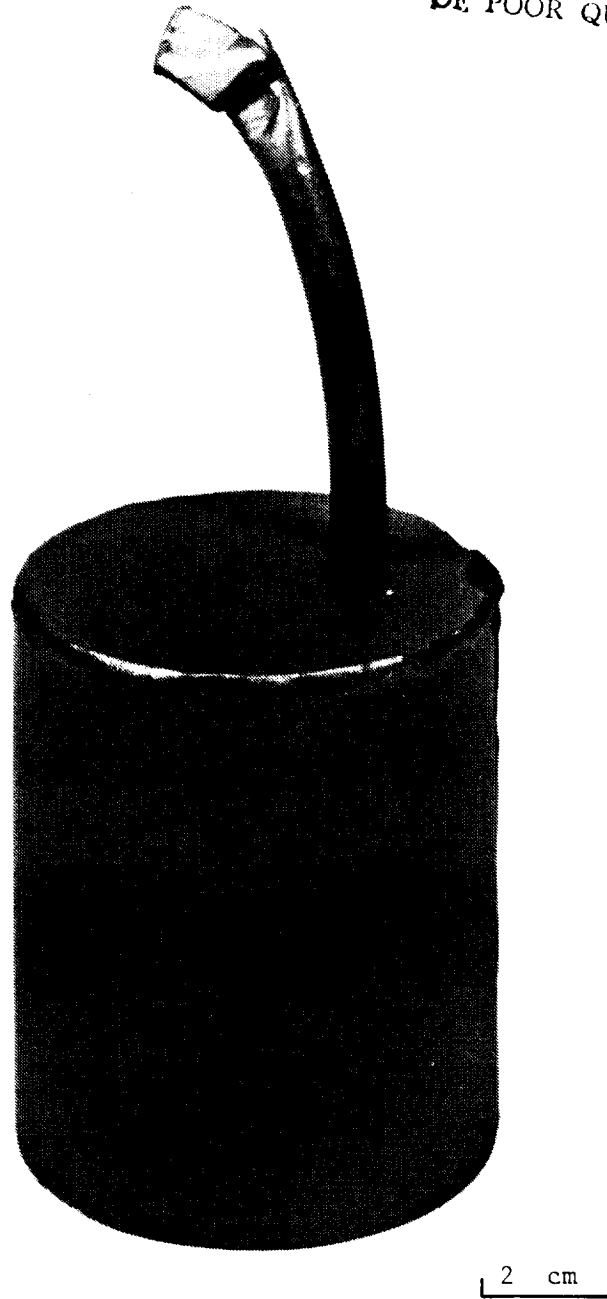
Figure 11. Inconel 718 Canister Utilized for Thermal Cycle Testing in Argon.
