NASA Technical Memorandum 101346

Molten Salt Corrosion of SiC and Si₃N₄

Nathan S. Jacobson, James L. Smialek, and Dennis S. Fox
Lewis Research Center
Cleveland, Ohio

November 1988

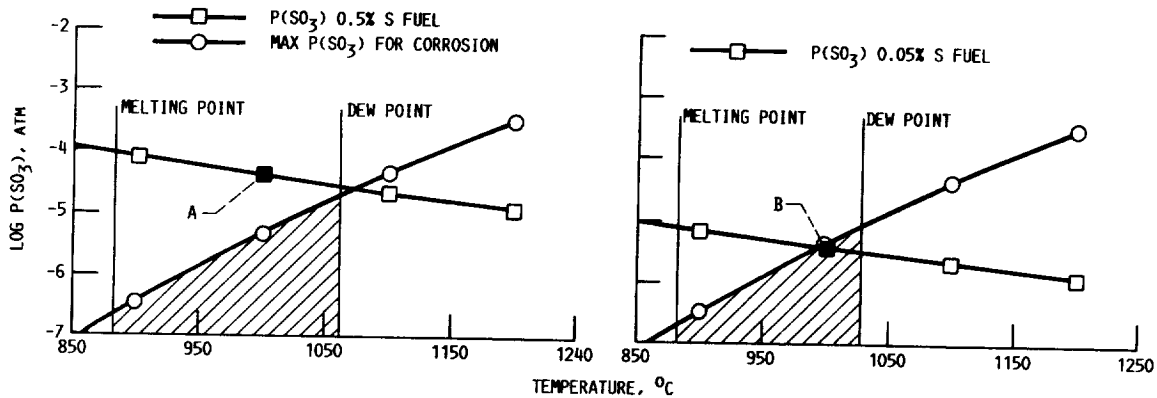
(a) 0.5% S FUEL, 2 PPM Na, 0.025 FUEL-TO-AIR RATIO, 1000 °C.

(b) 0.05% S FUEL, 2 PPM Na, 0.025 FUEL-TO-AIR RATIO, 1000 °C.

FIGURE 5. - CALCULATED CORROSION REGIMES FOR SiO_2 .

Thus from the minimum $a(\text{Na}_2\text{O})$ for dissolution, a maximum $p(\text{SO}_3)$ can be calculated. This is shown as an upper boundary for corrosion in Figure 5(a) and (b).⁵³ Using the NASA Chemical Equilibrium Code⁸⁵, the partial pressure of SO_3 in a heat engine can be calculated. The parameters which determine this include temperature, pressure, and sulfur

content in the fuel. The results for Jet A fuel (~0.05% S) are shown in Figure 5(a) and the results for No. 2 Diesel fuel (~0.5% S) are shown in Figure 5(b). When the $p(\text{SO}_3)$ in the engine is below the upper boundary of $p(\text{SO}_3)$ for dissolution, corrosion is predicted. Note that with Jet A fuel this occurs at about $\sim 995^\circ\text{C}$, whereas with No. 2 Diesel fuel this occurs at about $\sim 1080^\circ\text{C}$.

As mentioned, corrosion occurs between well defined temperature limits. The lower limit is the melting point for Na_2SO_4 -- 884°C . The upper limit is the dew point for Na_2SO_4 deposition, as shown in Table IV. These are shown on Figures 5(a) and (b). Note that dissolution can occur for the higher sulfur fuel above the dew point. Thus corrosion is not predicted for No. 2 Diesel fuel under the conditions described by Figures 5(a) and 5(b).

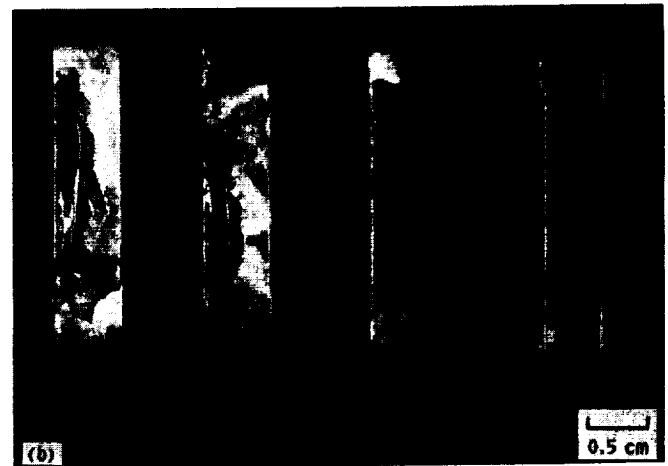
(a) NUMBER 2 DIESEL FUEL (0.5% S), 5 HR.

(b) JET A FUEL (0.05% S), 1 HR.

FIGURE 6. - SiO_2 COUPONS TREATED IN THE BURNER RIG, 2 PPM Na, 1000 °C.

This type of diagram can be generated for a variety of pressures and sodium and sulfur concentrations.⁵³ The figures shown here are for 4 atm total pressure, which corresponds to the NASA burner rig used for these studies. To test these calculations, quartz specimens were run in a burner rig under conditions corresponding to points (A) and (B) in Figures 5(a) and (b). Visual examination of the specimens suggested the higher sulfur fuel caused only limited corrosion, as shown in Figure 6. These coupons were also tested for water soluble silicon, which indicates the

presence of sodium silicate. The coupons corroded in Jet A fuel for only 1 hr with 2 ppm Na had 0.16 ± 0.10 mg Si/cm², whereas the coupons corroded for 5 hrs in No. 2 Diesel fuel with 2 ppm Na had 0.003 ± 0.003 mg Si/cm². These data are consistent with the predictions.

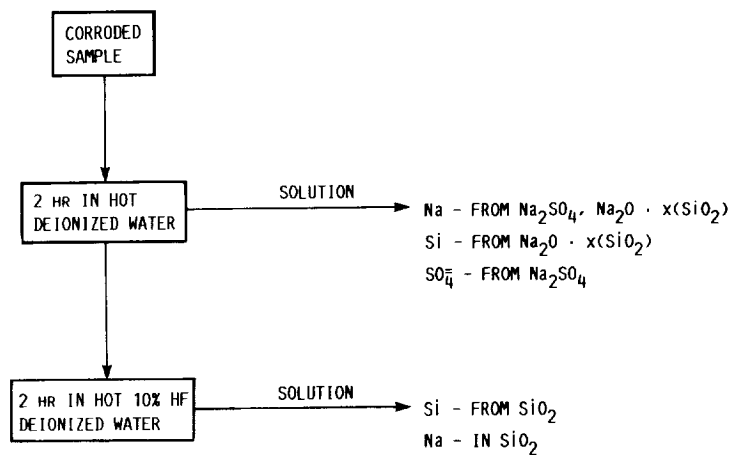
FIGURE 7. - CHEMICAL ANALYSIS SCHEME FOR DETERMINING COMPOSITION OF CORROSION PRODUCTS ON SiC .

An understanding of a corrosion mechanism includes more than just the major chemical reactions. It also includes a knowledge of the reaction rates and rate controlling steps. For heat engine applications, these are best studied through carefully controlled laboratory experiments using thin salt films. The thin salt films are airbrushed from a saturated aqueous solution onto a ceramic coupon, and the coated coupon is placed in a furnace with a well defined gas environment. The reaction can be followed with several techniques. The most common is thermogravimetric analysis, where the weight change is continuously monitored as a function of time. Another technique is chemical analysis of the corrosion scales at various time intervals. The corrosion products from silicon based ceramics are particularly well suited for chemical analysis because they consist of sodium silicate and sodium sulfate, which are both water soluble, and silica, which is only HF soluble. When a clear distinction occurs between these two phases, the authors have found the technique outlined in Figure 7 to provide useful information.⁴⁵

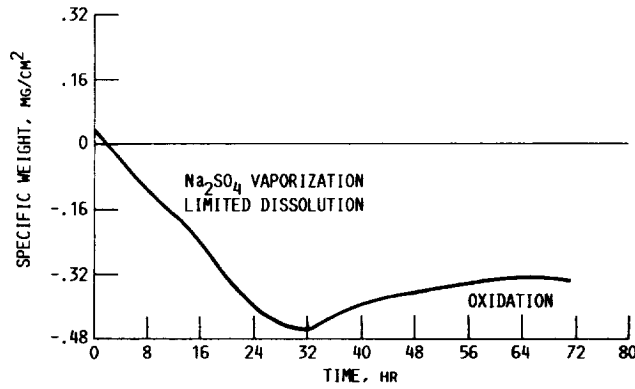
FIGURE 11. - TGA CURVE FOR HIP RBSN + Na_2SO_4/O_2 AT 1000 °C.

The Na₂CO₃ corrosion kinetics provide a good basis for examining Na₂SO₄ corrosion. As mentioned, this is a more acidic molten salt and will not readily dissolve SiO₂. Figure 11 shows thermogravimetric data for HIP RBSN + Na₂SO₄/O₂. Without an overpressure of p(SO₃), the a(Na₂O) would be expected to vary. Electrochemical measurements show that in a Na₂SO₄/O₂ system⁵³, a(Na₂O) varies from 5.6 x 10⁻¹⁴ to 1 x 10⁻¹². Referring to Figure 4, this is a region where SiO₂ would not be attacked. This explains the slow rates of reaction observed in Figure 11. The slow weight loss is essentially all due to the vaporization of Na₂SO₄, which has the same rate of weight loss when applied to an inert platinum coupon. There is also a limited amount of

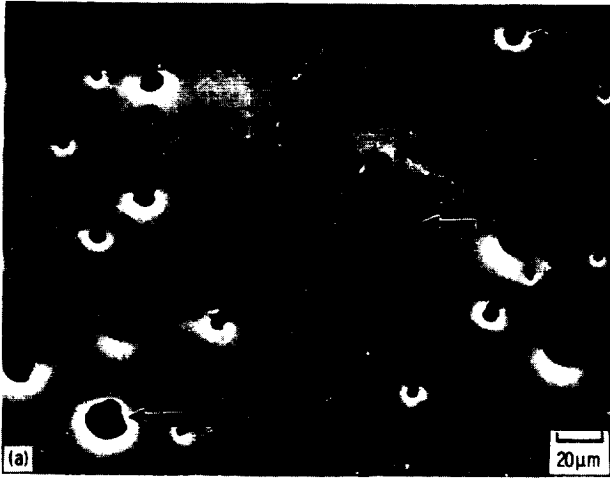
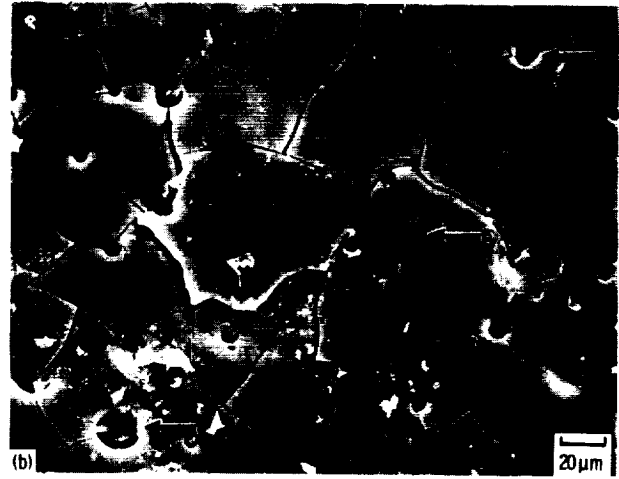
(a) AS-CORRODED SURFACE SHOWS BUBBLES AND PORES IN THE SILICATE LAYER.

(b) WATER LEACH REVEALS BUBBLES AND PORES IN THE SILICA LAYER.

(c) HF LEACH SHOWS THE CORRELATION OF THESE BUBBLES AND PORES TO SOME OF THE PITS IN THE CERAMIC, AS SHOWN BY THE THREE ARROWS.

FIGURE 16. - SEM PHOTOS OF SASC (B.C) + 4.07 MG Na₂CO₃/CM² REACTED FOR 1 HR AT 1000 °C.

The corrosion reactions (2) and (3) involve the release of gases. These escape through the scale as bubbles. These bubbles are 1-10 μm in diameter and are observed on all samples. Furthermore, they are often correlated with pits. Figure 16 shows a series of micrographs taken of the sodium silicate layer, the silica layer, and the SASC (B,C) substrate on a sample corroded with Na_2CO_3 . Note the larger pits correlate directly with a bubble. It appears that when a gas bubble forms it exposes a fresh portion of SiC, which is susceptible for further attack. This is shown schematically in Figure 17 for Na_2CO_3 corrosion. Evidence suggests that a similar mechanism is operative for Na_2SO_4 .⁵⁰

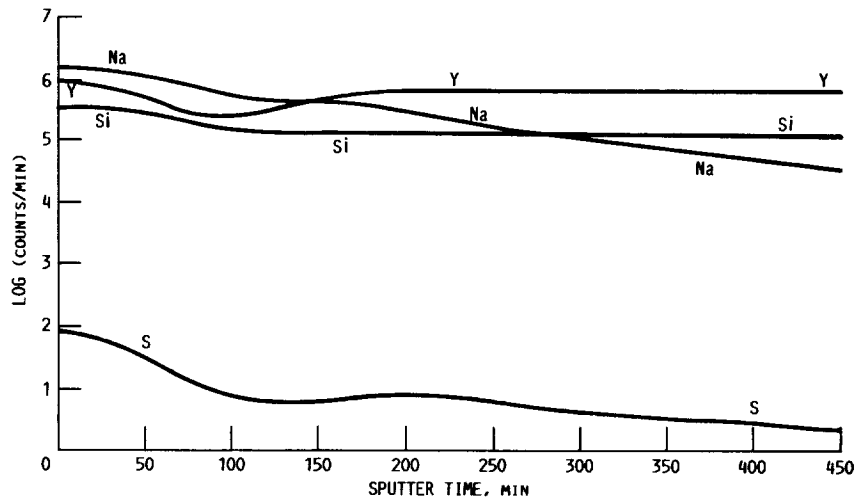
FIGURE 20. - SIMS PROFILE FOR SSN (Al_2O_3 , Y_2O_3) + Na_2SO_4/O_2 REACTED AT $1000\text{ }^\circ C$ FOR 48 HR. ANGLE LAPPED SPECIMEN, PROFILING STARTED AT SCALE/NITRIDE INTERFACE, FOR A TOTAL DEPTH OF $45\text{ }\mu m$ AFTER 450 MIN SPUTTER TIME.

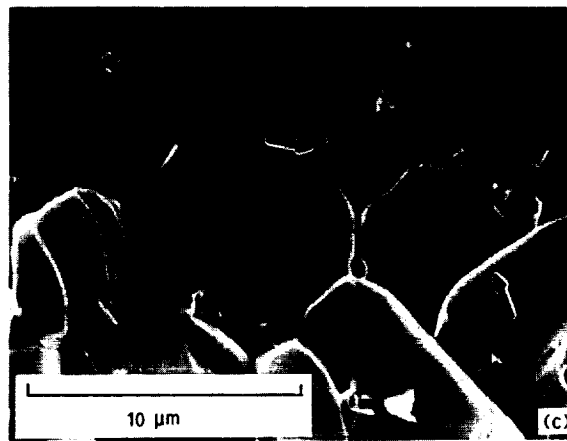
(a) RADIAL CRACK LINES EXTENDING TO THE ORIGIN.

(b) HONEYCOMB CORROSION PIT AT THE ORIGIN.

(c) PREFERENTIAL GRAIN BOUNDARY ATTACK AHEAD OF PIT IN (B).

FIGURE 23. - CORROSION PIT FRACTURE ORIGIN IN SASC (B,C) AFTER $\text{Na}_2\text{SO}_4/\text{SO}_3$ CORROSION AT 1000°C FOR 48 HR.

In order to further understand this strength degradation the fracture origins of numerous specimens were examined. In nearly all cases these were corrosion pits at the surface. Figures 23 and 24 show some representative fracture origins for SASC (B,C) tested in the furnace and burner rig, respectively. Note the deep pitting and grain boundary attack.

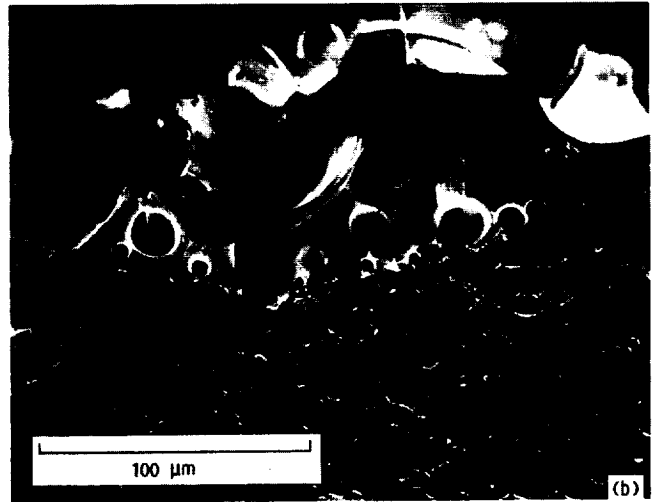
(a) MATTING HALVES OF FRACTURE ORIGIN.

(b) GLASSY PRODUCT AT ORIGIN.

(c) PITTING AT ORIGIN REVEALED BY HF DISSOLUTION OF GLASSY PRODUCT.

FIGURE 24. - CORROSION PIT FRACTURE ORIGIN FOR A BURNER RIG CORRODED SASC (B,C) USING JET A FUEL, 4 PPM Na, 13.5 HR EXPOSURE AT 1000 °C.
