NASA Technical Memorandum 101351
IEPC-88-035

Successful Completion of a Cyclic Ground Test of a Mercury Ion Auxiliary Propulsion System

SUCCESSFUL COMPLETION OF A CYCLIC GROUND TEST OF A MERCURY ION AUXILIARY PROPULSION SYSTEM

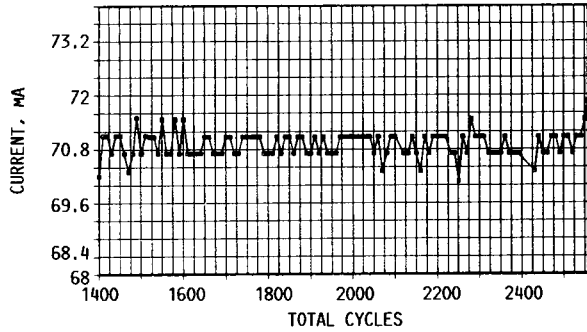
FIGURE 2. - SCREEN CURRENT.

The screen (beam) current (SI) shown in Fig. 2 did not fluctuate more than 1.20 mA (3 counts) throughout the test. The nominal value was 71.0 mA. A slightly lower value of SI was experienced during the first cycle after the thruster was restarted, but this was corrected for subsequent cycles. The constancy of the plotted data demonstrates the effectiveness of the beam current control loop in the flight software.

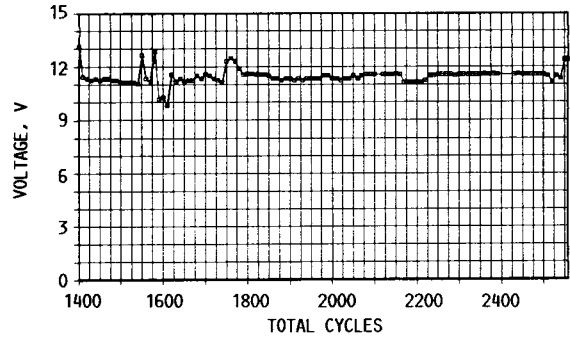
FIGURE 5. - DISCHARGE KEEPER VOLTAGE.

The discharge keeper voltage (DKV) was constant over the test except for the period of oscillations in the DKI. The nominal value of DKV was 11.2 V and as can be seen from the plot of DKV shown in Fig. 5 varied less than ± 1 V throughout the test. The change in the DKI setpoint at cycle number 1620 did cause a slight increase in the DKV (less than 0.5 V).

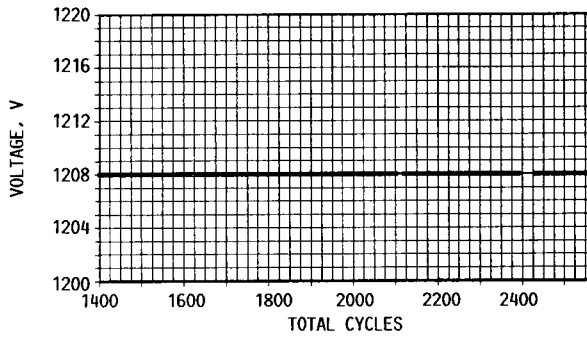
FIGURE 3. - SCREEN VOLTAGE.

The screen voltage was 1208 V and did not vary throughout the test (Fig. 3). The telemetry on this supply was near its upper limit. An actual measurement was made and it agreed with the telemetry value.

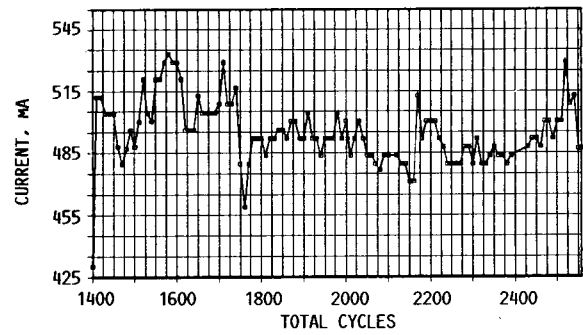
FIGURE 6. - DISCHARGE CURRENT.

The discharge current (DI) also varied. As can be seen in Fig. 6 the DI varied about ± 30 mA from a nominal 490 mA value. The largest values occurred when the oscillations in the DKI were observed and are believed to be due to the noise in the main discharge. The noisy discharge was a major contributor to the scatter in the DI data.

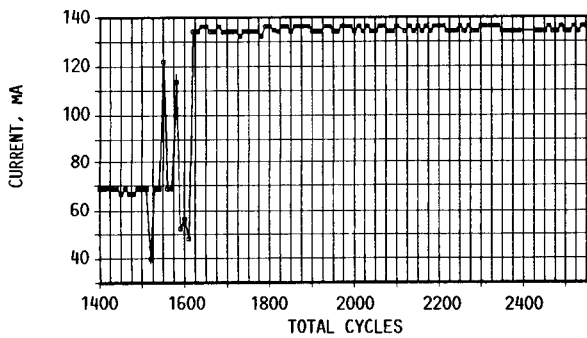
FIGURE 4. - DISCHARGE KEEPER CURRENT.

Figure 4 shows the variation in the discharge keeper current (DKI). The DKI was initially set at setpoint 0 which is 60 mA. But at cycle 1520 the DKI began to fluctuate and as the test progressed the variations increased. The DKI varied from a low value of 40 mA to a peak value of 123 mA, which was apparently due to noise on the main discharge. At cycle number 1620 the DKI was changed to setpoint 1 (120 mA) and this corrected the DKI oscillations. From cycle 1620 to the end of the test the DKI did not vary more than 2 mA. The cause of the change in operation has not been thoroughly investigated at this time. A possible reason is that the PEU-thruster entered an unstable region of control and by changing the setpoint the PEU-thruster entered a stable region of operation.

NOTE: DISCHARGE KEEPER CURRENT SETPOINT CHANGE MADE AT CYCLE 1620.

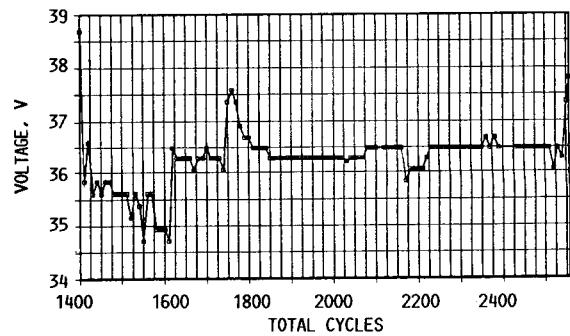
FIGURE 7. - DISCHARGE VOLTAGE.

The discharge voltage (DV) (Fig. 7) also had noticeable variations during the period of DKI's fluctuations. After the setpoint change in DKI the DV did not vary by more than ± 0.75 V. The discharge (main) vaporizer had a feedback signal for control which was the difference between the discharge voltage and discharge keeper voltage. This difference was maintained at 26.5 V. The slight increase in DV after the DKI setpoint change reflects the slight increase of DKV at the higher setpoint.

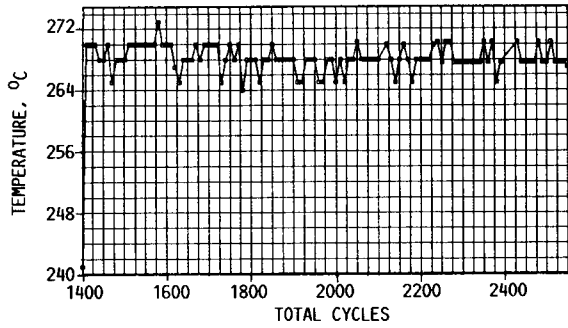
FIGURE 8. - DISCHARGE VAPORIZER TEMPERATURE.

The discharge vaporizer temperature (DVT) remained fairly constant over the entire test. From Fig. 8 it can be seen that the temperature varied approximately ± 2.5 degrees from a mean value of 268 °C during the test period after cycle 1620. The resolution of the data was not sufficient to make small flowrate changes observable. However, the slightly higher value of DVT recorded prior to cycle 1620 is significant. This higher value of DVT is due to the effect of the DKI and DKV oscillations on the main vaporizer control loop operation during this period of operation. This effect caused a higher than nominal discharge propellant flowrate.

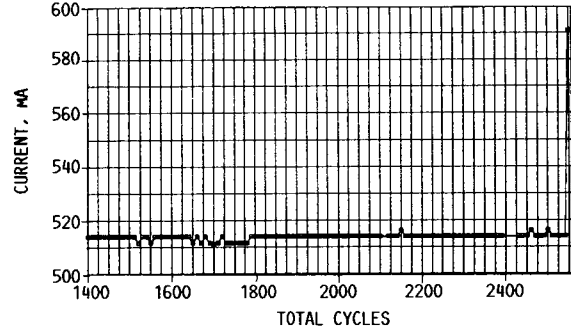
FIGURE 12. - NEUTRALIZER KEEPER CURRENT.

Figure 12 shows that the neutralizer keeper current (NKI) was maintained at the nominal 500 mA setpoint until cycle 2547. At cycle 2547 NKI was changed to the 600 mA setpoint to correct the coupling problem. At both setpoints the NKI remained constant and operated nominally.

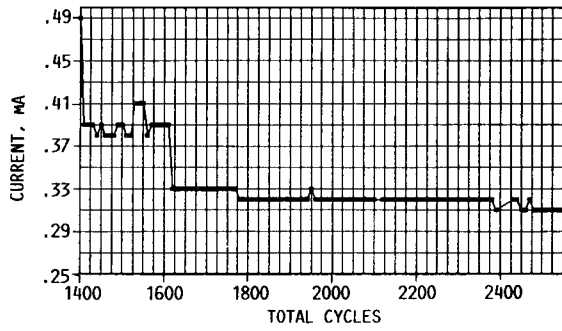
FIGURE 9. - ACCELERATOR CURRENT.

The accelerator current (ACCI) which is shown in Fig. 9 declined from 490 mA at the re-start of the test to 390 mA at cycle 1620 then to 320 mA and finally to 310 mA at the conclusion of the test. The initial reduction shows the reacquisition of the nominal thruster performance after the long period of thruster storage and facility inactivity. The decrease at cycle 1620 is due to the reduced main vaporizer flowrate that occurred when correcting the DKI oscillations (see DKI section) by increasing the DKI setpoint. The reduced flowrate improved the propellant efficiency which reduced the neutral losses and the charge exchange ion production. The further decrease in ACCI is principally due to the reduced collection area of the accelerator grid caused by erosion. It should be noted³ that a portion of the measured ACCI value is a constant facility effect arising from the contribution of back-sputtered neutrals from the frozen mercury target to the charge exchange ion production near the accelerator. Both this facility effect and the reduced propellant utilization up to cycle 1620 were major contributors to the charge exchange ion erosion of the accelerator noted at the conclusion of the test.

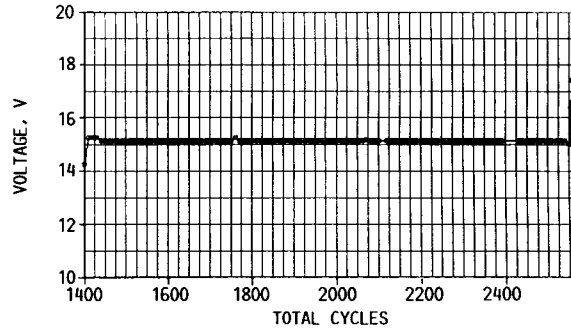
FIGURE 13. - NEUTRALIZER KEEPER VOLTAGE.

The neutralizer keeper voltage (NKV) is shown in Fig. 13. It was held constant at 15.2 V over the entire test because this value was the reference value maintained for the neutralizer vaporizer control loop. This evidently resulted in a significant decrease in the neutralizer flowrate, which is discussed in the following section. When the NKI setpoint was increased the NKV reference value was also increased to give a flowrate conducive to good coupling.

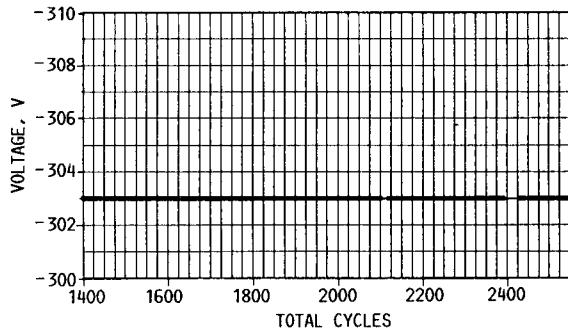
FIGURE 10. - ACCELERATOR VOLTAGE.

The accelerator voltage was -303 V and remained constant throughout the test (Fig. 10).

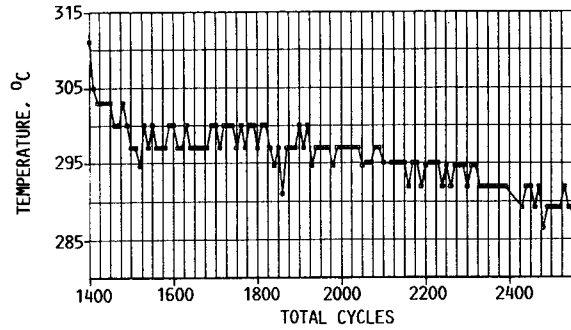
FIGURE 14. - NEUTRALIZER VAPORIZER TEMPERATURE.

The neutralizer vaporizer temperature (NVT) which is shown in Fig. 14 slowly decreased throughout the test. This resulted from a continual decrease of the NKV versus flowrate characteristic, which caused the flowrate and NVT (given the fixed reference value of NKV) to slowly decrease. The gradual decrease of the neutralizer flowrate is closely associated with the increase in the NFPV (Fig. 11). The jump in NVT at cycle 2547 was due to the deliberate change in the NKV reference value for the vaporizer control loop made when the NKI setpoint (Fig. 12) was changed. The new NKV reference value was chosen to achieve a flowrate giving good coupling.

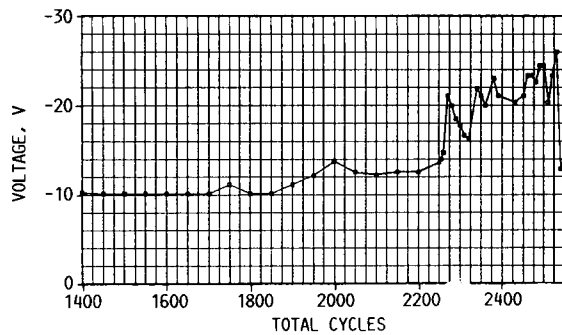
FIGURE 11. - NEUTRALIZER FLOATING POINT POTENTIAL.

Figure 11 shows the neutralizer floating point potential (NFPV) from cycle 1400 to cycle 2557.

The NFPV remained constant at -10.1 V for the first 400 cycles and then slowly began to rise. From cycle 2250 to 2533 the NFPV varied from -16 to -26 V. At cycle 2534 a loss of a liquid nitrogen supply caused a facility failure and contamination of the thruster. After the LN₂ failure the neutralizer failed to neutralize the ion beam. After re-conditioning of the neutralizer cathode and changing the neutralizer keeper current setpoint (see next section) full beam neutralization was reacquired at satisfactory floating point voltages. The process of achieving satisfactory neutralizer performance was gradual and by cycle 2557 the NFPV dropped to a value of -15.5 V. The increasing coupling voltage noted from cycle 2250 is apparently related to decreasing neutralizer flowrate (see NVT section). The coupling voltage increase was not due to an isolator leak or to the accretion of material in the keeper orifice (discussed in physical inspection section) which had been sputtered from the neutralizer tip. Both of these effects were observed in a prior durability test of an engineering model IAPS thruster (Ref. 6). Visual inspection of the thruster during operation and at the conclusion of the test showed no mass build up or aperture restriction of the neutralizer keeper orifice (see section on physical inspection).

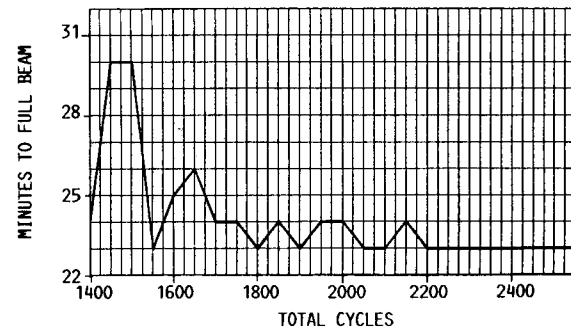
FIGURE 15. - TIME TO FULL BEAM.

Another important factor for routine thruster operation is the time required for the thruster to achieve full beam from a cold start. Figure 15 presents the startup time for this portion of the cyclic test. For the first 150 cycles (1400 to 1550) the thruster was manually cycled twice a day. This led to the thruster reaching a colder OFF cycle temperature thus causing a longer startup period. After the automatic command generator was installed and automatic cycling initiated, the startup period was 23.5 min and remained constant throughout the remainder of test. The startup time was constrained by the PEU heater supply limits.

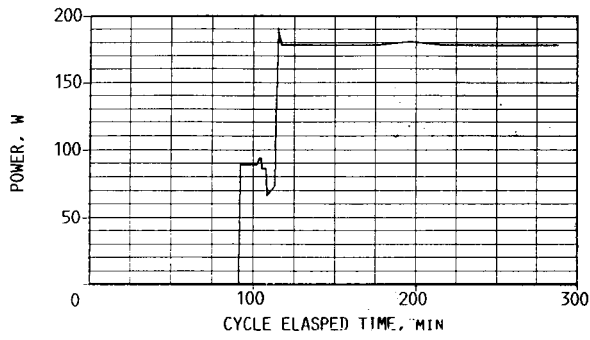
FIGURE 16. - TOTAL POWER CONSUMED.

Figure 16 shows the input power required by the PEU to run the thruster during cycle 2125. The PEU power plotted is the product of the 70 V bus current and voltage. An initial draw of 90 W is needed to heat the two vaporizer heaters and the two cathode tip heaters at nearly their maximum power settings. The discharge cathode is ignited at 103 min, the main discharge is ignited at 104 min and the neutralizer is ignited 1 min later. The main discharge is operated at high current for 5 min to further heat the thruster and aid in evaporating mercury condensed on thruster surfaces. After the neutralizer ignites the power draw drops from 95 to 65 W while the neutralizer vaporizer cools from 360 to 290 °C. After neutralizer operation has been established at the normal running conditions and the

high current operation of the main discharge has been concluded, "pre-beam" operation begins. The "pre-beam" operation elevates the discharge keeper current to 380 mA and adjusts the discharge propellant flowrate for high voltage application. After 3 min of "pre-beam" operation the high voltage is turned on and this results in a peak power draw of 189 W. The beam current control software brings the beam current up to full beam by 115 min into the cycle, or 24 min after the ON command was issued. Once the thruster is at full beam the power decreases to 178 W and remains there for the duration of the cycle.

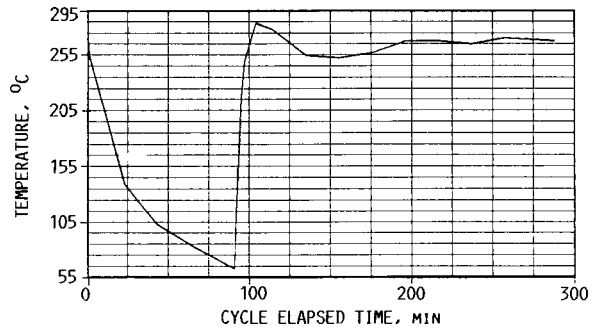
FIGURE 19. - DISCHARGE VAPORIZER TEMPERATURE.

The discharge vaporizer temperature (DVT) history during cycle 2125 is plotted in Fig. 19. As seen from the plot, the discharge vaporizer cools to 65 °C during the 90 min OFF (cooldown) period. Once the ON command is given high power is applied to the vaporizer heater and the DVT reaches the cathode starting level of 285 °C in approximately 10 min. The cathode is held at the starting level for 3 min before ignition is attempted. The cathode ignition was immediately successful (which is typical of a normal startup for this test). Following ignition and up to high voltage application (at 115 min), the DVT is controlled at near its normal running level which is a few degrees below the starting level.

After the high voltage has been applied at 115 min into the cycle and full beam is achieved the discharge vaporizer power is controlled by the software control loop. The control loop maintains a fixed reference value for the difference between the discharge voltage and the discharge keeper voltage. The drop in DVT to 251 °C during the initial full beam operation is due to the evaporation of mercury condensed in the main isolator during startup from a cold condition. Supplementary tests demonstrated that the evaporation of the condensed mercury caused the vaporizer to be automatically controlled at a correspondingly reduced flowrate. After all the condensed mercury evaporates (as seen to have occurred at approximately 200 min into the plotted cycle) the DVT rises to a running level of 267 °C. The DVT remains at this level for the remainder of the cycle.

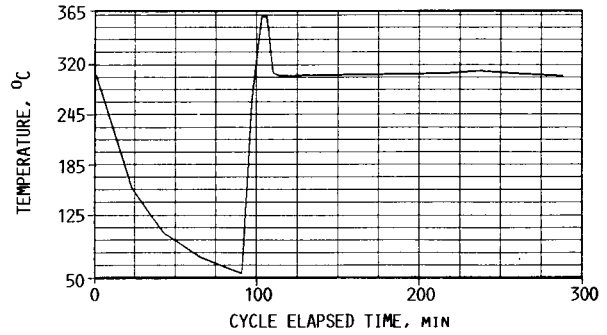
FIGURE 20. - NEUTRALIZER VAPORIZER TEMPERATURE.

The neutralizer vaporizer temperature (NVT) plotted for cycle 2125 in Fig. 20 cools down to 57 °C during the OFF period. When the ON command is given high power is applied to the neutralizer vaporizer heater and NVT rises to 364 °C within 14 min. It is then held at this level for three more minutes before ignition is attempted. The ignition was instantly successful. After neutralizer ignition,

the vaporizer is allowed to cool down to below its normal running level and the neutralizer keeper voltage is tested to assure that there is not an excessive amount of mercury vapor in the thruster. After the test is successfully completed (110 min into cycle 2125), the operation of the vaporizer is placed into closed loop control for the remainder of the cycle. This control resulted in NVT holding within a one count range of 292 to 295 °C throughout the remainder of the cycle.

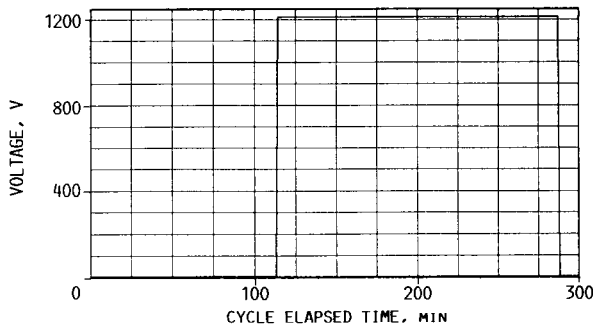
FIGURE 18. - SCREEN VOLTAGE.

The screen voltage (SV) shown in Fig. 18 rises to its fixed value of 1208 V 115 min into the cycle and remains at this level throughout the cycle.

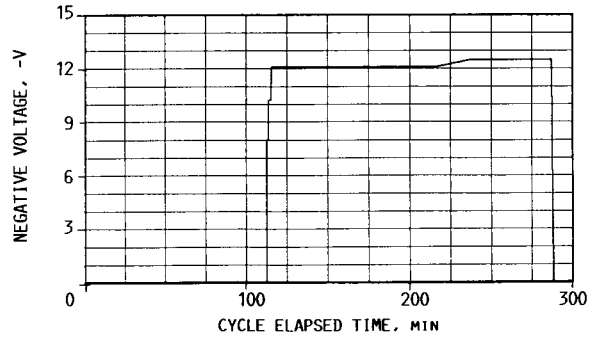
FIGURE 21. - NEUTRALIZER FLOATING POINT POTENTIAL.

The neutralizer floating point potential (NFPV) for cycle 2125 is plotted in Fig. 21. The NFPV remains at 0 V until the high voltage is applied, which occurred at 115 min into the cycle. Once the high voltage is applied the NFPV rises in steps (following the increase in beam current) until at full beam the value of NFPV is -12.1 V. Somewhat later the NFPV reached -12.5 V where it remained until the end of the cycle.

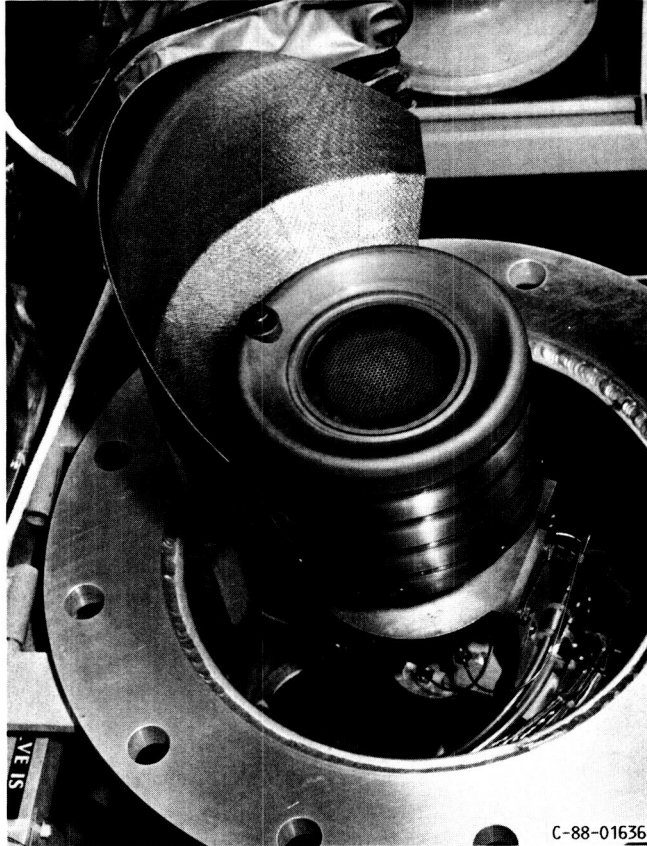
FIGURE 22. - THRUSTER-BEAM SHIELD UNIT (POST TEST).

Figure 22 shows the thruster exterior and the beam shield interior at the end of the test. The beam shield interior showed three regions (bands) of erosion/deposition. The boundaries of these bands were parallel arcs at successive downstream locations. The region at the beam shield tip was approximately 4 cm wide and showed significant net erosion. The shield thickness measured at the tip was 0.92 mm compared with its original thickness of 1.15 mm. This indicates that the shield could withstand another 25 000 hr of thruster operation at the same conditions before being completely eroded through by the high energy divergent fringing ions of the ion beam. The original 2000 Å molybdenum coating on the beam shield interior was also completely removed in the tip region. Point to point resistance measurements made in the tip region showed the high resistance of the bulk fiber-glass-epoxy composite of which the beam shield is constructed. The intermediate region visible on the beam shield interior extended back almost to the crease connecting the downstream cylindrical and the upstream conical sections of the shield (Fig. 22). This region closely resembled its original appearance and was uneroded in thickness. Since the surface resistance measurements of this region were 500 Ω, this region apparently retained a coating of molybdenum.

The upstream region visible on the beam shield interior included all of the conical mounting section. It showed net deposition of material which was significantly nonmetallic. This was evident both from its appearance and from surface resistance measurements of greater than 50 000 Ω. It is believed that this region accumulated material from the facility (such as silicone pump oil).

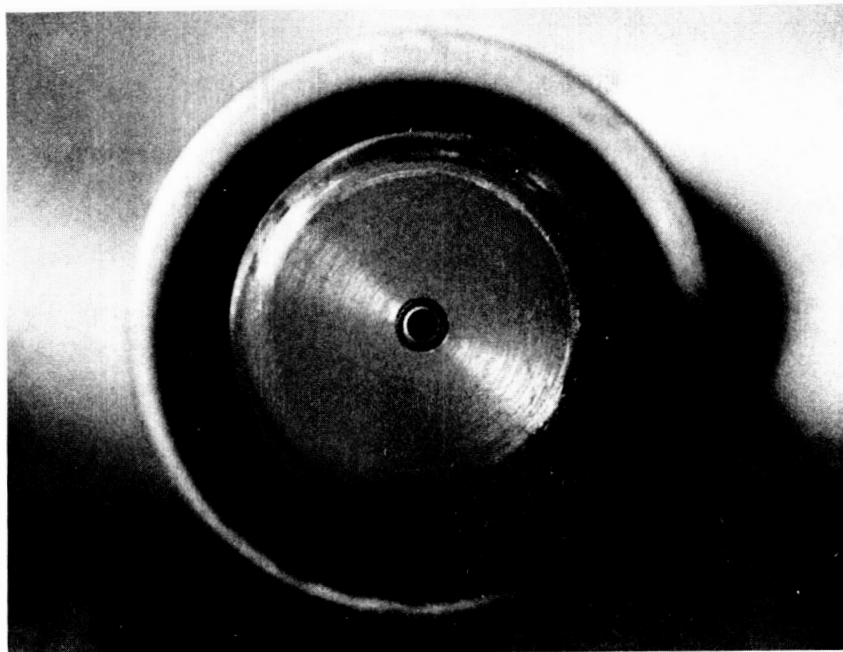
FIGURE 23. - NEUTRALIZER KEEPER CAP.

The neutralizer assembly appeared clean and free of visible deposits in the post test inspection. Figure 23 shows the enclosed neutralizer keeper cap. There was no deposition within the keeper orifice nor on the upstream or downstream surfaces adjacent to it. The absence of deposits on the upstream surface was verified by telescopic observation at an

oblique angle of the keeper orifice with the keeper discharge operating, just prior to the conclusion of the test. The keeper orifice also showed no erosion or enlargement and its diameter was unchanged from the initial value of 1.78 mm. To the extent it could be viewed through the keeper orifice, the neutralizer tip also showed no visible erosion. These observations are in substantial contrast to the post test condition of the neutralizer from the IAPS thruster life test reported in Ref. 6. That test resulted in extensive sputter erosion of the neutralizer tip, with deposition of the sputtered material in the keeper orifice and on the upstream surface around it.

Point to point resistance checks were made on the exterior surface of the tantalum neutralizer keeper cap. Resistance values were low (1 to 2 Ω) on the side surface. Near the orifice on the downstream surface the value was approximately 70 Ω and farther away from the orifice the resistance measured 150 to 200 Ω . It can be concluded from these measurements that dielectric material originating from the facility (such as silicone pump oil) had deposited on the keeper cap. The downstream surface of the keeper cap, with its full exposure to the likely sources of contaminants, would accumulate the heaviest coating of these materials. The problem of the neutralizer to neutralize the thruster beam near the end of the test may be attributed to these facility contaminants. Prior to the neutralizer coupling problem a LN₂ failure caused a shutdown with the thruster hot and allowed the facility surfaces to warm up above normal operating conditions. This failure may have caused contaminants (dielectric material e.g., silicone pump oil) to coat the keeper cap. The slow recovery of neutralization capability with operating time following the incident correlates with the slow sputter removal of the contaminant coating.

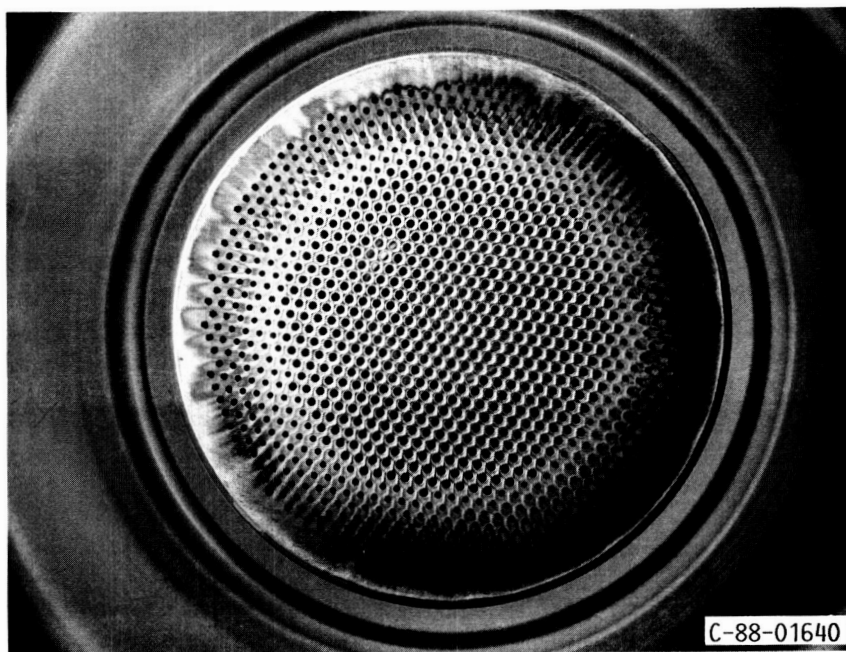
FIGURE 24. - POST TEST ACCELERATOR GRID.

The accelerator grid downstream surface, seen in Fig. 24, showed substantial charge exchange erosion. This was concentrated in the central region of the grid and showed the normal pattern of a triangular pit in the webbing between each grouping of 3 grid holes. None of the pits was observed to have penetrated through the 0.51 mm thickness of the grid. The deepest pits were judged to be more than half way through the grid. The causes of the prominent charge exchange erosion are the same as those for the high accelerator drain current observed during the test and have been previously discussed.

Moderate ion beamlet impingement erosion of the accelerator grid holes was observed. The central region holes, originally 1.14 mm in diameter, were found to be between 1.17 and 1.27 mm with one hole near the center measured as 1.31 mm in diameter. The outer region holes, originally 0.89 mm in diameter, were all found to be greater than 0.91 mm. Most were 0.94 mm in diameter with the innermost ring of these holes measuring 0.97 mm in diameter. The peripheral holes of the outside region experienced some nonsymmetric ion beamlet milling. This is generally observed in the operation of 8-cm mercury ion thrusters and is attributable to the nonsymmetric repulsion of the ion beamlets of the outer holes by the beamlets of the surrounding inner holes. Overall, the increase in the total accelerator open area due to the impingement erosion over the entire life test operation of the thruster is estimated to be 17 percent.

Only rudimentary observations could be made of the thruster discharge chamber through the accelerator grid (Fig. 24). From these observations it was established that there were no loose flakes of material in the chamber and no prominent erosion or deposition on any visible surface. The visible components were the baffle, the cathode pole piece,

and to a limited extent the upstream endplate of the chamber. The discharge cathode and the anode could not be observed without disassembling the grids.
