NASA Technical Memorandum 100938

As-Received Microstructure of a SiC/Ti-15-3 Composite

Bradley A. Lerch and David R. Hull
National Aeronautics and Space Administration
Lewis Research Center
Cleveland, Ohio

AS-RECEIVED MICROSTRUCTURE OF A SiC/Ti-15-3 COMPOSITE

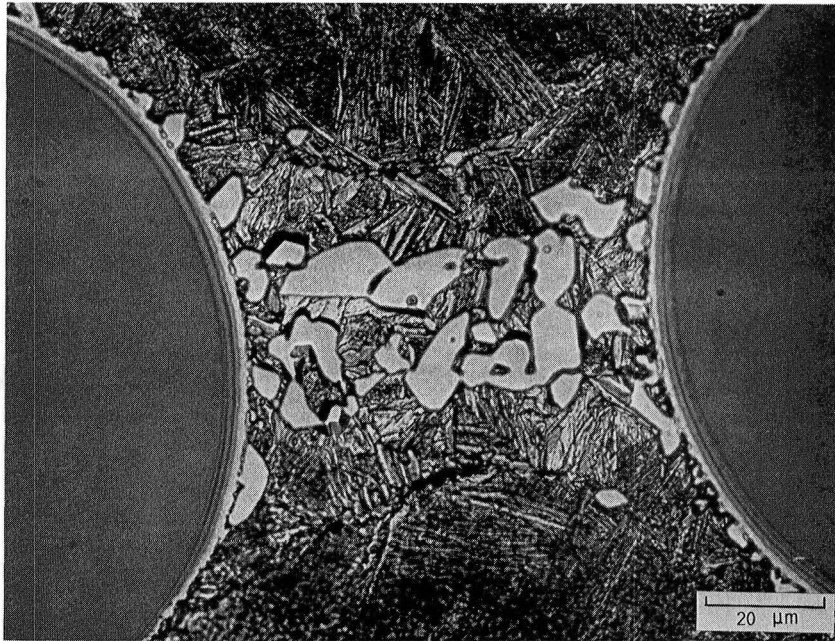
FIGURE 6. - LARGE, WHITE PARTICLES OF TiC AND α - β LAMELLAR STRUCTURE FORMED FROM Ti WIRE WOVEN BETWEEN FIBERS PRIOR TO CONSOLIDATION (SPECIMEN POLISHED AND ETCHED).

approximately 5-mm intervals along the fiber length to keep the fibers parallel during fabrication. The large white particles in figure 6 were a result of this reaction. Chemically analyzed with the SEM and found to be high in Ti and C, these particles are probably TiC. The solubility of C in Ti is very low (ref. 10), and therefore little C is required to form these particles. The small particles between the laminae (fig. 5) are also suspected to be TiC as determined by their color due to interference layering.

In the matrix between the woven carbides was a coarse lamellar structure. Since no major compositional differences were observed between the two lamellar phases, this structure is believed to be α - β Ti. The coarse lamellae are reportedly a result of very slow cooling (ref. 10). Surrounding the woven carbides was a dark phase (fig. 3). Elemental analysis indicated this area to be lean in V, Al, Cr, and Sn, but rich in Ti compared to the matrix. No other differences were observed between the matrix and this phase. On the basis of the chemical analysis and its appearance, the dark area is believed to be the β' -phase. The β' -phase is a solute lean, coherent, bcc zone which forms where precipitation of the α -phase is sluggish (ref. 11). It has been observed in several β -Ti-alloys (refs. 11 to 13).

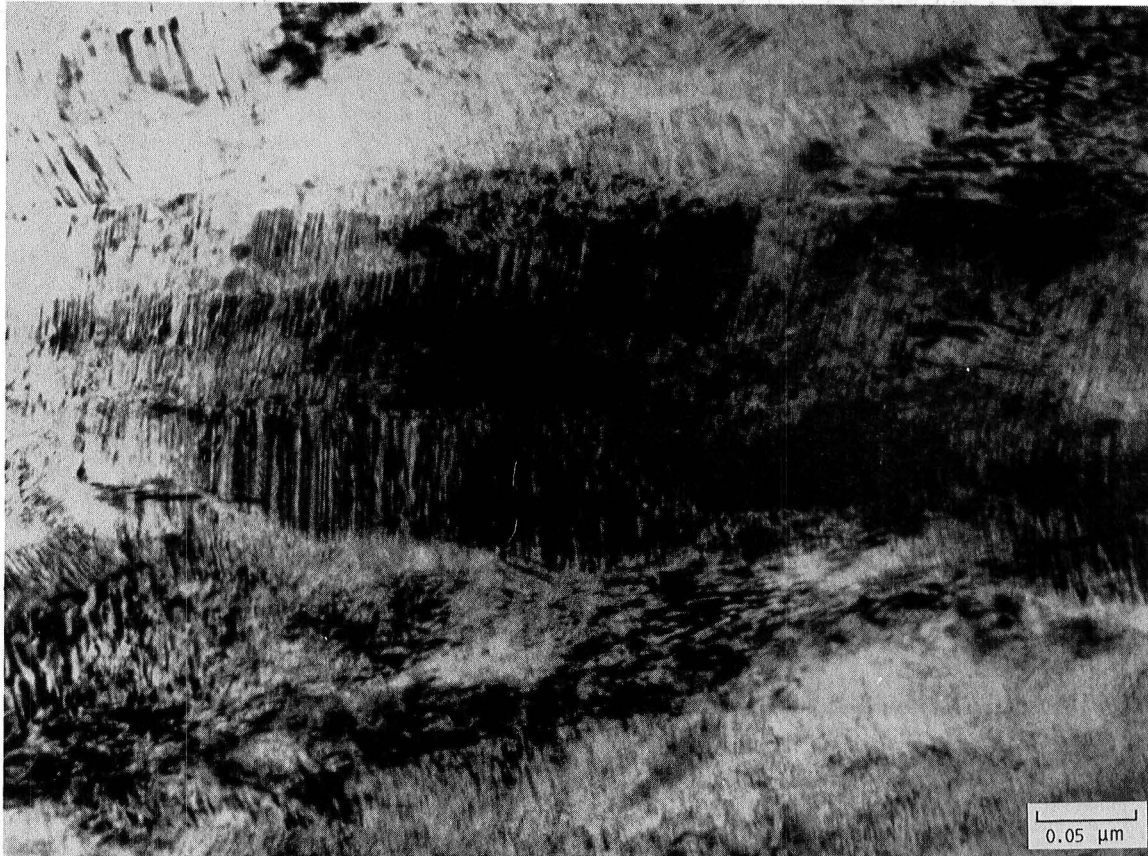
(A) LARGE, ELONGATED GRAINS CONTAINING STACKING FAULTS.

(B) DIFFRACTION PATTERN OF AREA IN FIGURE 9(A).

FIGURE 9. - TRANSMISSION ELECTRON MICROSCOPE (TEM) MICROGRAPH OF LARGE-GRAINED SiC (REGION 4) AND DIFFRACTION PATTERN.

Fiber. - The SiC (SCS-6) fiber was manufactured by Avco Specialty Metals Division. It was produced by a chemical vapor deposition (CVD) process which has been described elsewhere (refs. 3 and 4). The fiber is a complex, multi-layered structure (fig. 7), which starts as a $33\text{-}\mu\text{m}$ -diameter carbon monofilament at the center of the fiber (region 1). A pyrolytic carbon coating was deposited on the carbon core (ref. 3) up to a thickness of $1.5\ \mu\text{m}$ (region 2). This coating consists of feathery grains, which are elongated in the radial, or growth, direction. Silicon carbide is deposited upon this substrate. At the interface of the pyrolytic carbon coating and the SiC (fig. 8), the SiC forms first as small equiaxed crystallites having a diameter of $\sim 0.03\ \mu\text{m}$. As the SiC grows, the grains become elongated (fig. 8) in the radial direction (region 3). At $21\ \mu\text{m}$ from the pyrolytic coating, there is a change in structure (fig. 7). At this point the SiC grain diameter increases by about a factor of three (region 4). From this transition to the outer radius of the SiC, the fiber consists of large elongated grains, as shown in the TEM image in figure 9(a). The grains are heavily faulted, and this gives rise to streaks in the corresponding electron diffraction pattern (fig. 9(b)). Also shown in the diffraction pattern is an asterism, which is indicative of slight misorientations between the grains. The $\{111\}$ diffraction spots are parallel to the growth direction, and the asterism in these spots indicates that not all grains have

The fiber is composed of the β -SiC phase (refs. 3 to 5) which has a face-centered cubic (fcc) crystal structure (ref. 14). A detailed description of this structure is given in refs. 4 and 5, and only a few pertinent details will be mentioned here. The grains have a preferential growth direction of $\langle 111 \rangle$ (figs. 9 and 10), which is parallel to the long dimension of the grain. However, the grains are not all perfectly parallel. The slight misorientation gives rise to an asterism in the $\{111\}$ diffraction spots, as depicted in figure 9(b). The lines running perpendicular to the growth direction are stacking faults (refs. 4, 5, 14, and 15). In the dark field image in figure 10(a) the grain normal is parallel to an $[011]$ direction, and the faults are observed edge-on (ref. 5). Disturbances in the stacking sequence give rise to the various streaks shown in the diffraction patterns in figures 9(b) and 10(b).

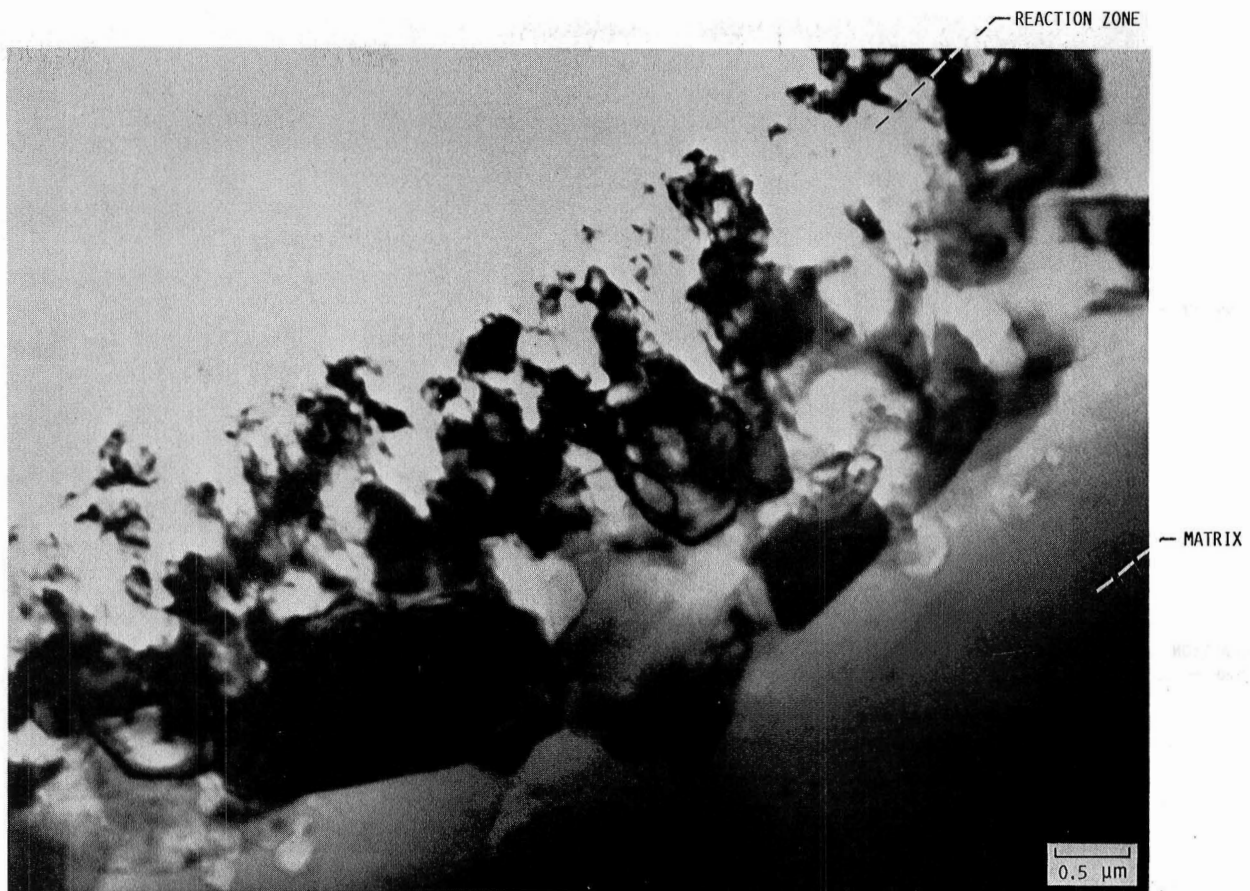
(A) SMALL CRYSTALLITES WITHIN REACTION ZONE.

(B) COMPLEX DIFFRACTION PATTERN OF REACTION ZONE AS A RESULT OF VARIOUS ORIENTATIONS AND CRYSTAL STRUCTURES OF MINUTE GRAINS.

FIGURE 14. - TEM MICROGRAPH OF REACTION ZONE (REGION 6) AND DIFFRACTION PATTERN.

A reaction (region 6) formed at the interface between zone IV and the titanium matrix. This reaction zone had a thickness of 0.10 to 0.35 μm . Its distance from the outer diameter of the SiC varied greatly, probably depending on the original roughness of the zone IV coating. The reaction zone was composed of tiny crystallites having dimensions on the order of 0.01 to 0.2 μm (fig. 14(a)), which gave rise to a very complex diffraction pattern (fig. 14(b)). Smaller crystallites were located at the coating side of the reaction zone, while larger, more widely separated particles were observed on the matrix side. A dark field micrograph imaged with a diffraction spot from a particle at the coating side of the reaction zone is shown in figure 15. The

The reaction zone consisted of small crystallites, those next to the carbon coating having 0.01- μm diameters and those adjacent to the matrix having 0.1- to 0.2- μm diameters. The reaction zone is not a continuous layer or film as suggested by the SEM and optical micrographs (figs. 7 and 16). Because of the fineness of the particles, several of them were analyzed within the selected area aperture at one time. This yielded a diffraction pattern such as that observed in figure 14(b). A multitude of spots present as a result of numerous grain orientations and various crystal structures made identification of the particles impossible by conventional diffraction techniques. An accurate identification of the particles could only be done with convergent beam microscopy in which the beam could be focused to 0.04 μm . However, analysis of this type is extremely time consuming and was not deemed worthwhile for the present study.
