NASA Technical Memorandum 100950

Component Improvement of Free-Piston Stirling Engine Key Technology for Space Power

Donald L. Alger
Lewis Research Center
Cleveland, Ohio

Prepared for the
4th International Conference on Stirling Engines
sponsored by the Japan Society of Mechanical Engineers
Tokyo, Japan, November 7-10, 1988

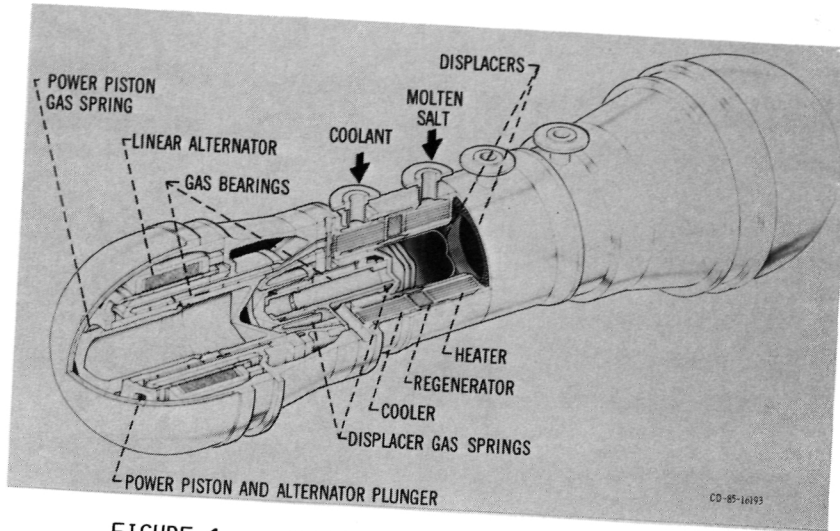
FIGURE 1. - SPACE POWER DEMONSTRATOR ENGINE.

A description of the SPD engine, and details of engine testing, have been reported elsewhere (1,2). The SPD engine, as shown in the cut-a-way drawing of Fig. 1, is actually two free-piston Stirling engine/alternators constructed in an axially opposed configuration. A brief listing of the engine's nominal characteristics is given in Table I.

The SPD engine's heat exchanger assembly, as shown in Figs. 1 and 8, consists of one unit which houses the heaters, regenerators and coolers of both engines. The region between the heaters defines the common expansion space for the two opposed engines. The entire assembly, including the tube plates and tubes, was fabricated of Inconel 718 alloy. The assembly, except the tubes was E-beam welded together. During welding, the E-beam welding parameters required careful definition in order to minimize the formation of microcracks in the heat-affected-zone of each E-beam weld. This was accomplished by welding numerous samples, having the same geometrical configuration and thickness as the actual heat exchanger part, followed by metallurgical evaluation of the samples for the existence of microcracks.

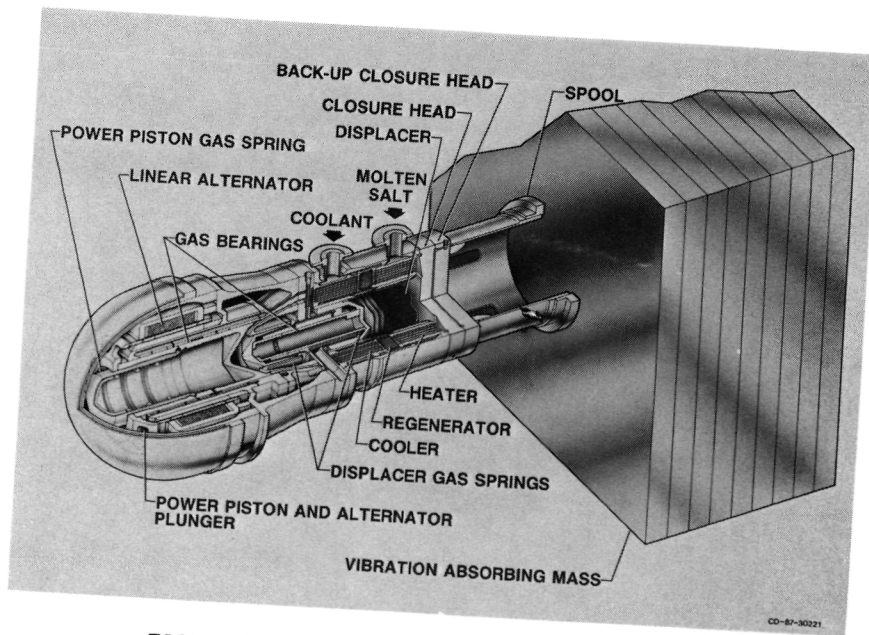
FIGURE 2. - SPACE POWER RESEARCH ENGINE.

It was decided that component technological development could be carried out more efficiently by cutting the SPD engine into two pieces to produce two half-SPD engines. With the addition of closure hardware to complete the pressure vessel of each half-SPD engine, the engine halves were renamed Space Power Research (SPR) engines. One such engine is shown in Fig. 2. The SPR engines are unbalanced engines that are either attached to a large mass or to a vibration absorber to reduce the vibration amplitude of the engine casing to an acceptable level.

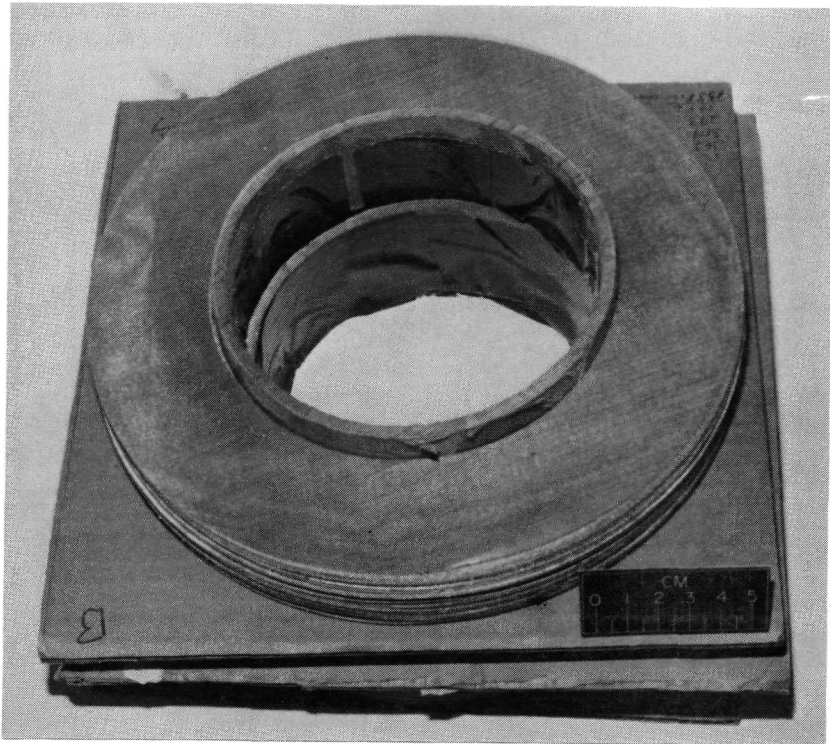
FIGURE 3. - STACK OF 350 TYPE 304 STAINLESS STEEL
REGENERATOR SCREENS.

The regenerator matrix for each of the two regenerators of the SPD engine is made up of a stack of 350 annular shaped, 200 mesh, woven screens with a wire thickness of 41 μm , or a screen crossover nominal thickness of 82 μm (Fig. 3). The screens fill a regenerator length of about 2.54 cm.

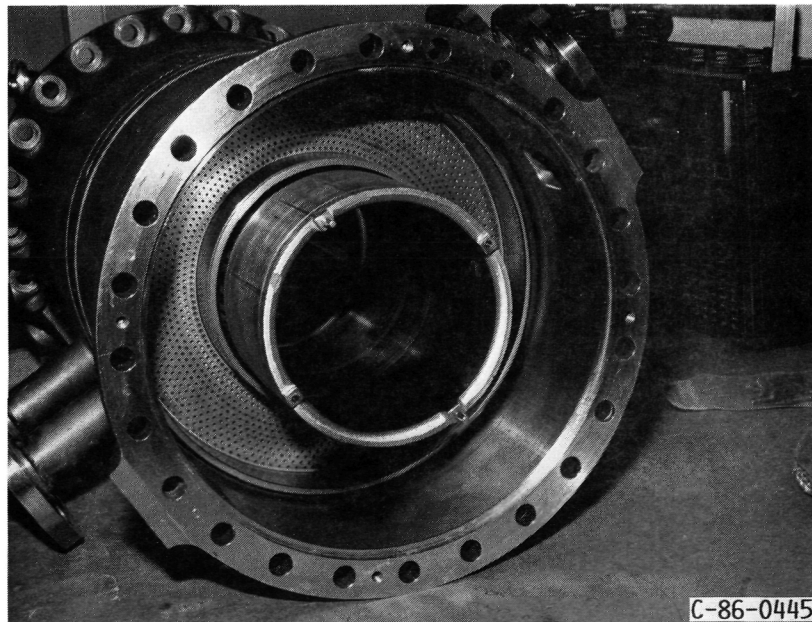
FIGURE 4. - DISASSEMBLED ENGINE SHOWING ANNULAR SPACE AT
BASE OF HEATER WHERE REGENERATOR SCREENS ARE LOCATED.

The loose regenerator screens were installed into the base of the heater, as shown in Fig. 4. The cooler assembly, shown in Fig. 5, was then slid into place at the base of the screens and was supposed to compress the loose screens tightly together. Unfortunately, the initial batch of screens had been subjected to a light cold-roll process after the wire weaving process. The rolling process has reduced each screen thickness, at the crossovers, by 20 percent. The effect of the cold-roll process can be seen in the scanning electron micrograph of the "as received" screen shown in Fig. 6. These dimensional changes were not detected prior to engine operation, allowing the screens to move freely within the regenerator cavity.

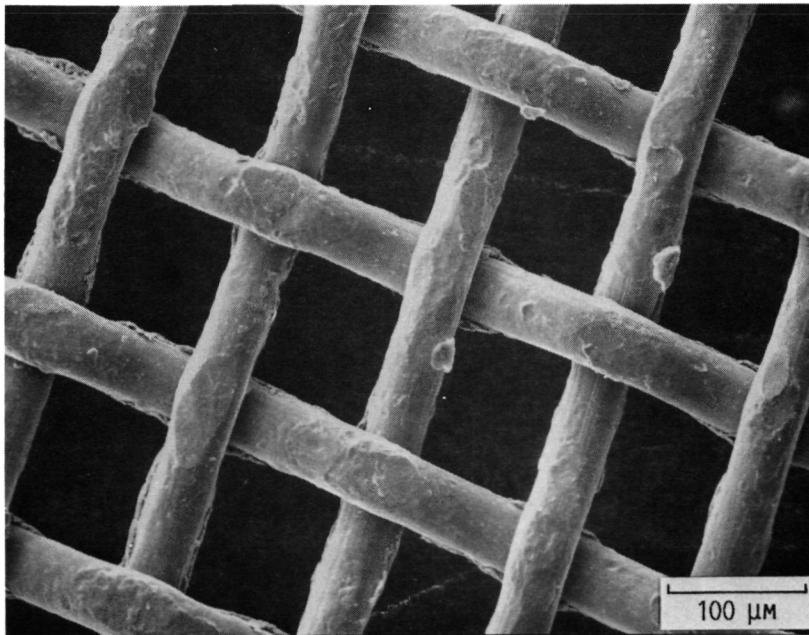
FIGURE 6. - SCANNING ELECTRON MICROGRAPH OF "AS-RECEIVED"
REGENERATOR SCREEN.

After more than 75 hr of operation, the engine was shut down for routine inspection. Screen debris was found throughout the engine. Metallurgical analysis of the debris determined it to be cracked-off-deformed pieces of the 304 stainless steel regenerator screen. Scanning electron microscopy of the cracked screens revealed failures occurring at wire crossovers (Fig. 7) and fatigue striations on the fracture surface of the wires. It was determined that failure of the screens occurred at wire crossovers where there were; a 30 percent reduction of wire thickness, stress concentration, and a highly worked microstructure, all of which provided a site for crack initiation and subsequent fatigue failure. Details of the regenerator matrix failure are reported in Ref. 4.

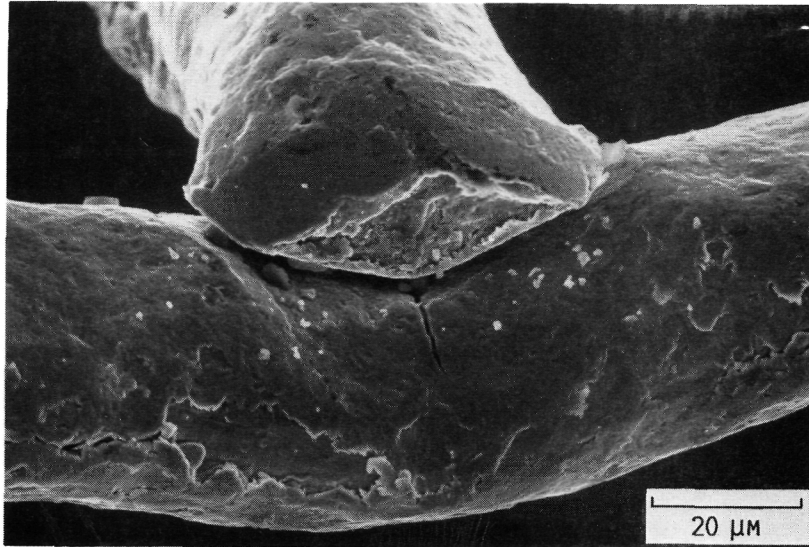
FIGURE 7. - SCANNING ELECTRON MICROGRAPH OF WIRE FRACTURE
AT CROSSOVER.

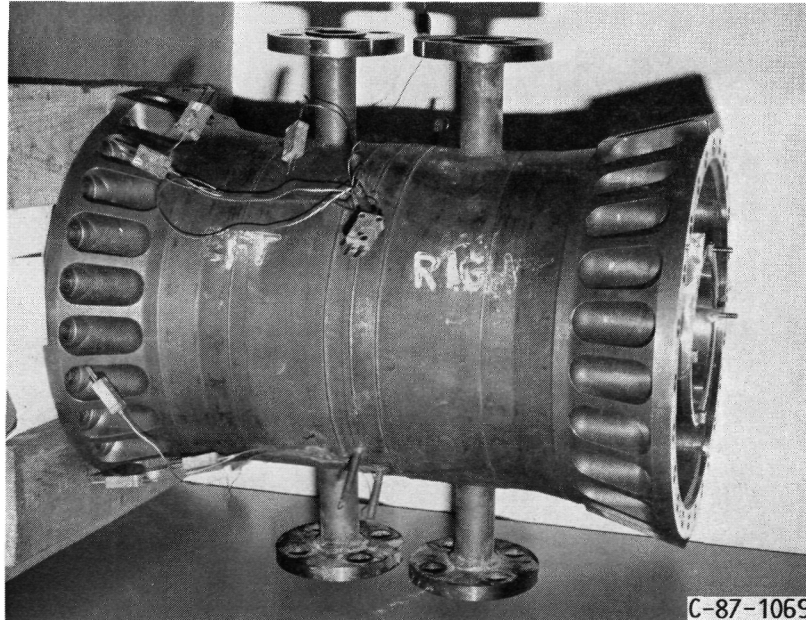
FIGURE 8. - SPD ENGINE'S HEAT EXCHANGER HOUSING.

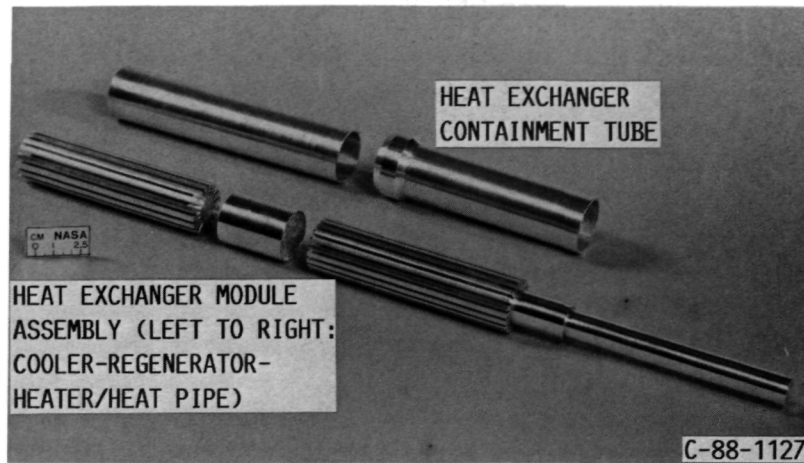
FIGURE 9. - STIRLING MODULAR HEAT EXCHANGER ASSEMBLY.

In the design of the modular type of heater shown in Fig. 9, the material chosen to fabricate the module must provide the creep-rupture strength required for long life in space and, at the same time, have a reasonable thermal conductivity in order to minimize the temperature drop across the heat pipe wall. A cross-section of a typical module showing the helium flow passageways and the heat pipe wall is shown in Fig. 10.

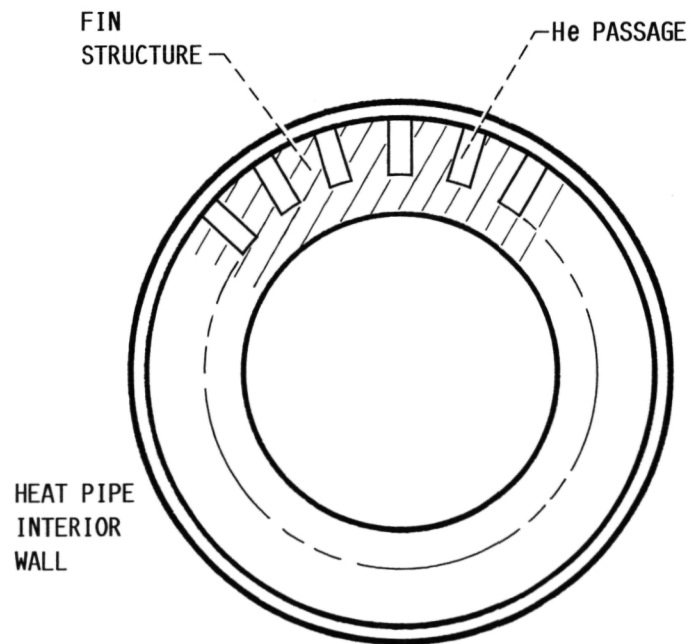
FIGURE 10. - CROSS SECTION OF MODULAR HEATER.

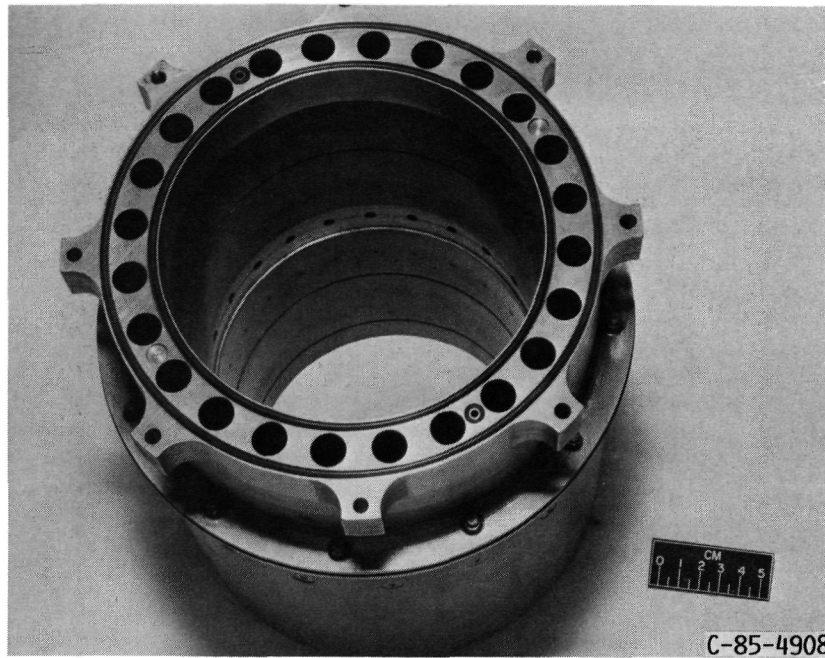
FIGURE 11. - SPD ENGINE'S CYLINDER SHOWING BEARING ORIFICES.

The SPD engine was designed to operate at a 20 mm stroke. Hydrostatic gas bearings were used to support the piston and displacer, but the bearing system was not designed for part-stroke operation. Gas for the bearing system was designed to be pumped from the piston gas springs by an integral ported compressor. A bearing manifold pressure of 5 to 7 bar was required for effective support of the piston and displacer at full piston stroke. The bearing gas was manifolded through passageways in the cylinder wall to orifices through the walls of the piston and displacer cylinders. This flow of helium established the gas bearings for support of the piston and displacer. The orifices can be seen in the power piston cylinder shown in Fig. 11.
