EXPERIENCE WITH DUPLEX BEARINGS
IN NARROW ANGLE OSCILLATING APPLICATIONS

D.D. Phinney,* C.L. Pollard,* and J.T. Hinricks*

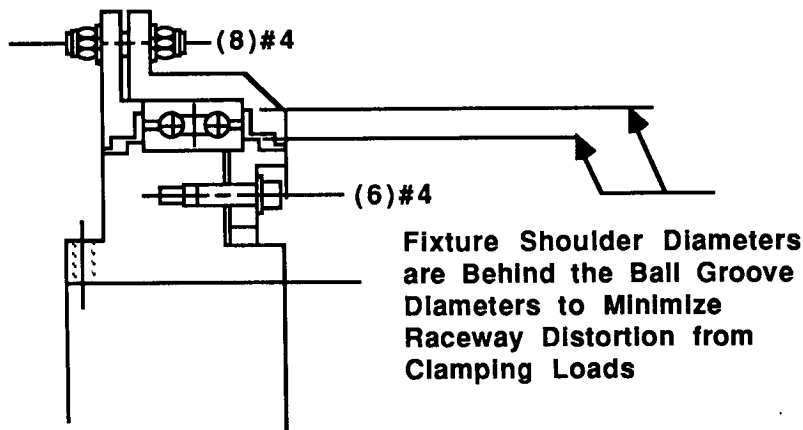
Figure 1. Life test bearing sets were mounted in steel cartridges with plates clamping the races.

Bearing sets were installed in the test cartridges shown in Figure 1. As the hub and housing were dimensioned, inner ring fits varied from line-to-line to 0.0125 mm (0.5 mil) loose; outer rings varied from 0.0025 to 0.015 mm (0.1 to 0.6 mil) loose. Deliberate gaps at the flanges of the inner and outer race clamp plates were provided to assure positive clamping. As shown in Figure 1, contact surfaces between the plates and bearing rings were located behind the raceway grooves to minimize race distortion from clamping force. The bearing mounts were made of cold rolled steel and were electroless nickel plated, except for the bearing mounting diameters. These diameters were specified for 0.4 μm (16 $\mu\text{in.}$) surface finishes.

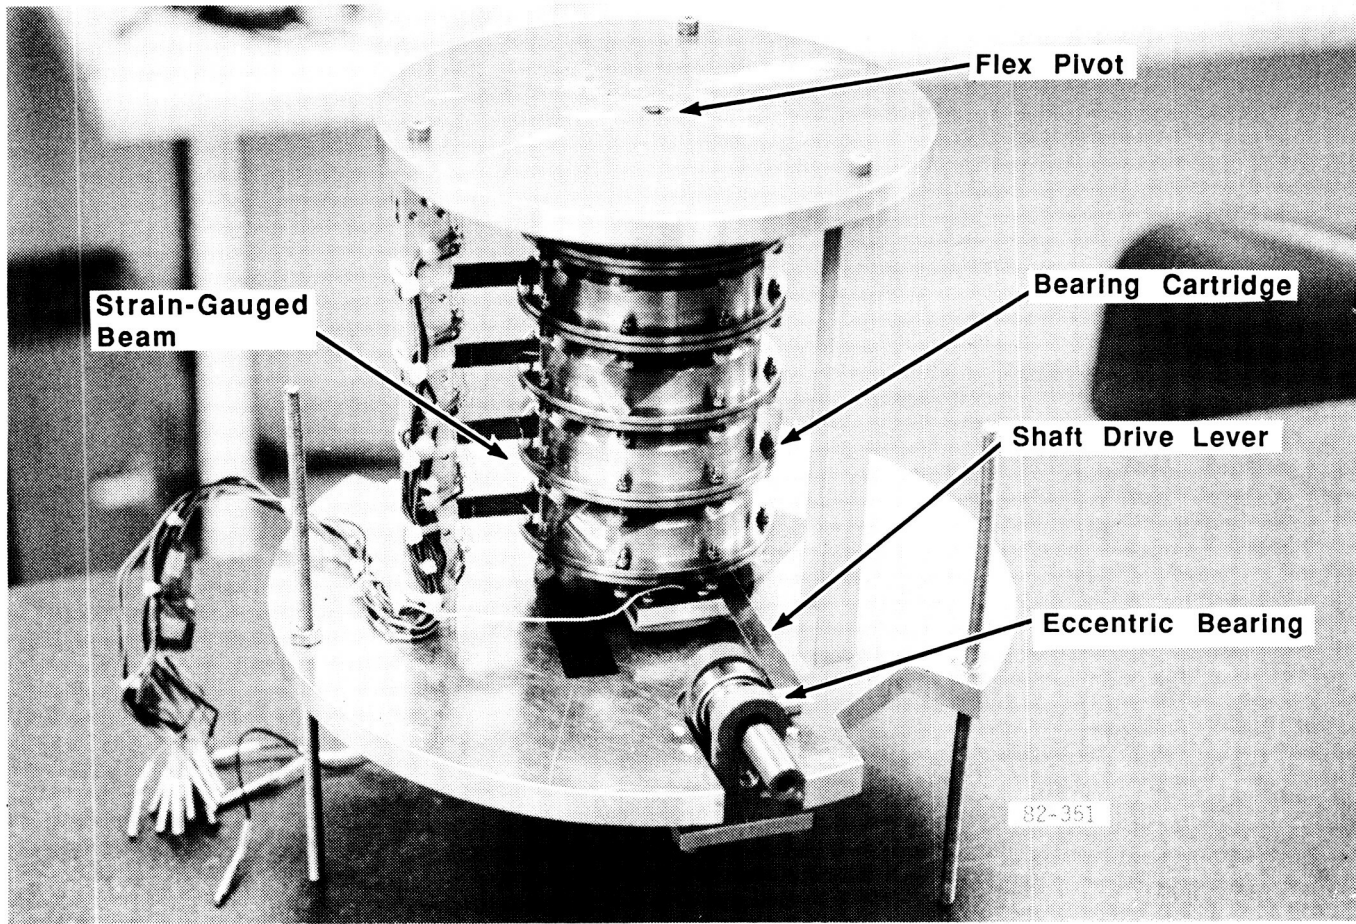
Figure 2. Five life test cartridges were mounted on a common shaft, oscillated by a lever and bearing on an eccentric. Strain-gauged beams measured bearing torque.

Figure 2 shows the test assembly before installation in the vacuum chamber. The five test cartridges were mounted on a single 25.4 mm steel shaft suspended top and bottom on Bendix flexures. The shaft was oscillated by a lever which was driven by a small bearing. This bearing was on an eccentric so that ± 0.3 deg (0.6 deg total) of test cartridge oscillation occurred with each rotation of the eccentric shaft. The eccentric shaft was mounted on dry-lubed ball bearings inside the vacuum chamber and driven from outside with a magnetic feedthrough.

Test bearing torque was determined by strain gauged steel cantilever beams, which gave a torque sensitivity of 0.007N (0.025 oz-in.) or better. Angular displacement was measured with a Spectrol conductive film potentiometer.

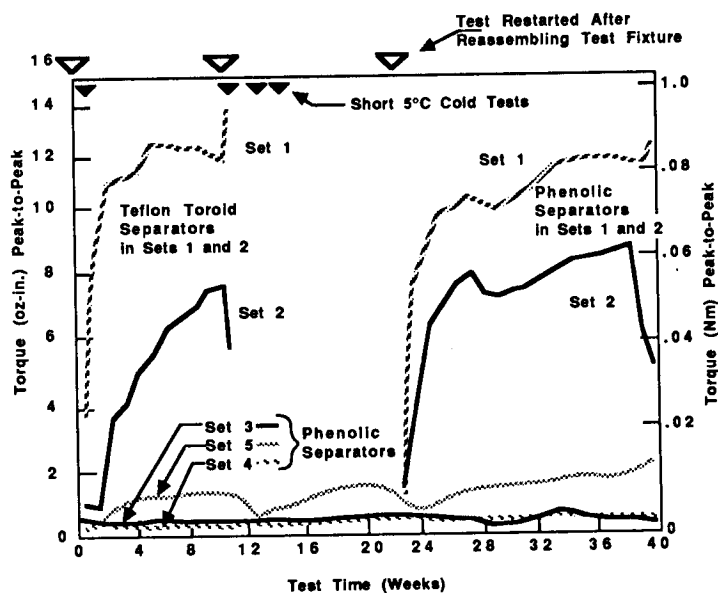
Figure 3. Two bearing sets were perfect through the entire 39.5-week test. The other three developed blocking.

The bearings were then subjected to a test that lasted 39.5 weeks. Figure 3 shows the torque behavior of the five bearing pairs during this 39.5-week test. Torque is the peak-to-peak amplitude during a representative oscillating cycle of ± 0.3 deg. Bearing sets 3 and 4 behaved properly throughout the test and ran at approximately .0035 Nm (0.5 oz-in.) or less. Set 5 torque gradually climbed away from its low limit each time the setup was opened and restarted, finally finishing with a 4x increase. Sets 1 and 2 quickly developed very high torques. Torque increases in Sets 1, 2, and 5 were eventually attributed to blocking. Blocking occurs if some of the bearing balls jam into the ends of the separator pockets as a result of creeping away from their centered positions. Reference 2 contains a more complete discussion of this phenomenon, as well as recommendations for preventing it. Coincidentally, Reference 2 was issued the same month (May 1981) the 39.5-week test started, and was a great help to us in understanding the results.

The 39.5-week test was interrupted twice for Sets 1 and 2. These bearings were taken out in the tenth week and examined with great care. Neither lubricant degradation nor contaminant buildups could be detected. They were cleaned, rebuilt with phenolic separators, relubed, and returned to testing in the 23rd week. Their performance repeated almost exactly that obtained with Teflon separators. Later in this paper, we discuss our analysis of one of these bearing sets and the corrective action taken.

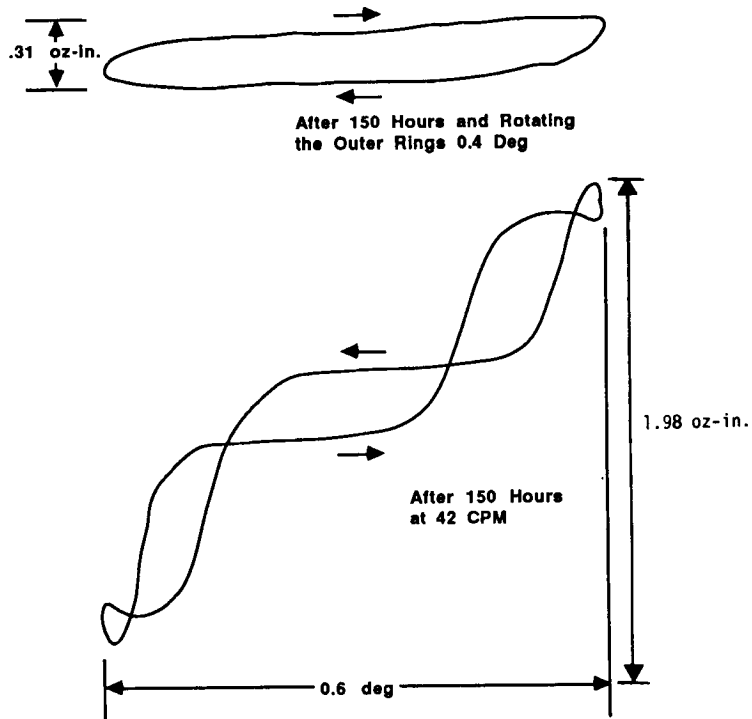
Figure 4. After 150 hours, Set 3 had developed a high, irregular torque that was corrected by moving ball contacts to new locations on the raceways.

When the fixture was first operated in the vacuum chamber, all bearing sets showed increasing torque with time. At 151 hours, the test was interrupted with set 3 showing the highly irregular hysteresis loop of Figure 4. This loop was drawn using an X-Y plotter with shaft position (potentiometer output) on the X-axis and torque on the Y. When the outer race was rotated just enough to relocate the ball contacts away from their initial position, the regular and low-torque upper loop of Figure 4 was produced.

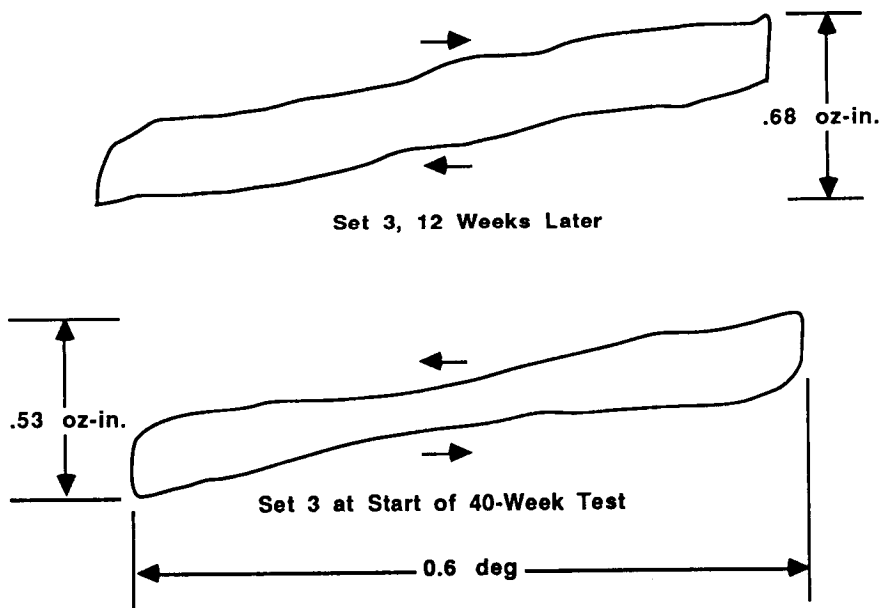
Figure 5. After cleaning, Set 3 shows smooth hysteresis loops when the 39.5-week test started, and 12 weeks later.

Figure 5 shows a hysteresis loop from Set 3 when the test was restarted, and one of the last loops taken 12 weeks later. Torques are low and quite smooth. Although no other hysteresis loops were taken during the last 22 weeks of the test, it is safe to infer from the low constant torque for Set 3 (shown in Figure 3) that loops at the end of the test would have been similar.

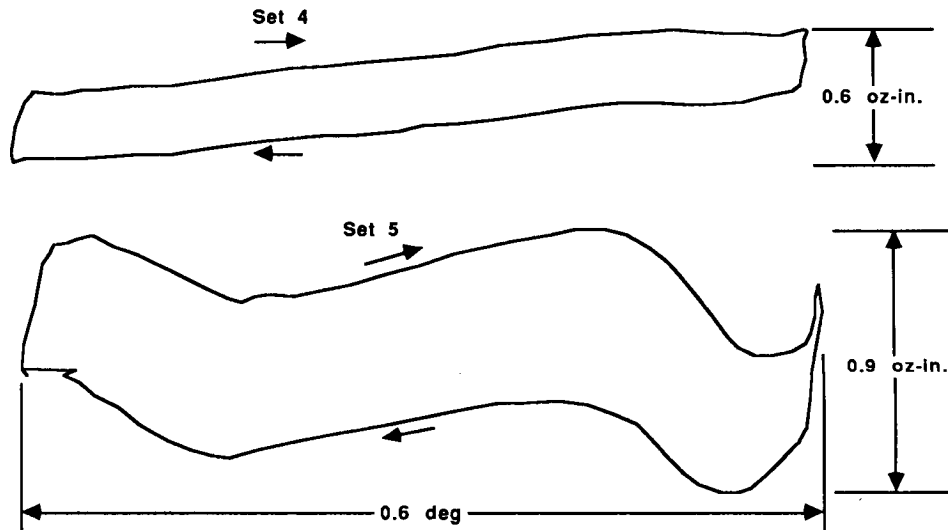
Figure 6. After 12 weeks, Set 5, which had higher torque during most of the test, shows an irregular hysteresis loop, while Set 4 is very smooth.

Set 5, which also ran the full test but at up to 4x the torque of the good sets, displayed irregular hysteresis loops (Figure 6). A Set 4 loop taken the same day is shown for comparison. The reason for the difference was never determined. No hysteresis loops were made for Sets 1 and 2 during the 39.5-week test.

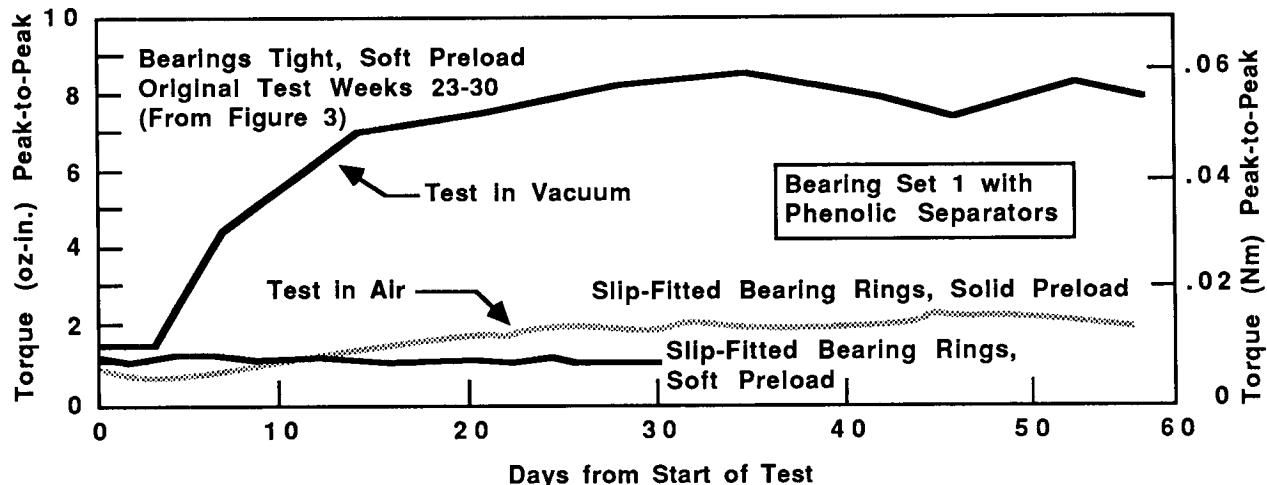
Figure 7. When Set 1 bearings were made slightly loose in their test fixture, torque dropped to 0.007 Nm (1 oz-in.) and was constant for 30 days. With solid preload and slipfits, torque increased from 0.007 to 0.014 Nm in 25 days and then stabilized.

disturbing or rotating the bearings. Figure 7 shows the torques during these two tests as well as the torque for 51 days of the original test with phenolic separators (from Figure 3). Opening up the race fits caused the maximum torque to drop from 0.06 to 0.014 Nm with the solid preload, but a two-fold increase with operation still occurred. Soft preloading restored the initial 0.007 Nm torque level that existed at the start of the solid preload test, and this torque was essentially constant for 1.8 million cycles.

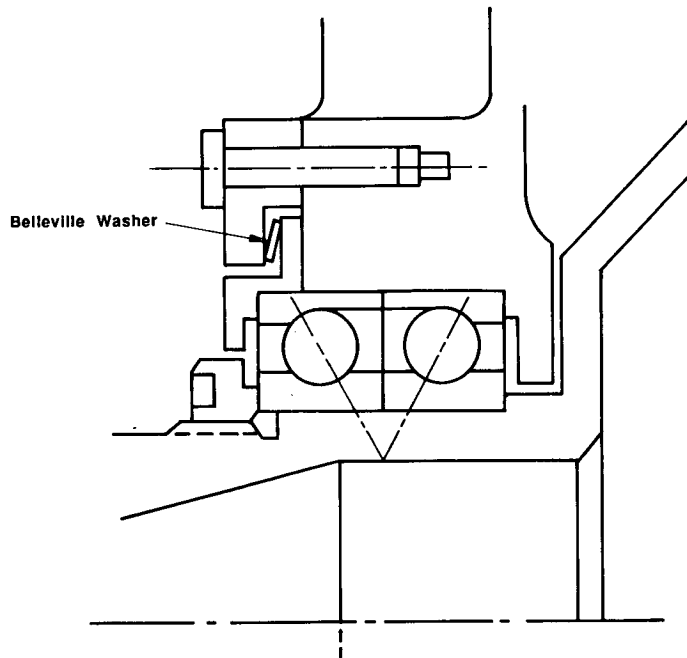
Figure 8. The initial gimbal design used Belleville washers to provide soft preload on its duplex bearings.

The original concept for mounting the inner axis duplex pair bearings is shown in Figure 8. Belleville washers were used to provide a soft preload. This design was abandoned when it was determined that the bearing outer ring fits could not be loose (in order to meet axis perpendicularity specifications). Slip fits are necessary for the Belleville to be able to restore the bearings to the preloaded condition after vibration.

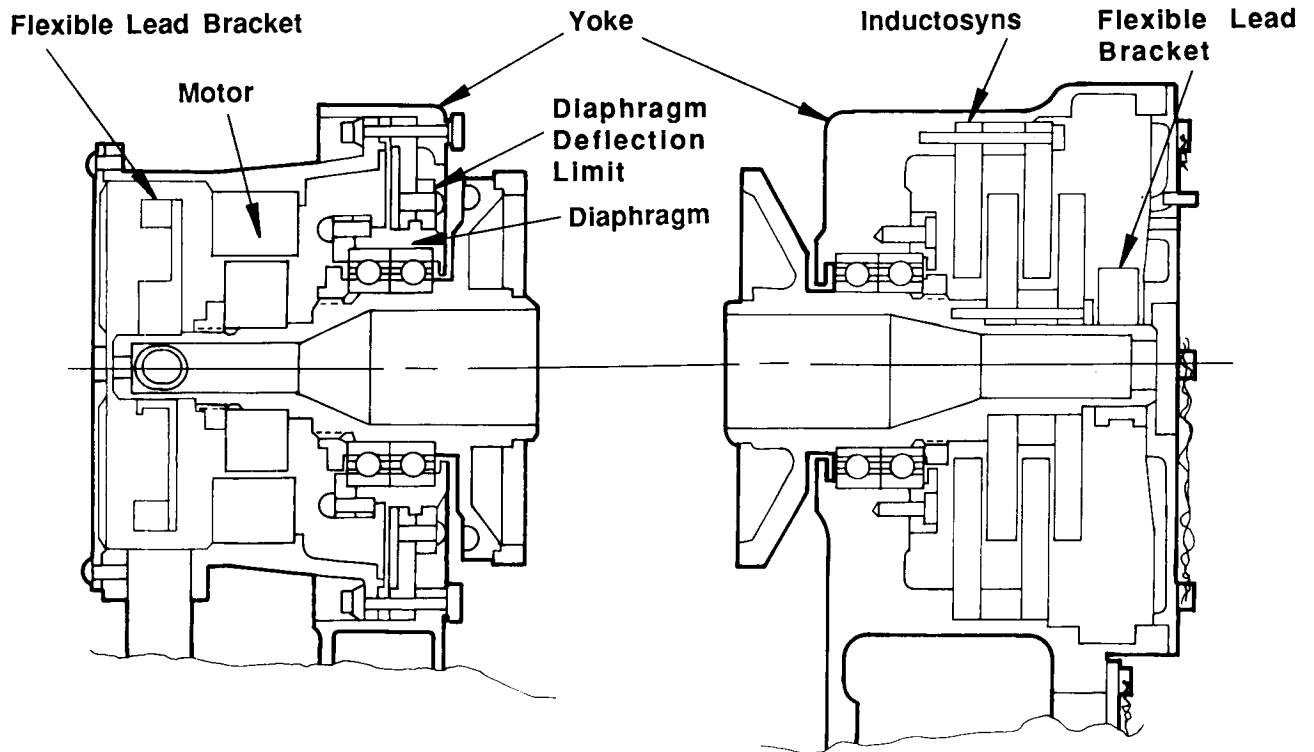
Figure 9. Final configuration of inner axis driveline components. Soft preloading of the duplex bearings could not be used.

The final configuration for inner axis driveline components is shown in Figure 9. A payload mass-simulator connects the two shaft hubs during BASD tests. The bearing seats are match-machined to each bearing pair to provide a 0.0025 mm slip to 0.0025 mm press fit on the diameter. This close fit is not ideal from the blocking standpoint, but was felt to be the best possible compromise. The gap between the outer race retaining ring and housing is shimmed to 0.025 mm maximum when the bearing outer races are just brought into contact with each other, making clamping force on the races independent of torque on the clamping screws. We experienced no problems with bearing race distortion by the large nuts used as inner race retainers. The bearings are ABEC 7 with nominal raceway conformities of 0.549 outer and 0.528 inner. Outer race conformity is more open than usual, in keeping with a life test conclusion. The shafts, diaphragm, and yoke are titanium 6AL-4V. Bearings are lubricated with BASD 36234 oil, which has such a low outgassing rate that reservoirs are not required when closures, as shown with barrier film, are provided.

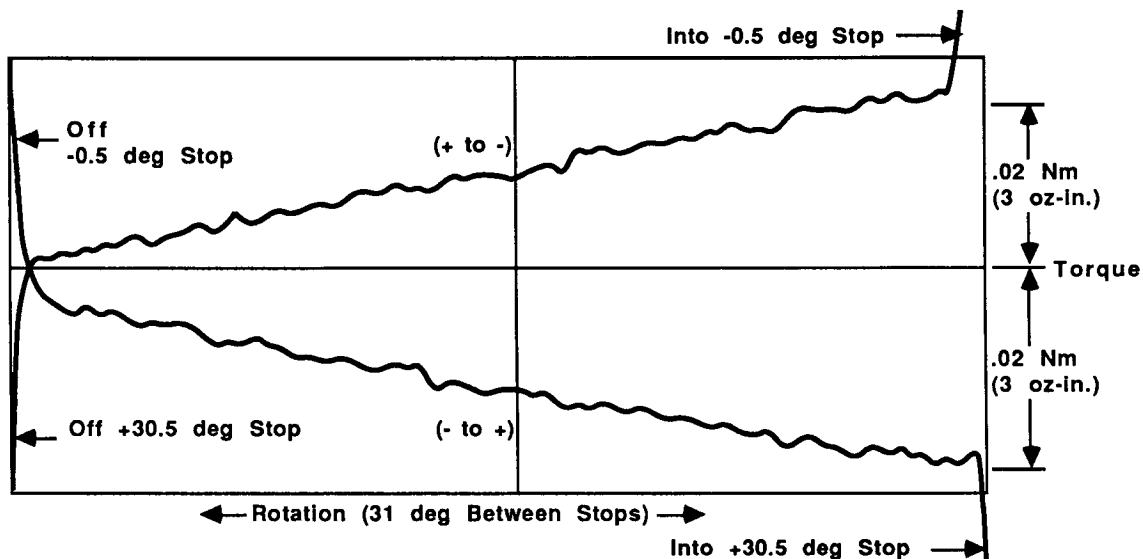
Figure 10. An acceptable inner axis torque trace. Only minor torque ripple is seen between stops.

Inner axis drag torque is measured as a part of gimbal acceptance testing. The axis is rotated at a constant speed (approximately 30 deg/min) by an external motor. Torque is measured with a torque transducer, producing the typical trace shown in Figure 10. The top trace indicates rotation from the +30.5 deg stop to the -0.5 deg stop. At end-of-travel, the axis is driven into the stop slightly, compressing the stop spring, to assure complete travel. The lower trace shows rotation in the opposite direction, again reading left to right. The slope in the traces is caused by spring torque of the flexible electrical leads at both ends of the axis. These leads are wound in opposition to each other, and their torques cancel in the middle of the travel range.

Four of the six gimbal assemblies tested had torque traces similar to those shown in Figure 10. Two assemblies exhibited traces as shown in Figure 11. Note the large spikes just inside the stop locations. Following is a summary of the investigation and analysis of this anomaly.

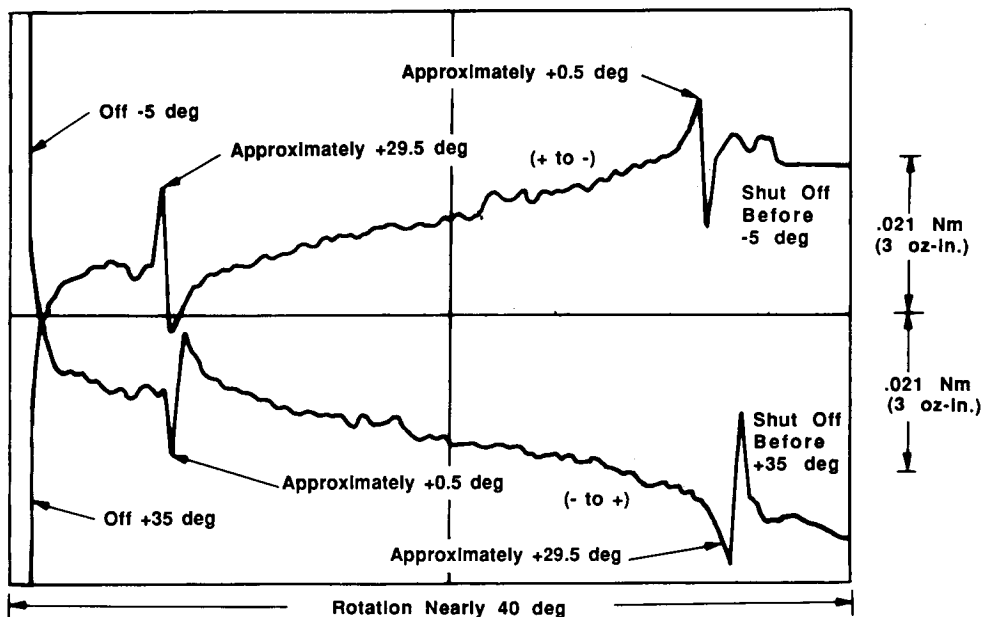
Figure 12. When the drive was rotated beyond the original travel limits, torque spikes remained in their previous locations.

Figure 12 was taken. If this anomaly were blocking, the spikes should have disappeared after the first pass. Since the spikes were still present on the return part of the cycle, blocking was not the problem.

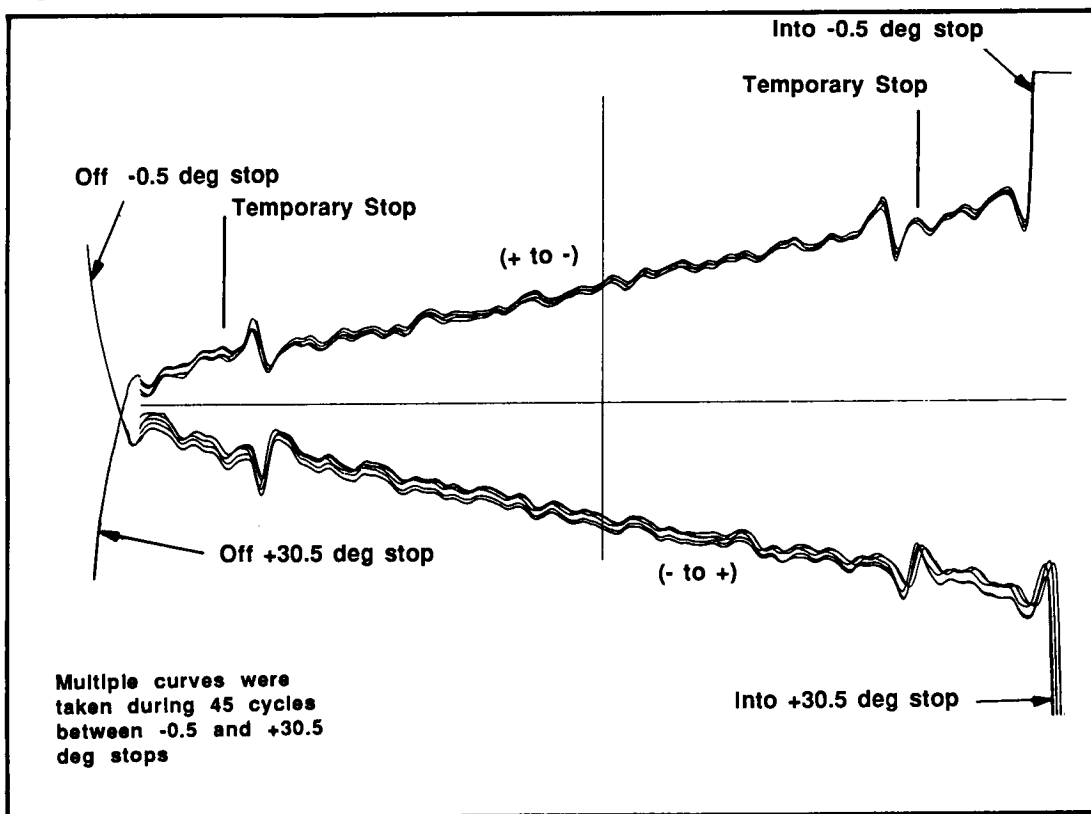
Figure 13. Cycling between temporary stops set inside the original travel limits produced new figure spikes which persisted for more than 45 cycles when the travel was increased again.

Assuming that debris caused the anomaly, it should be possible to produce spikes in other locations; therefore, blocks were attached to the second discrepant gimbal to limit travel to 24 deg. Initially, no spikes were present at the new stop locations; cycling block-to-block generated new ones. Traces taken after the 24-deg stops were removed show the new spikes and the original ones (Figure 13). The spikes remained after several stop-to-stop and random cycles. A trace taken after the gimbal sat overnight, to see if the debris hills would flow away, still showed all the spikes. Just to be positive, the travel was reduced to 21.7 deg and again

spikes were created. The blocks were removed as were the stop springs, to permit 40 deg of travel, and all six spikes were visible. Cycling at 40 deg did not generate any new spikes, however, and after 500 cycles the existing spikes were noticeably smaller. After 1000 cycles they were gone. Subsequent attempts to create spikes by shortening travel were unsuccessful.
