# NASA Contractor Report 172462

## Structural Tests and Development of a Laminar Flow Control Wing Surface Composite Chordwise Joint

LOCKHEED-GEORGIA COMPANY  
Marietta, Georgia 30063

CONTRACT NAS 1-17487  
December 1984

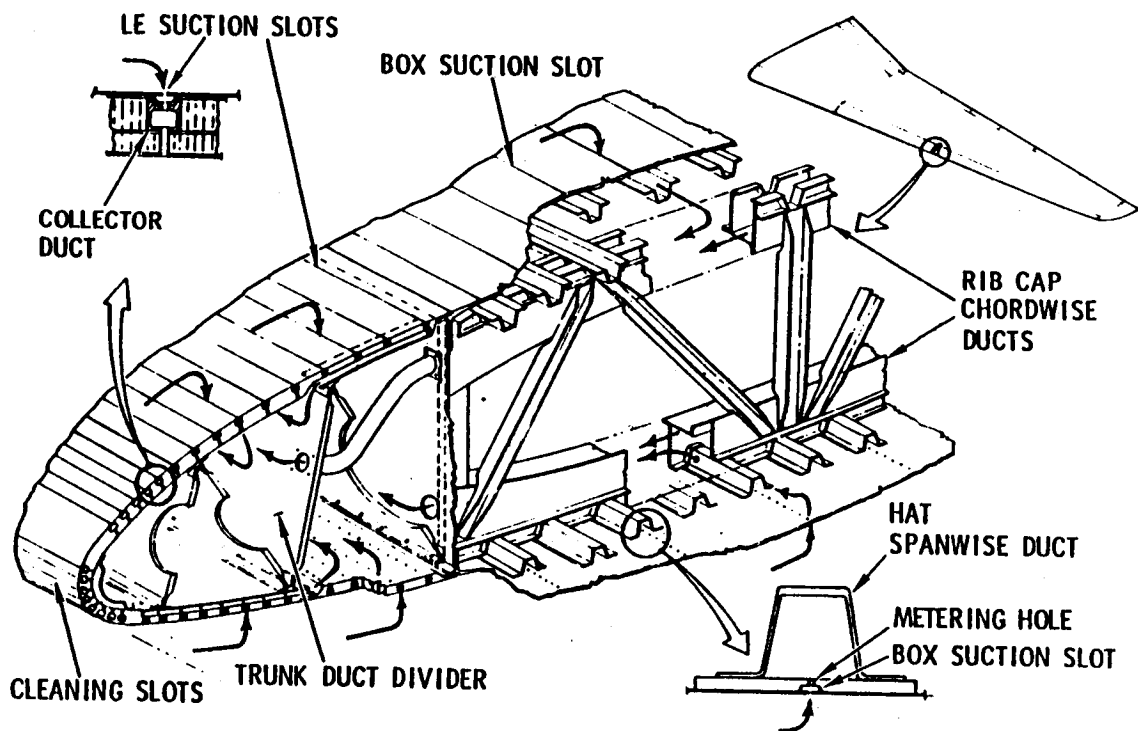
Figure 1. LFC Wing Structural Design

The baseline LFC wing concept developed during the LFC WSSD project is shown in Figure 1. Airflow from slots in the leading edge, upper surface, and lower surface into an internal system of ducts, to the main trunk ducts in the leading edge (shown by the arrows). Figure 2 shows the layouts of the basic structural geometry of the wing and the location of the principal structural members.

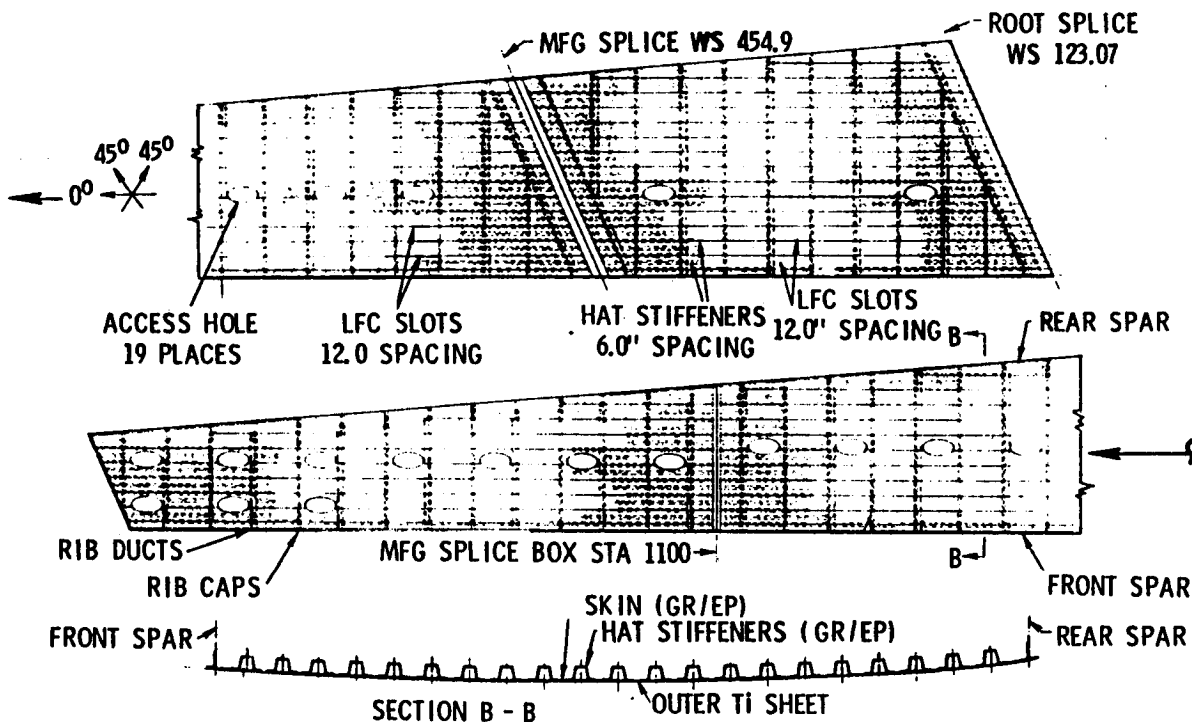
Figure 3. Wing Box Upper Cover - 1993 LFC Transport

The LFC wing box upper cover for the 1993 LFC transport is shown in Figure 3. The wing box upper surface extends from the WS 123 root splice to the W.S. 1439 tip. The cover is broken into three sections for manufacture and spliced at WS 454 and Box Sta. 1100. Each cover segment consists of a bonded assembly of titanium outer sheet, graphite/epoxy inner skin, spanwise hat stiffeners, rib caps, rib ducts, spar caps, and miscellaneous clips.

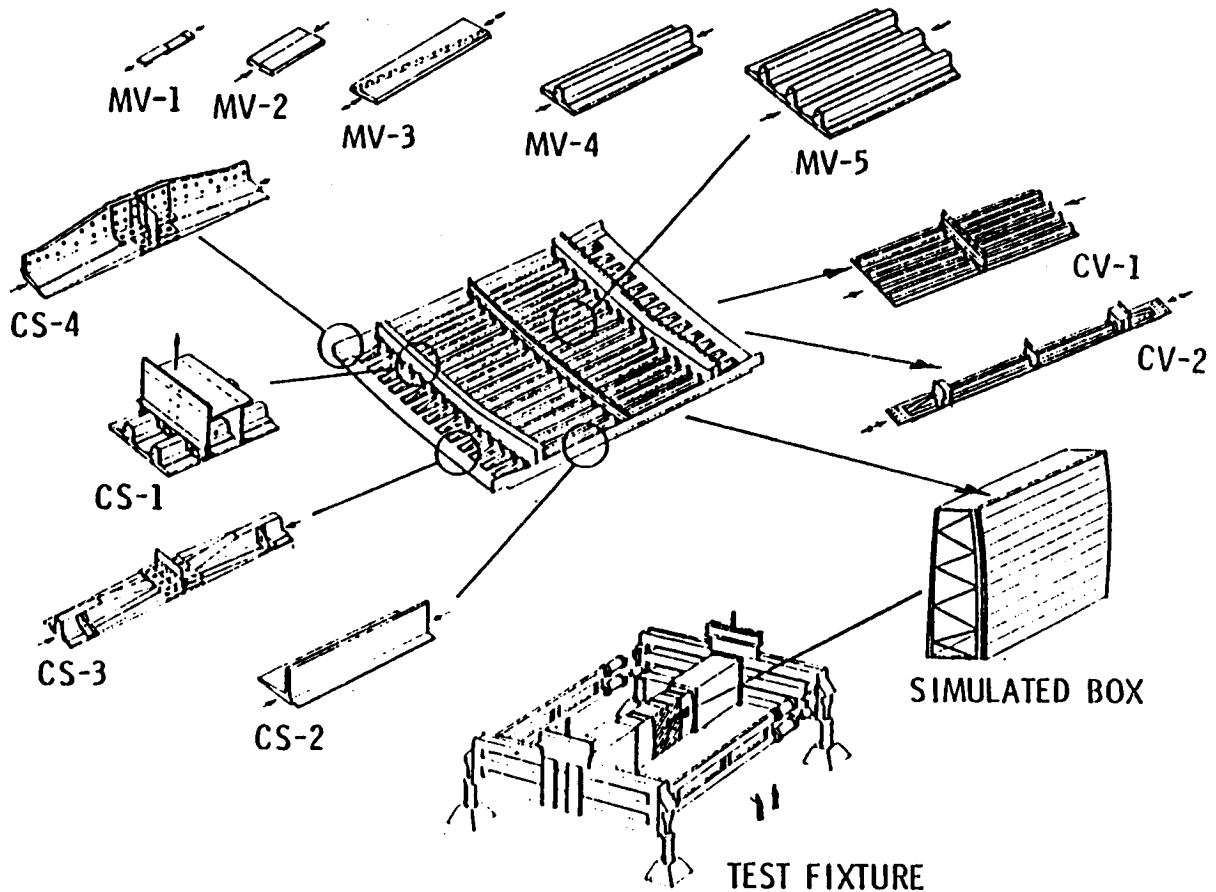
Figure 5. Integrated Wing Surface Panel Development

The original long-range plan for developing the LFC wing surface is summarized in Figure 5. A series of material verification (MV) specimens were fabricated and tested to verify the materials and processes. Concept selection (CS) specimens were used to develop the critical design details, tools and manufacturing processes. Concept verification (CV) anticipates the manufacture and test of the large surface panel. The first panels made on the wing surface tool will be structurally tested to verify the design and the tool. These panels are identified as CV-1 and CV-2. The large panel assembly with ribs, rib ducts, chordwise joints and spar caps is identified as CV-4. CV-4 will be installed in a simulated wing box for testing the integrated LFC wing structure under simulated flight loads. The CV panels were not fabricated in the original WSSD program (reference 2). The present report summarizes the fabrication and test of the chordwise joint CV2 panel.

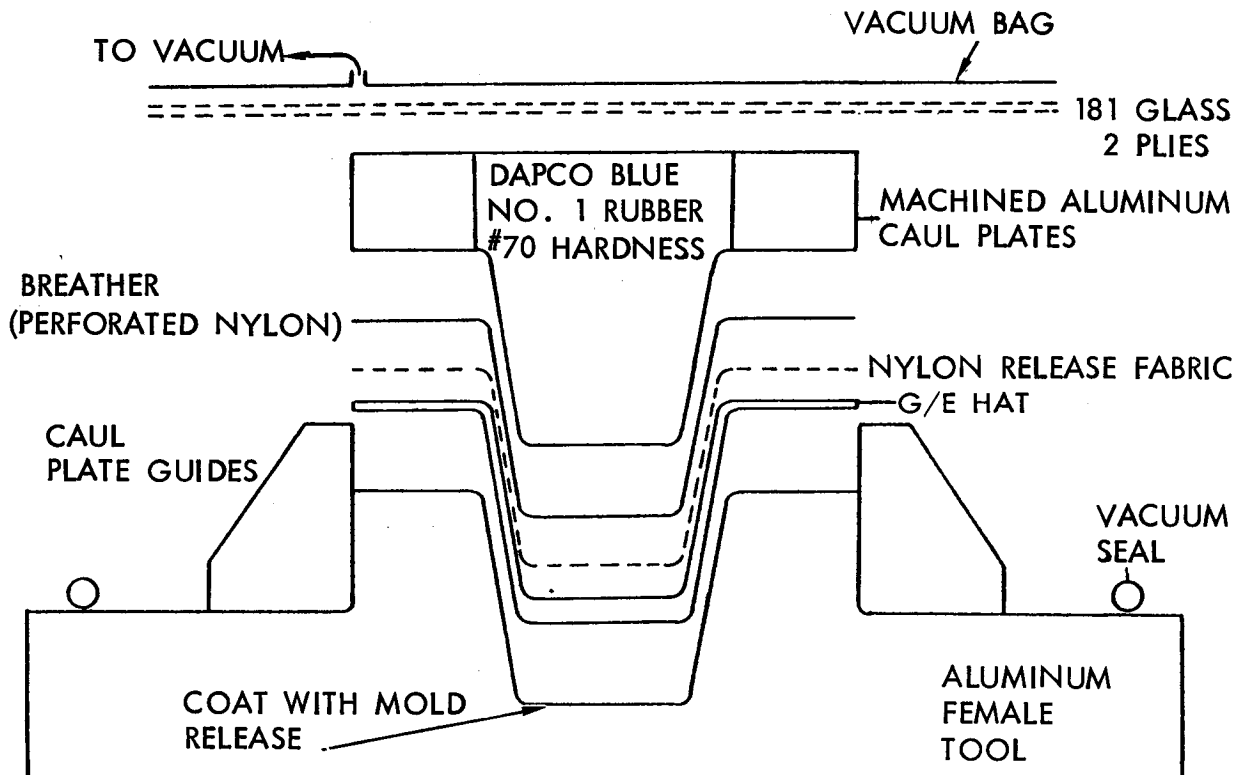
Figure 6. Schematic of Hat Layup for Cure

The case rubber tool block used for the CS-3 hat section was used as a pattern, and a second rubber tool block was cast. Figure 6 shows a schematic of the hat layup and tool. Figure 7 shows the empty female hat, and Figure 8 shows the complete tool with all details in place prior to vacuum bagging for the autoclave.

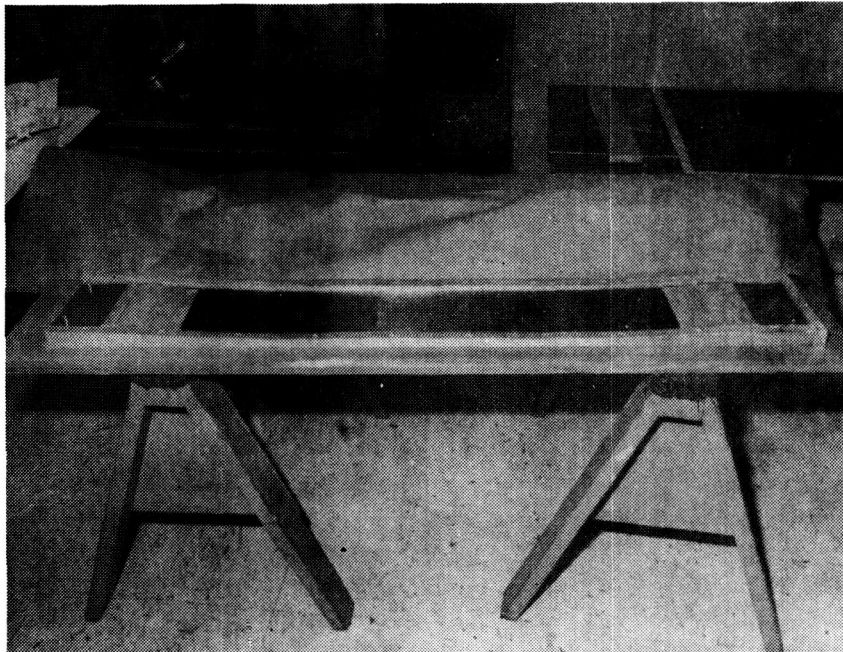
Figure 9. Skin Tool with Skin Layup

The tool concepts used for the skin panels of the CS-3 specimen were modified slightly for use on the skin panel. The basic tool was a 1/2-inch aluminum plate with aluminum dams attached for both sides and one end of the skin panel. Figure 9 shows an overall view of the skin tool and layup. The other end of the panel was open as shown in Figure 10. Two aluminum plates (one for each end) were machined to the proper thickness to provide the proper offset of the joint details from the exterior surfaces. Each plate had two holes drilled in them for aluminum dowel pins. On the open end of the tool these dowel pins extended into the basic 1/2-inch plate, firmly locating one end of the specimen. On the closed end, this end plate was pushed against the end dam to locate it during specimen layout. This detail permitted the end of the skin to slide differentially with the aluminum base plate during their thermal expansion in the cure cycle, and not displace any of the graphite/epoxy plies with respect to the titanium plies on each end.

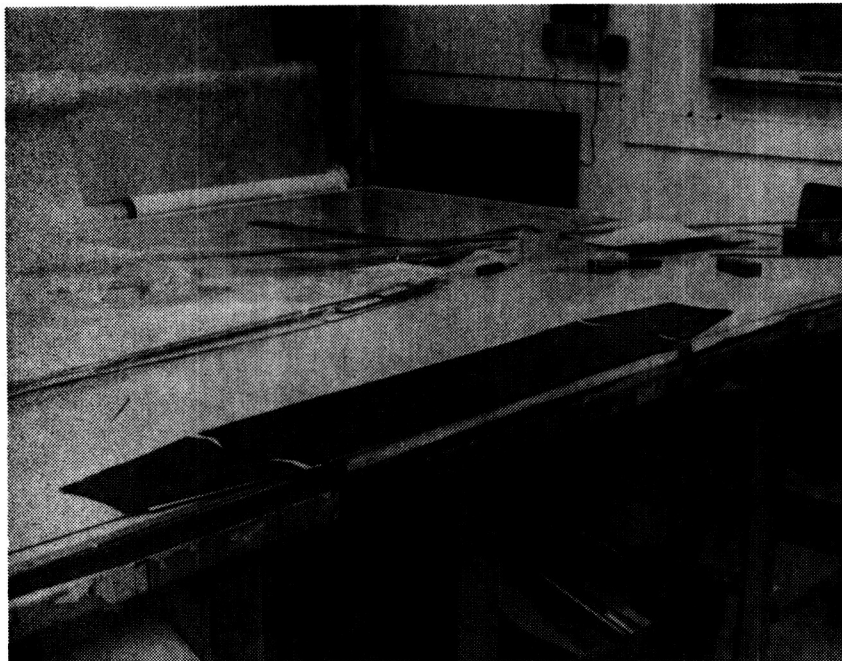
Figure 11. View of a Hat Ply Template and Prepreg Ply

Concepts for the tools used for the rib details were the same as those used for the CS-1 specimen. Male cast rubber tool blocks were used to lay up green clip details for the ribs. Ply templates were made and used to cut the plies for the hat section and rib clips. Figure 11 shows a pair of cut plies for the hat section. The skin tool was used as an assembly fixture to bond the hat to the skin. This assured that the outer surface would remain flat.

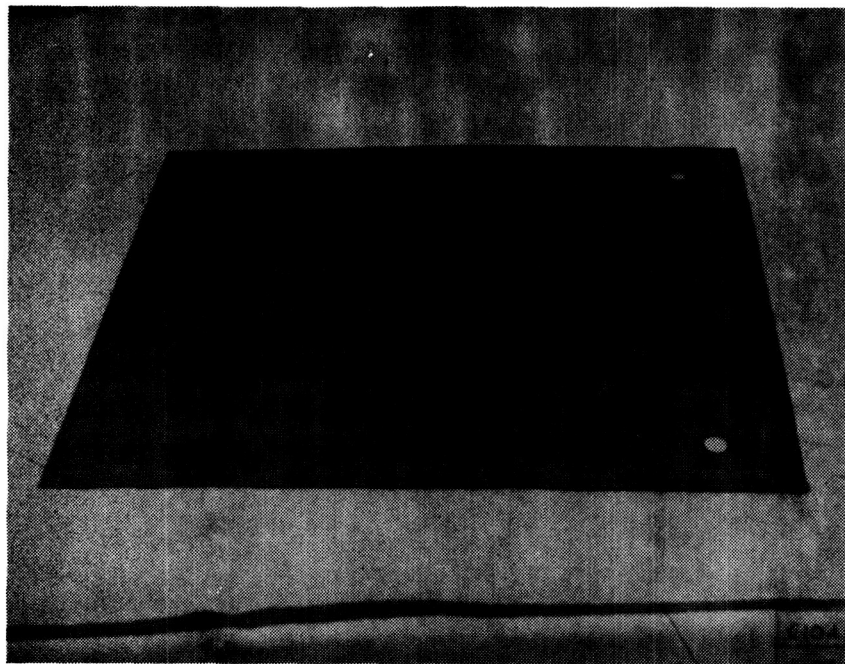
Figure 15. Titanium Detail with Adhesive Applied

Layup of the skin panel was accomplished using a detailed layup sheet which specified which ply, graphite/epoxy or titanium, where it was located, and where adhesive was required. No ply templates were used as all G/E plies were rectangular. White cotton gloves were used when handling all titanium plies. The basic tool was coated with mold release, and two machined fiberglass filler details were placed on each end per drawing. The fiberglass part nearest each end was wrapped with teflon tape to prevent it from being bonded to the assembly at this time. Titanium and graphite/epoxy plies were carefully laid up with a layer of FM300 adhesive being used to bond the titanium plies to each other and

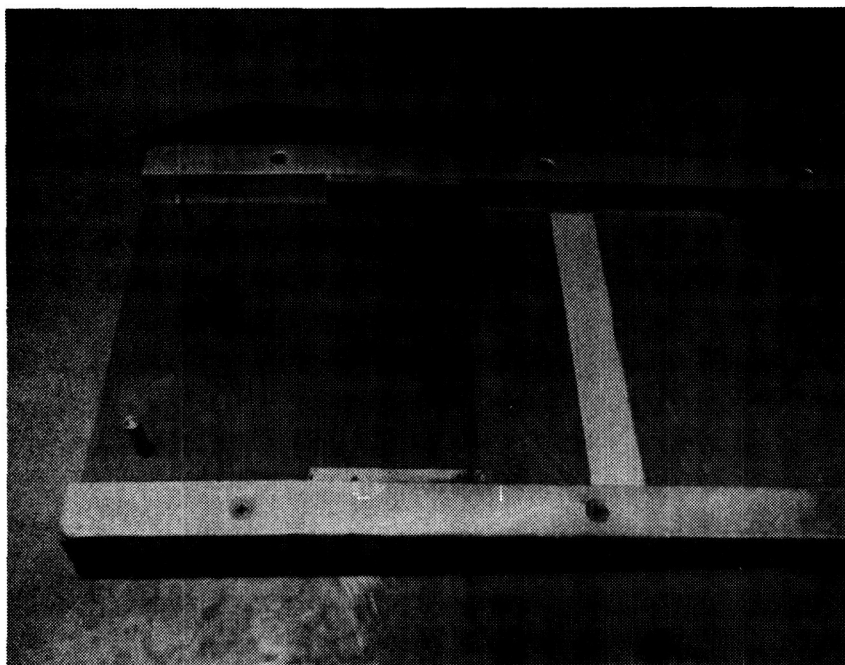
Figure 16. Skin Tool Showing First G/E Ply in Place and Titanium Detail Pinned to Locater Pins

to the graphite/epoxy plies. The skin panel was vacuum debulked several times during the layup sequence. Figures 16, 17, and 18 show the skin panel with the layup process nearly completed. Figure 19 shows the completed layup with rubber plate just prior to vacuum bagging for the autoclave. Figures 20 and 21 show the skin panel after removal from the autoclave. Figure 22 shows the end of the titanium plies where they are not completely bonded to each other. It was thought that this condition was caused by small differences in the forming of the titanium plies.

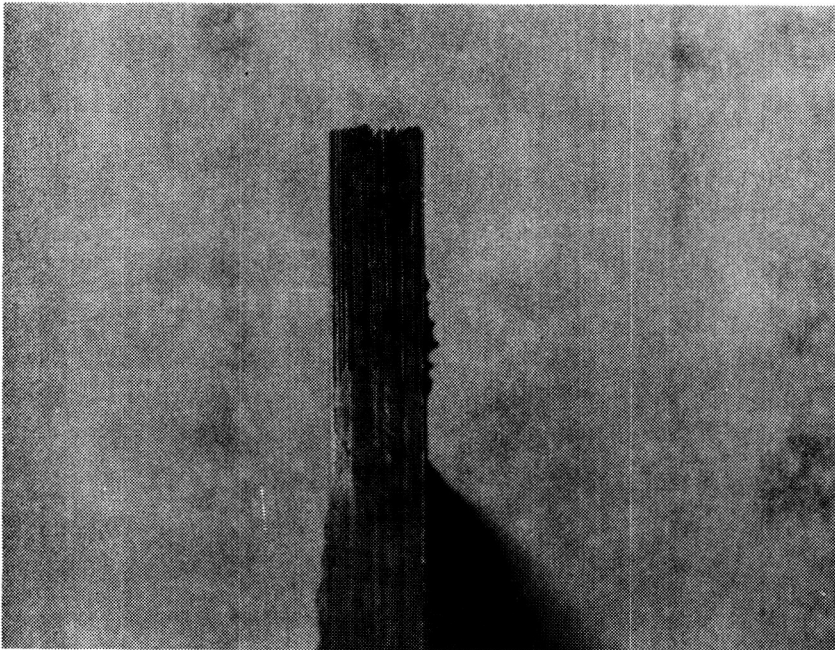
Figure 22. End of Skin Showing Titanium Detail Misfit

A total of three skin panels were made. One was scrapped due to slippage of the fiberglass wedge filler inboard. This was solved by pinning the filler to the titanium details. It could not be pinned to the aluminum tool due to thermal mismatch. The two skins were ultrasonic inspected and found to be clear of voids and porosity.

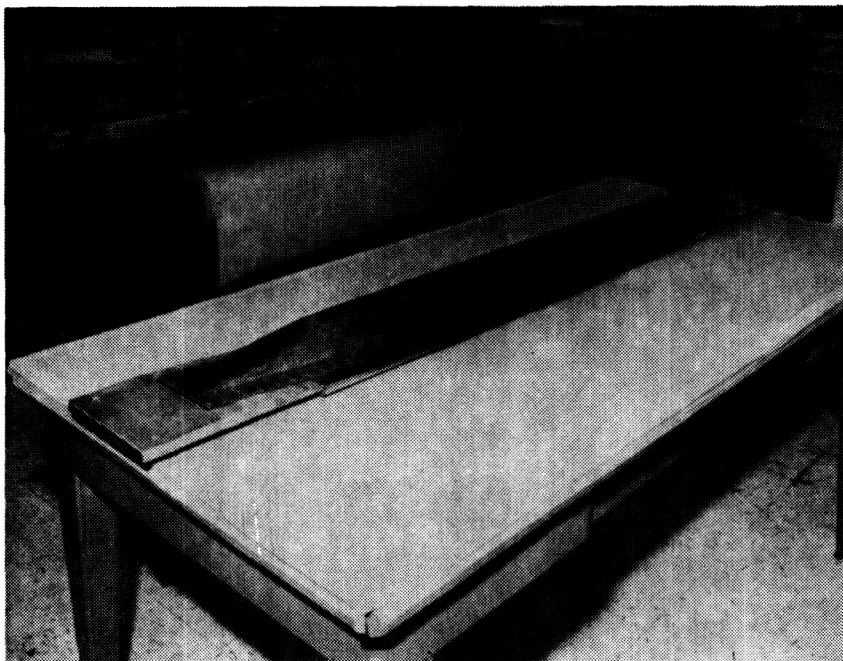
Figure 23. View of Hat and Skin Stiffener Being Prefitted Prior to Bonding

After trimming the hats and skins to dimension, they were prefitted for bonding as shown in Figure 23. A verification bond cycle was conducted on both specimens. Two layers of FM73 adhesive -(0.06PSF), STM 30-102, was placed between one mil thick Teflon film and the hat and skin assemblies. The skin tool was used as the bond fixture. After curing the adhesive at 250°F and under 30 psi pressure, the details were separated and the teflon and cured adhesive film removed. Thickness of the adhesive film along the bond line was determined and low-pressure areas noted for additional layers of adhesives. Less than 5 percent of the bond needed an additional layer on either assembly. Fit of the

details was considered good and well within bonding tolerance. The details were then cleaned and adhesive applied in accordance with the verification results. Cure of the assembly was accomplished in an autoclave at 30 psi pressure and 250°F for 60 minutes. Following bonding of the assemblies, an ultrasonic nondestructive inspection was conducted. No disbonds were found in either the CV2-1 or CV2-2 specimens.

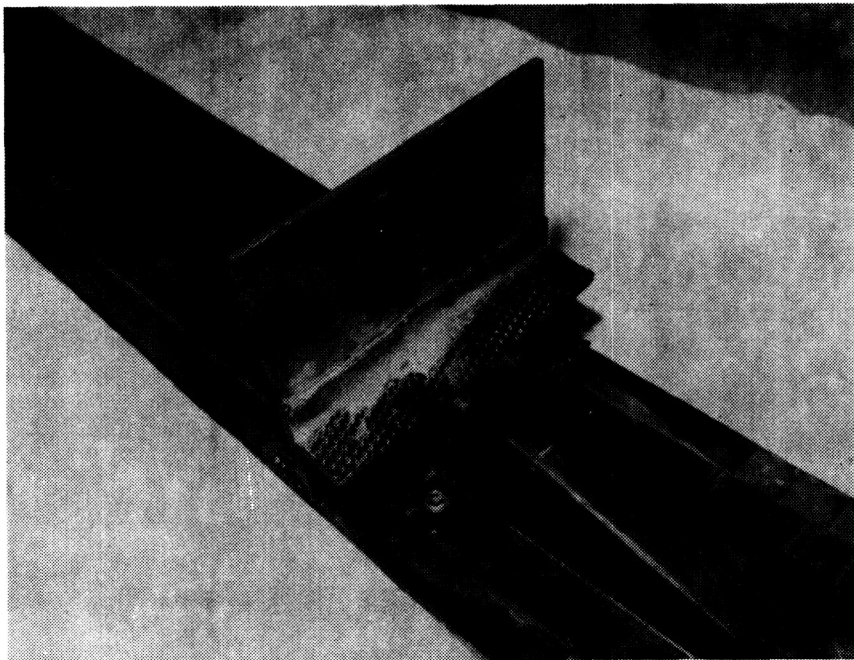
Figure 24. View of Rib Cap Assembly from Specimen End

The web and other flat details of the assembly were cut from precured details. They were then cleaned and adhesive applied to all mating surfaces. All formed details were laid up over rubber form blocks from G/E fabric. The details were then assembled and bagged for cure. Again the skin tool was used as a curing fixture, and cure was accomplished at 30 psi and 250°F. Following cure and cleanup, holes were drilled and the rib cap fasteners installed. Figures 24, 25, and 26 show different views of the rib cap assembly installation.

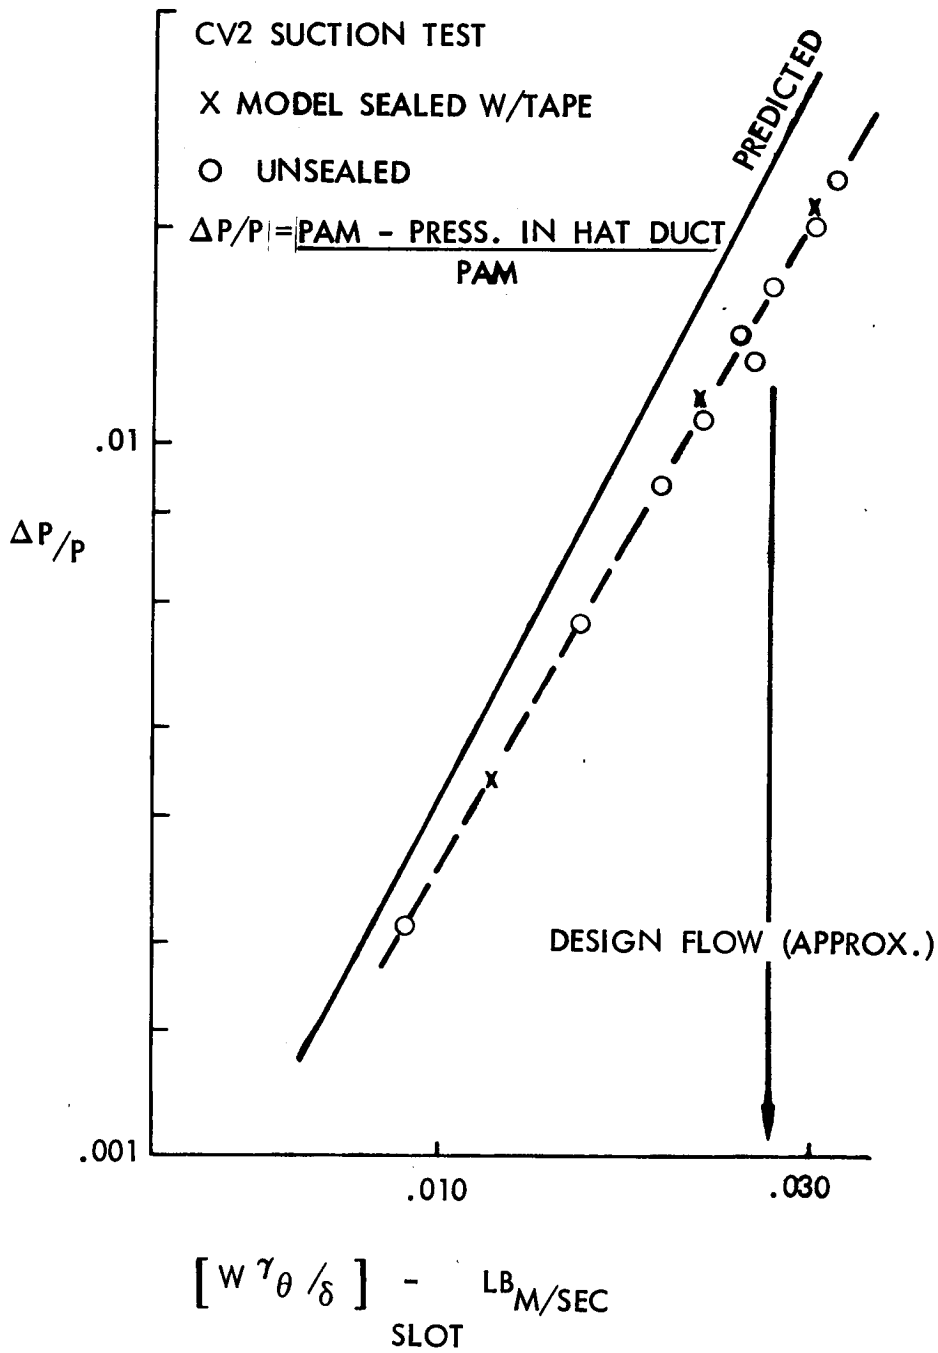
Figure 31. Flow vs. Pressure Loss

Data are shown for the model "sealed" and "unsealed." Considerable leakage was found along the edges of the test piece and at the bolt hole openings in the surface skin at both ends of the panel. The model was sealed with duct tape and vacuum putty in an attempt to stop the leakage. It is suspected that some leakage still occurred after the model was sealed although use of an acoustic leak detector apparatus failed to locate any additional source of leaks. However, the results seem to indicate that leakage did not adversely impact the test results.

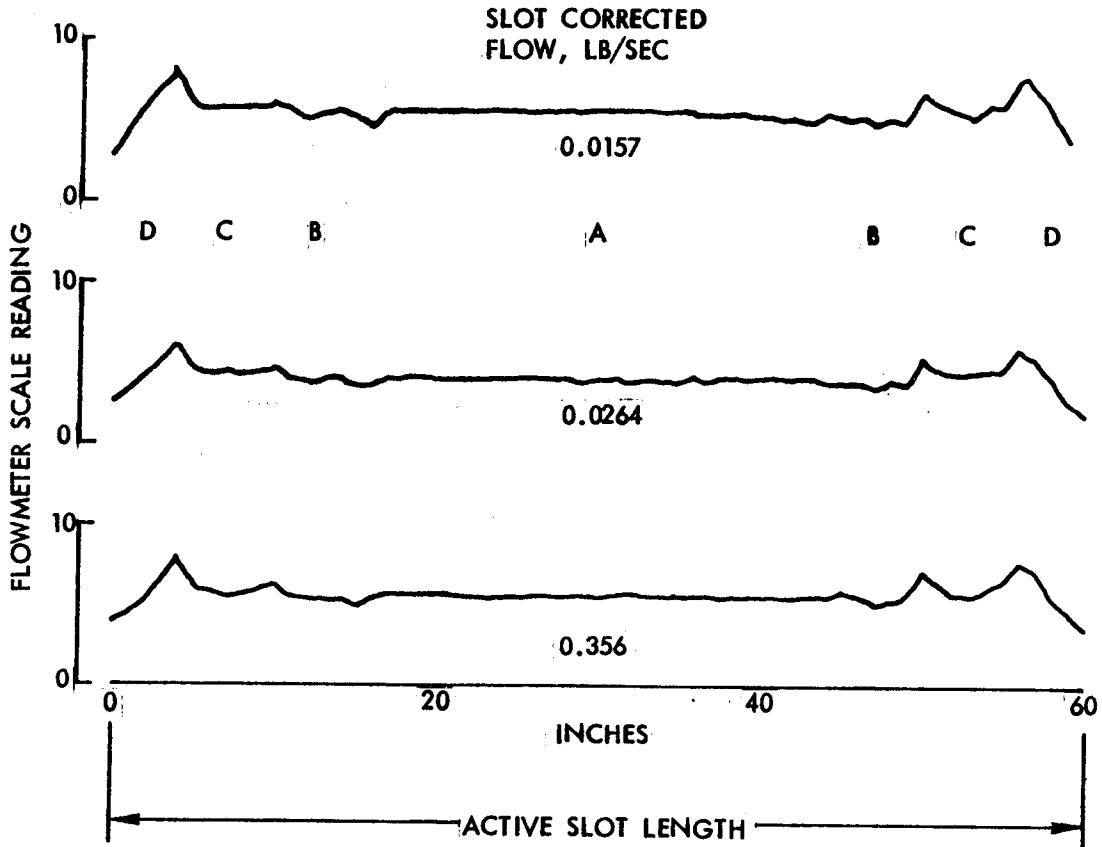
Figure 32. Slot Spanwise Flow Distribution

Figure 32 illustrates the results of spanwise local slot flow measurements made at three levels of suction total flow. The measurements were made using a small hand-held rotameter. Four regions are indicated on the figure which represent the four subsurface configurations which serve to interconnect the slot duct with the hat duct. Refer to Drawing LGA134A-326, Appendix A, for details of the subsurface geometry. The spanwise flow surveys indicate good flow distribution over all regions except D and the interfaces region between B and C. In region D, flow is routed from the slot duct through metering orifices to another larger duct which carries the flow spanwise to the plenum-like cavity of region C. Discounting blockages in these ducts or other fabrication anomalies, it appears that the duct geometry of region D may not provide the desired even flow distribution across the simulated chordwise joint. Further testing is required to identify the problem and a solution. Three hat duct pressures measured indicated less than a 1 percent variation in hat duct pressure from the center tap to the taps at either end of the panel.

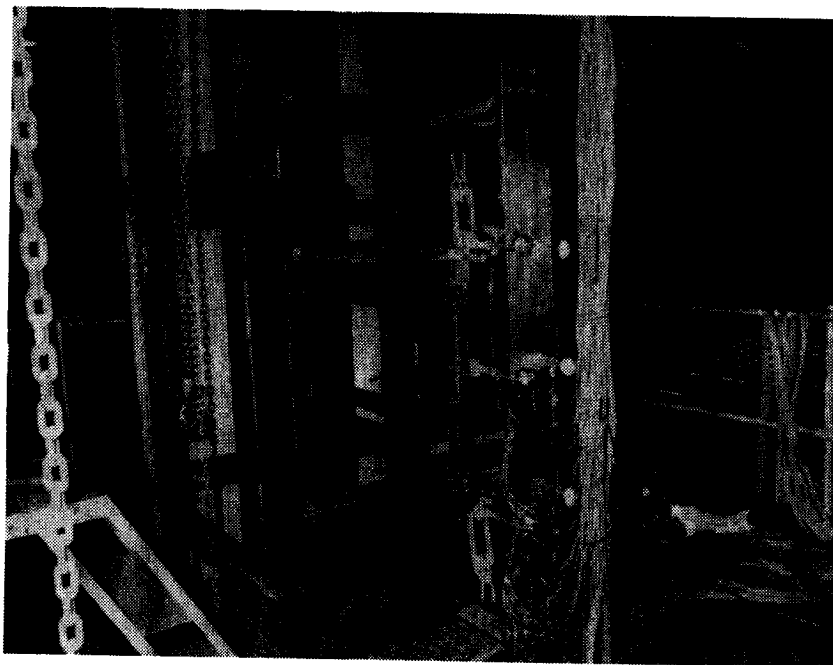
Figure 33. CV2-1 Test Setup

The CV2-1 panel was static-tested to failure in a tensile mode in a normal laboratory environment at room temperature in the universal test machine. A loading check to 40 KIPS was carried out as shown below. See Table 4 for dial gauge readings. An increasing dial gauge value shows a skin movement "away" from the hat direction.

After completion of four lifetimes of fatigue, a residual strength tensile static test of the CV2-2 specimen was conducted. The test set-up was essentially the same as for the previously tested CV2-1 tension static test (Figures 33 and 34). The strain gauges were located as shown on Table 12. The dial gauges were located as shown on Table 3.

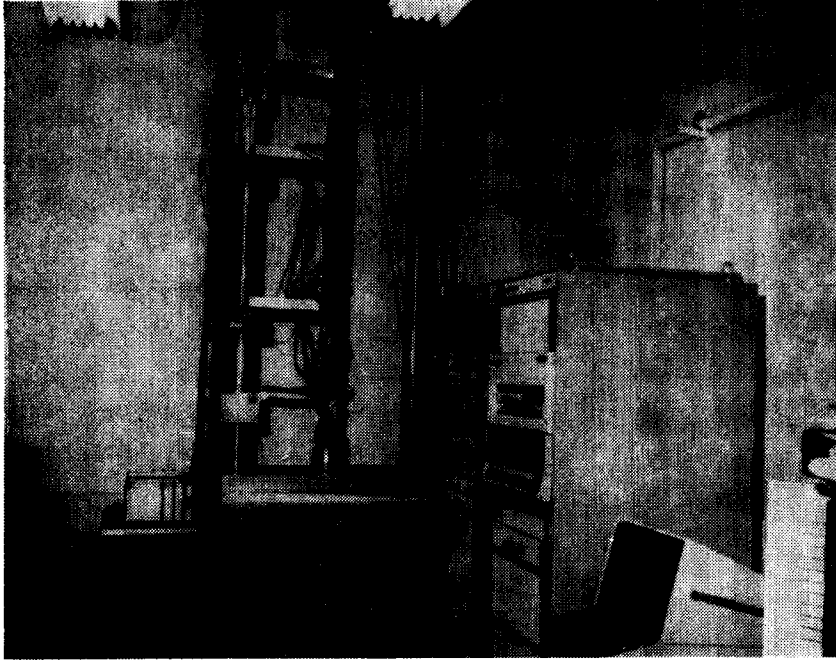
Figure 37. CV2-2 Fatigue Test Setup

The specimen was installed in a computer controlled 100-KIP capacity (75-KIP capacity in fatigue) fatigue test machine using the same attachment end fittings which were used for the CV2-1 static specimen installation. Shims were used as necessary to obtain concentricity at both ends. The specimen was supported laterally at the chordwise joint centerlines and at the two rib caps. The supports were attached to one of the vertical columns of the test machine as shown in Figures 37 and 38. Prior to fatigue testing, lateral deflection of the specimen under load was checked at -40 KIPS using dial gauges attached to the vertical column of the test machine. Deflection was measured at the centerline of the chordwise joints, at the rib caps, and at the transverse centerline of the specimen. A maximum lateral deflection of 0.014 in. at a load of -40 KIPS occurred at the lower rib cap. All measured deflections were in a direction such that the lateral support members were loaded in tension. Deflection at the transverse centerline of the specimen was negligible.

After 360 flights of the load spectrum, the vertical leg of the aluminum angle member of the lateral support at the lower chordwise splice was removed to reduce the stiffness of the support. In this final configuration, the deflection at the lower rib cap at -40 KIPS was 0.009 in.

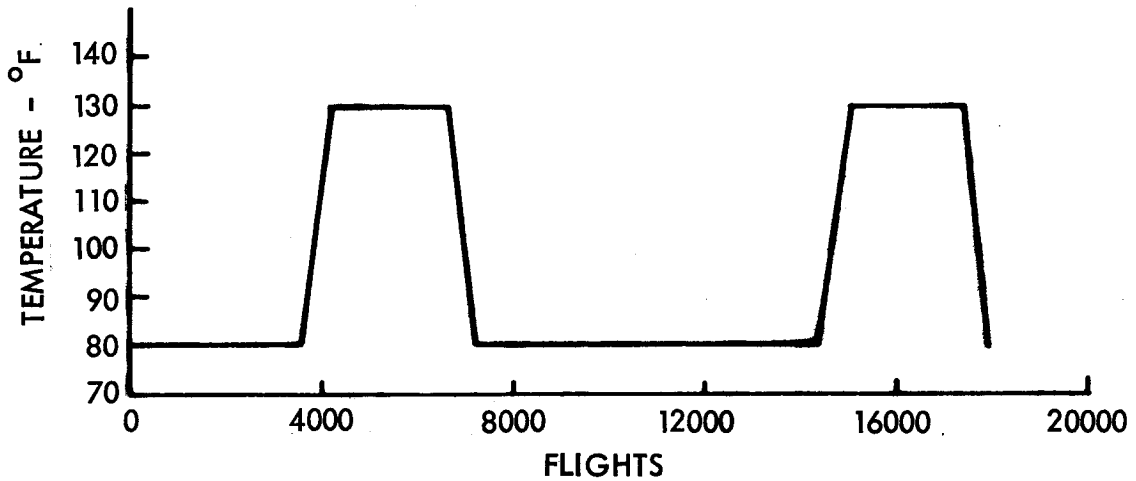
Figure 40. CV2-2 Fatigue Test Temperature Cycles

During application of the fatigue spectrum, part of the loads were applied with specimen temperature raised to 130°F. The temperature profile for the first lifetime is shown in Figure 40. The profile for lifetimes 2, 3, and 4 was the same.

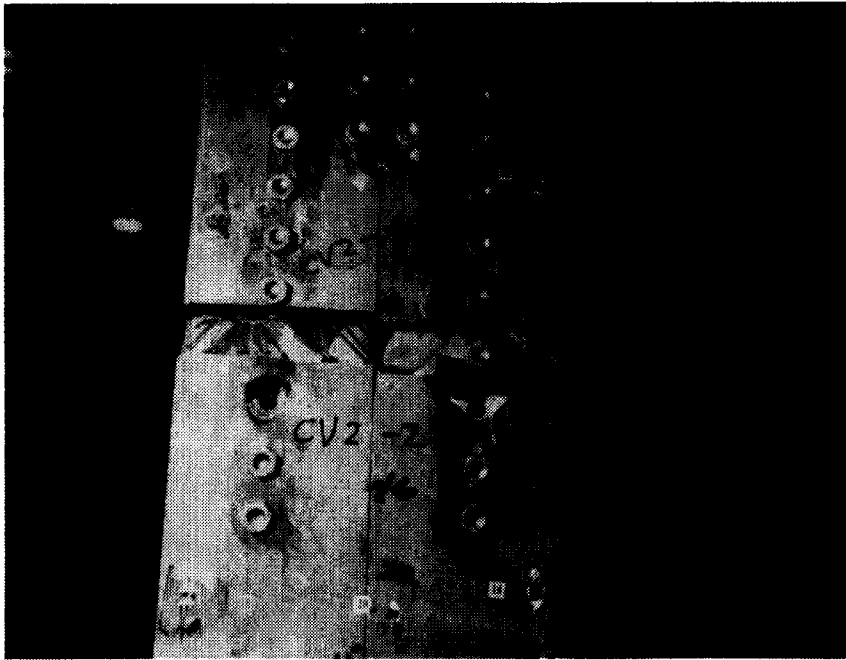
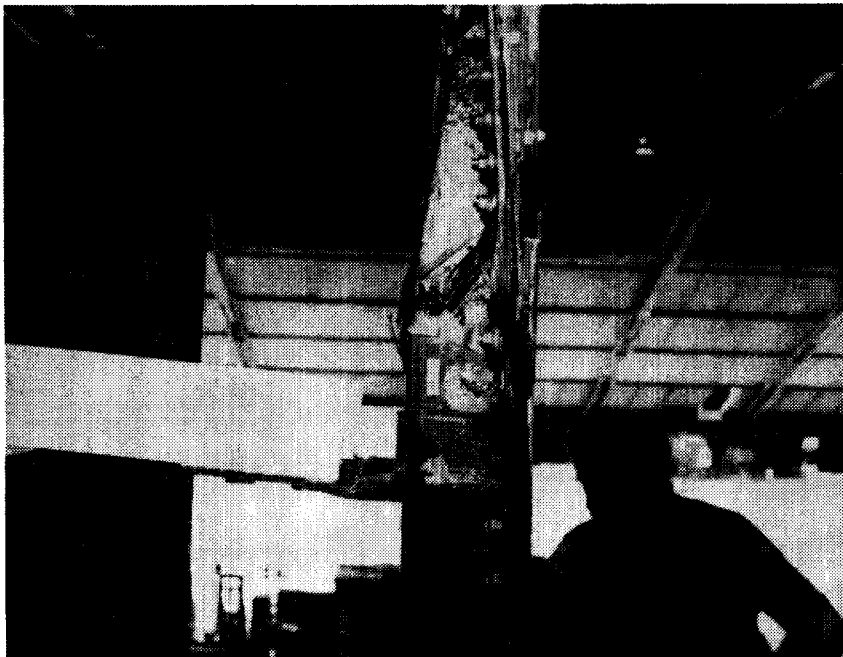
The CV2-2 residual strength test failing load was 130 KIPS. The failure mode was net section failure (including titanium outer skin), (Figures 41, 42, 43, and 44) at a point four inches above the upper composite rib cap. Note that the hat also failed in a net section failure mode, therefore the 24 bolts of 5/16 diameter prevented peel or shear tear out failure modes.

The section width was measured and recorded as 6.94 in. Using the 6.94 in. section width an allowable net section tension load of 133 KIPS was predicted. Note wet graphite composite material allowables (Table 19) were used. The failing load of 130 KIPS is two percent of the predicted tension load of 133 KIPS. Therefore, the static tension structure integrity strength was verified for the CV2-2 panel.

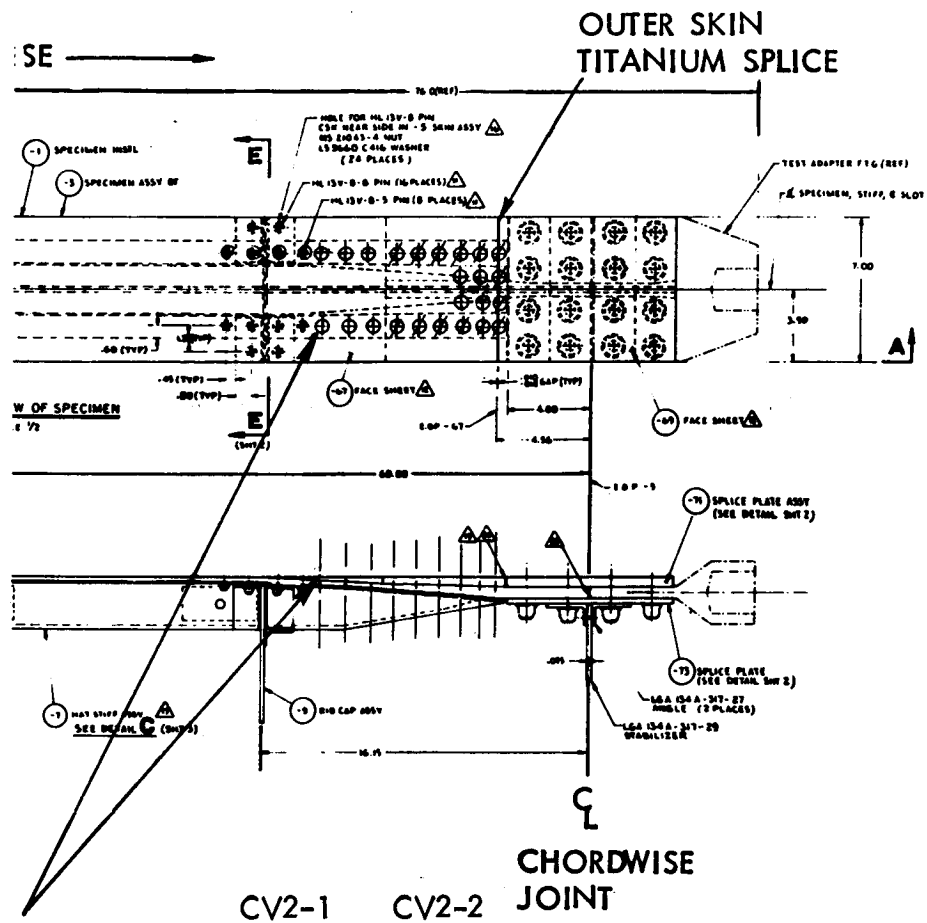
SHEET 5

5/16" DIAMETER  
SPACING = 1.0"  
E/D = .50"  
NAS 6205  
NUT 68563  
WASHER LS9660

CV2-1	CV2-2
5/16" DIAMETER	14	24
SPACING = 1.0"	∅	0
E/D = .50"		
NAS 6205		
NUT 68563		
WASHER LS9660

The CV2-1 specimen was repaired by cold bonding the separated hat section and by adding 14 NAS 6205 bolts 5/16 in diameter at both ends (see Section 5.2). The CV2-1 specimen was reinstalled in the test machine and a satisfactory strain check to 40 KIPS tension load was conducted.

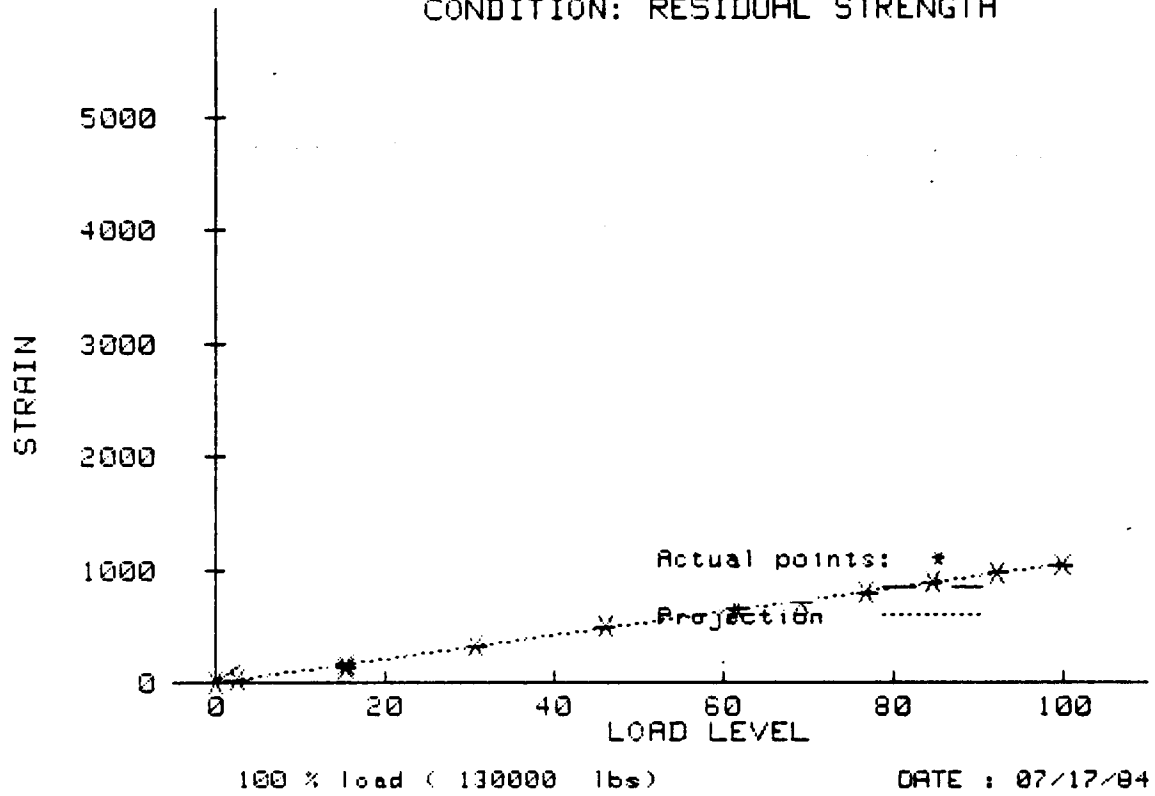
Figure H-1. CV2-2 Residual Strength Tension Test -  
Strain Gauge Readings - Plot Gage 1

GAGE: 1A  
SPECIMEN: CV2-2  
CONDITION: RESIDUAL STRENGTH

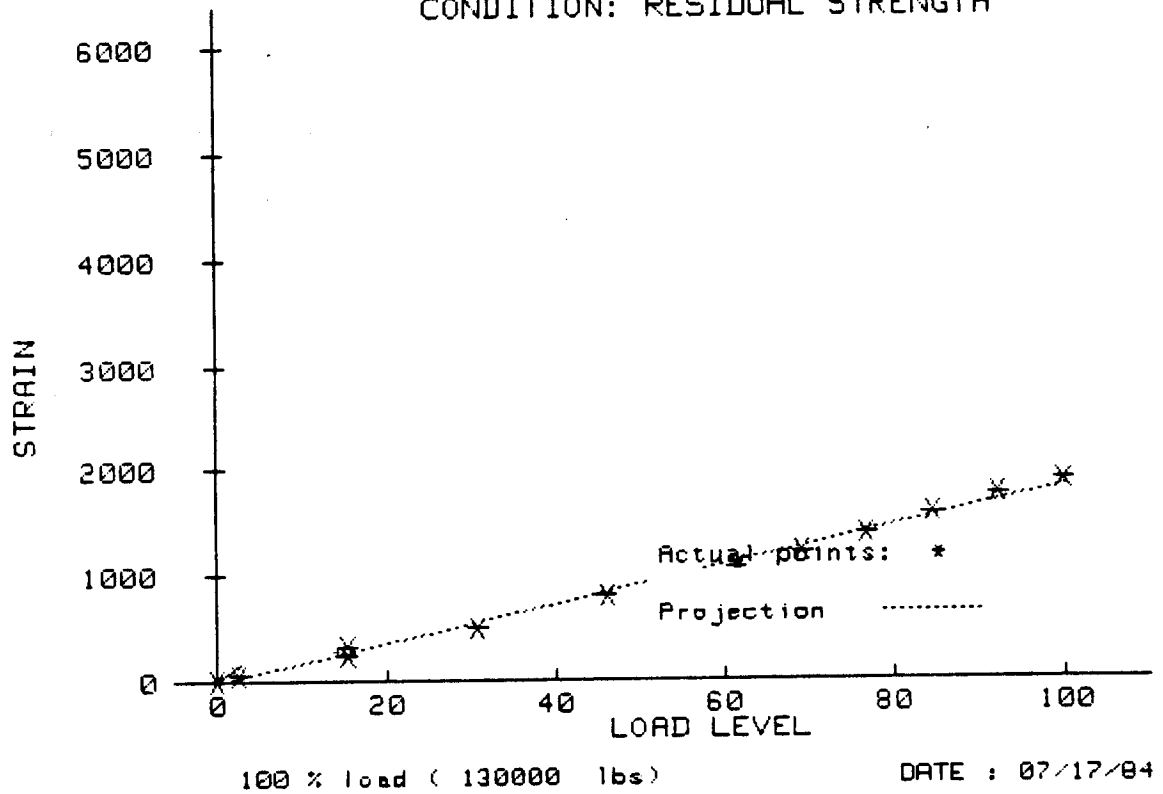
Figure H-2. CV2-2 Residual Strength Tension Test - Strain Gauge Readings - Plot Gage 2

GAGE: 2A  
SPECIMEN: CV2-2  
CONDITION: RESIDUAL STRENGTH

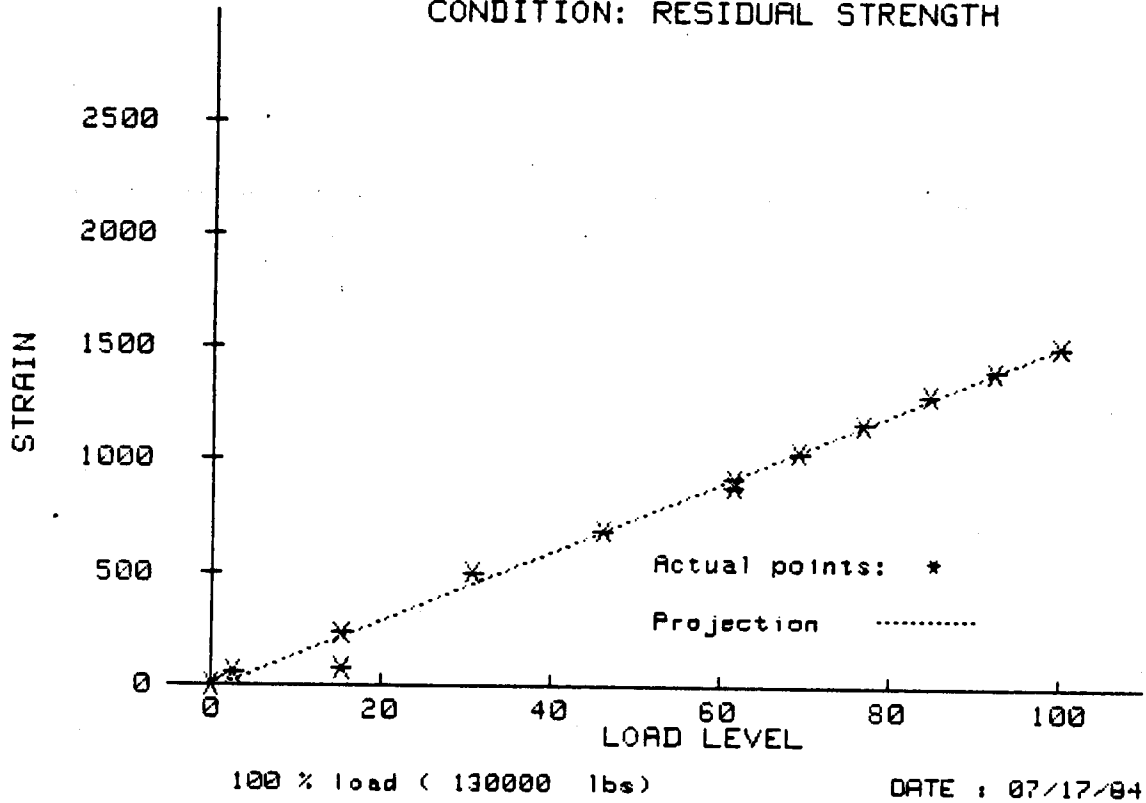
Figure H-9. CV2-2 Residual Strength Tension Test - Strain Gauge Readings - Plot Gage 9

GAGE: 9A  
SPECIMEN: CV2-2  
CONDITION: RESIDUAL STRENGTH

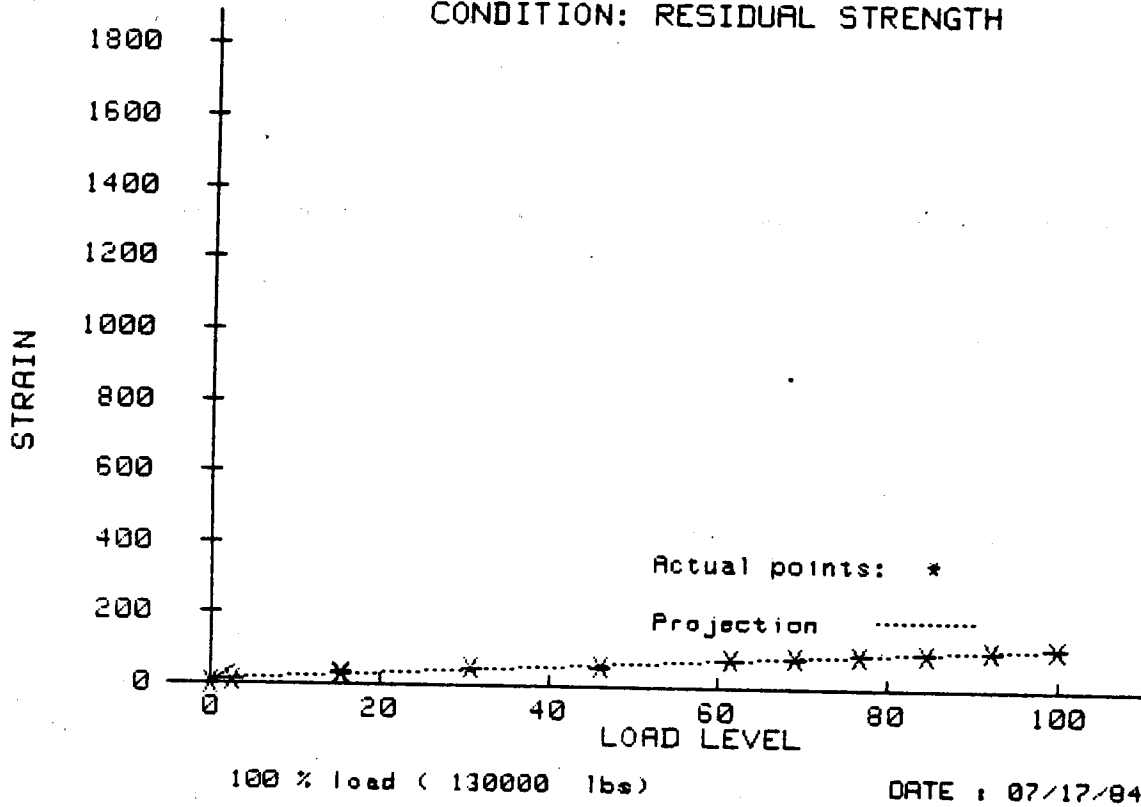
Figure H-11. CV2-2 Residual Strength Tension Test - Strain Gauge Readings - Plot Gage 11

GAGE: 11A  
SPECIMEN: CV2-2  
CONDITION: RESIDUAL STRENGTH

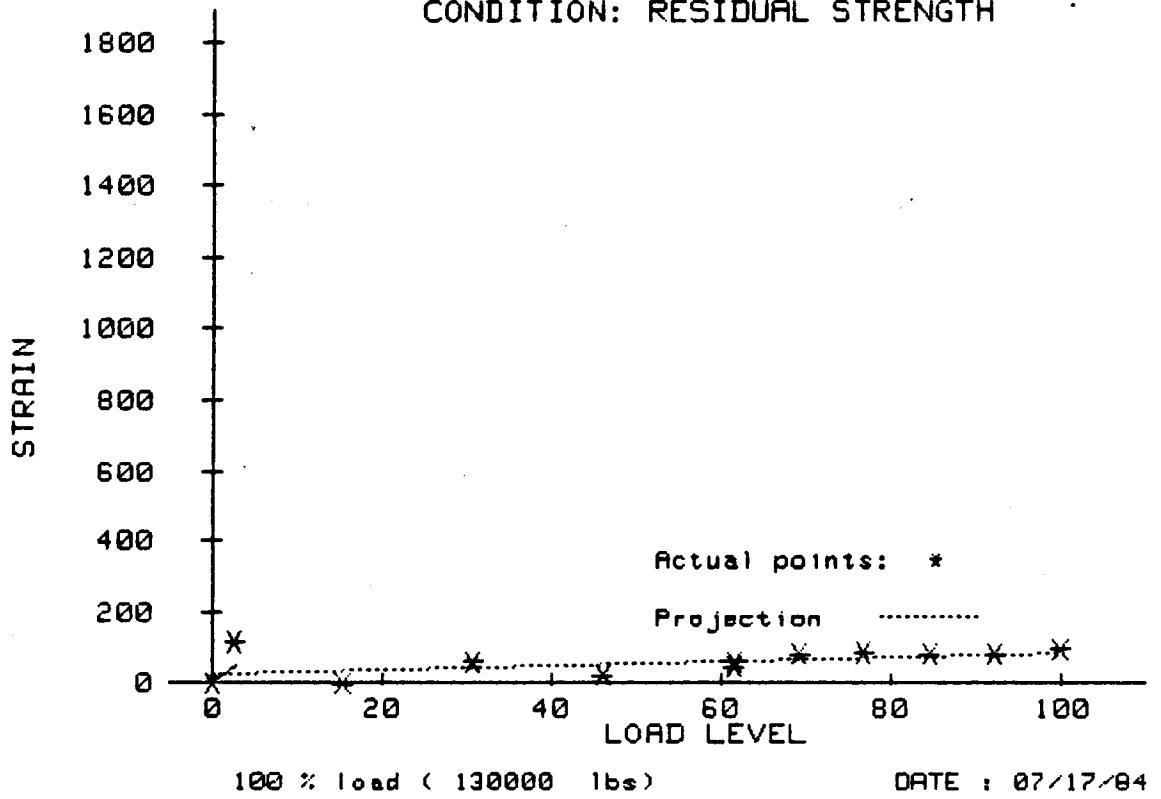
Figure H-12. CV2-2 Residual Strength Tension Test - Strain Gauge Readings - Plot Gage 12

GAGE: 12A  
SPECIMEN: CV2-2  
CONDITION: RESIDUAL STRENGTH

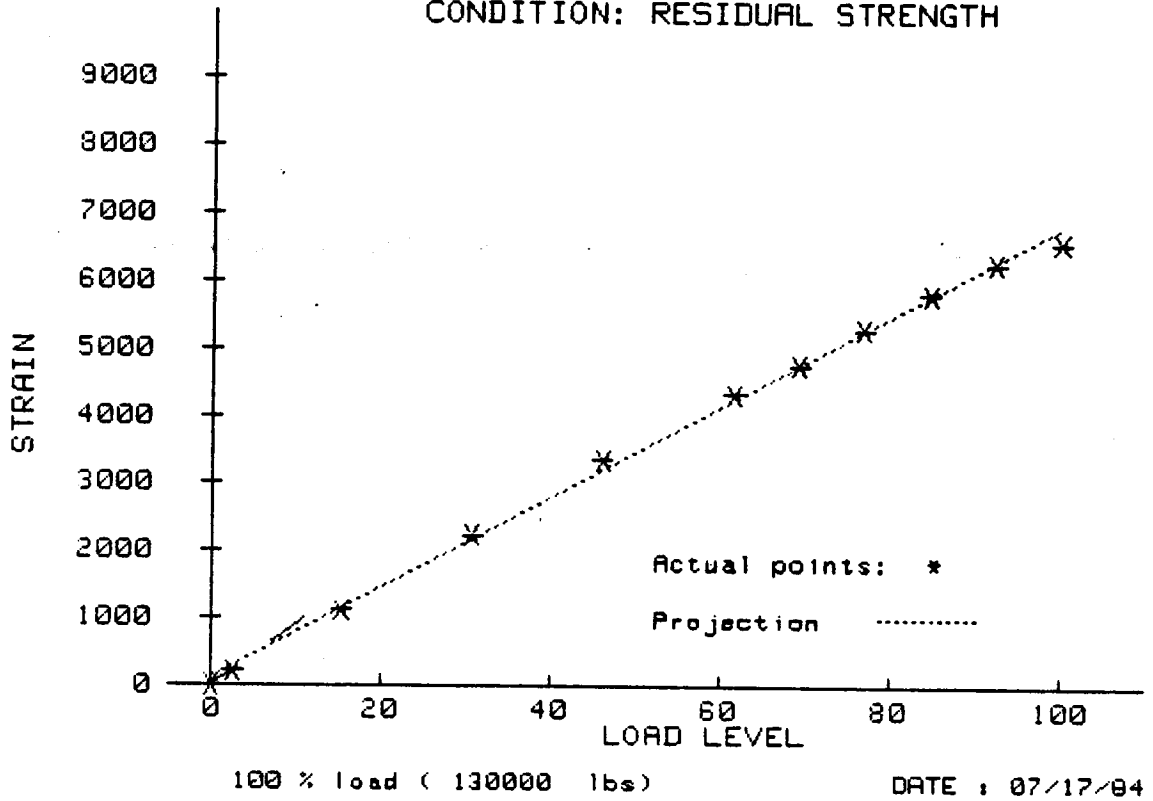
Figure H-17. CV2-2 Residual Strength Tension Test - Strain Gauge Readings - Plot Gage 17

GAGE: 17A  
SPECIMEN: CV2-2  
CONDITION: RESIDUAL STRENGTH
