# NASA Contractor Report 172462

## Structural Tests and Development of a Laminar Flow Control Wing Surface Composite Chordwise Joint

LOCKHEED-GEORGIA COMPANY  
Marietta, Georgia 30063

CONTRACT NAS 1-17487  
December 1984

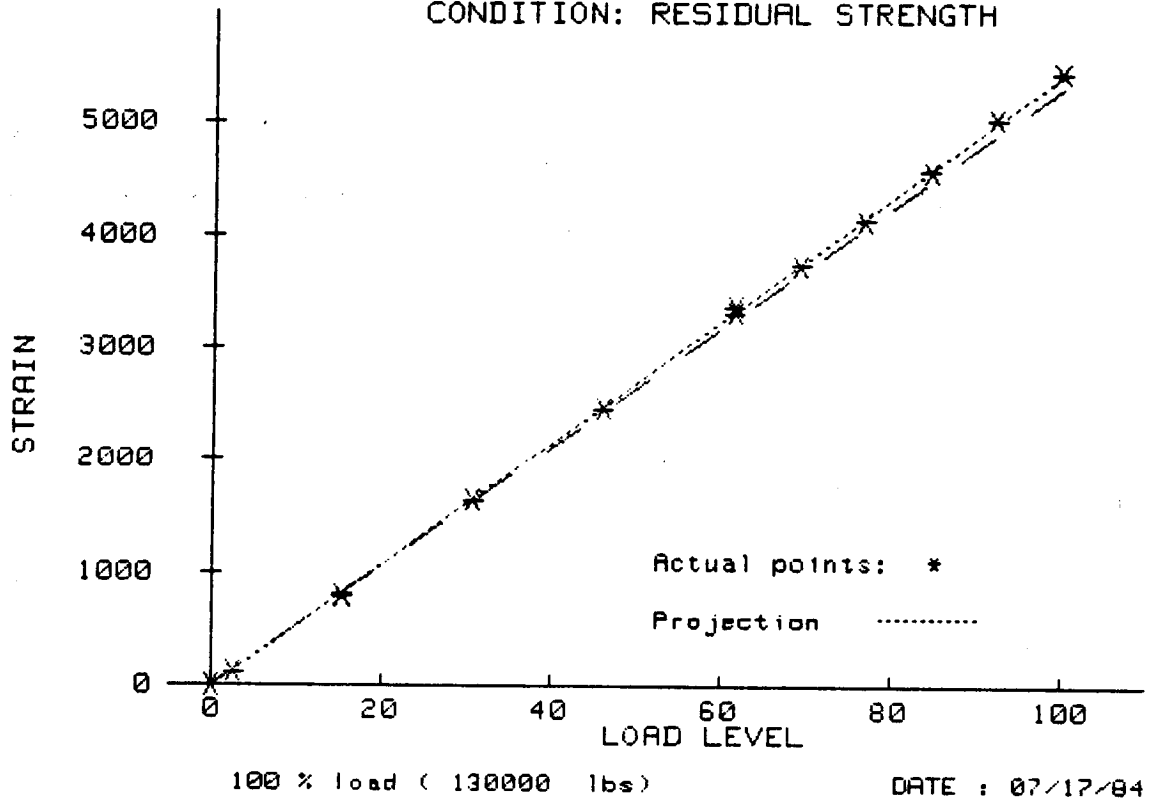
Figure H-18. CV2-2 Residual Strength Tension Test -  
Strain Gauge Readings - Plot Gage 18

GAGE: 18A  
SPECIMEN: CV2-2  
CONDITION: RESIDUAL STRENGTH

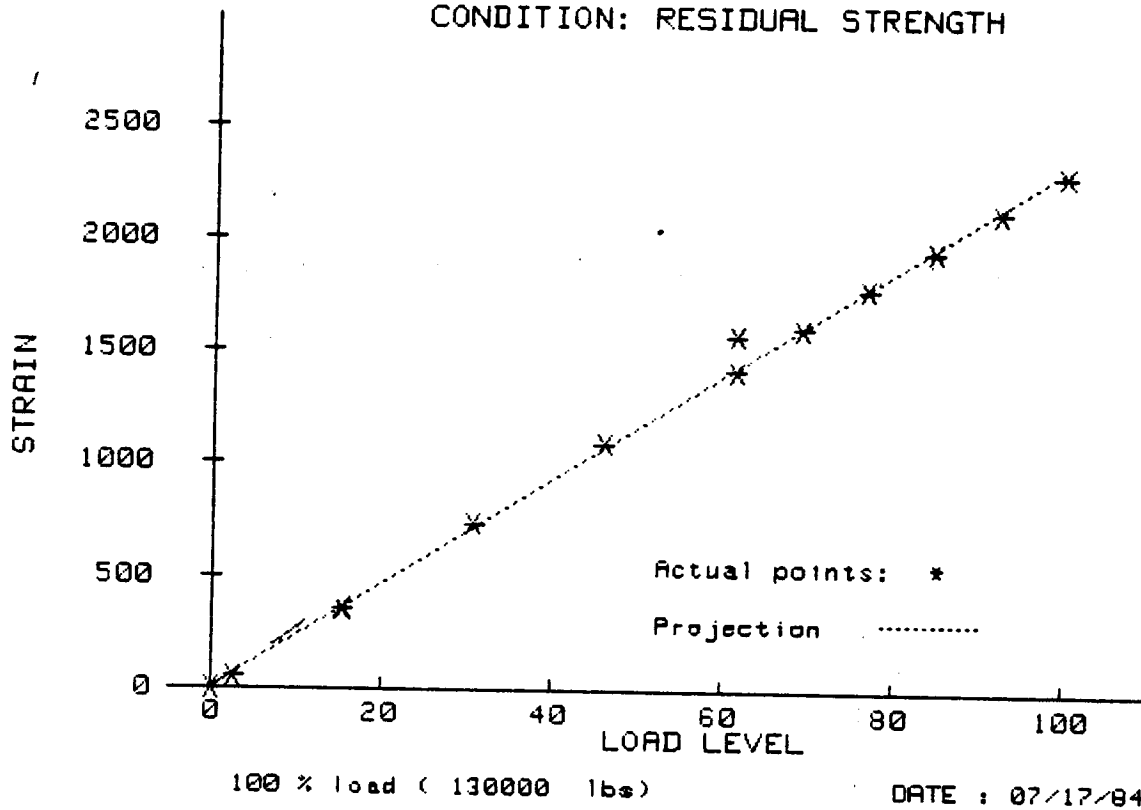
Figure H-21. CV2-2 Residual Strength Tension Test - Strain Gauge Readings - Plot Gage 21

GAGE: 21R  
SPECIMEN: CV2-2  
CONDITION: RESIDUAL STRENGTH

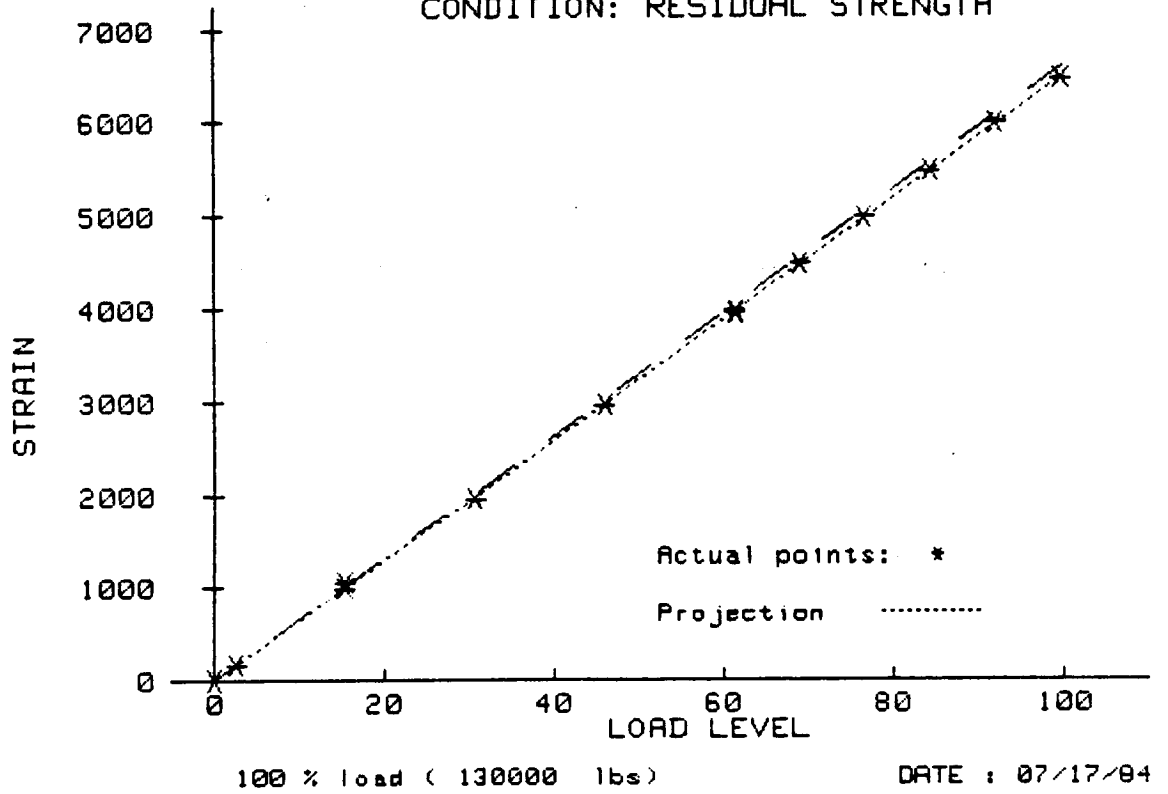
Figure H-22. CV2-2 Residual Strength Tension Test - Strain Gauge Readings - Plot Gage 22

GAGE: 22R  
SPECIMEN: CV2-2  
CONDITION: RESIDUAL STRENGTH

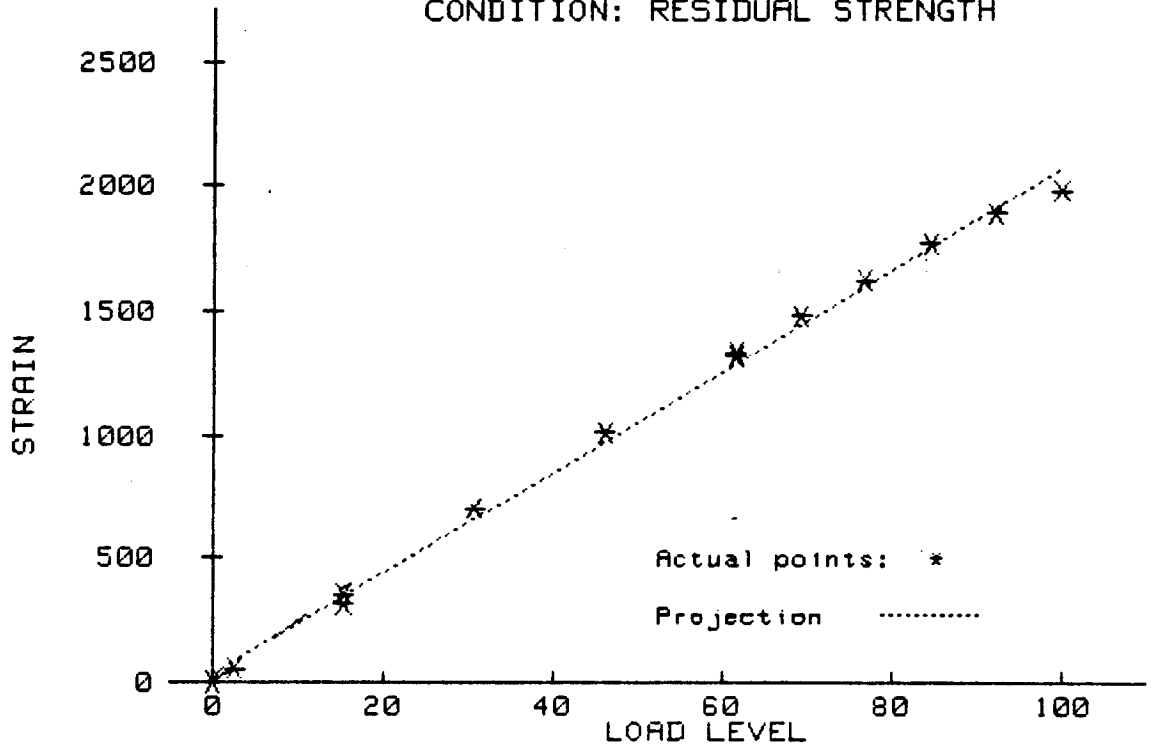
Figure H-24. CV2-2 Residual Strength Tension Test - Strain Gauge Readings - Plot Gage 24

GAGE: 24R  
SPECIMEN: CV2-2  
CONDITION: RESIDUAL STRENGTH

100 % load ( 130000 lbs)

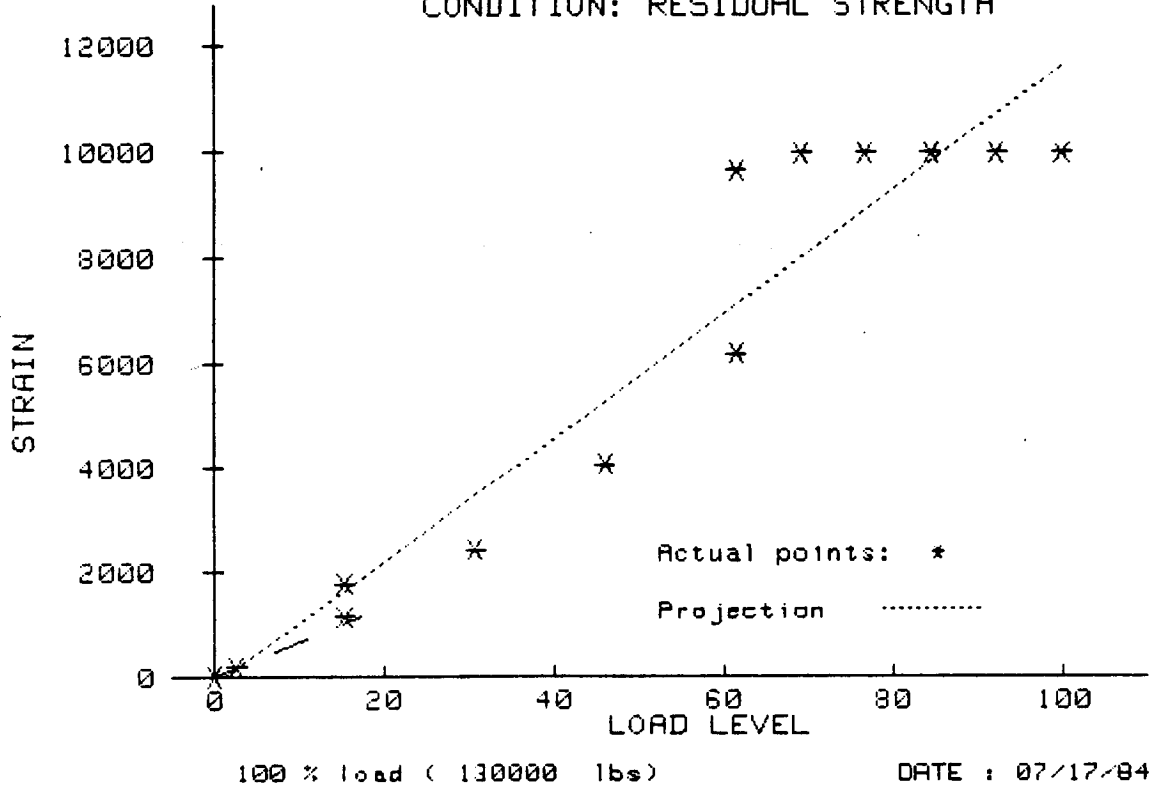
Figure H-29. CV2-2 Residual Strength Tension Test - Strain Gauge Readings - Plot Gage 29

GAGE: 29A  
SPECIMEN: CV2-2  
CONDITION: RESIDUAL STRENGTH

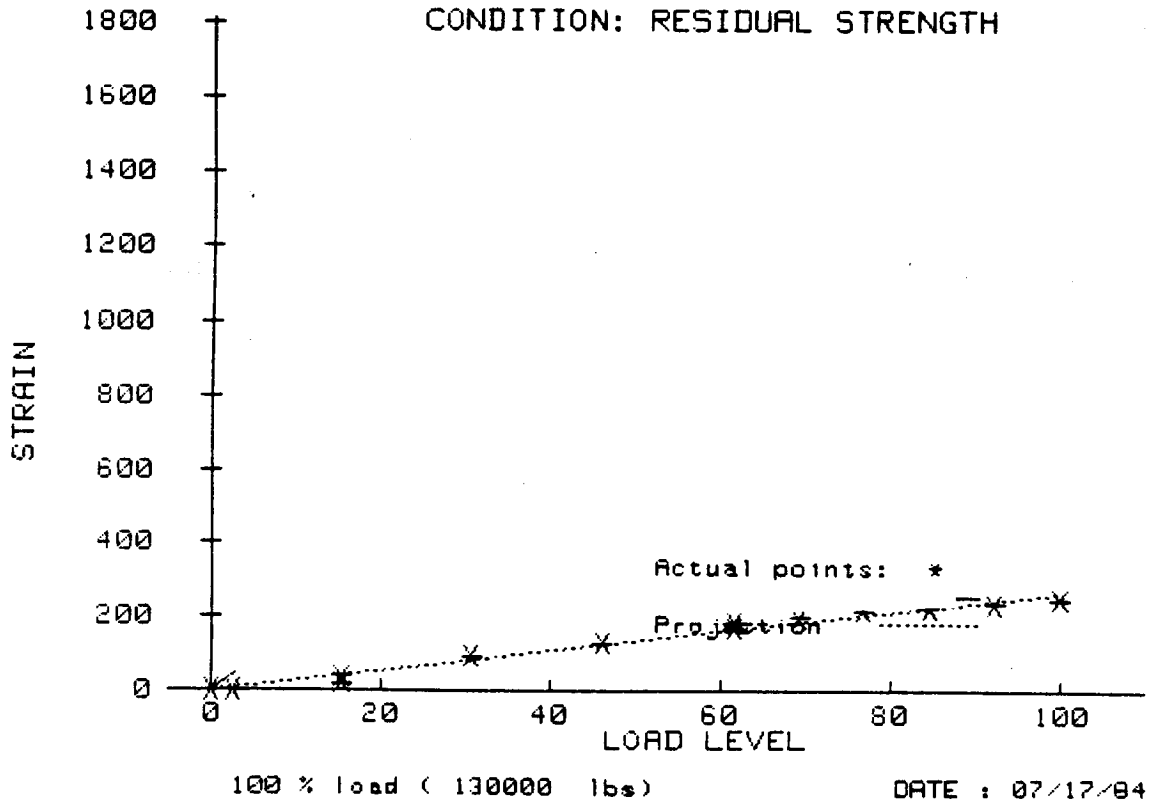
Figure H-33. CV2-2 Residual Strength Tension Test -  
Strain Gauge Readings - Plot Gage 33

GAGE: 33R  
SPECIMEN: CV2-2  
CONDITION: RESIDUAL STRENGTH

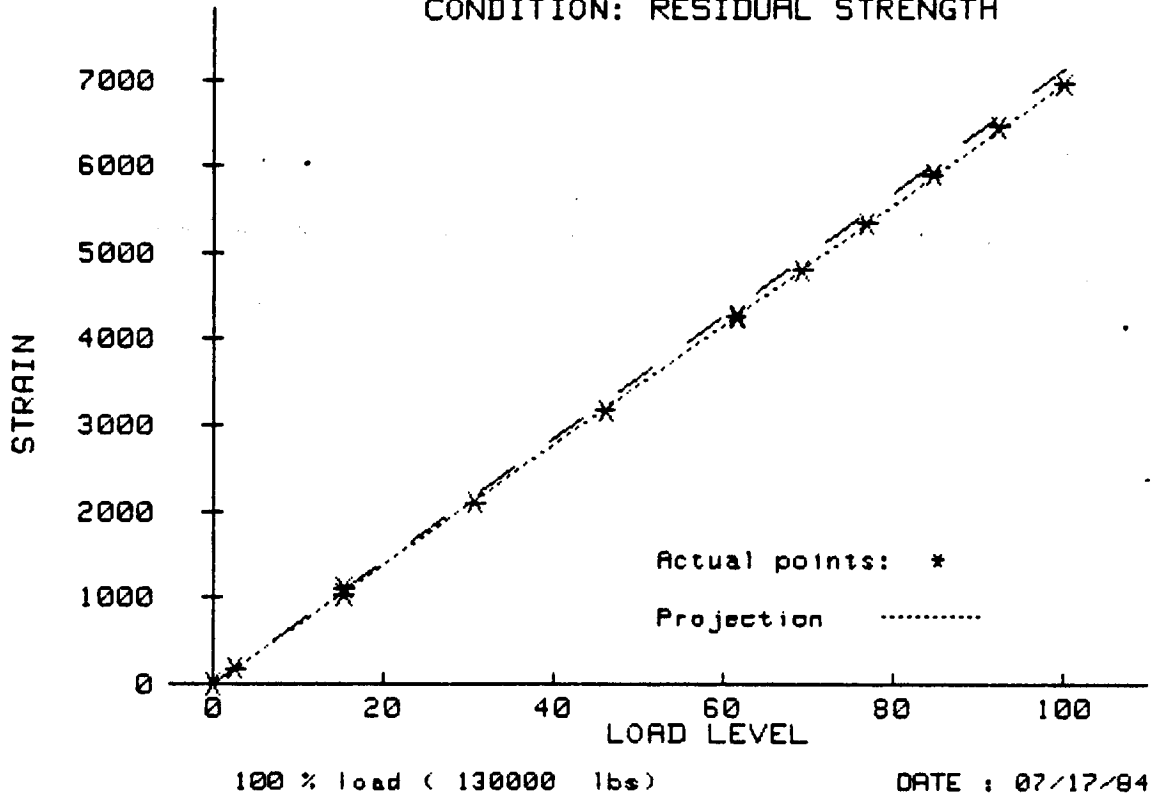
Figure H-34. CV2-2 Residual Strength Tension Test - Strain Gauge Readings - Plot Gage 34

GAGE: 34R  
SPECIMEN: CV2-2  
CONDITION: RESIDUAL STRENGTH

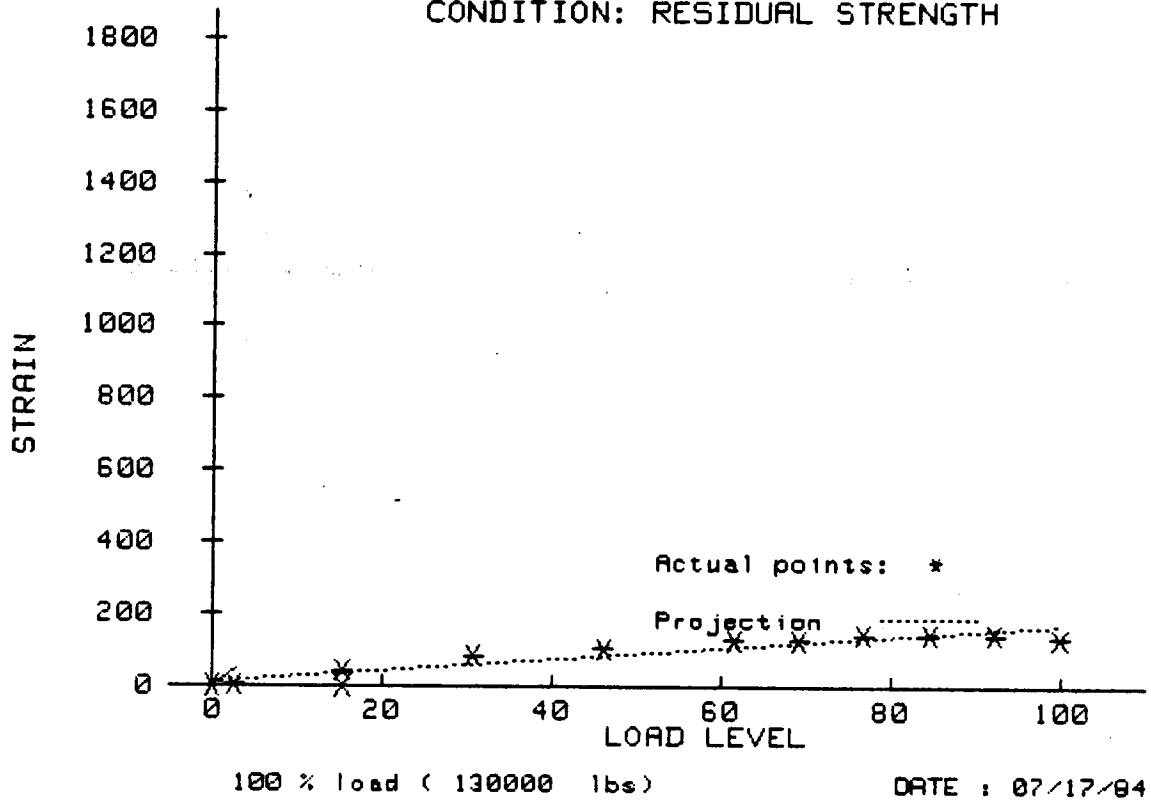
Figure H-36. CV2-2 Residual Strength Tension Test -  
Strain Gauge Readings - Plot Gage 36

GAGE: 36R  
SPECIMEN: CV2-2  
CONDITION: RESIDUAL STRENGTH

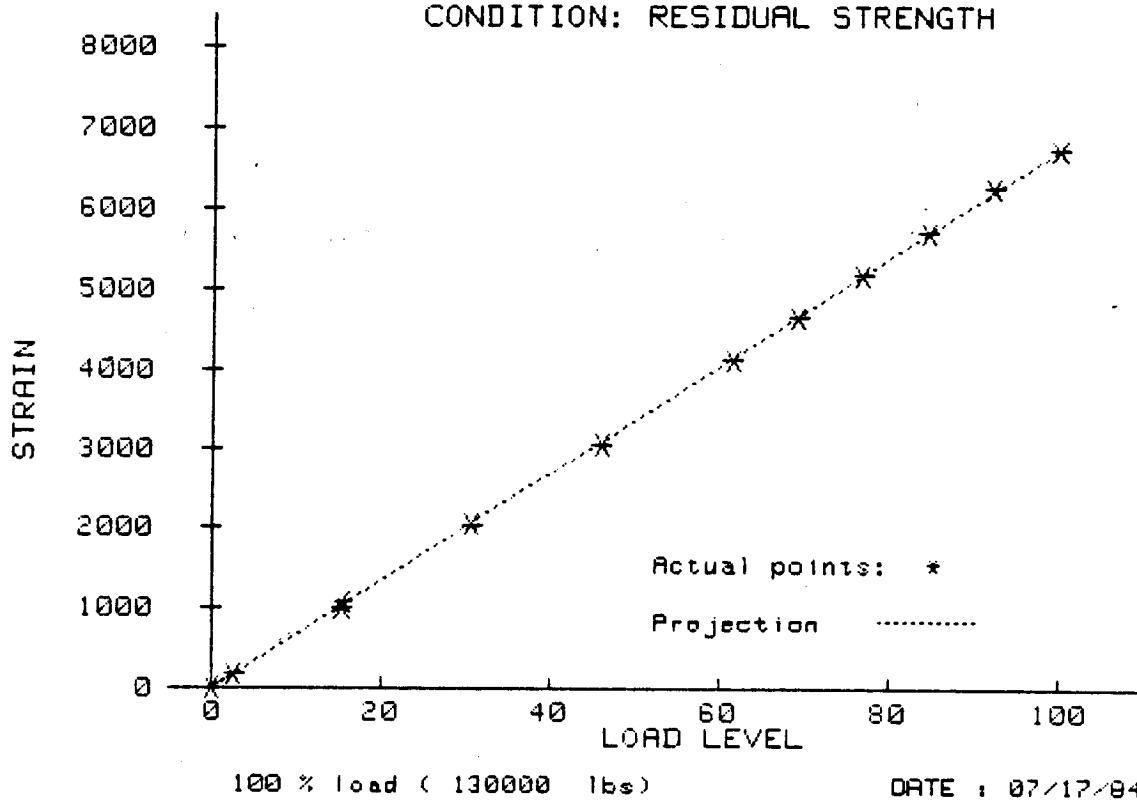
Figure H-37. CV2-2 Residual Strength Tension Test - Strain Gauge Readings - Plot Gage 37

GAGE: 37R  
SPECIMEN: CV2-2  
CONDITION: RESIDUAL STRENGTH

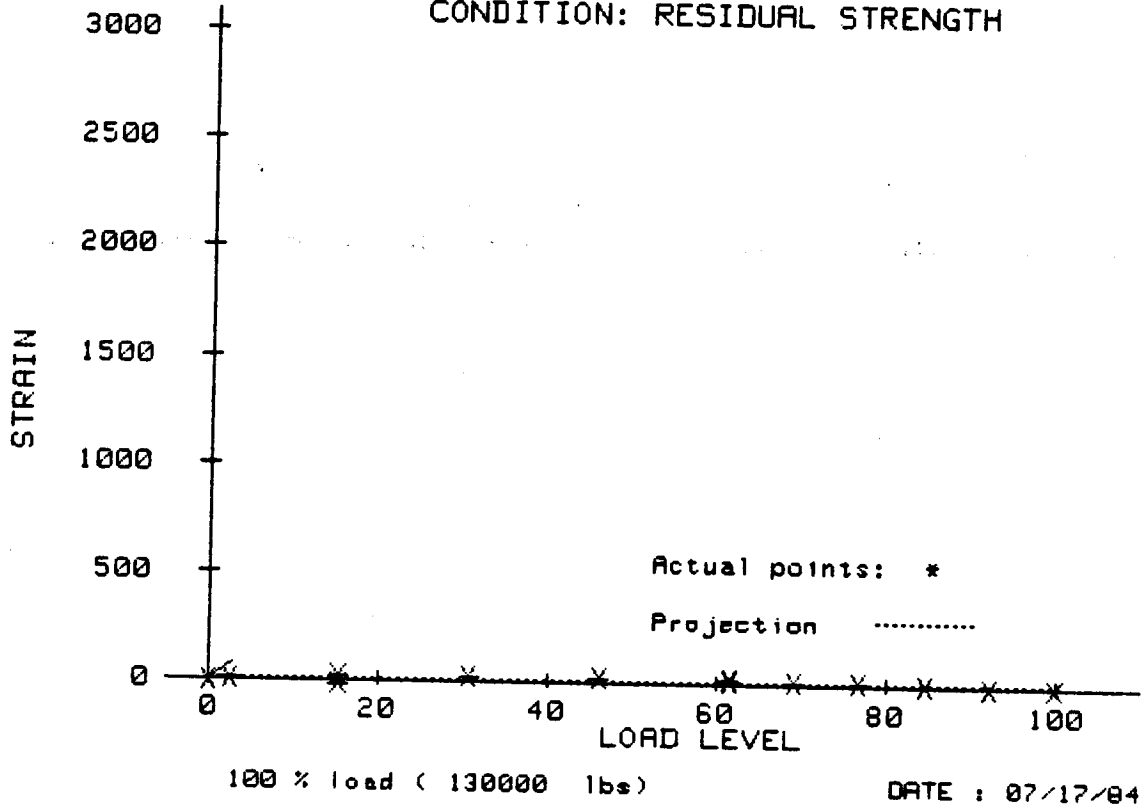
Figure H-38. CV2-2 Residual Strength Tension Test - Strain Gauge Readings - Plot Gage 38

GAGE: 38A  
SPECIMEN: CV2-2  
CONDITION: RESIDUAL STRENGTH

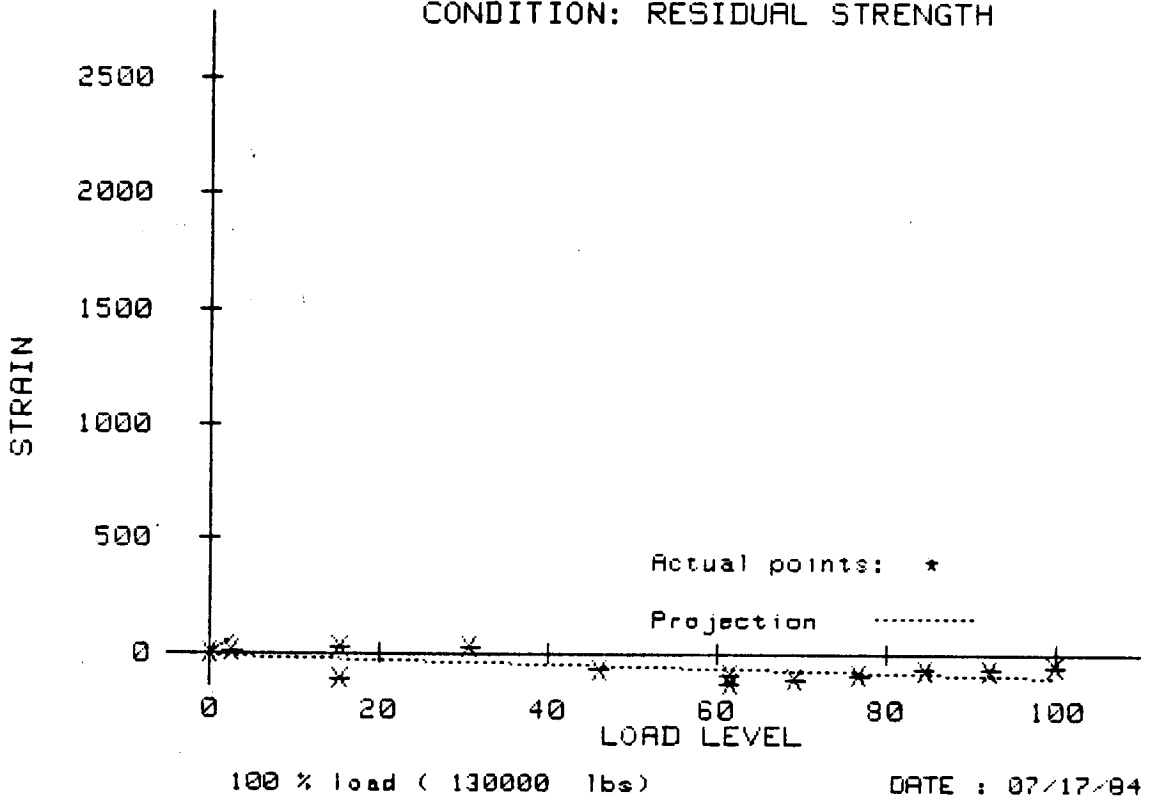
Figure H-39. CV2-2 Residual Strength Tension Test - Strain Gauge Readings - Plot Gage 39

GAGE: 39A  
SPECIMEN: CV2-2  
CONDITION: RESIDUAL STRENGTH

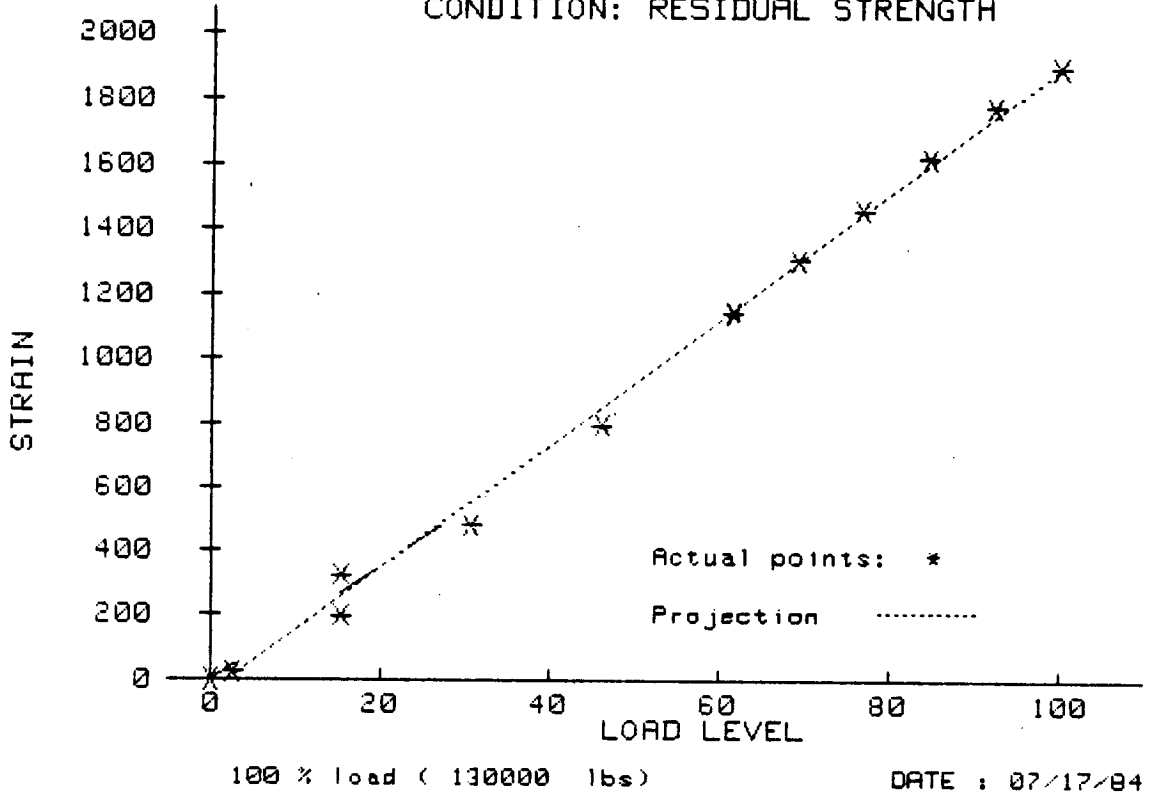
Figure H-41. CV2-2 Residual Strength Tension Test - Strain Gauge Readings - Plot Gage 41

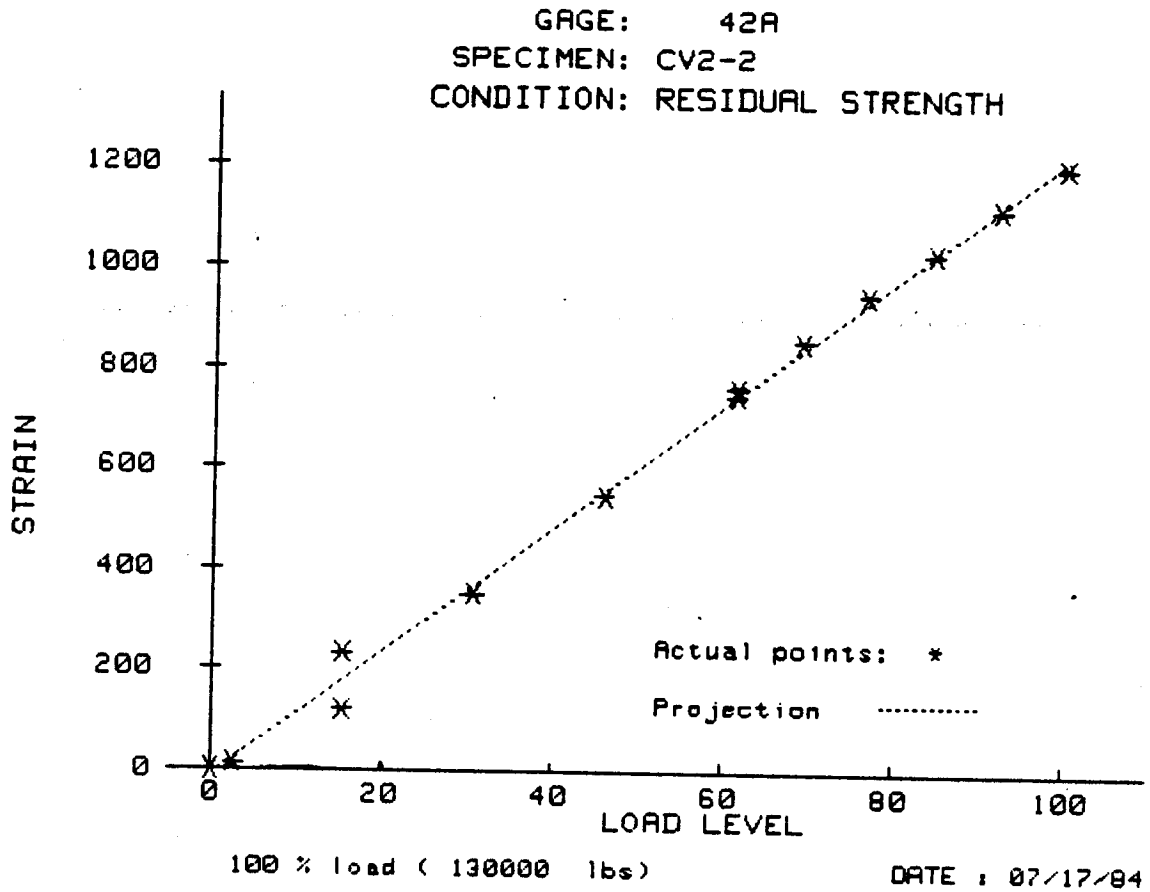
Figure H-42. CV2-2 Residual Strength Tension Test - Strain Gauge Readings - Plot Gage 42

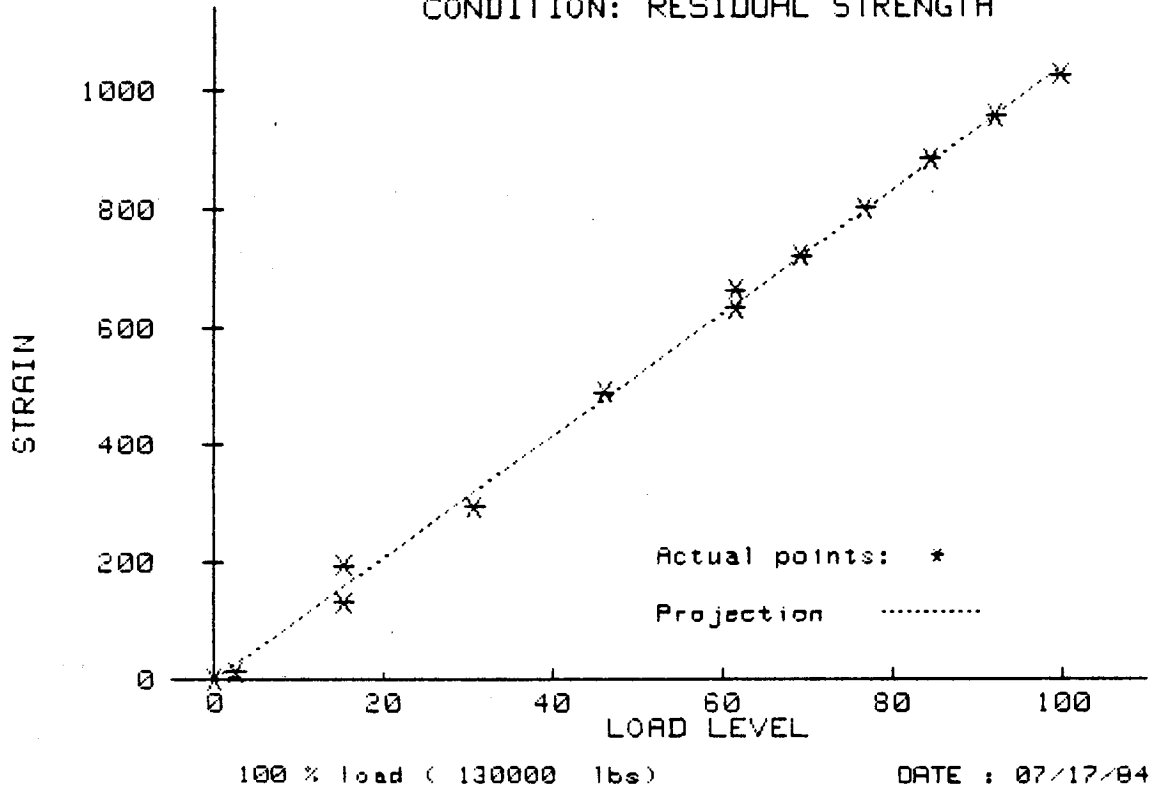
Figure H-43. CV2-2 Residual Strength Tension Test - Strain Gauge Readings - Plot Gage 43

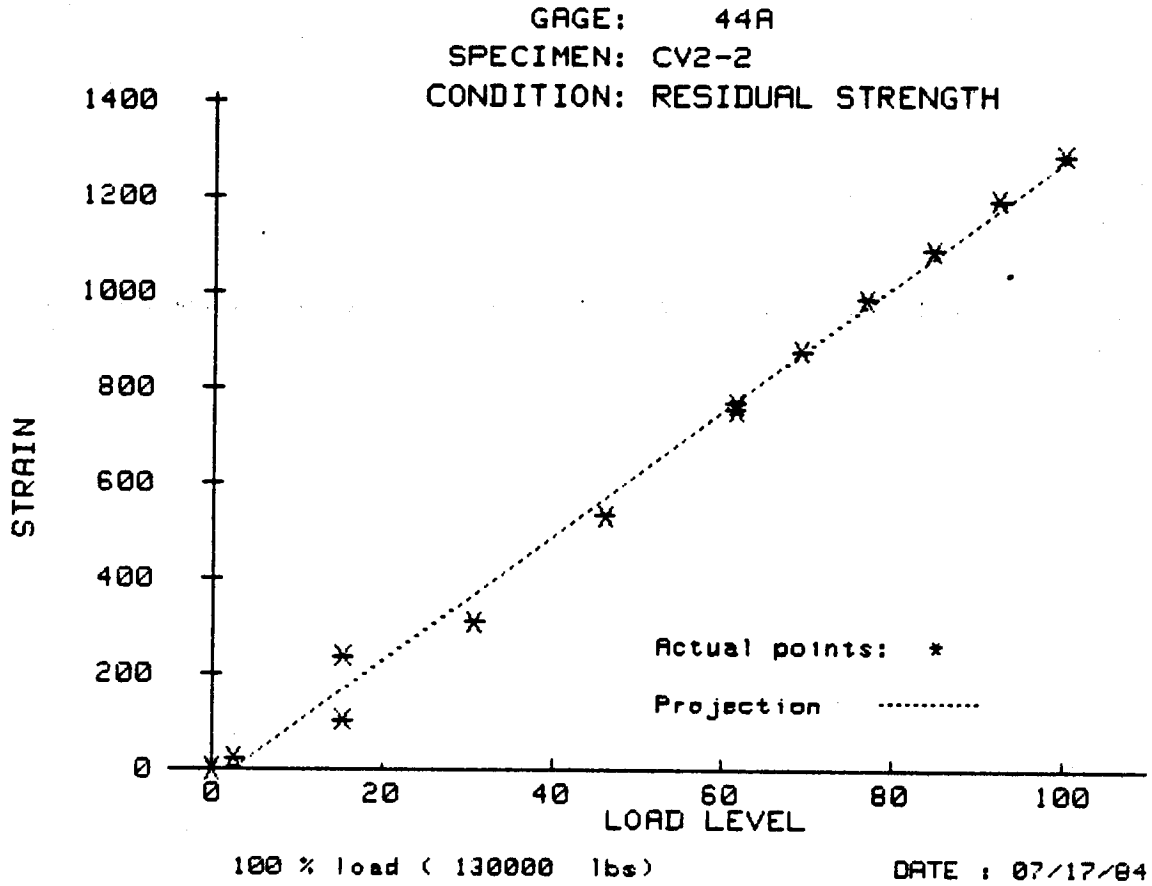
Figure H-44. CV2-2 Residual Strength Tension Test - Strain Gauge Readings - Plot Gage 44

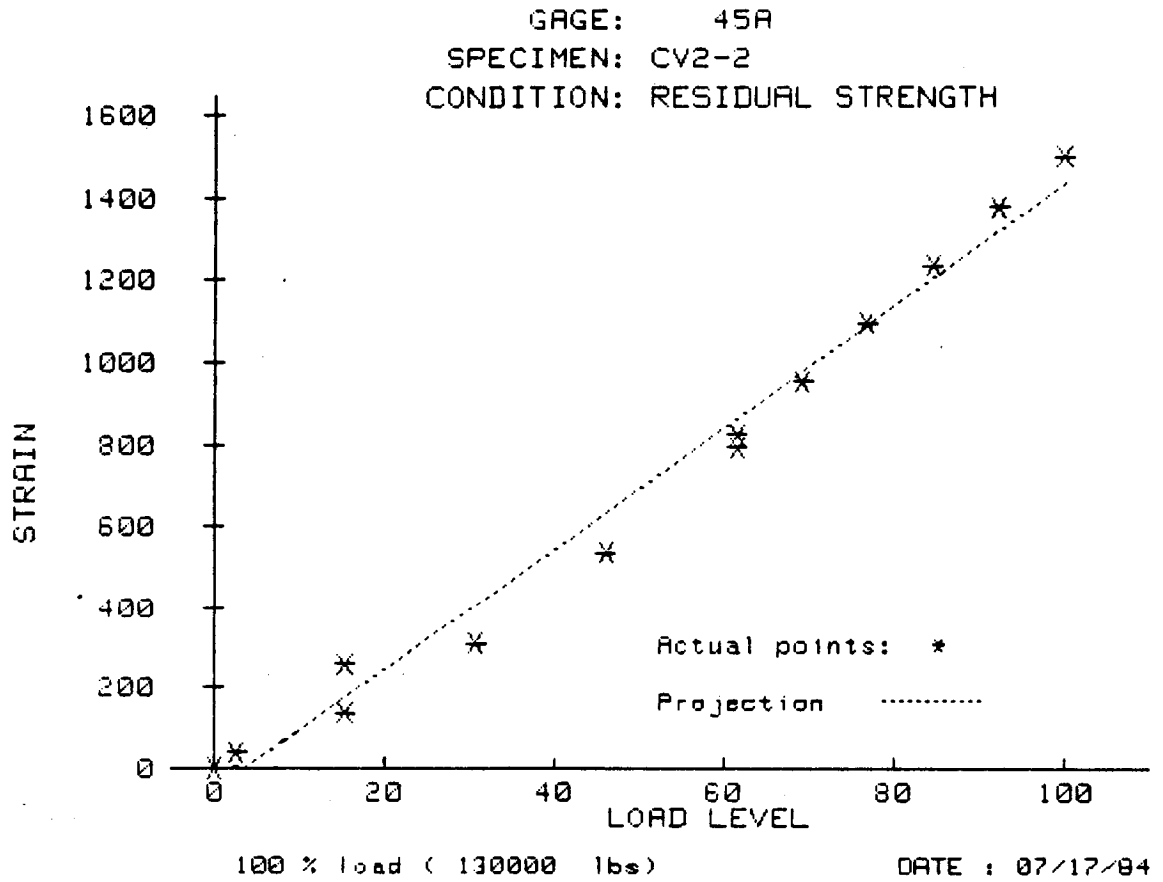
Figure H-45. CV2-2 Residual Strength Tension Test - Strain Gauge Readings - Plot Gage 45

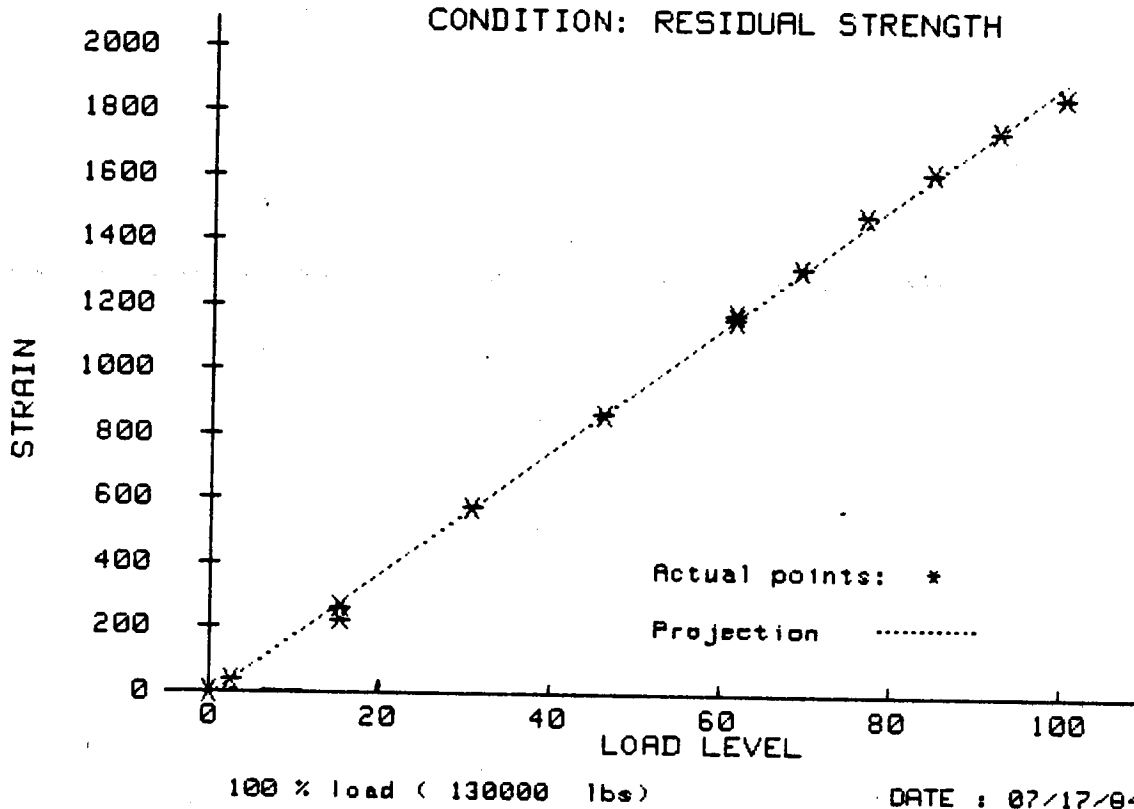
Figure H-46. CV2-2 Residual Strength Tension Test - Strain Gauge Readings - Plot Gage 46

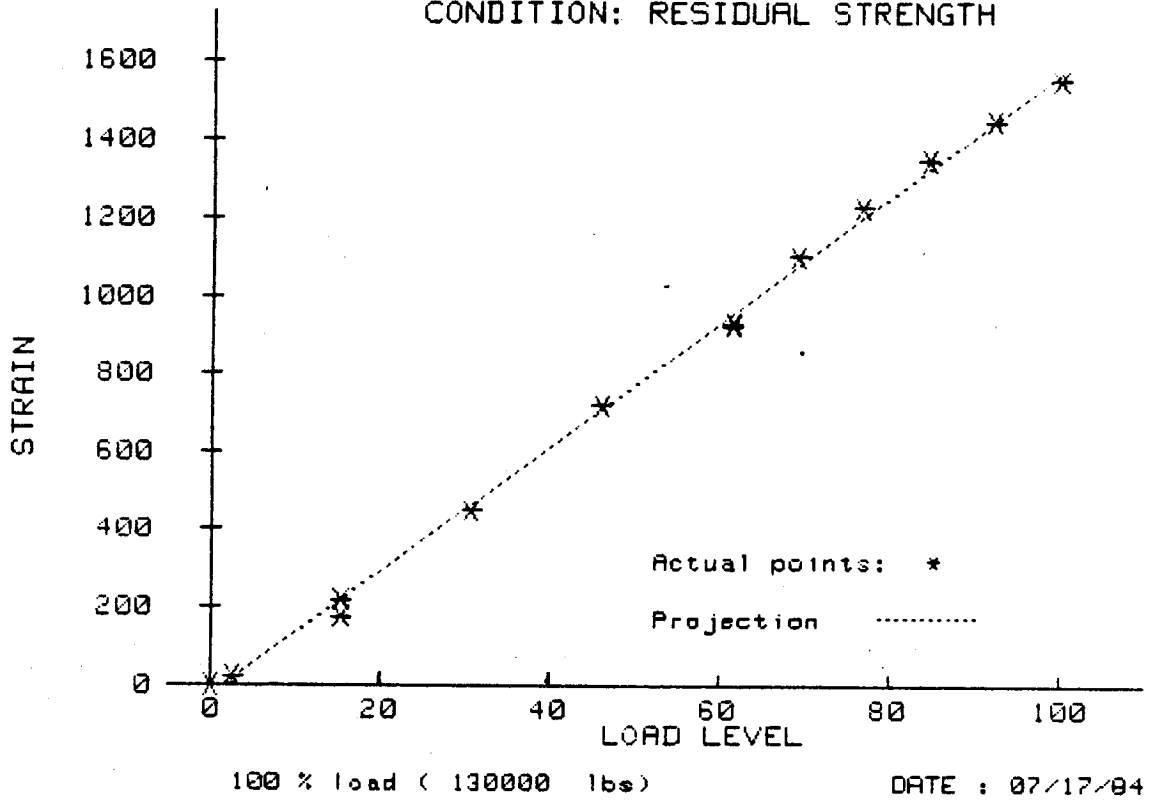
Figure H-47. CV2-2 Residual Strength Tension Test -  
Strain Gauge Readings - Plot Gage 47

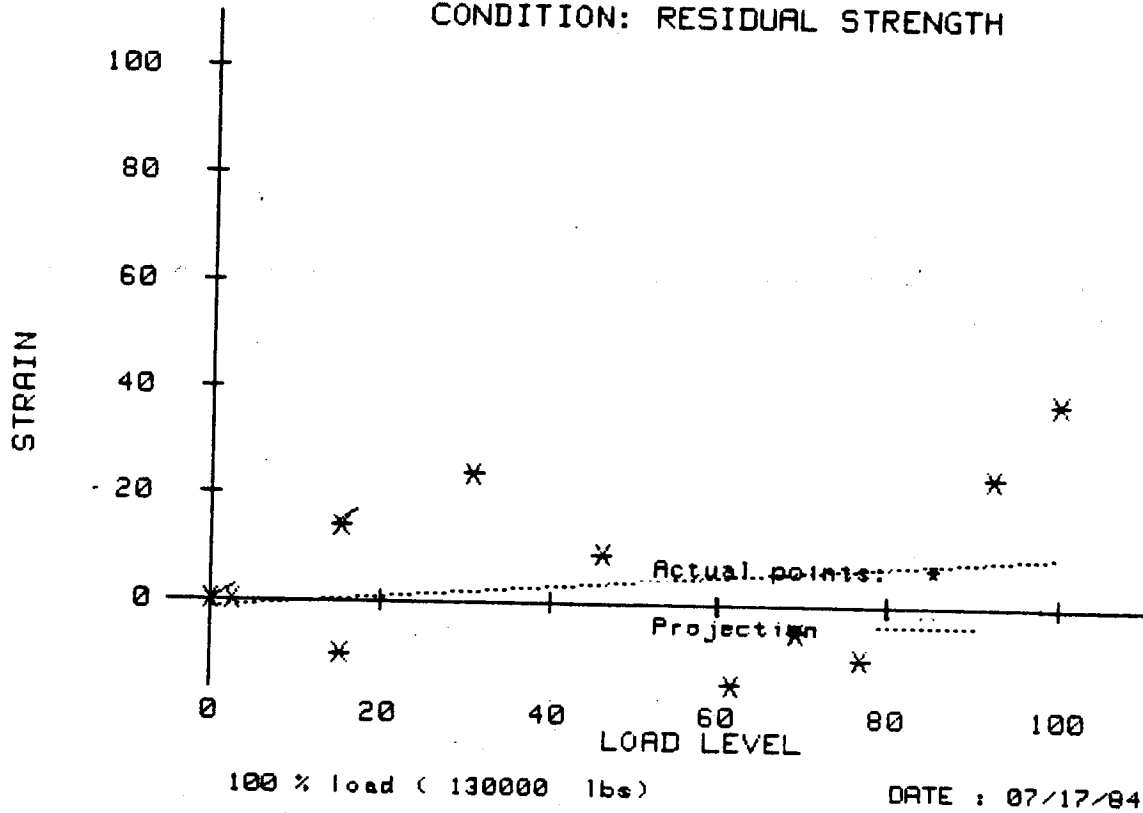
Figure H-48. CV2-2 Residual Strength Tension Test - Strain Gauge Readings - Plot Gage 48

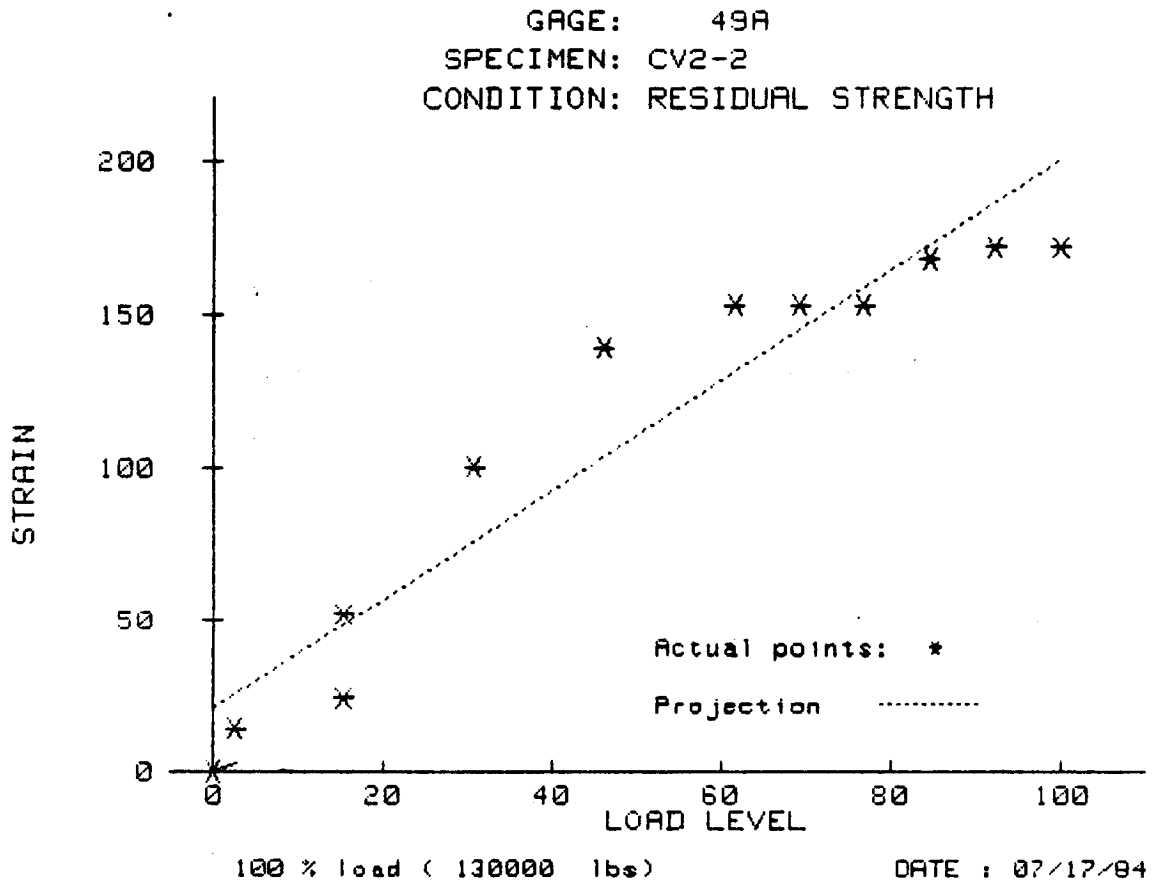
Figure H-49. CV2-2 Residual Strength Tension Test - Strain Gauge Readings - Plot Gage 49

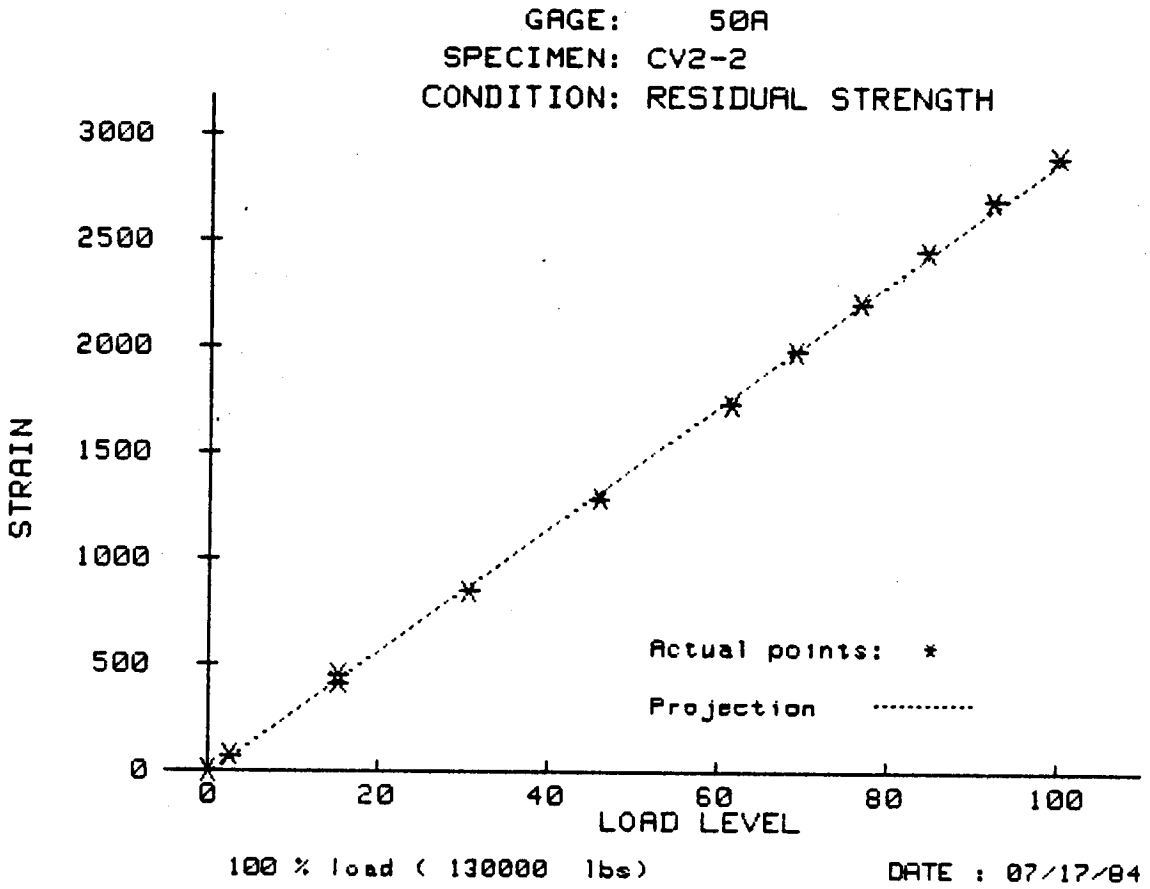
Figure H-50. CV2-2 Residual Strength Tension Test - Strain Gauge Readings - Plot Gage 50

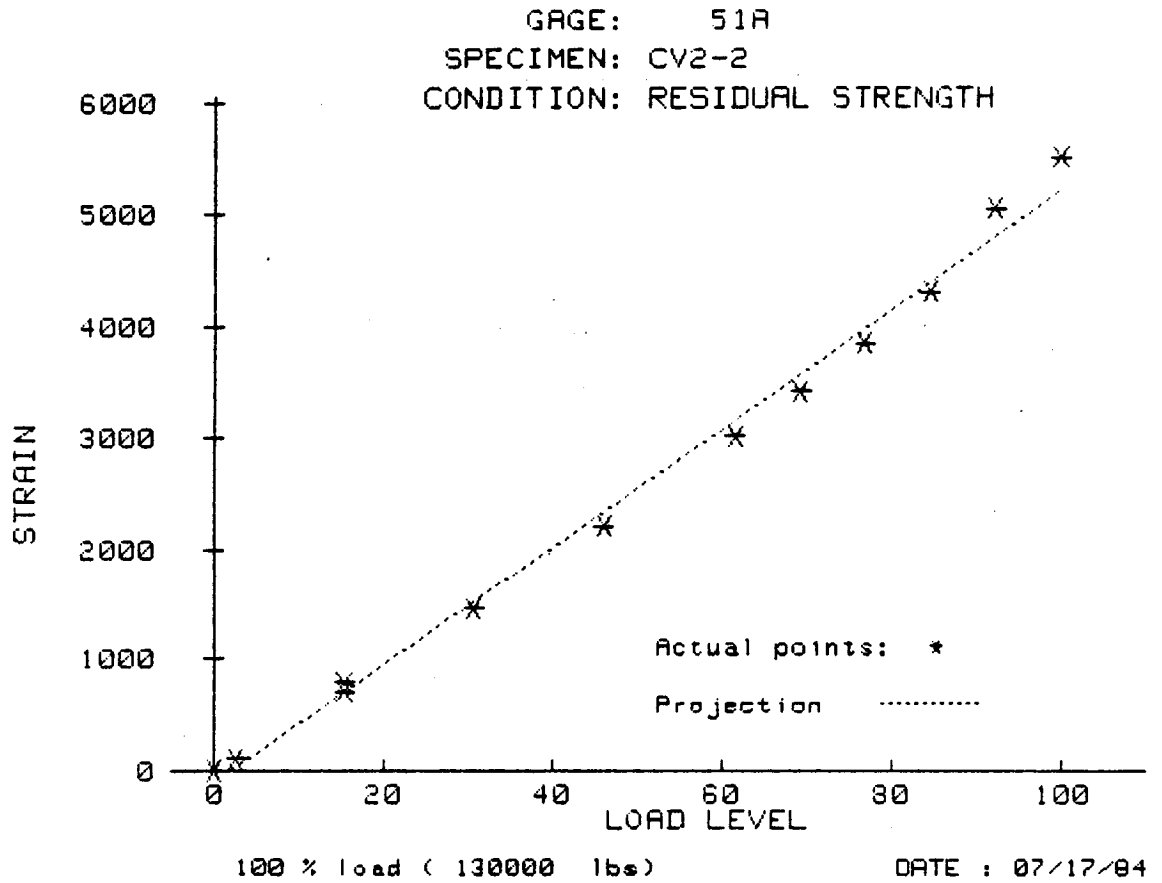
Figure H-51. CV2-2 Residual Strength Tension Test - Strain Gauge Readings - Plot Gage 51

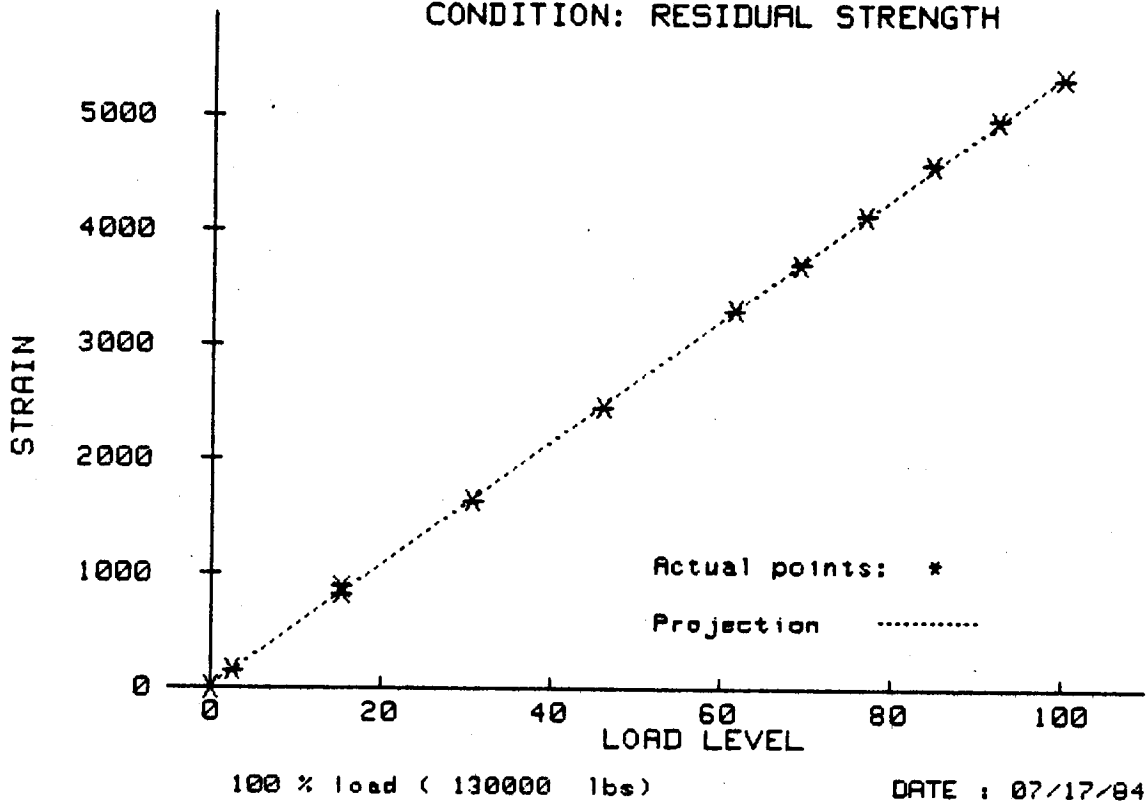
Figure H-52. CV2-2 Residual Strength Tension Test - Strain Gauge Readings - Plot Gage 52
