# NASA Contractor Report 172462

## Structural Tests and Development of a Laminar Flow Control Wing Surface Composite Chordwise Joint

LOCKHEED-GEORGIA COMPANY  
Marietta, Georgia 30063

CONTRACT NAS 1-17487  
December 1984

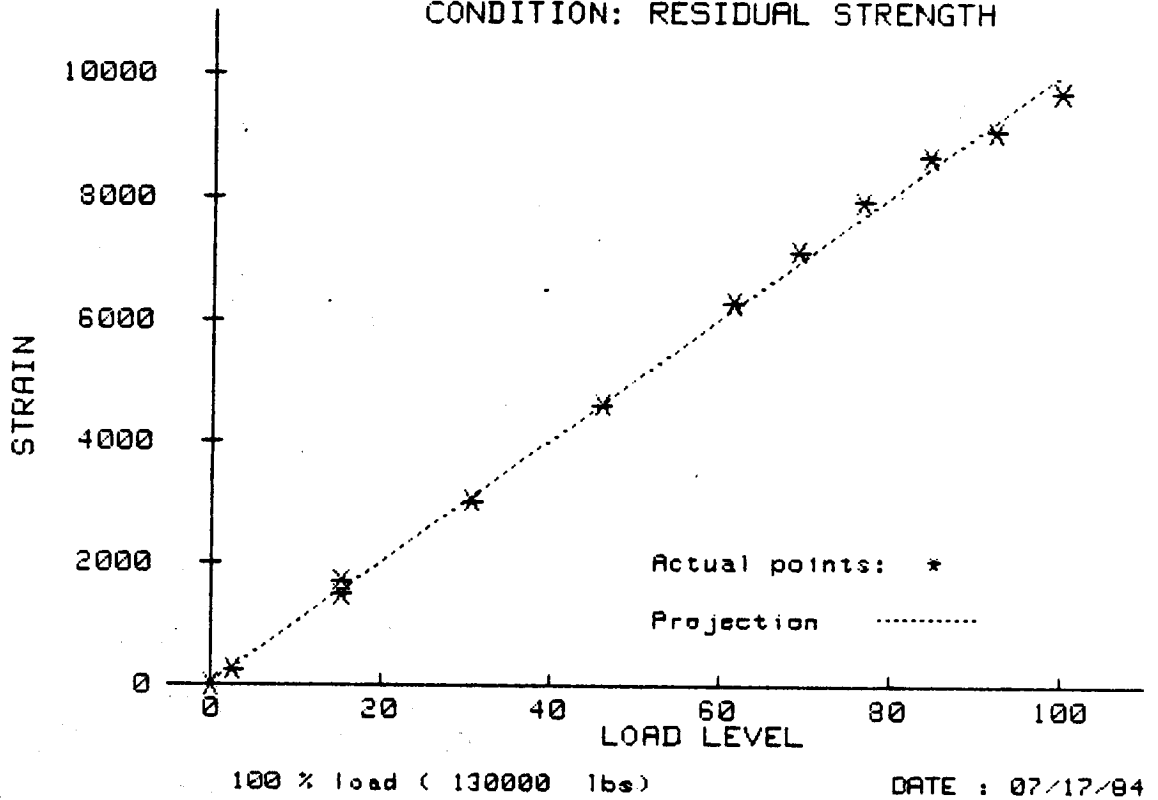
Figure H-53. CV2-2 Residual Strength Tension Test - Strain Gauge Readings - Plot Gage 53

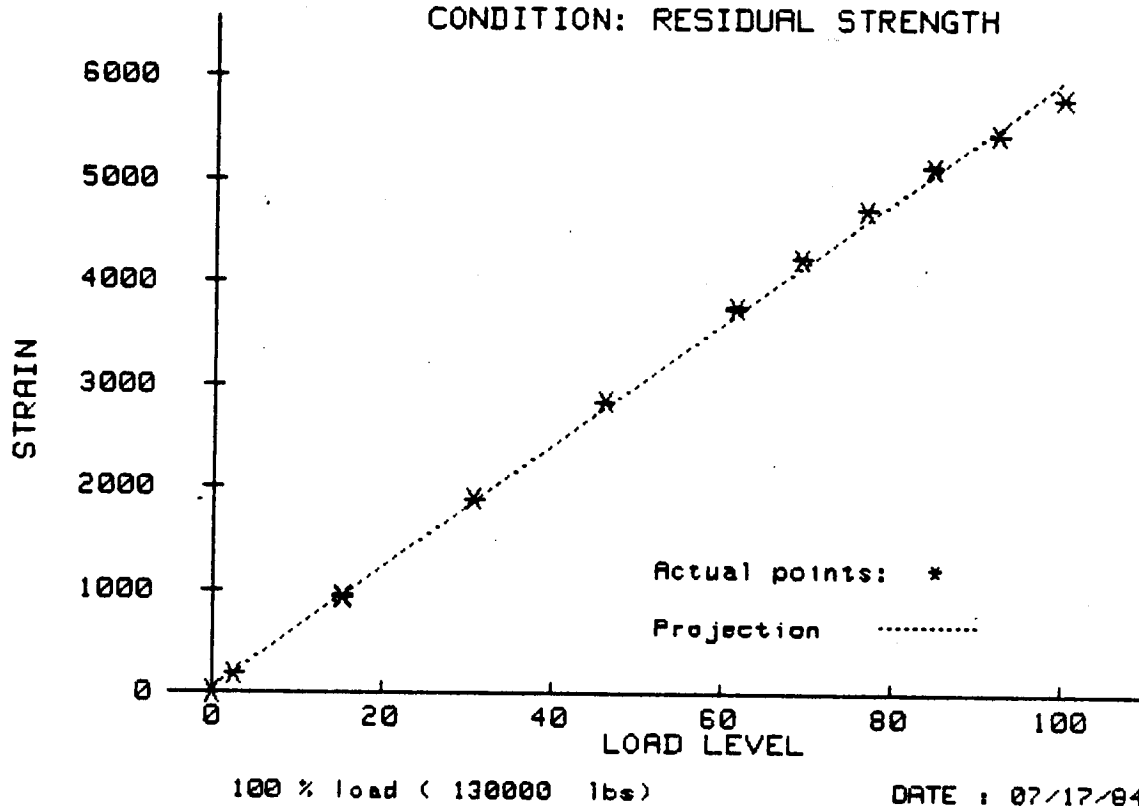
Figure H-54. CV2-2 Residual Strength Tension Test - Strain Gauge Readings - Plot Gage 54

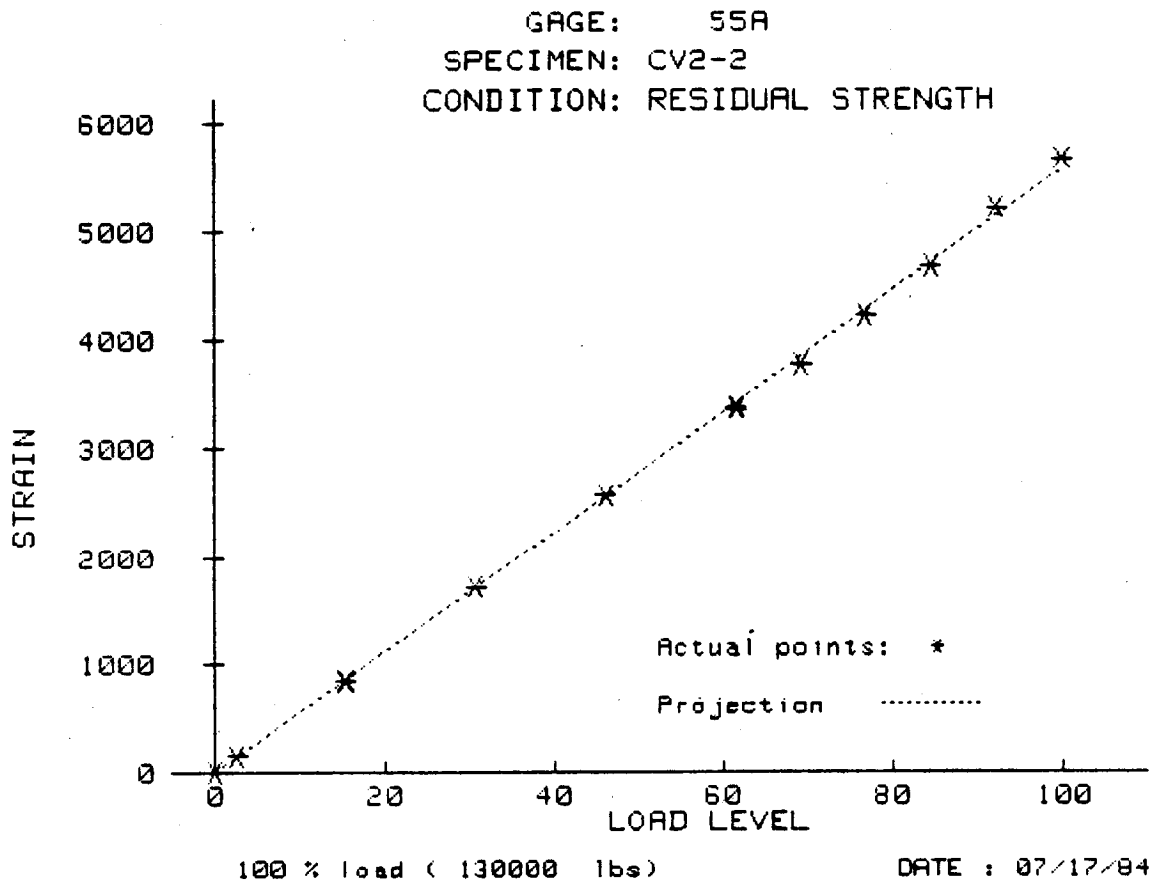
Figure H-55. CV2-2 Residual Strength Tension Test - Strain Gauge Readings - Plot Gage 55

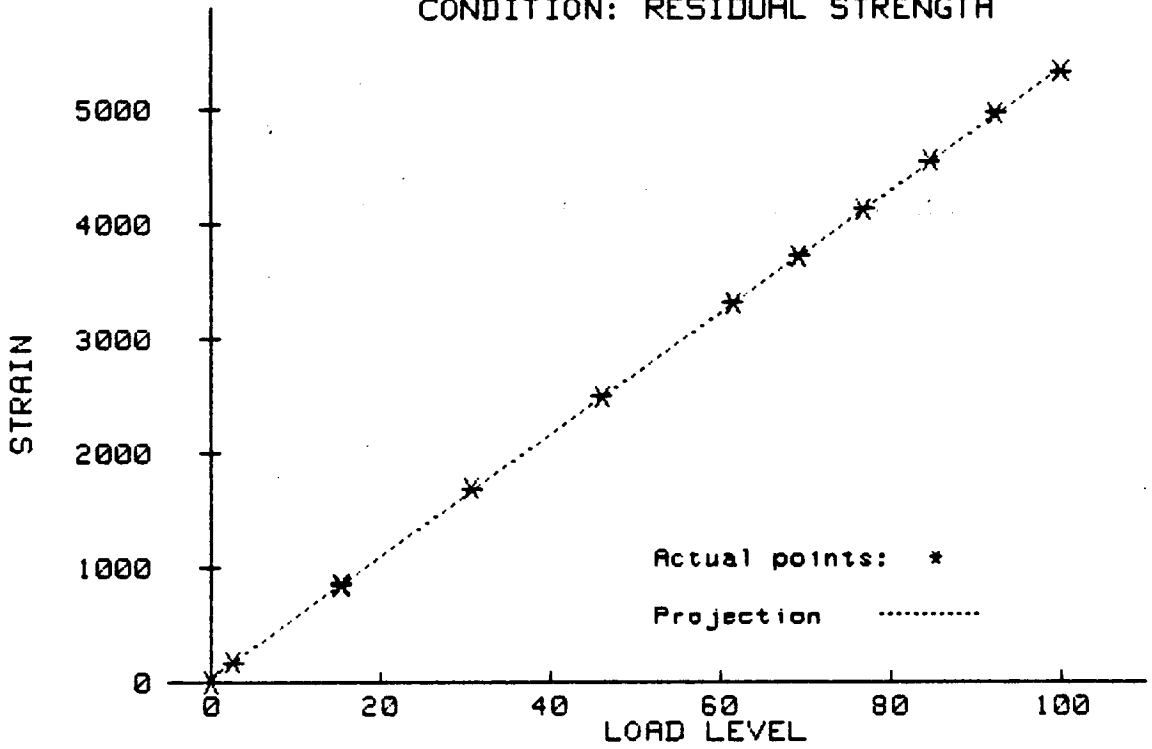
100 % load ( 130000 lbs)

Figure H-56. CV2-2 Residual Strength Tension Test -  
Strain Gauge Readings - Plot Gage 56

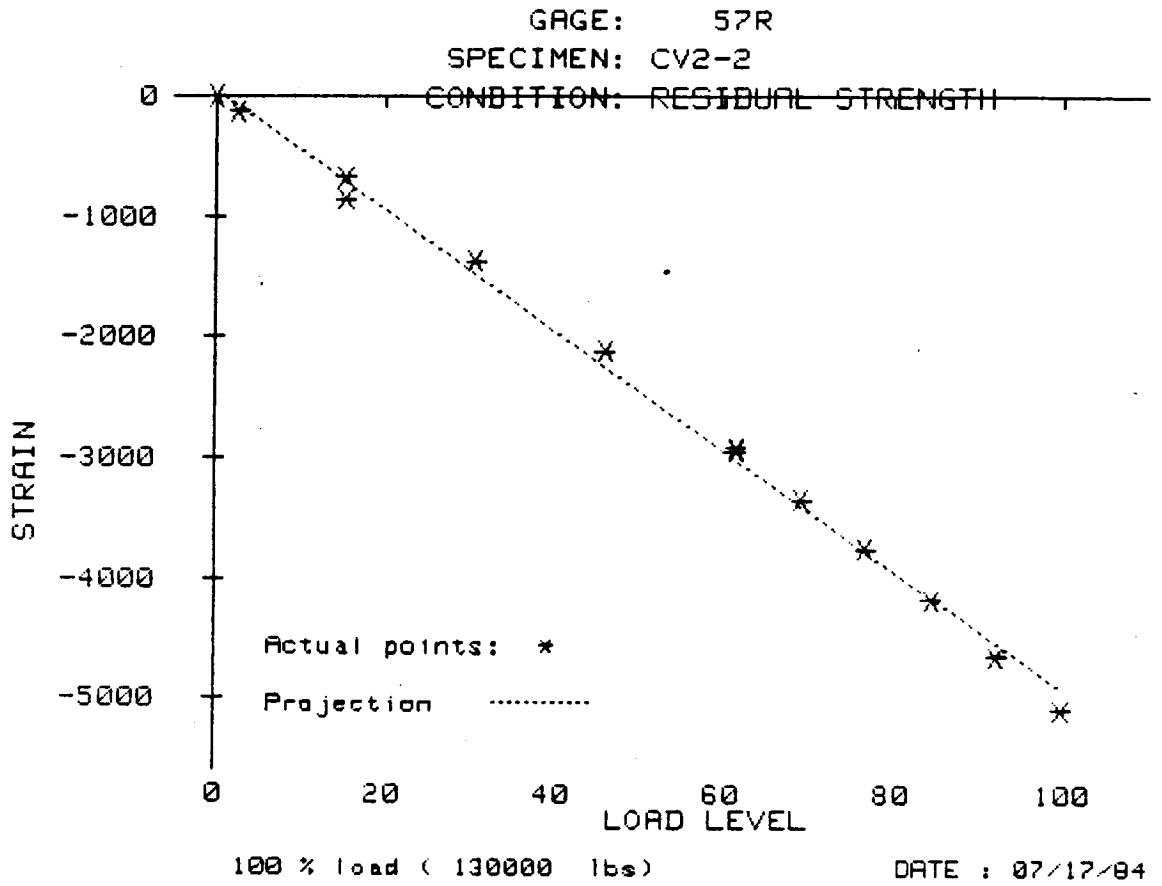
Figure H-57. CV2-2 Residual Strength Tension Test - Strain Gauge Readings - Plot Gage 57

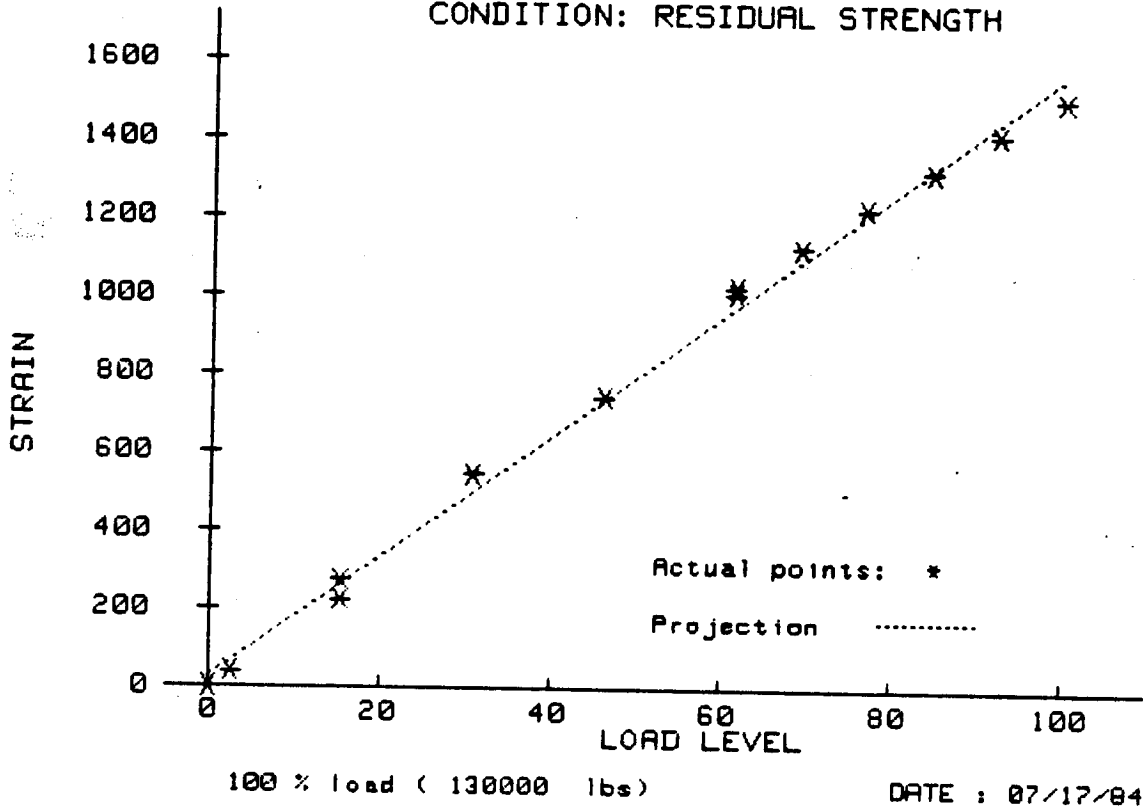
Figure H-58. CV2-2 Residual Strength Tension Test - Strain Gauge Readings - Plot Gage 58

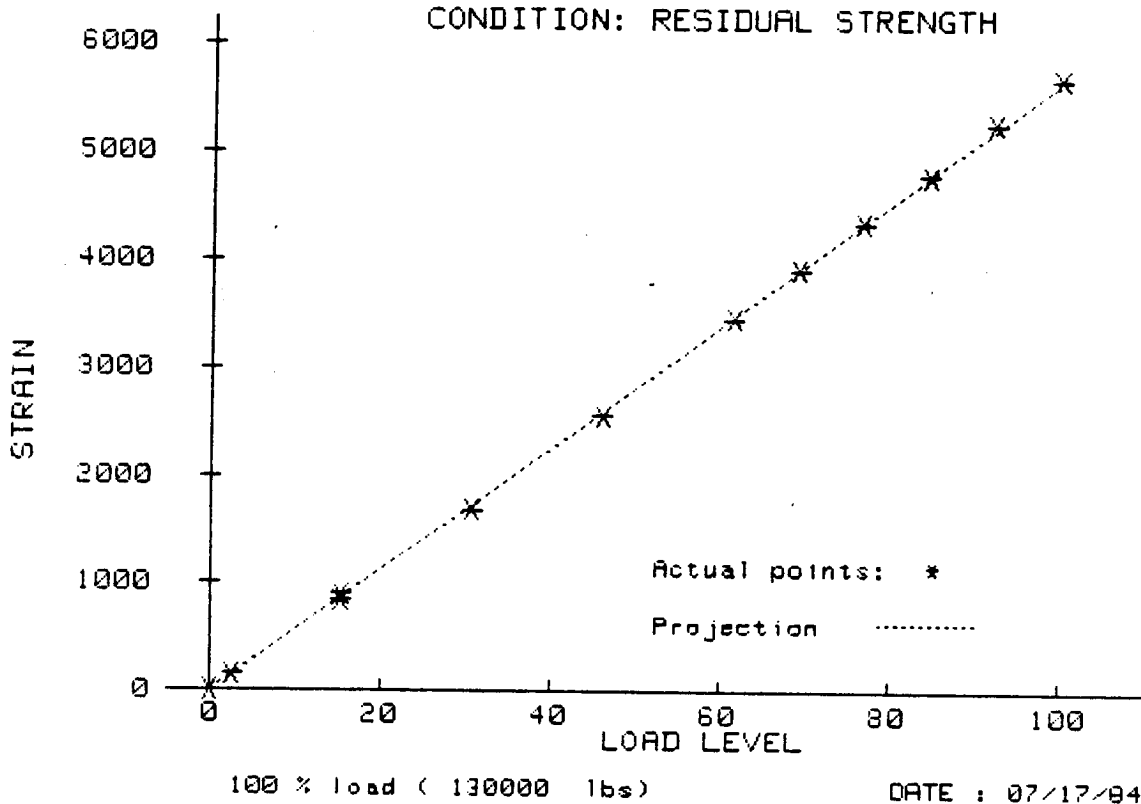
Figure H-59. CV2-2 Residual Strength Tension Test - Strain Gauge Readings - Plot Gage 59

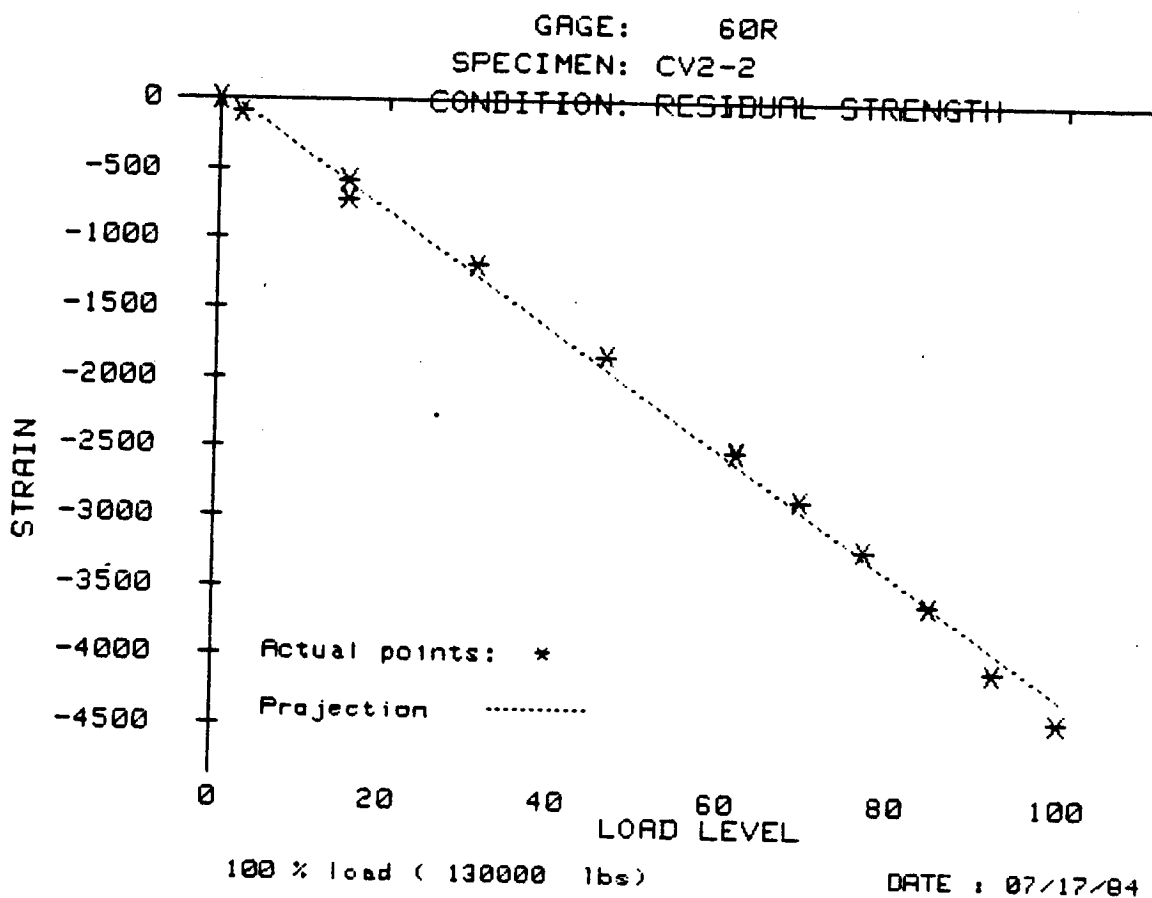
Figure H-60. CV2-2 Residual Strength Tension Test -  
Strain Gauge Readings - Plot Gage 60

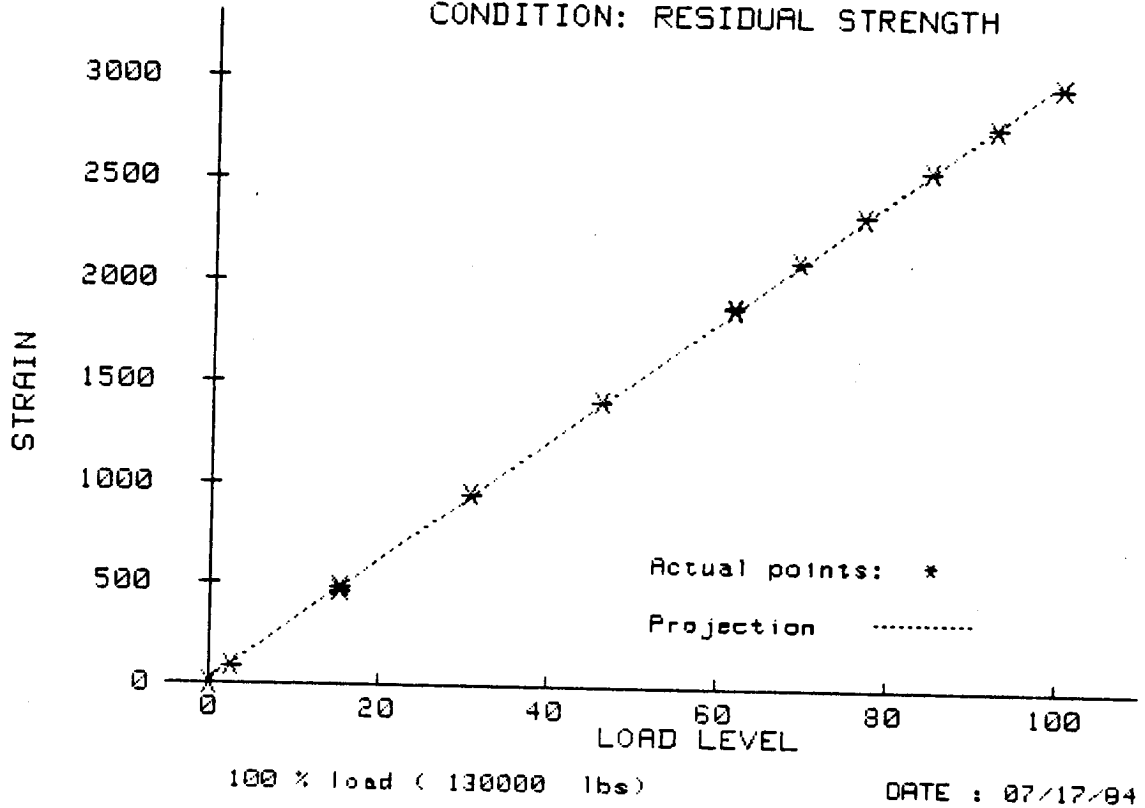
Figure H-61. CV2-2 Residual Strength Tension Test - Strain Gauge Readings - Plot Gage 61

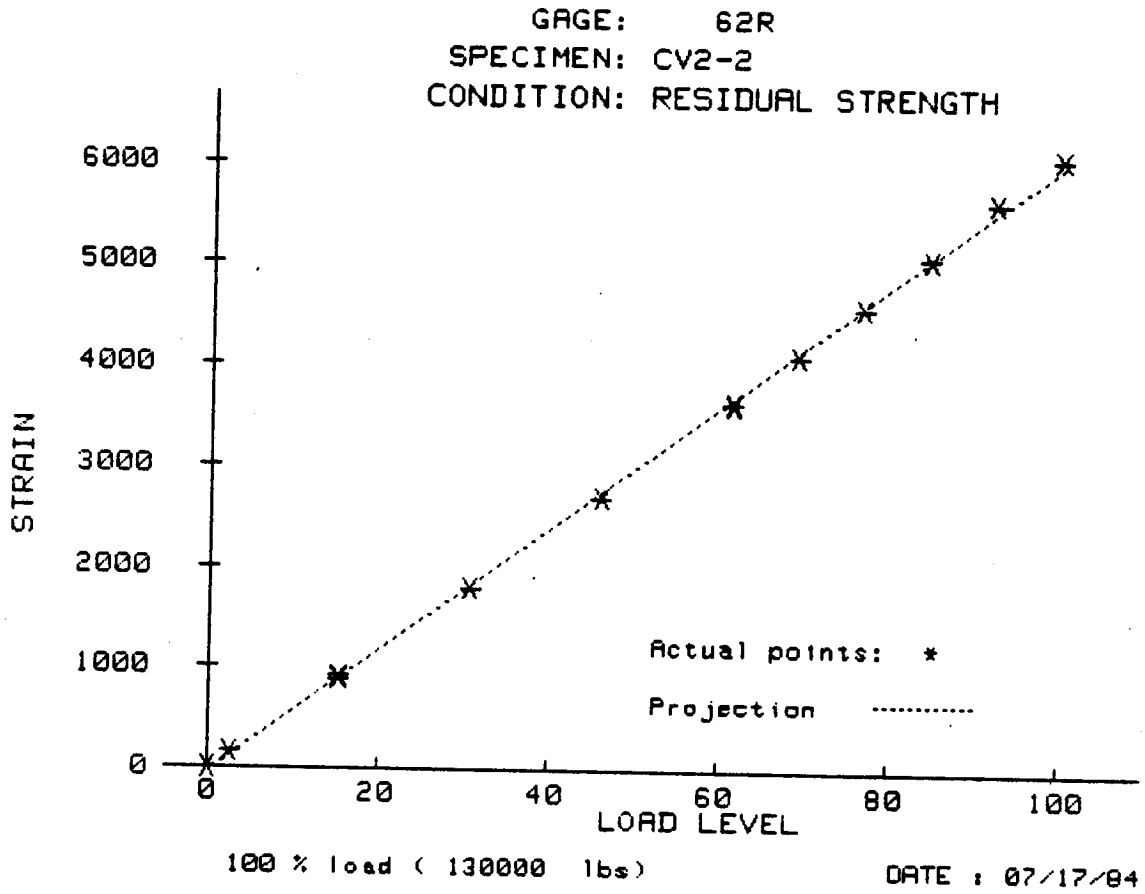
Figure H-62. CV2-2 Residual Strength Tension Test - Strain Gauge Readings - Plot Gage 62
