NASA Technical Memorandum 4008

Antarctic Field Tests of SARSAT Personal Locater Beacons

Robert Bindschadler
*Goddard Space Flight Center
Greenbelt, Maryland*

1987

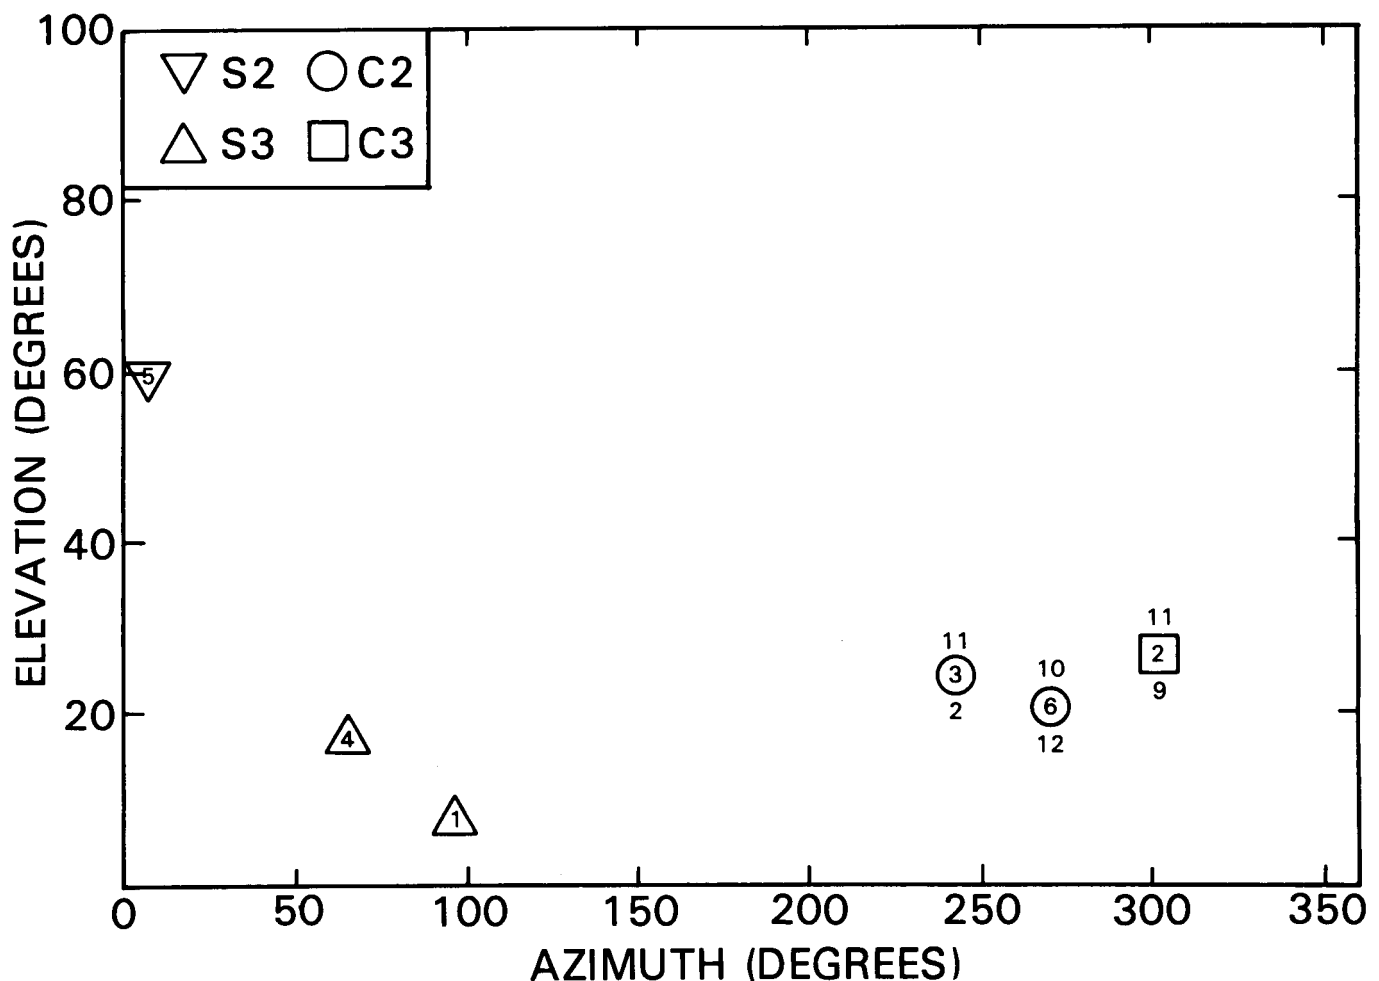
Figure 1. Passes for all operational SARSAT satellites which occurred during Test #1. Azimuth and elevation above horizon correspond to the point of closest approach to the PLB. Number within symbol gives order in which alerts were received in McMurdo. Numbers above and below C2 and C3 passes correspond to counts received by the control and test PLB respectively. The count data were not available for S2 and S3.

This was a short test; data from only six passes were collected. Figure 1 shows that for one of these passes, C2 did not receive adequate data from PLB 406 to calculate a position. For this pass the azimuth of PLB 406 was true South. For all other passes, however, a location accurate to ± 3 kilometers resulted. Usually the independent locations determined for the two PLBs agreed to within 2 kilometers. The position of Observation Hill as read off a map of the McMurdo area was in agreement with the locations from SARSAT.

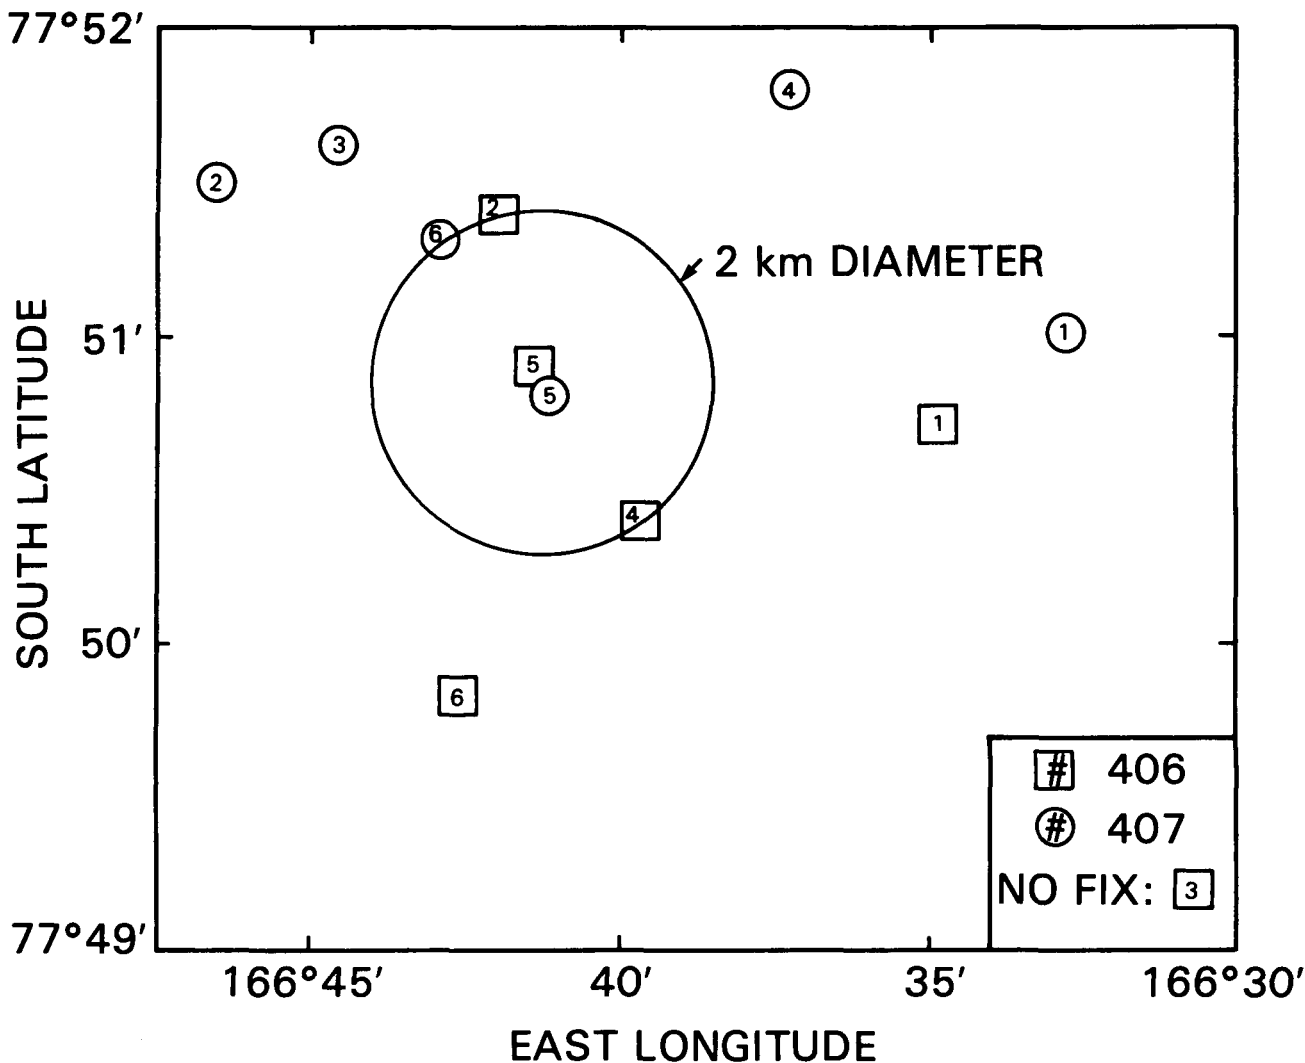
Figure 2. Locations calculated from each SARSAT pass for each PLB during Test #1. Numbers within symbol correspond to numbers in symbols in Figure 1 (i.e., order of alert receipt in McMurdo). Passes with no fix obtained are also noted.

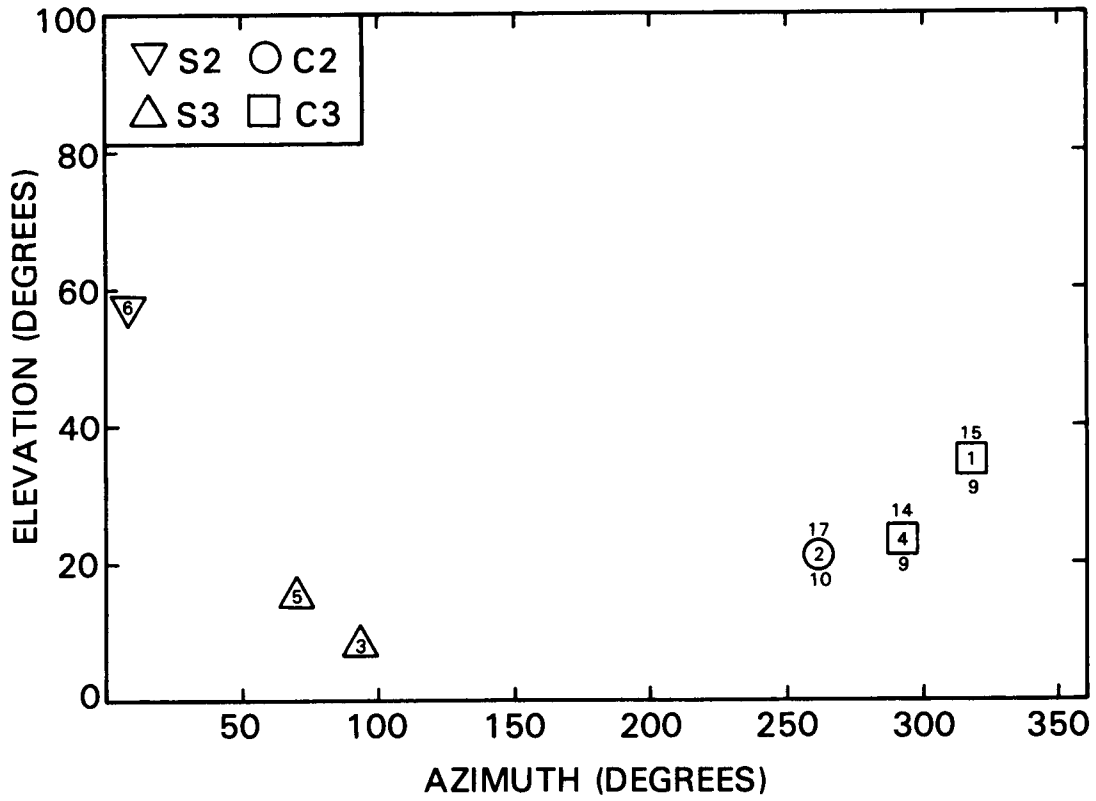
Figure 3. Pass geometries during Test #2. Explanation of symbols is identical to Figure 1.

Six passes occurred during the test. Figure 3 shows that most passes had low elevation angles and fewer counts for the PLB in the trench. Figure 4 demonstrates that the locations of the surface PLB were well clustered while the consistency of locations of the trench PLB was significantly worse (19 kilometers from the South Pole in two of the six cases). The one case where both the surface and trench PLB were poorly

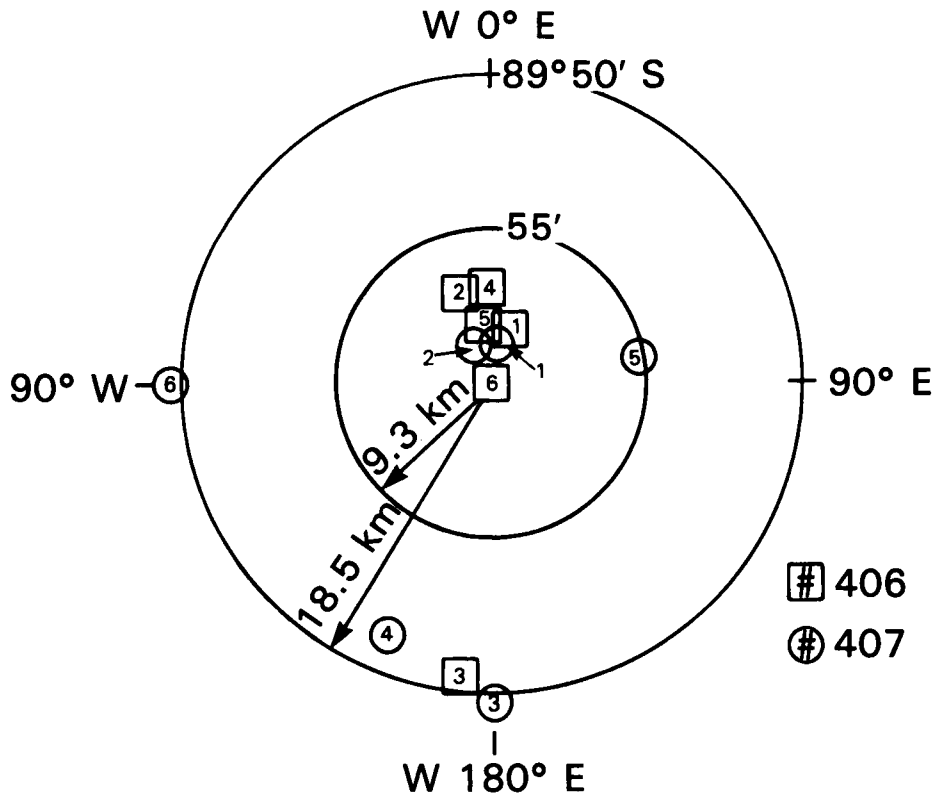
Figure 4. Calculated PLB locations for Test #2. Numbers within symbols correspond to numbers in symbols in Figure 3.

located was the lowest elevation pass (8 degrees above the horizon). Even the accuracy of the surface PLB was somewhat worse than the 2 kilometers of Test #1. This may be a result of the low elevation of each pass.

The cluster center did not coincide with the location of the South Pole, but was displaced 3 to 4 kilometers from it on a bearing of approximately 0° true. Whether this discrepancy is real or a result of an error in the location of the sign indicating the location of the true South Pole is not known. In any case, these errors are not significant for anticipated rescue operations in this area.

Some of the data used for the poor locations passed through the snow but there is no strong correlation between pass azimuth and location accuracy. There is no apparent reason for the poor location for pass #4, when passes #1 and #2 with similar geometry were so good.

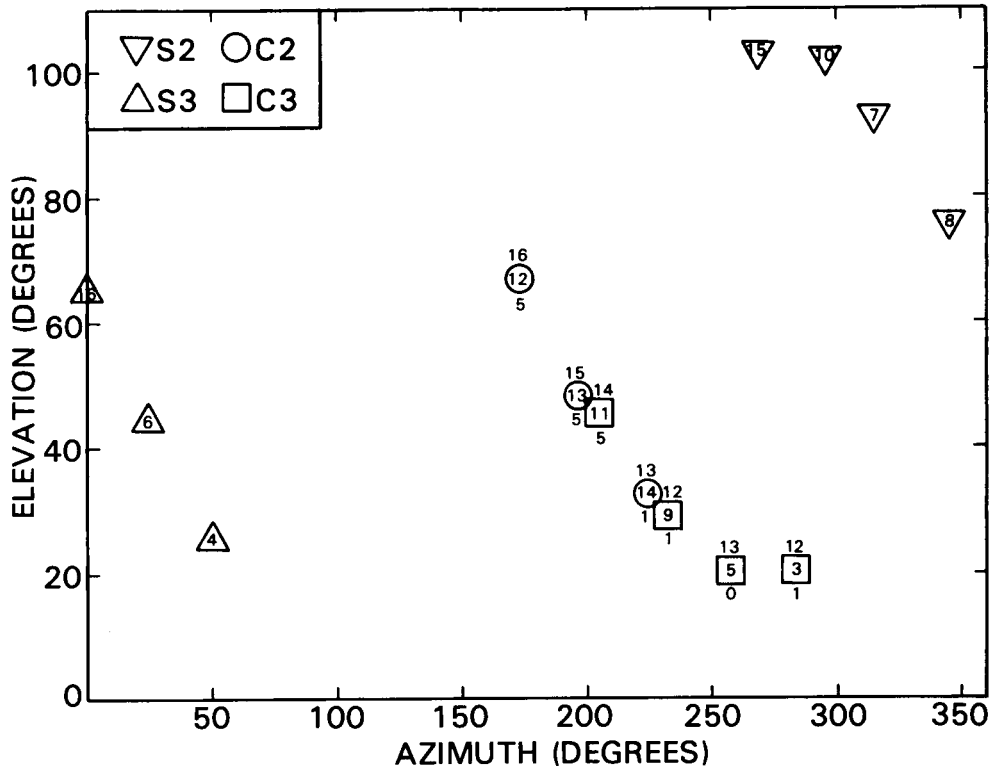
Figure 5. Pass geometries during Test #3. Explanation of symbols is identical to Figure 1.

Data from 14 passes (numbered 3 through 16) were collected. This provided a wide range of pass azimuths and elevation angles as Figure 5 shows. All of the surface PLB locations except one occurred within a 1.5 kilometer radius area (see Figure 6). By contrast, the crevasse PLB was not located at all in five cases. Figure 5 shows that these five cases correspond to the five cases of lowest elevation angle. This strongly suggests that the PLB will never be located when the signal must penetrate a significant depth of warm snow. While the snow conditions did not appear to be excessively wet, the above-freezing air temperature probably contributed significantly to the obscuration of the crevasse PLB because even small amounts of water strongly attenuate energy at the 406 MHz frequency.

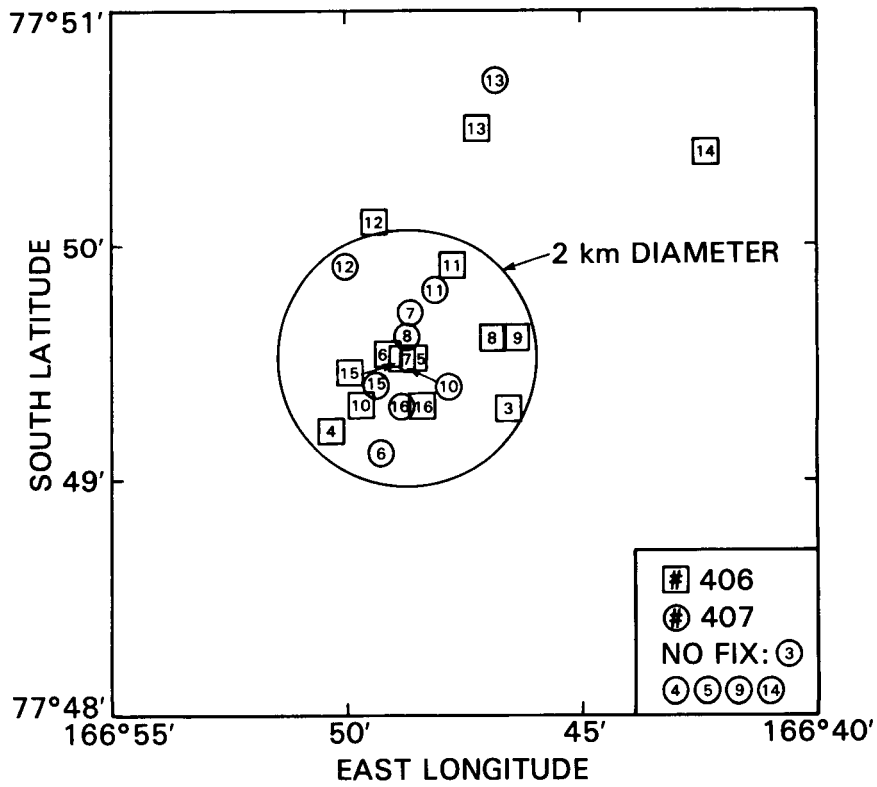
Figure 6. Calculated PLB locations for Test #3. Symbols are as described in Figure 2.

On passes for which the crevasse PLB was detected, the locations were as good for this PLB as for the surface PLB. This is particularly apparent for passes #11, 12 and 13 where there were only five counts collected for the crevasse PLB but 14, 15 and 16 counts (respectively) received from the surface PLB. This is probably due to the fact that the counts received from the crevasse PLB were most likely to occur at the highest elevation when the Doppler shift in frequency was greatest: it is these counts which are most significant in calculating an accurate position.

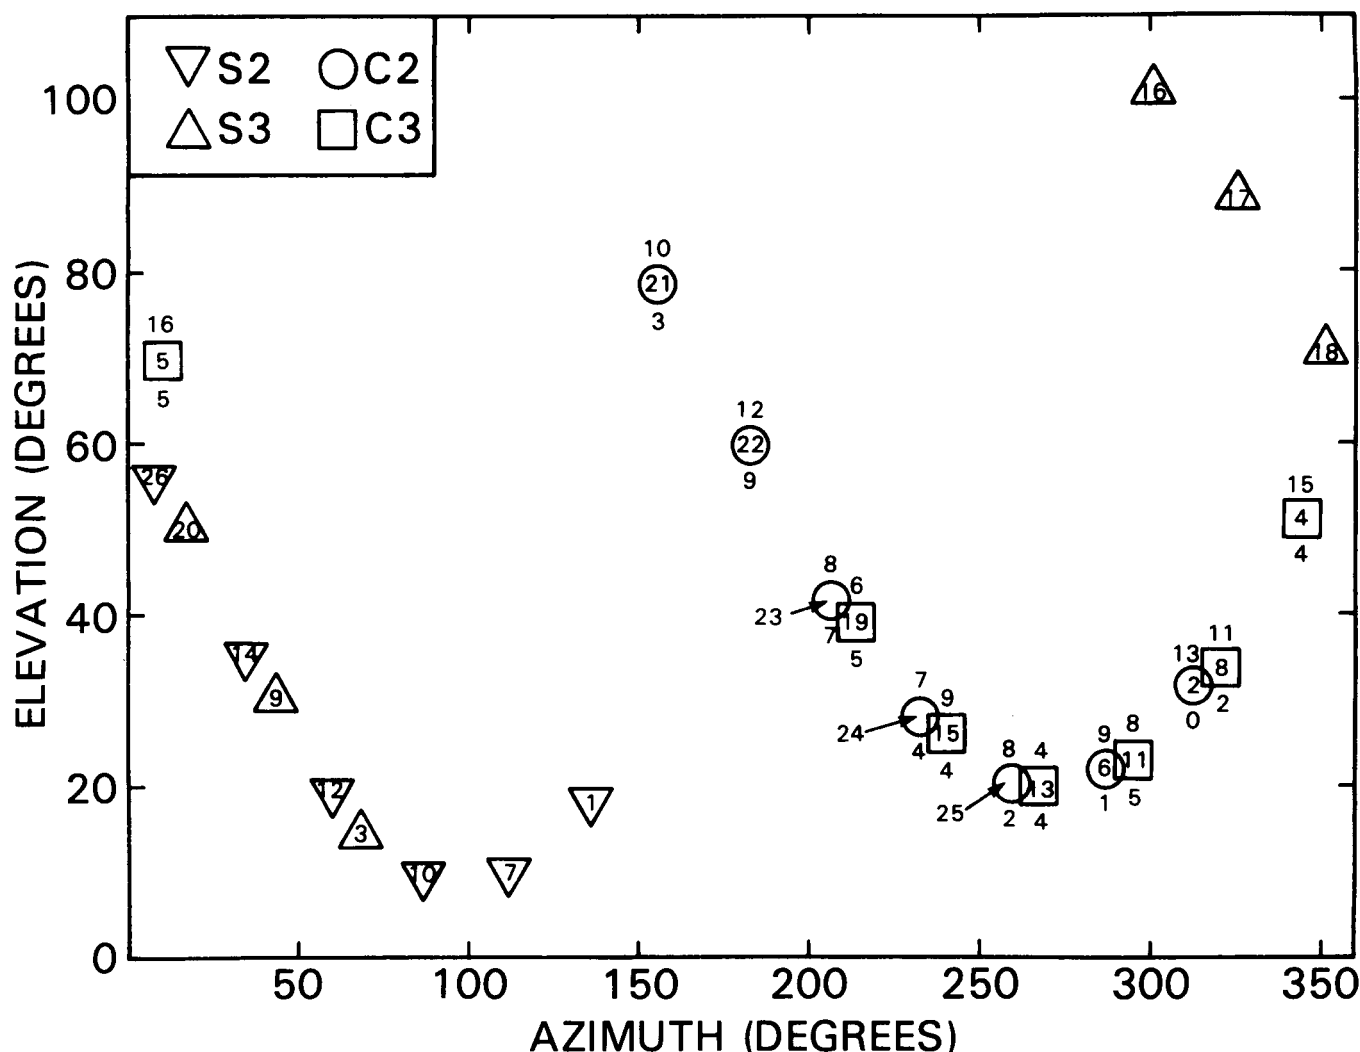
Figure 7. Pass geometries during Test #4. Explanation of symbols is identical to Figure 1.

which lasted 9 hours, collected a large number of different pass geometries (see Figure 7). The particular geometry of the trench is diagrammed in Figure 8.

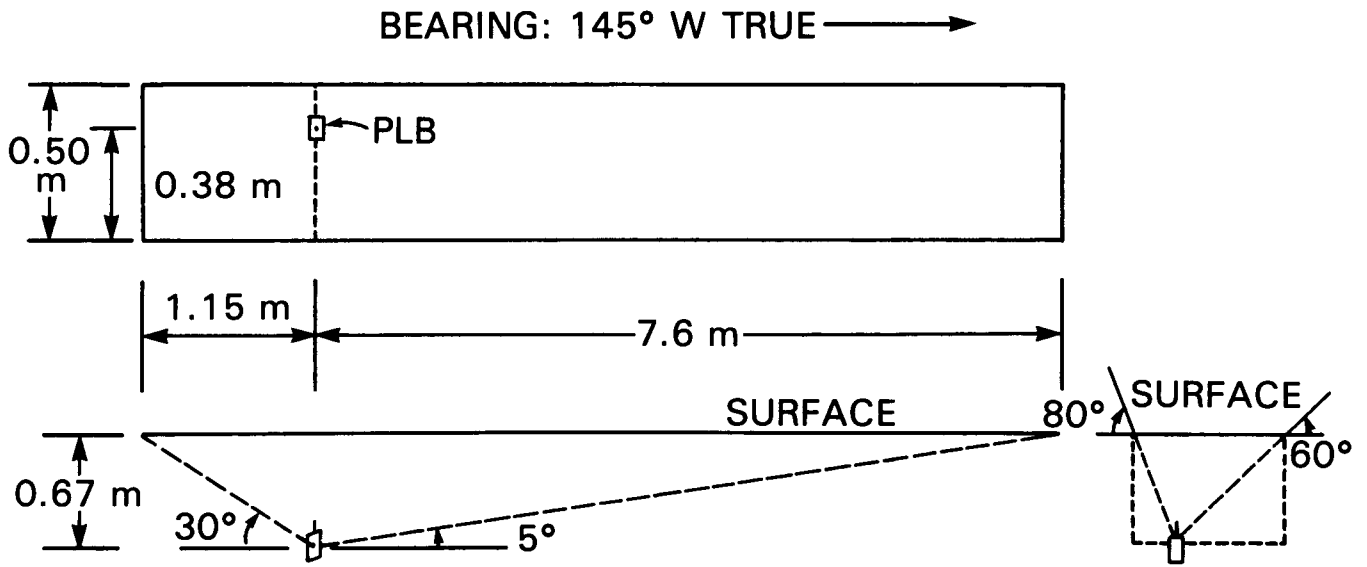
Figure 8. Geometry of snow trench used in Test #4.

The site of the test was near Williams Field IV on the McMurdo Ice Shelf. A trench of the specified dimensions and orientation was dug with shovels. The temperature at the bottom of the trench (0.67 meters below the surface) was -1°C . The snow density measured in the side of the trench was 448 kg/m^3 .

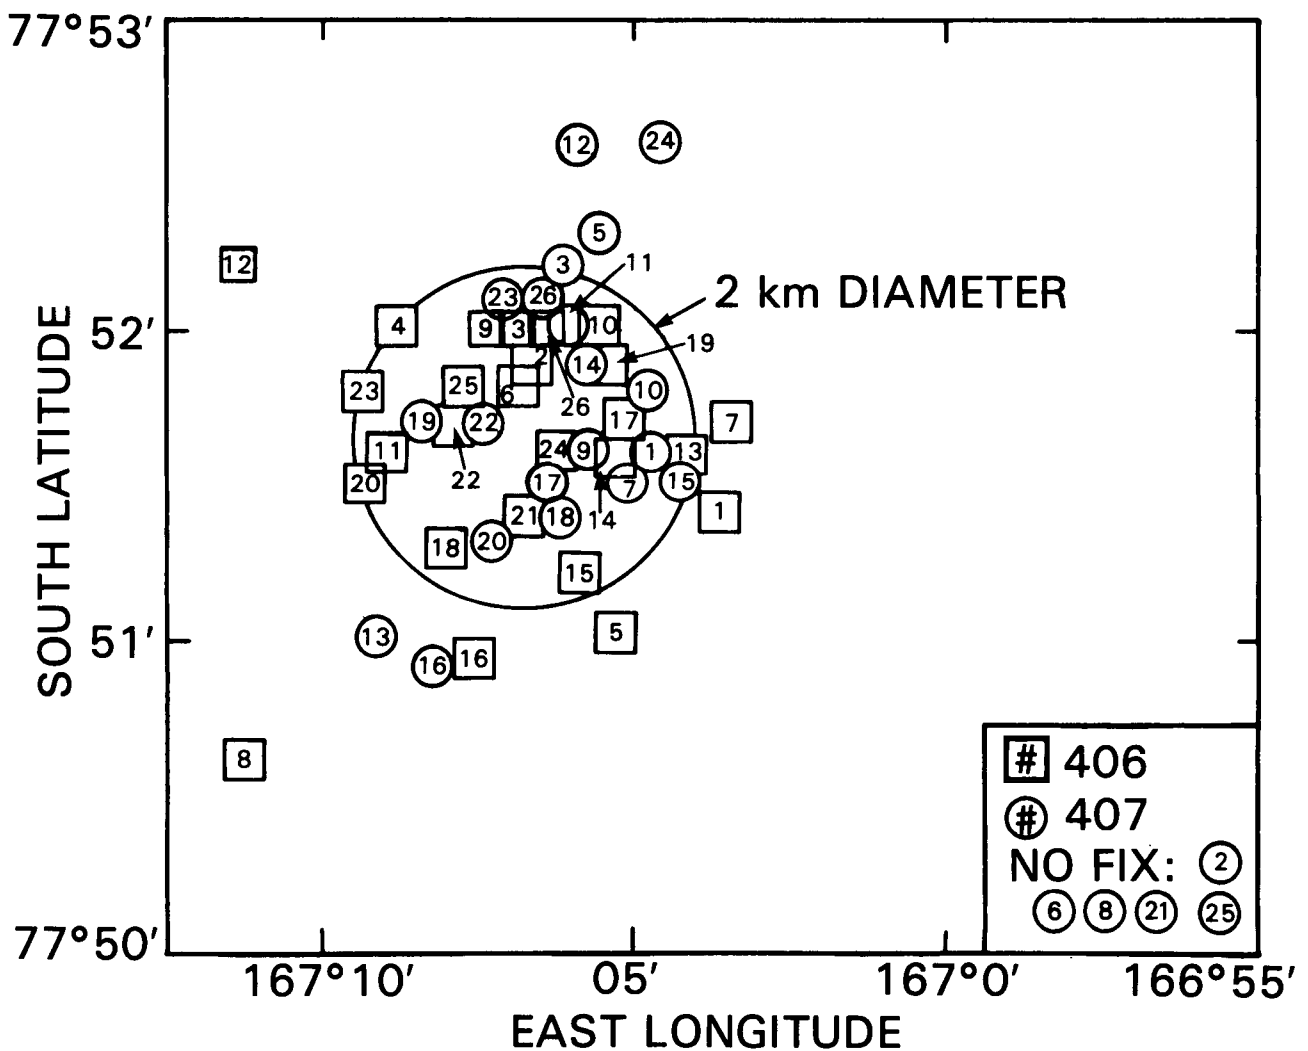
Figure 9. Calculated PLB locations for Test #4. Symbols are as described in Figure 2.

Low elevation passes at azimuths between 250 and 360 degrees were designed to be obscured the maximum amount. Figure 9 shows that, indeed, these passes constituted the majority of passes for which the position of PLB 407 in the trench was either not calculated or was rather poor. Passes #11 and 13 are notable exceptions to this trend. Many of the other cases required partially obscured signals, but the positions for nearly all passes cluster within a 1.5 kilometer radius circle. This suggests that transmission of the PLB signal through a limited distance of snow is possible. This snow was more dense than the snow in Test #3. It is believed that the more important parameter for signal attenuation is the presence of liquid water from melting snow.

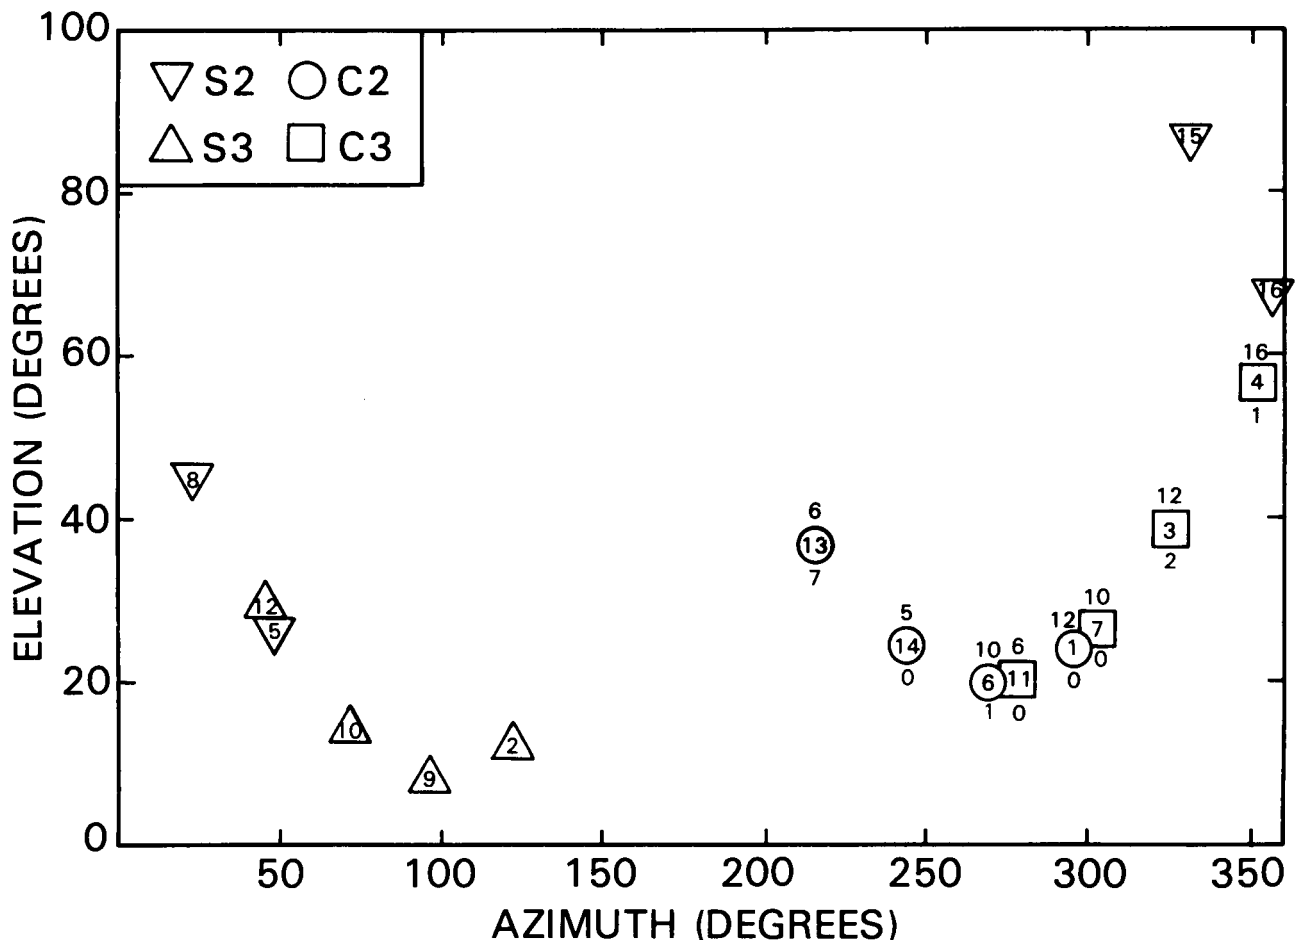
Figure 10. Pass geometries during Test #5. Explanation of symbols is identical to Figure 1.

For this test, the same crevasse as was used in Test #3 was used again but PLB 407 was lowered to a depth of 7.5 meters below the surface at the same location as in Test #3. PLB 406 was again placed on the surface at the same location as the previous crevasse test. Figure 10 shows that even the geometry of the satellite passes was approximately the same as for Test #3. While the temperature was not measured, it was estimated to be slightly above freezing as in Test #3.

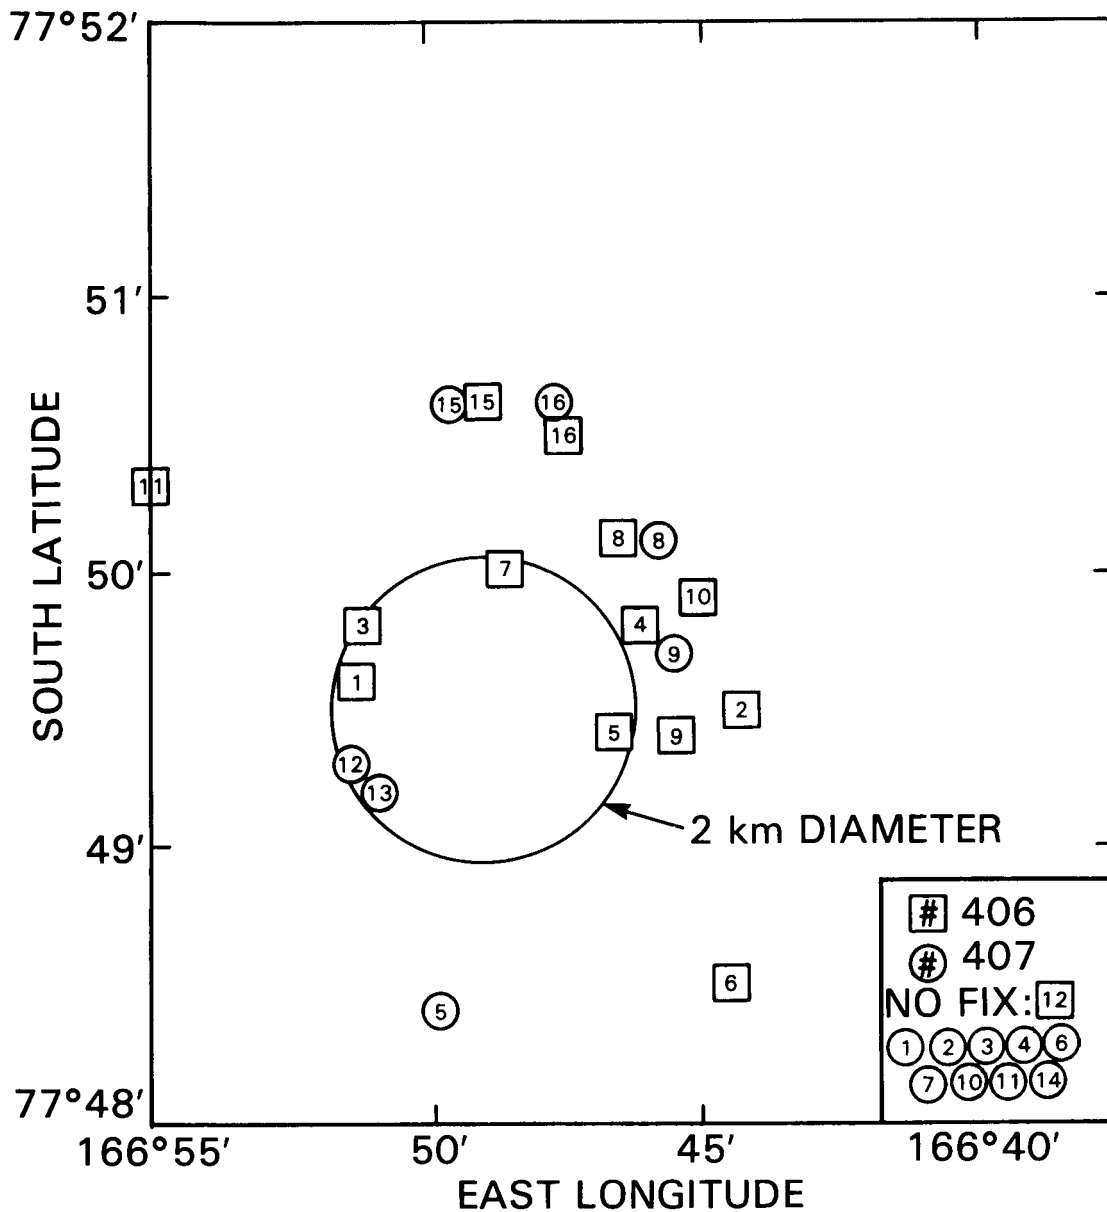
Figure 11. Calculated PLB locations for Test #5. Symbols are as described in Figure 2.

For a large number of passes the satellites were unable to detect either the presence or the location of the PLB in the crevasse. With one exception, this was true of all passes with elevations below 20 degrees or azimuths between 240 and 350 degrees. The one exception, pass #9, provided an acceptable position but it is not known how many counts were collected on this pass by either PLB.

Another comparison between this test and Test #3 is that the clustering of positions which were calculated is considerably worse for this test than for the earlier test. This fact holds true for both the surface PLB as well as the one in the crevasse. There is no obvious explanation for this, as the same PLB was left at the same spot for the same period of the day with similar passes occurring. A possible cause is differences in the atmosphere on the 2 days which would affect the travel path of the signal to the satellite.

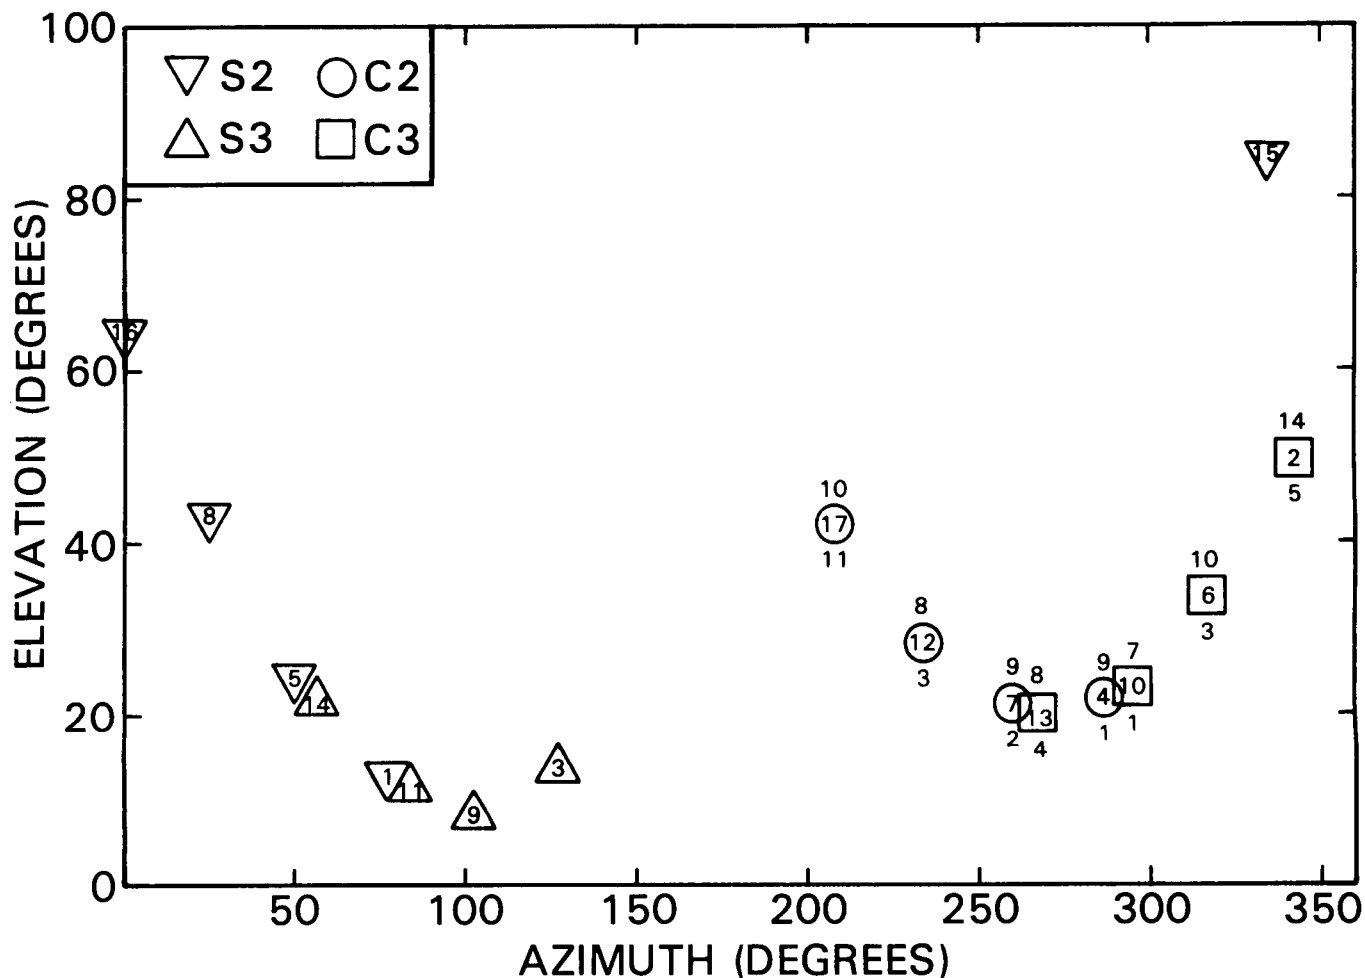
Figure 12. Pass geometries during Test #6. Explanation of symbols is identical to Figure 1.

Of the passes for which count data are available, only pass #17 is atypical in that a large number of counts were received from the suspended PLB. In all other cases, only a few counts were received from this PLB. In the majority of these cases a position was calculated for each PLB, but for PLB 407 the position

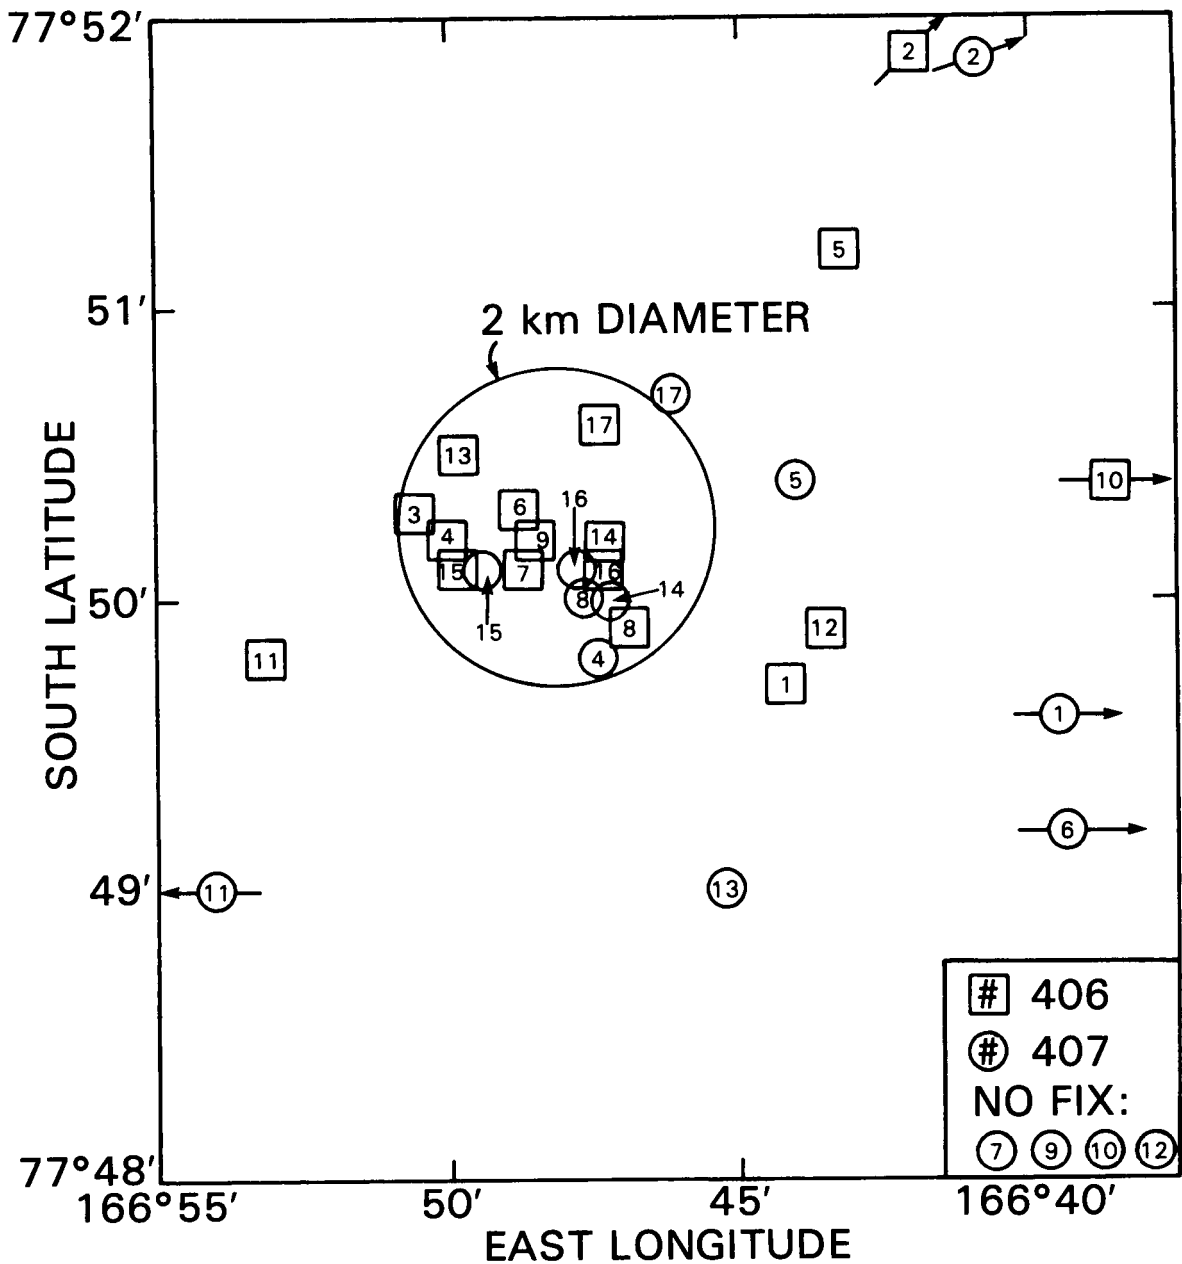
Figure 13. Calculated PLB locations for Test #6. Symbols are as described in Figure 2.

was usually quite poor (see Figure 13). The bulk of the surface PLB positions are clustered within a 1.5 kilometer radius, while the suspended PLB position varied greatly. In four cases, no position was calculated for the crevasse PLB.
