Annual Progress Report
(April, 1986 - August, 1987)

**MICROMECHANICS OF COMPRESSION FAILURES
IN OPEN HOLE COMPOSITE LAMINATES**

E. Gail Guynn
Walter L. Bradley
Department of Mechanical Engineering
Texas A&M University
College Station, TX 77843
(409) 845-1259

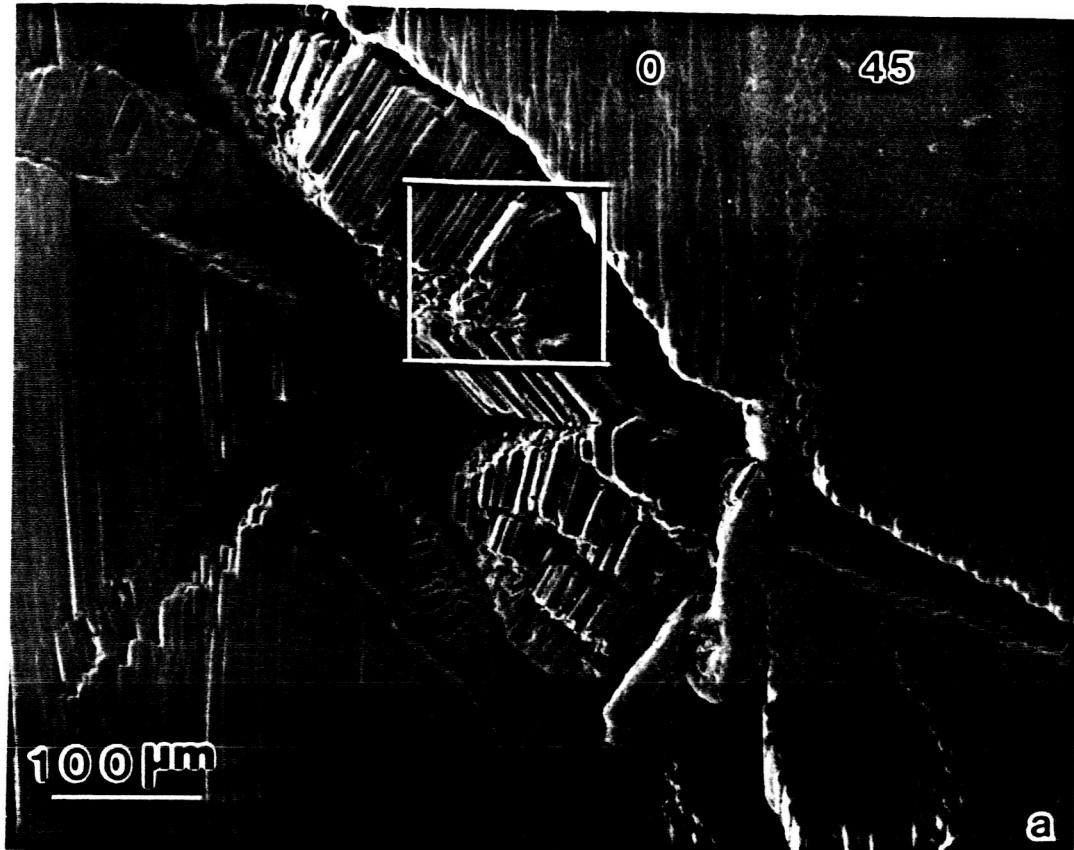
Figure 18 shows the shear crippling zone in SEM micrographs from a longitudinal section cut from the gripped end of one of the HST-7 modulus tests. Figure 18a shows the shear crippling zone in the 0° and $+45^\circ$, respectively labeled on the figure, plies (9^{th} and 10^{th} plies from the surface). Notice the rotating of the fibers in many directions, regardless of the support provided by the grip. The box in Fig. 18a is enlarged in Fig. 18b to show the rotated and broken (tensile type breaks) 0° fibers within the shear crippling zone.

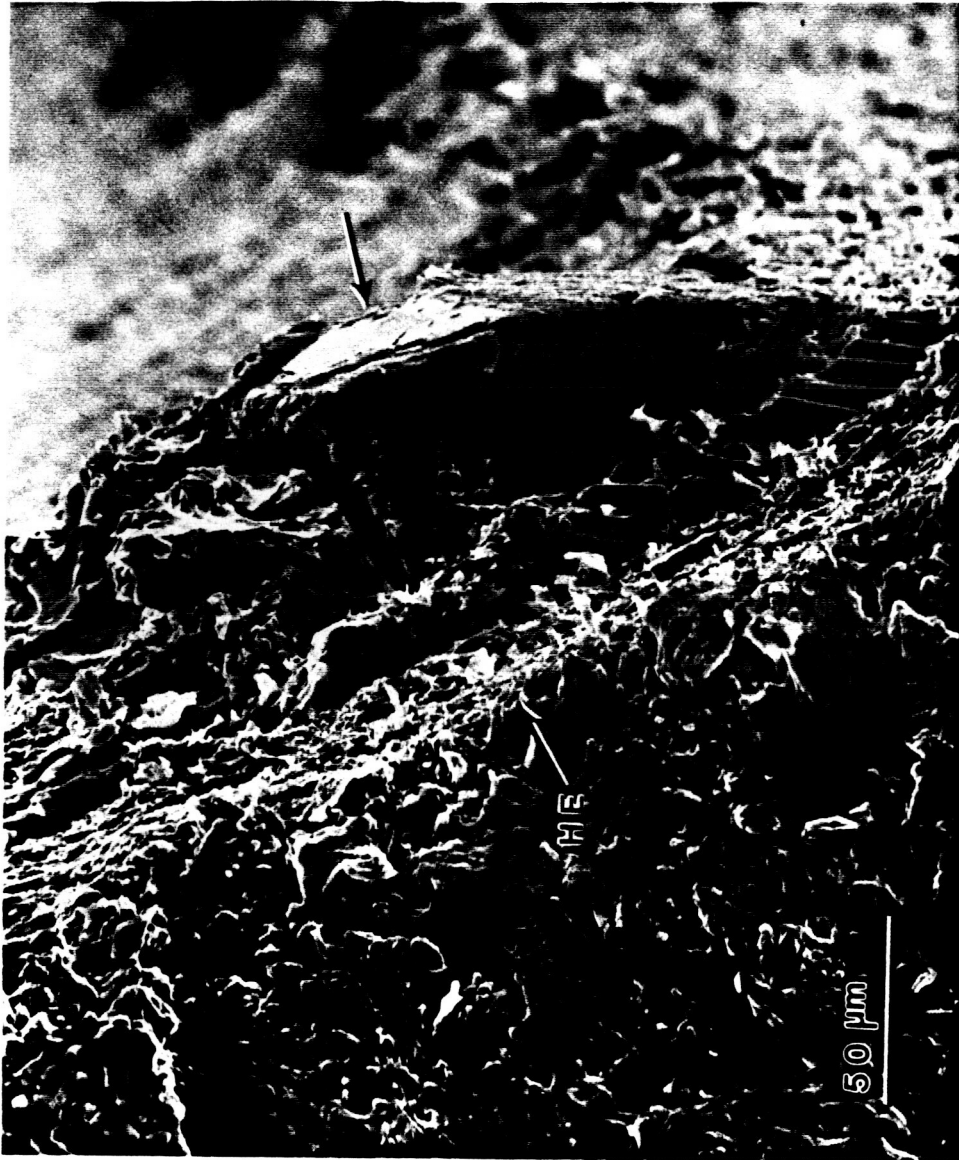
Fig. 42 Section 1 ($x_k = 0.00$ mm) of PEEK specimen *L* showing shear crippling and/or fiber microbuckling damage in 0° plies. Additionally, the local delamination at the -45/0 interface of group 1 and at both interfaces of group 4 0's are indicated with arrows.

of Specimen *L* details the interior damage behind the edge of the hole (*Y-Z* plane). Figure 42 shows section 1, just after mounting and polishing specimen *L*. At this section, x_k is defined to be 0.00 mm. For consistency, the 0° ply groups have been numbered 1-4 in every figure where appropriate, consecutively counting from the surface damage. This figure shows the shear crippling and fiber microbuckling extending to the fourth group of 0° fibers. The void areas are due to damaged material in the shear crippling zone falling out during the polishing process. The featureless zone along the *X* axis on the right of the figure is a this layer of strain gage adhesive coating the hole radius. The surface ± 45 's and the first group of 0's have a slight column buckling shape toward the surface damage. Local delaminations to allow large amounts of fiber microbuckling and/or shear crippling are present at each interface of each group of 0° plies. Local delamination at the $-45/0$ interface of group 1 and at both interfaces of group 4 are indicated by the arrows on Fig. 42. Other local delaminations are magnified in Fig. 43 for each interface of the second group of 0's and Fig. 44 for the right interface of group 1 (Fig. 44a) and both interfaces of group 3 (Fig. 44b). Additionally, the four different shear crippling zones in 0° ply groups 1-4 (shown in Fig. 42) lie approximately in the *X-Z* plane at elevations along the *Y* axis that range over approximately $150 \mu\text{m}$.

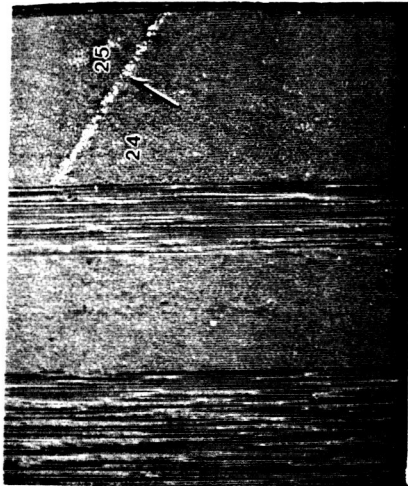
Fig. 49 Section 3 ($x_k = 0.58$ mm) of PEEK specimen *L*. The out of plane (*X-Y*) buckling matrix deformation in the $\pm 45^\circ$'s is very predominant in these micrographs.

Figure 49 shows the shear crippling damage in section 3 of specimen L , 0.58 mm from the hole edge. In addition to the shear crippling in the four groups of 0° plies, matrix cracks appeared in the 12th, 24th, and 25th plies, all 90° plies (indicated by arrows). Note that some groups of 0° plies contain two individual plies (see stacking sequence given in Table I). Thus, the 12th ply lies in the 6th group, with only the 0° ply groups numbered 1-4. This appearance was the first and only observation of damage in the 90° plies. The shear crippling zone near the surface damage zone is buckled further out of the $X-Y$ plane than in previous sections. The matrix cracking and deformation in the $\pm 45^\circ$ plies connecting group 1 and group 2 0° 's is much larger than that seen previously in section 2 and also runs along the $\pm 45^\circ$ interface. The out of plane shear crippling ($Y-Z$ plane) can only be accommodated by shear deformation in the adjacent $\pm 45^\circ$ plies. An uneven stiffness in the first and second group of 0° 's, resulting from the different sizes of shear crippled zones within these plies, would give a shear stress in the Y direction in the $X-Y$ plane that could coalesce the shear damage introduced by the shear crippling, as seen

in Fig. 49. Furthermore, the radial type matrix cracking is now evident in the -45° ply closest to the specimen surface. The elevation in the Y direction of the shear crippling in the 0° plies now ranges over $650-700 \mu\text{m}$, indicating again that the damage planes associated with shear crippled zone grows at various angles to the X axis. The details of this damage are magnified in Fig. 50, enlarging the matrix cracking and deformation in the $\pm 45^\circ$'s, rotating and kinking within the 0° plies, the 0° fiber damage protruding into the 45° plies, and the absence of local delaminations at the ply interfaces. It appears in this case that the fiber kinking or microbuckling in the X - Y plane produces a plane (X - Z) of material which can easily shear giving out of plane (Y - Z) shear crippling.

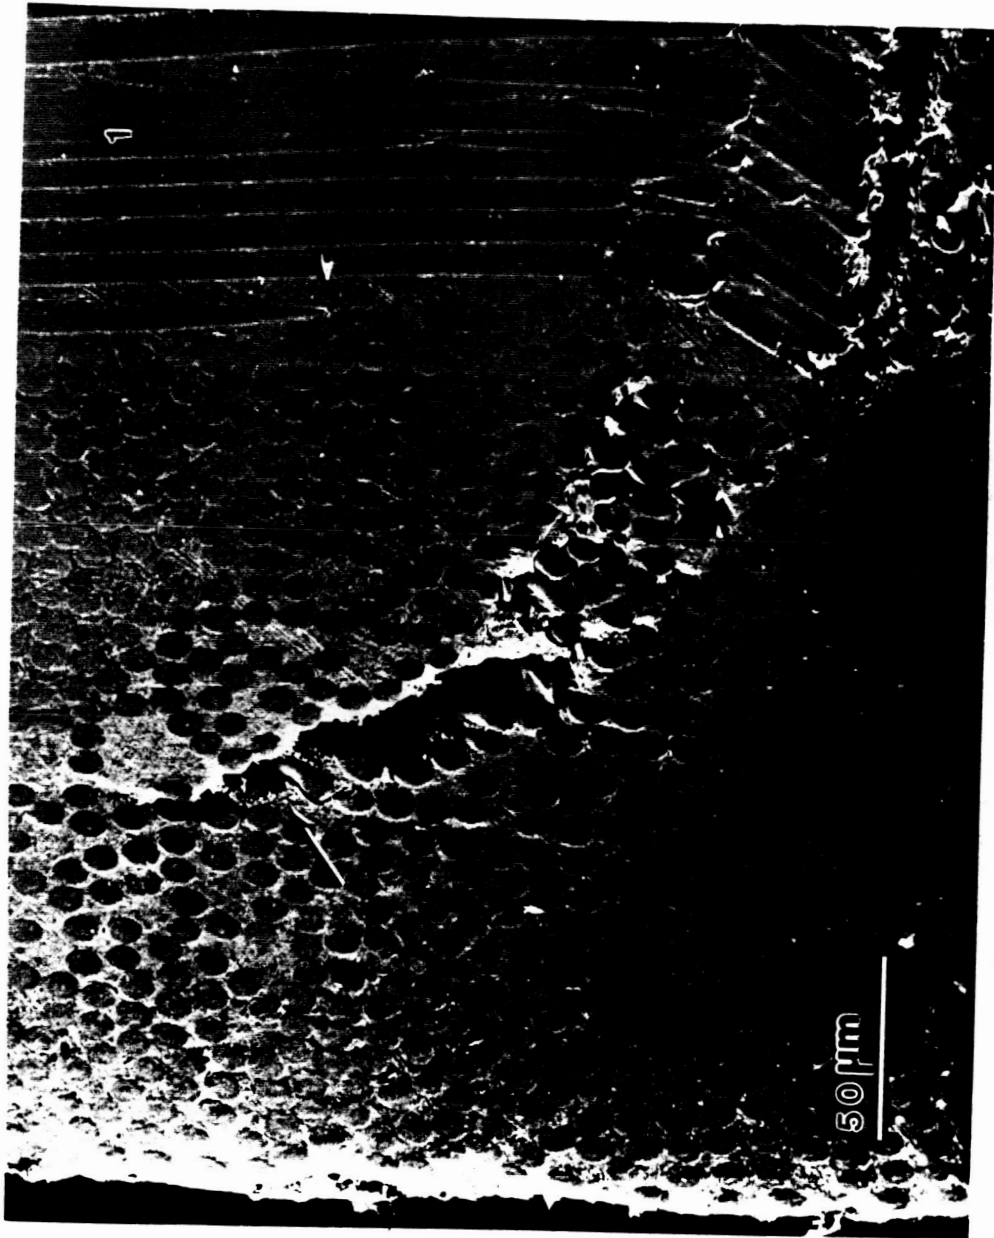
Fig. 53 Shear crippling zone in section 5 ($x_k = 1.25$ mm) of PEEK specimen *L*.

Figure 53 shows section 5 at 1.25 mm from the hole edge. The damage in the 0° plies ranges over $1200 \mu\text{m}$ apart along the Y -direction, and the connectiong

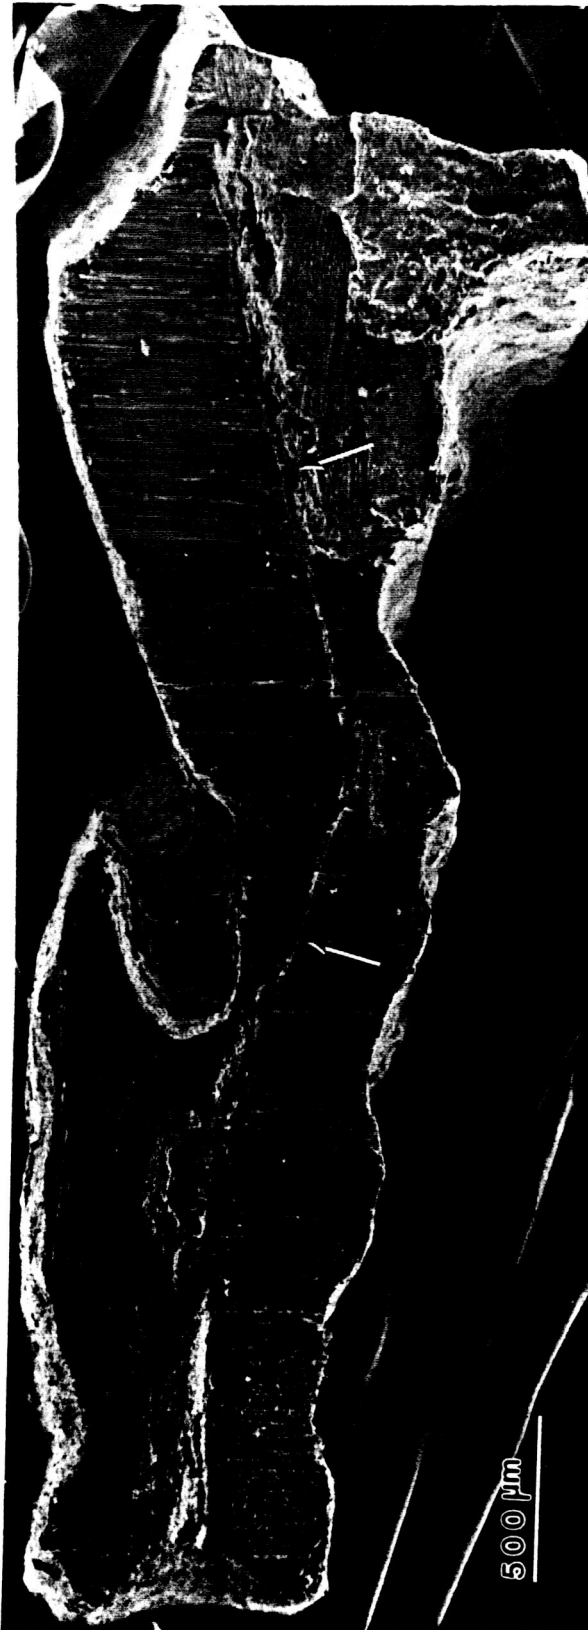
Fig. 71 Bend type fiber breaks within the shear crippling zone of the sectioned HST-7 specimen.

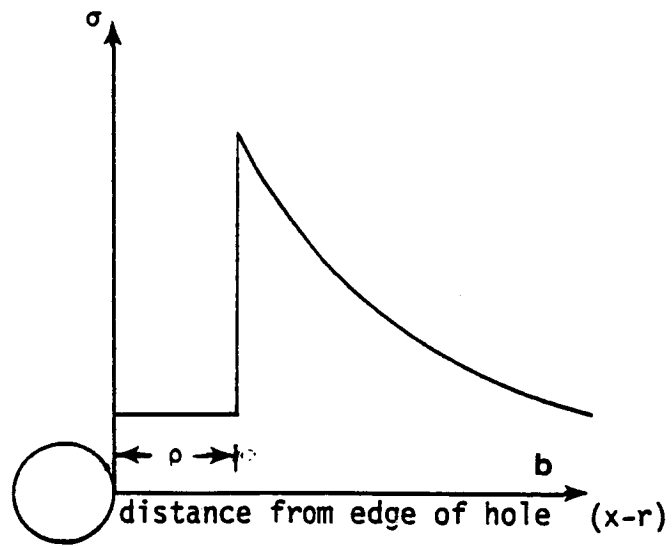
- Fig. 73 Stress distribution across remaining ligament width.
- a) Dugdale type analysis.
 - b) Crush zone in compression loaded composite laminates.
