**THIN FILM STRAIN GAGE DEVELOPMENT PROGRAM  
FINAL REPORT**

**Contract NAS3-21262**

December, 1983

**Commercial Engineering  
Pratt & Whitney  
UNITED TECHNOLOGIES CORPORATION**

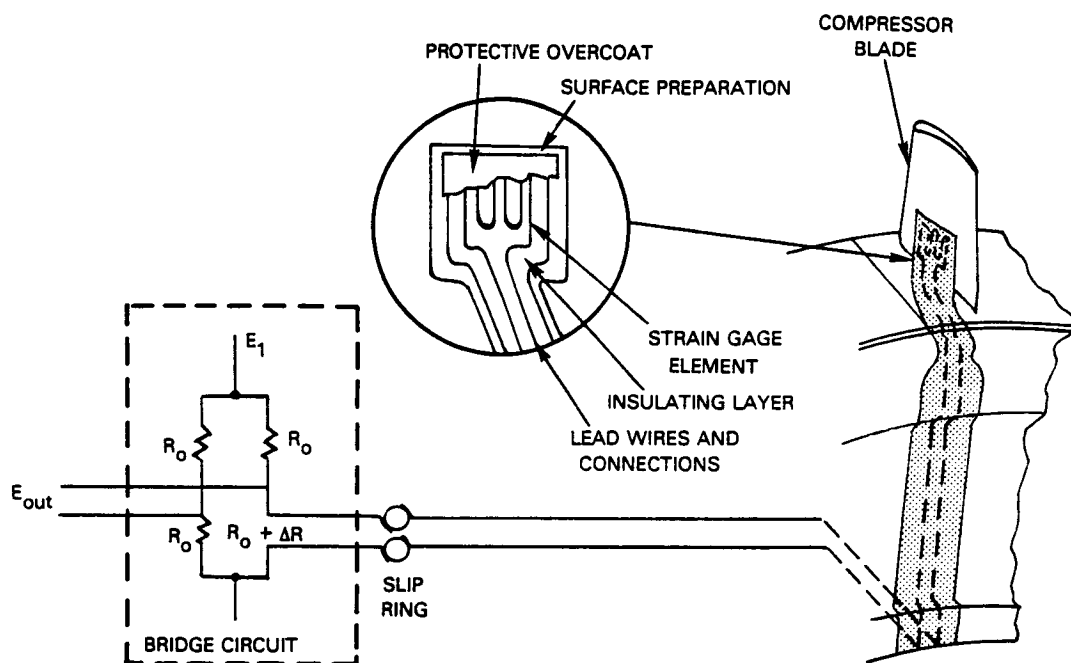
A resistive strain gage system is shown in Figure 1. The bridge circuit shown is powered from a constant voltage source,  $E_1$ . Each of the four arms of the bridge has a nominal resistance of  $R_0$  ohms.

Figure 1 A Resistive Strain Gage System for Dynamic Strain Measurement.

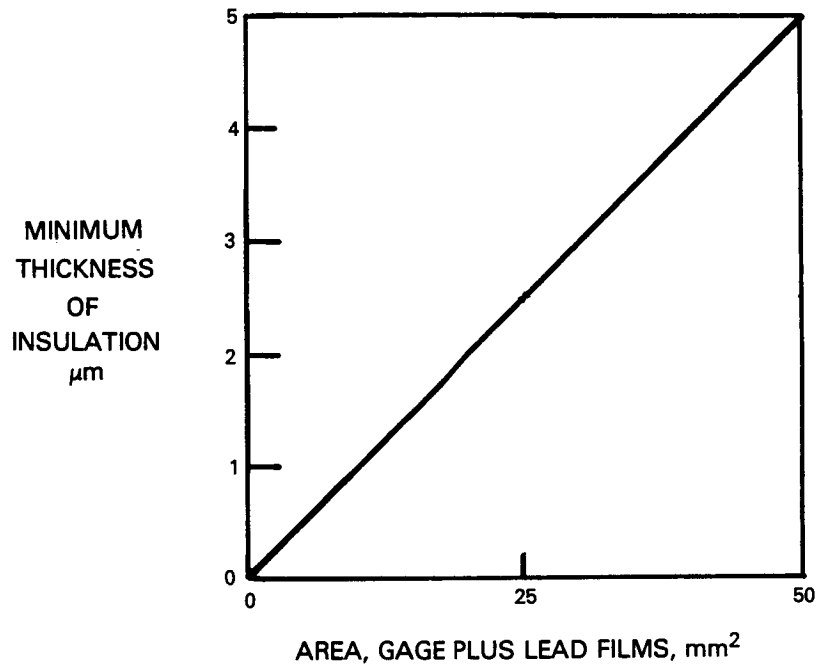
where  $\rho_2$  is insulation resistivity (ohm-cm),  $t_2$  is insulation thickness, (cm), and  $A$  is the combined area of gage film and lead films ( $cm^2$ ). For example, Figure 2 shows minimum required insulation thickness,  $t_2$ , versus area,  $A$ , for  $R_L = 10^5$  ohms, assuming  $\rho_2 \geq 10^8$  ohm-cm. Figure 2 will be discussed further in the sections on film configurations and lead film configurations.

Figure 2 Minimum Required Insulation Thickness versus Area of Gage plus Lead Film for Insulation Resistance of  $10^5$  ohms at Resistivity of  $10^8$  ohm-cm.

The lead film surface area must be taken into account when calculating the insulation layer thickness required for high resistance to ground (Figure 2). For the 2 mm x 2 mm gage configurations of Figure 8, the gage area is approximately 2 mm<sup>2</sup> (i.e., about half of the 2 mm x 2 mm gage envelope area). For comparison, note that the two 10 mm x 1.1 mm leads found reasonable for lead resistance have an area of 22 mm<sup>2</sup>. The sum of film and lead area must be used when calculating resistance to ground (Equation 5).

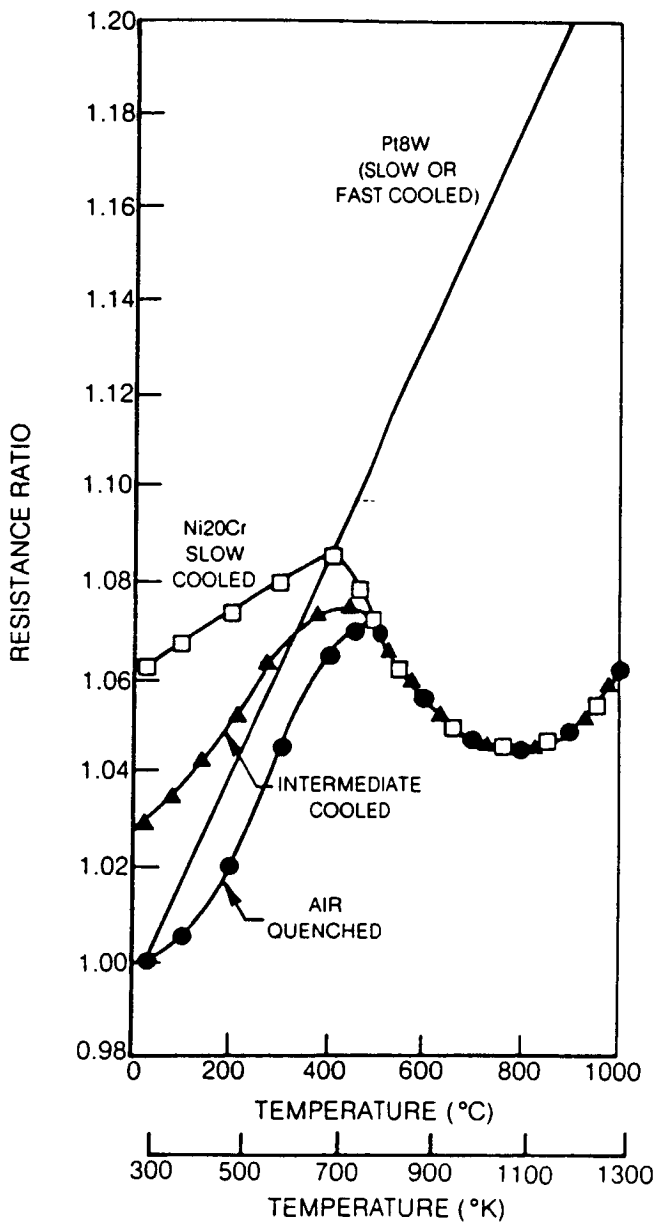
An example of the problem is shown in Figure 3, where the resistance vs. temperature of Pt8W and Ni20Cr are compared. The material with the low  $\alpha$  is Ni20Cr, but at about 800K there is a sudden drop in its resistance; also, when Ni20Cr is cooled from a temperature above 800K, the curve becomes extremely nonlinear and the curve shape becomes dependent upon rate of cooling.

Figure 3 Resistance Versus Temperature for Ni20Cr and Pt8W.

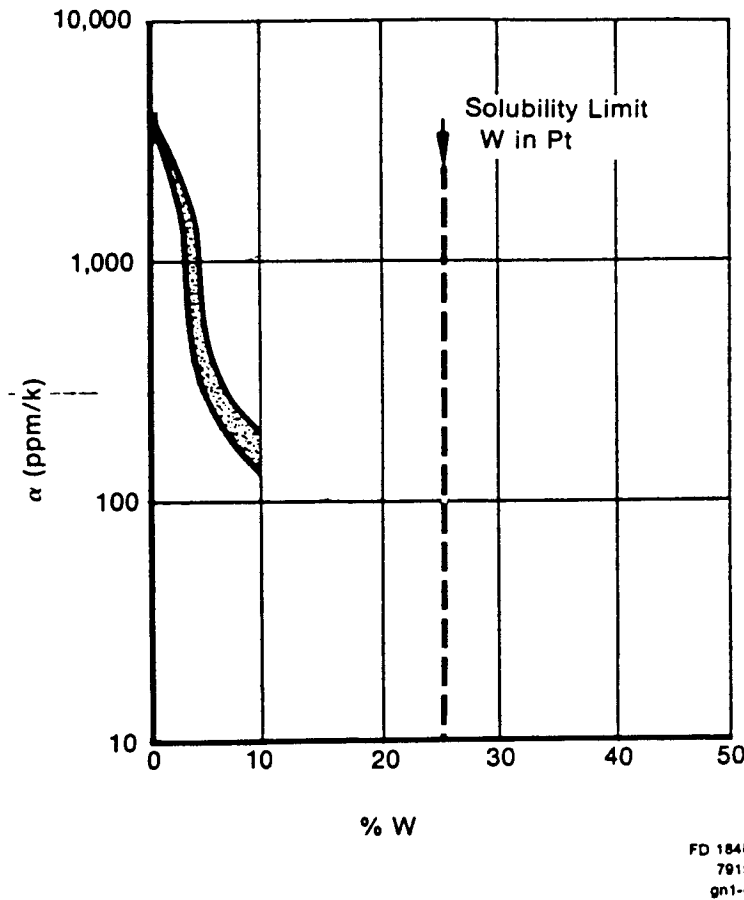
The PtW alloy family is a typical example of dilute alloy behavior. Figure 4 illustrates  $\alpha$  as a function of percent W in the alloy, and shows that  $\alpha$  decreases from 3900 ppm/K (at 0%W) to 145 ppm/K (at 10%W). There is no electrical data in the literature beyond 10%W because the alloys with higher W content are too hard to be mechanically workable in wire form. The scatter band in Figure 4 is the effect of different heat treatments employed by different investigators. Similar curves are found for all dilute alloys, differing only in quantitative detail.

Figure 4 Temperature Coefficient of Resistance ( $\alpha$ ) versus Percentage Tungsten in a Platinum-Tungsten Alloy Wire.

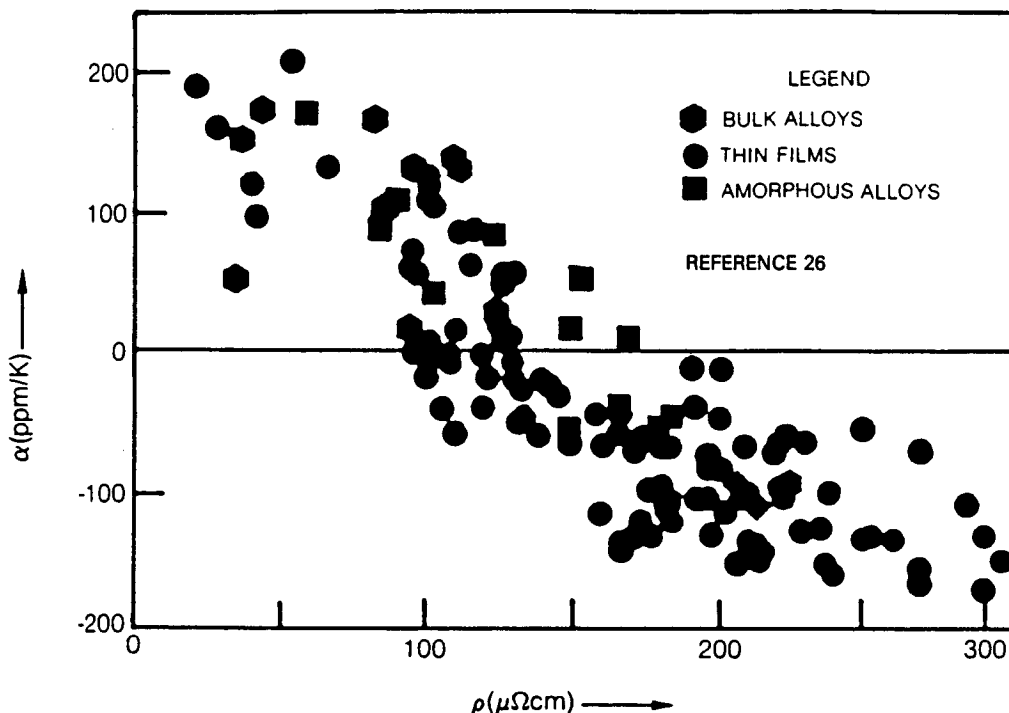
The  $\alpha$  -  $\rho$  correlation is shown in Figure 5, reproduced from Reference 31. Data on Figure 5 are from 27 different binary alloy systems and 3 ternary systems. Several different compositions within some systems are represented, and the data cover a wide range of temperatures for some particular alloys.

Figure 5 Temperature Coefficient of Resistance versus Resistivity for Bulk Alloys.

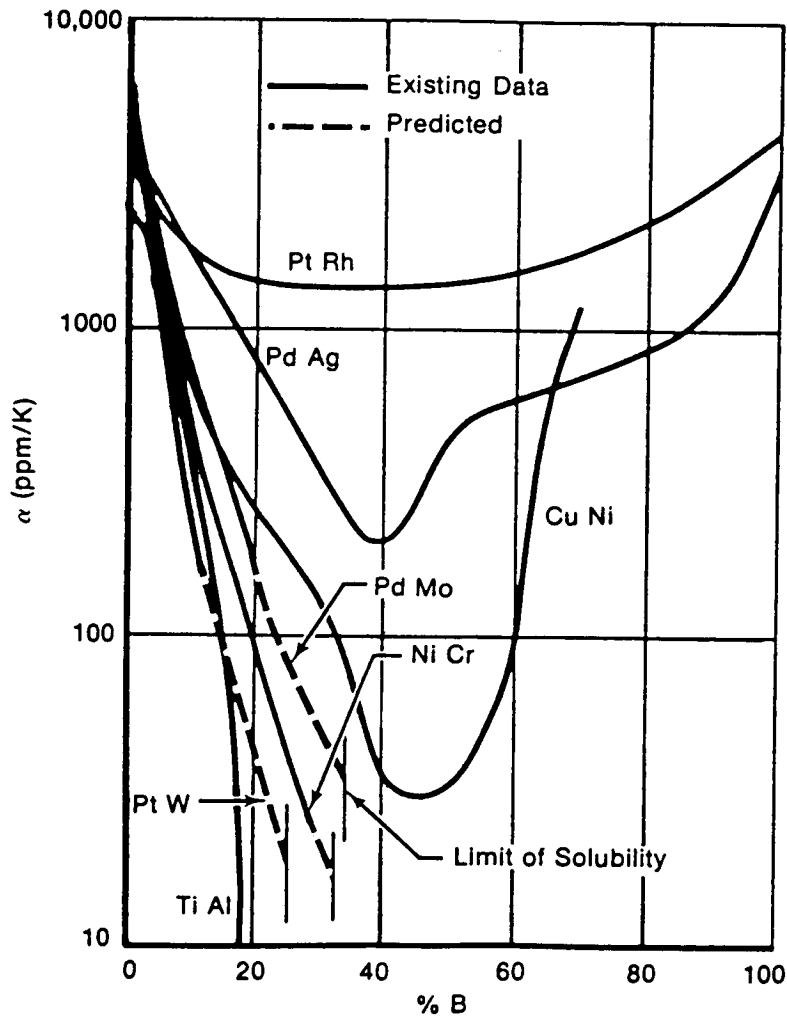
The phase diagrams for the seven alloy systems of Figure 6 are presented in Appendix A. The periodic behavior of atomic species is quite evident in the phase diagrams and the  $\alpha$  vs. %B curves.

Figure 6 Temperature Coefficient of Resistance ( $\alpha$ ) versus Composition (% B) for Seven Binary Alloys.

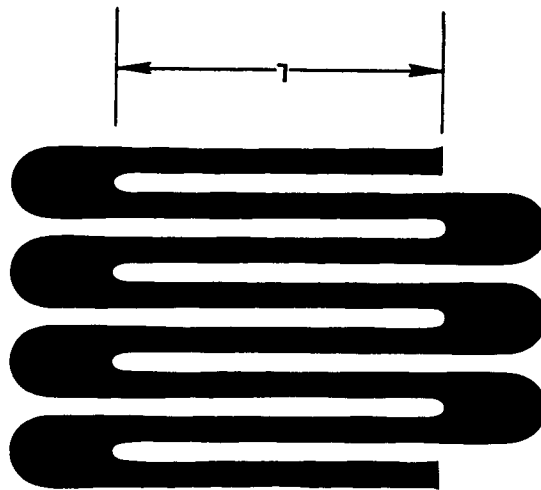
In the present program, an overall gage grid size about  $2 \text{ mm} \times 2 \text{ mm}$  was desired, with gage resistance of about 200 ohms, using a gage alloy with a resistivity of about  $10^{-4} \text{ ohm-cm}$ , and with line width equal to line spacing.

Figure 7 Thin Film Strain Gage Grid Model for Analysis.

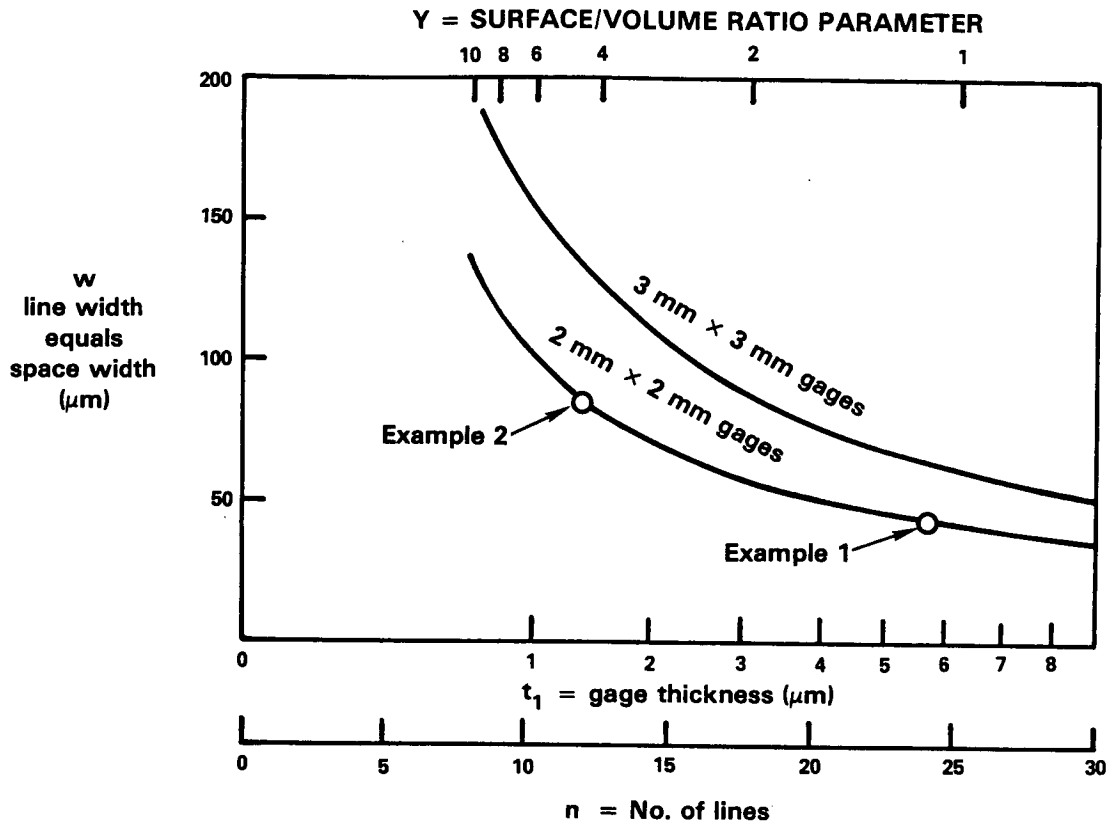
With these constraints, specifying any one of the geometrical parameters fixes the values of all the rest. The relationships are derived in Appendix B. The result is the design curve shown in Figure 8. Two examples are marked on Figure 8 and are discussed here.

Figure 8 Design Curves for Thin Film Strain Gages, for  $R = 200$  ohms and  $\rho_1 = 10^{-4}$  ohm-cm.

Corrosion (and oxidation in particular) poses a more serious threat to thin film strain gage measurement stability. The large surface-to-volume ratio of the gage configuration selected (Figure 8) suggests that oxidation will produce about five times more drift than would be experienced by the usual wire strain gages (using 25  $\mu\text{m}$  wire), for the same gage material and protection. Wire gages are normally buried beneath a protective layer of cement or flame-sprayed  $\text{Al}_2\text{O}_3$  more than 100  $\mu\text{m}$  thick. It is, therefore, to be expected that the thin film strain gages will require overcoating for oxidation protection. The overcoat must be electrically nonconducting, adherent on the gage material, and provide some degree of barrier to oxygen penetration. The most reasonable material for initial trial is the material found most suitable for the insulating layer under the gage, with thickness to be decided by trials. A composite overcoat consisting of an insulating layer plus a metal layer was a second alternative considered since the dense metal layer could provide a better oxygen barrier and could serve in a sacrificial role. Composite overcoat layers involve additional complication in fabrication, however, and were beyond the scope of the present program.

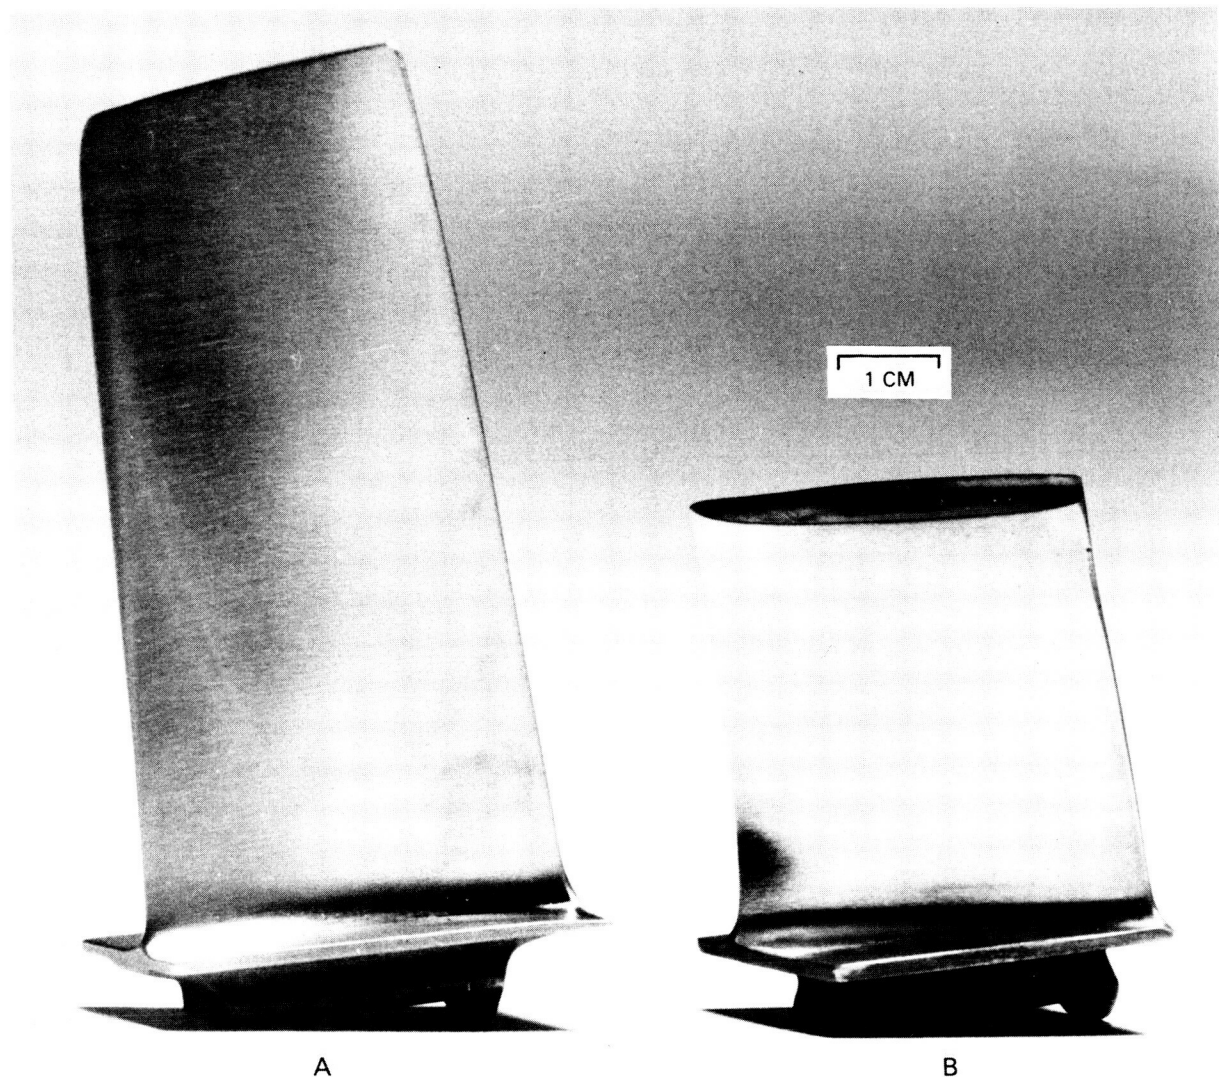
Figure 9 Compressor Blades Used in the Components Program. (A) AMS 4928 titanium alloy blade for service to 600K. (B) Incoloy 901 nickel steel alloy blade for service to 900K.

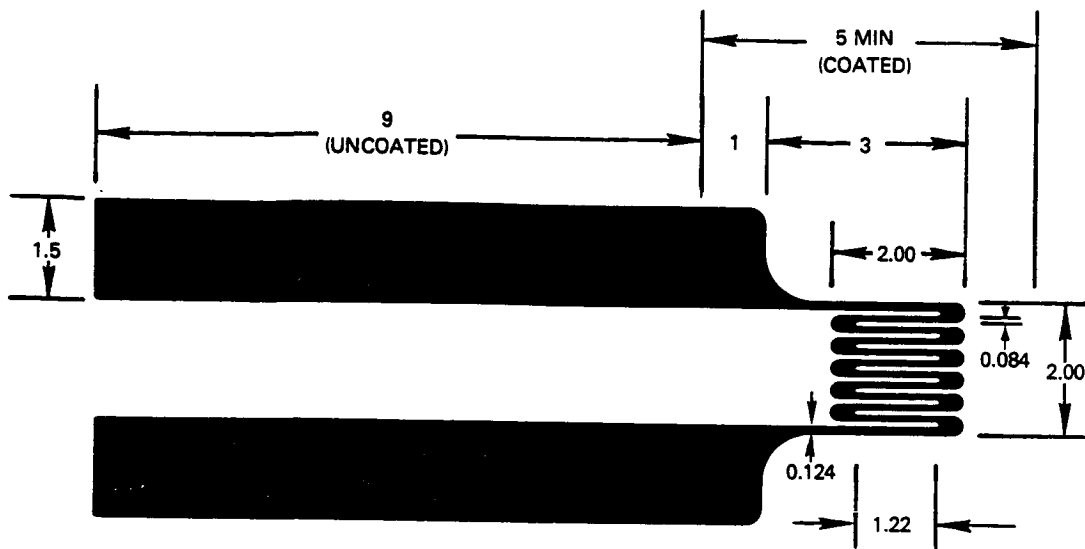
The gage configuration employed throughout the gage program is shown in Figure 11. The gage grid is the same 12-line, 2 mm x 2 mm pattern used in the Components Program (Figure 10), but the lead films are wider and spaced farther apart to facilitate lead-wire connection. The lead-film length-width ratio of 18 assured that the total resistance of the two lead films would be less than 3% of the gage resistance as discussed in Section 3.8. The overcoating, as noted in Figure 11, covers all of the gage grid and part of the lead film, but most of the lead film is left bare for connection of lead wires. A thin protective overcoating of cement is later applied over the lead wires and lead films, as described in Section 5.4.

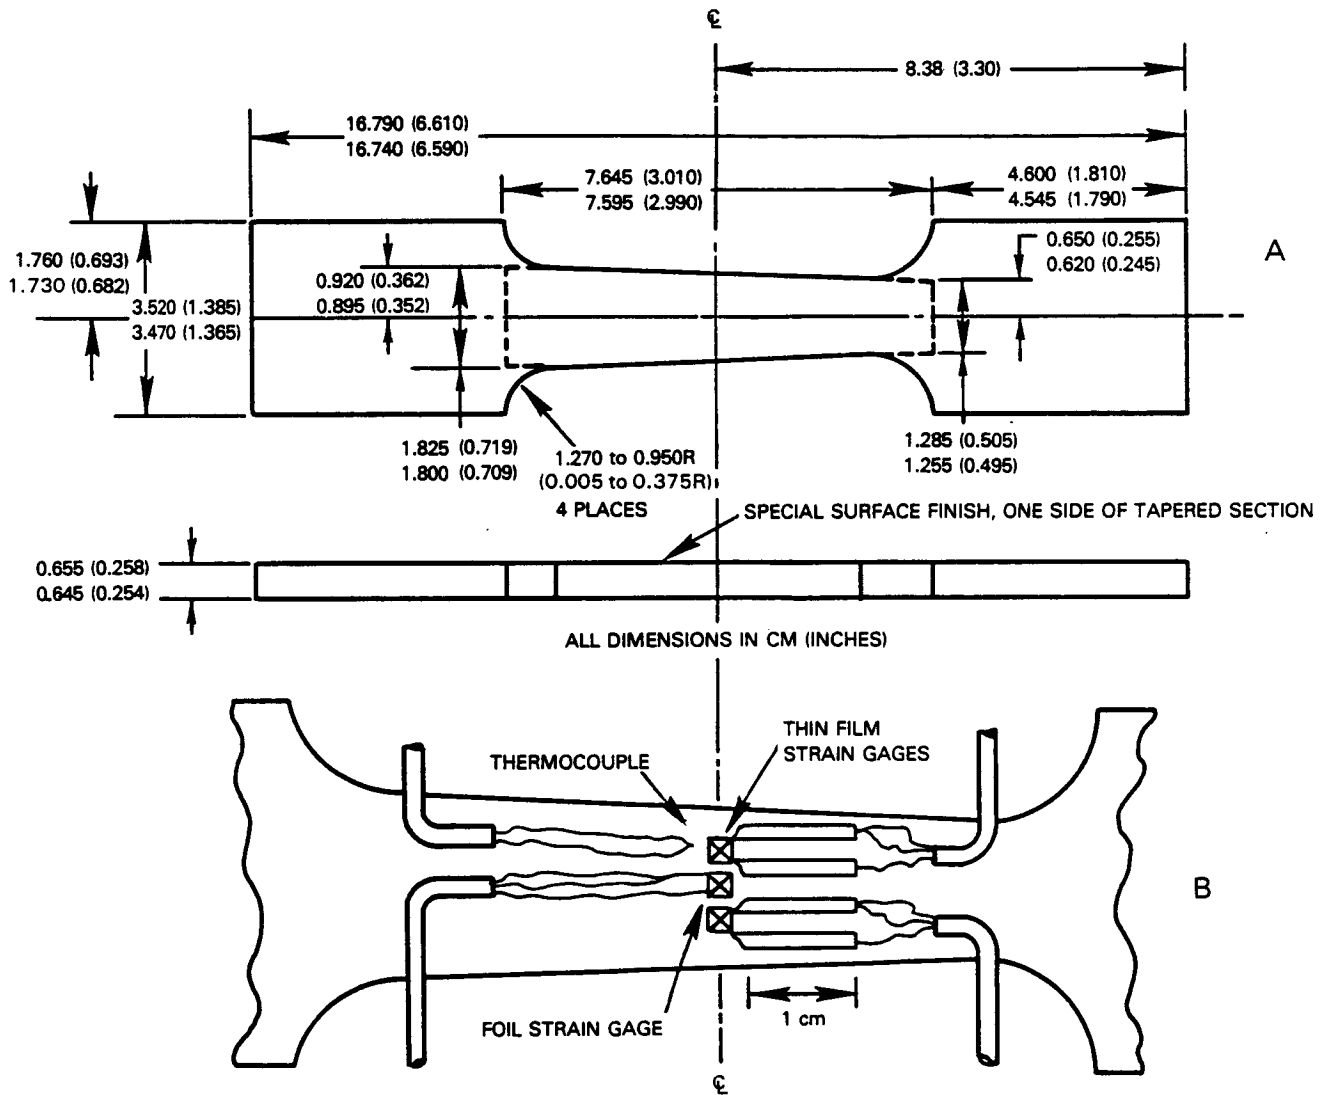
On the static test bars and on the special NASA bars, a reference commercial foil strain gage and a Chromel-Alumel thermocouple were also mounted as shown in Figure 12. The reference gage was a Micromasurements™ WK-60-062-AP-350 with option B-87 (76  $\mu\text{m}$  nickel clad copper leads attached), a 1.57 mm (0.062 inch) nickel-chromium alloy gage with glass-film reinforced epoxy-phenolic resin carrier for short-term service to 670K. The commercial gage was used to verify applied strains during initial tests on each test bar, as described in Section 5.5. The thermocouple provided surface temperature data.

Figure 12 Static Test Bar Design. (A) Dimensions of Test Bar. (B) Layout of Instrumentation on the Test Bar.

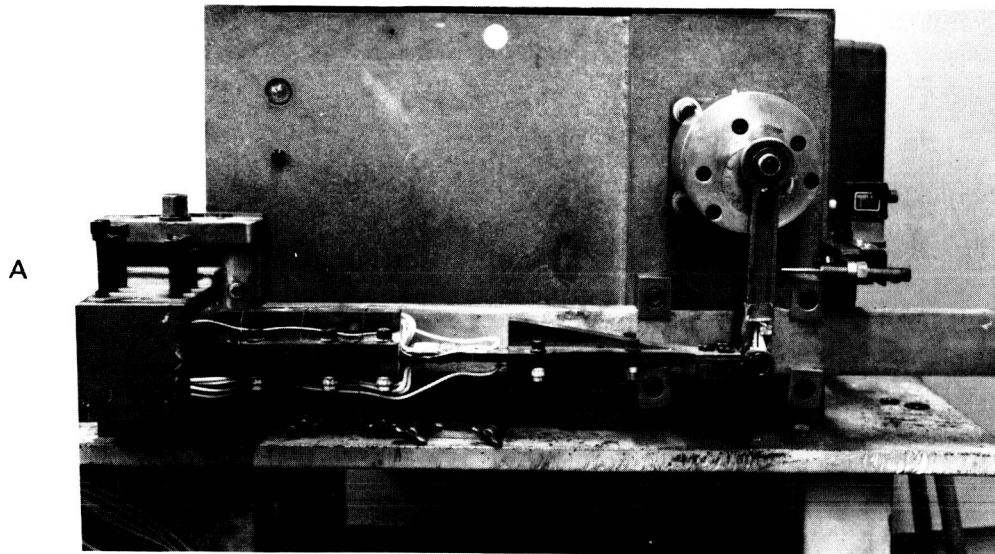
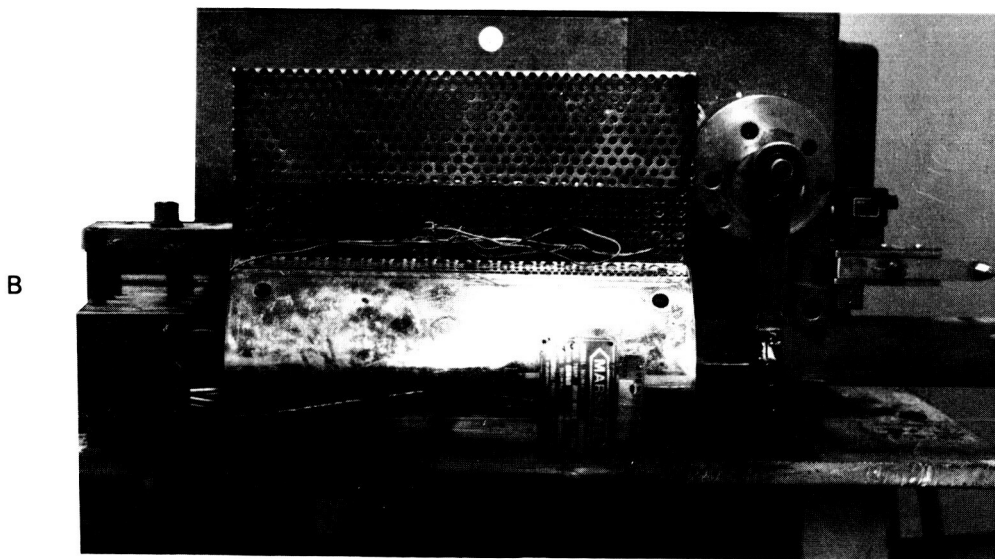
Figure 15 Fatigue Machine Shown (A) with Oven Removed, and (B) with Oven Installed. This apparatus was used for gage factor testing and for 900K fatigue testing.  
(78-444-4019-A)  
(78-441-4019-B)

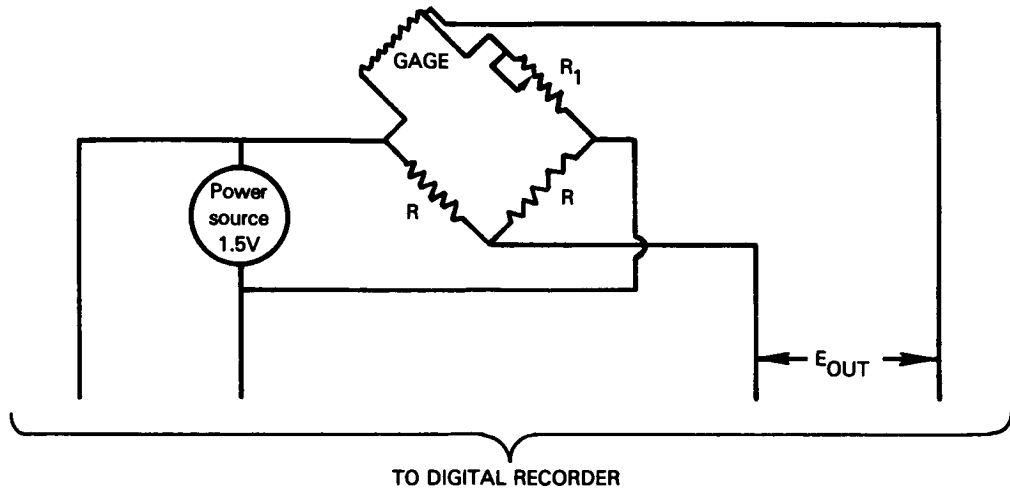
Figure 16 Strain Gage Bridge used for Gage Factor Testing.

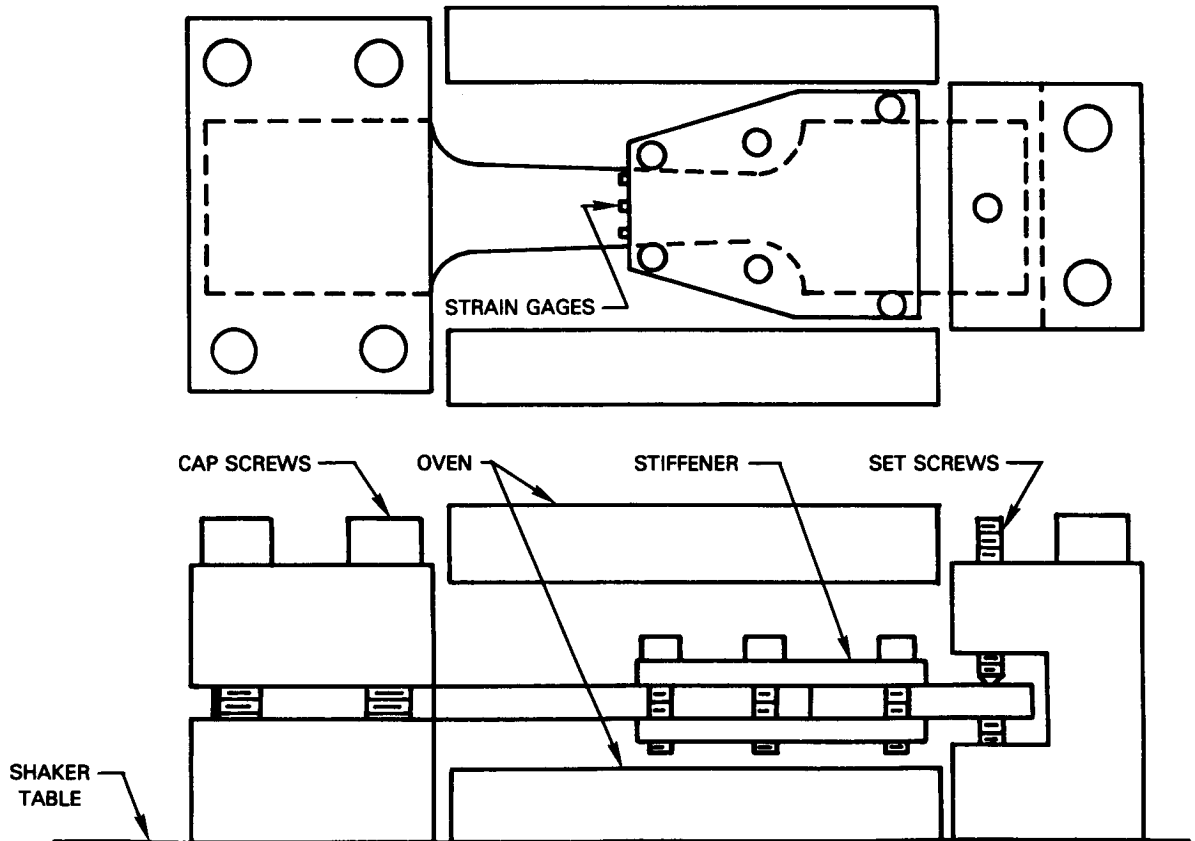
Figure 17 Fatigue Testing Fixture on Electrodynamic Shaker.

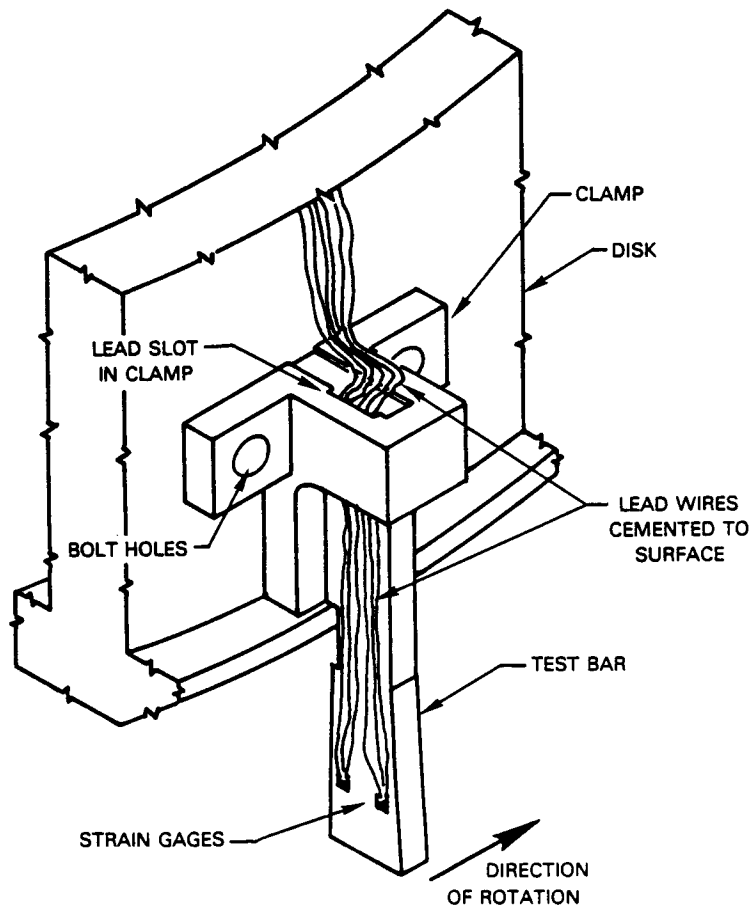
Figure 18 Installation of Spin Test Bar on Spin Disk.

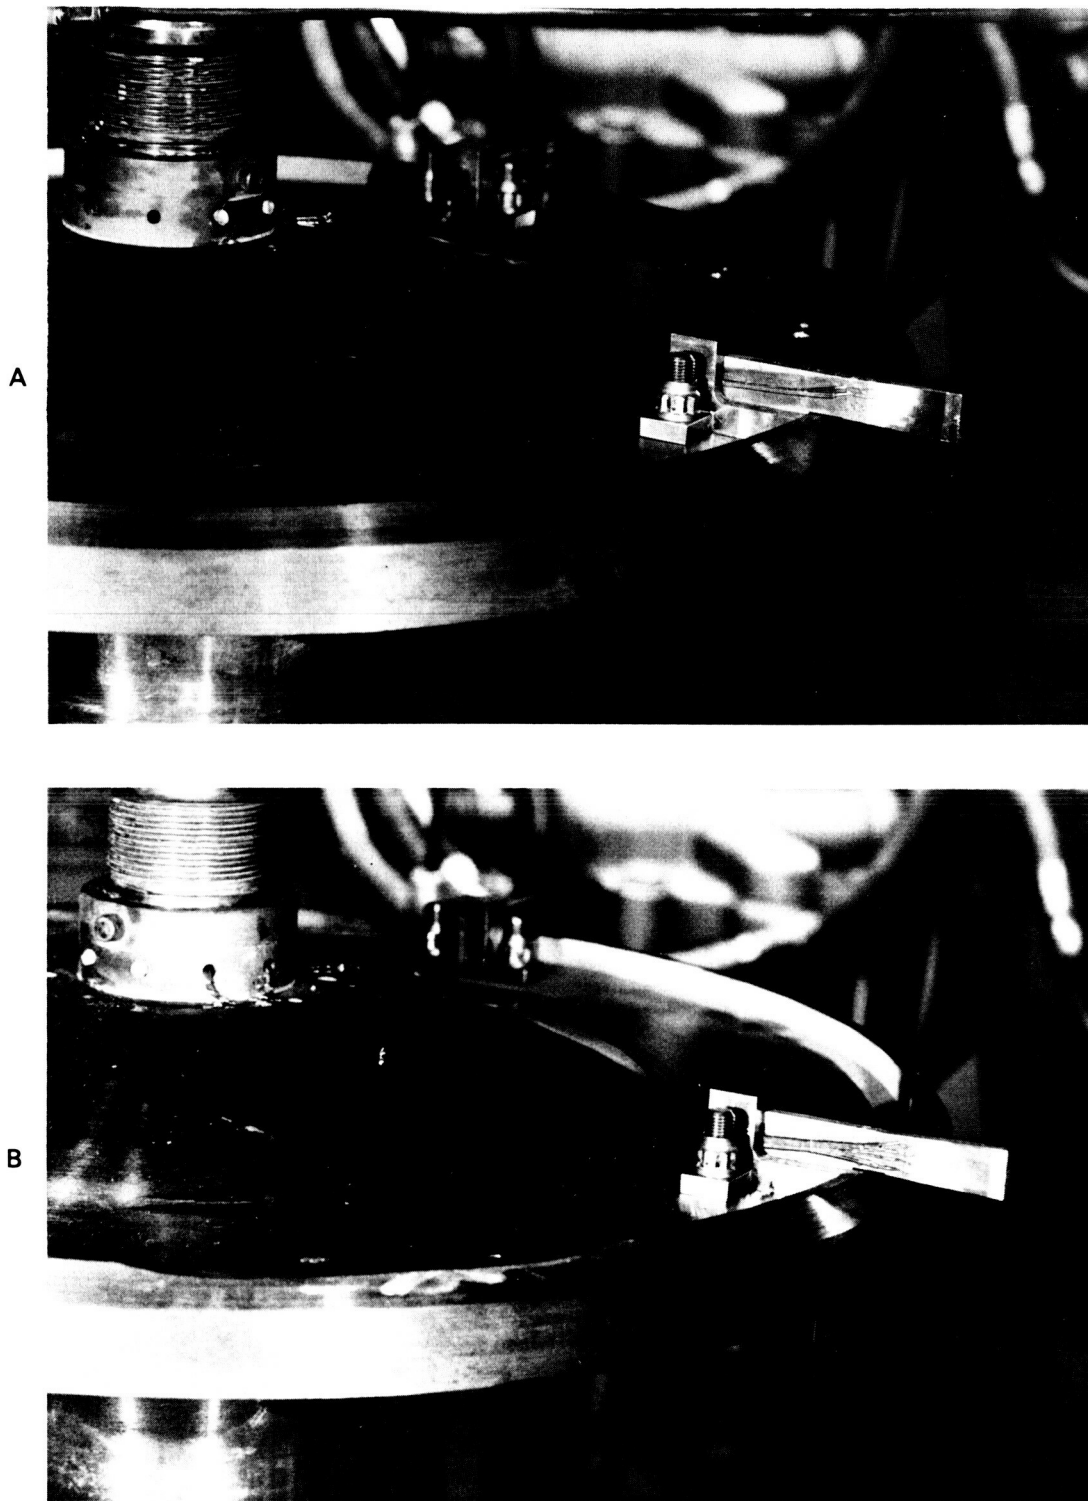
Figure 19 Spin Disk with Spin Test Bars Installed. (A) Bar A-3 in Foreground, Bar C-19 in Background. (B) Bar C-19 in Foreground, Dummy Bar in Background.  
(83-C0734-0003)  
(83-C0734-0002)

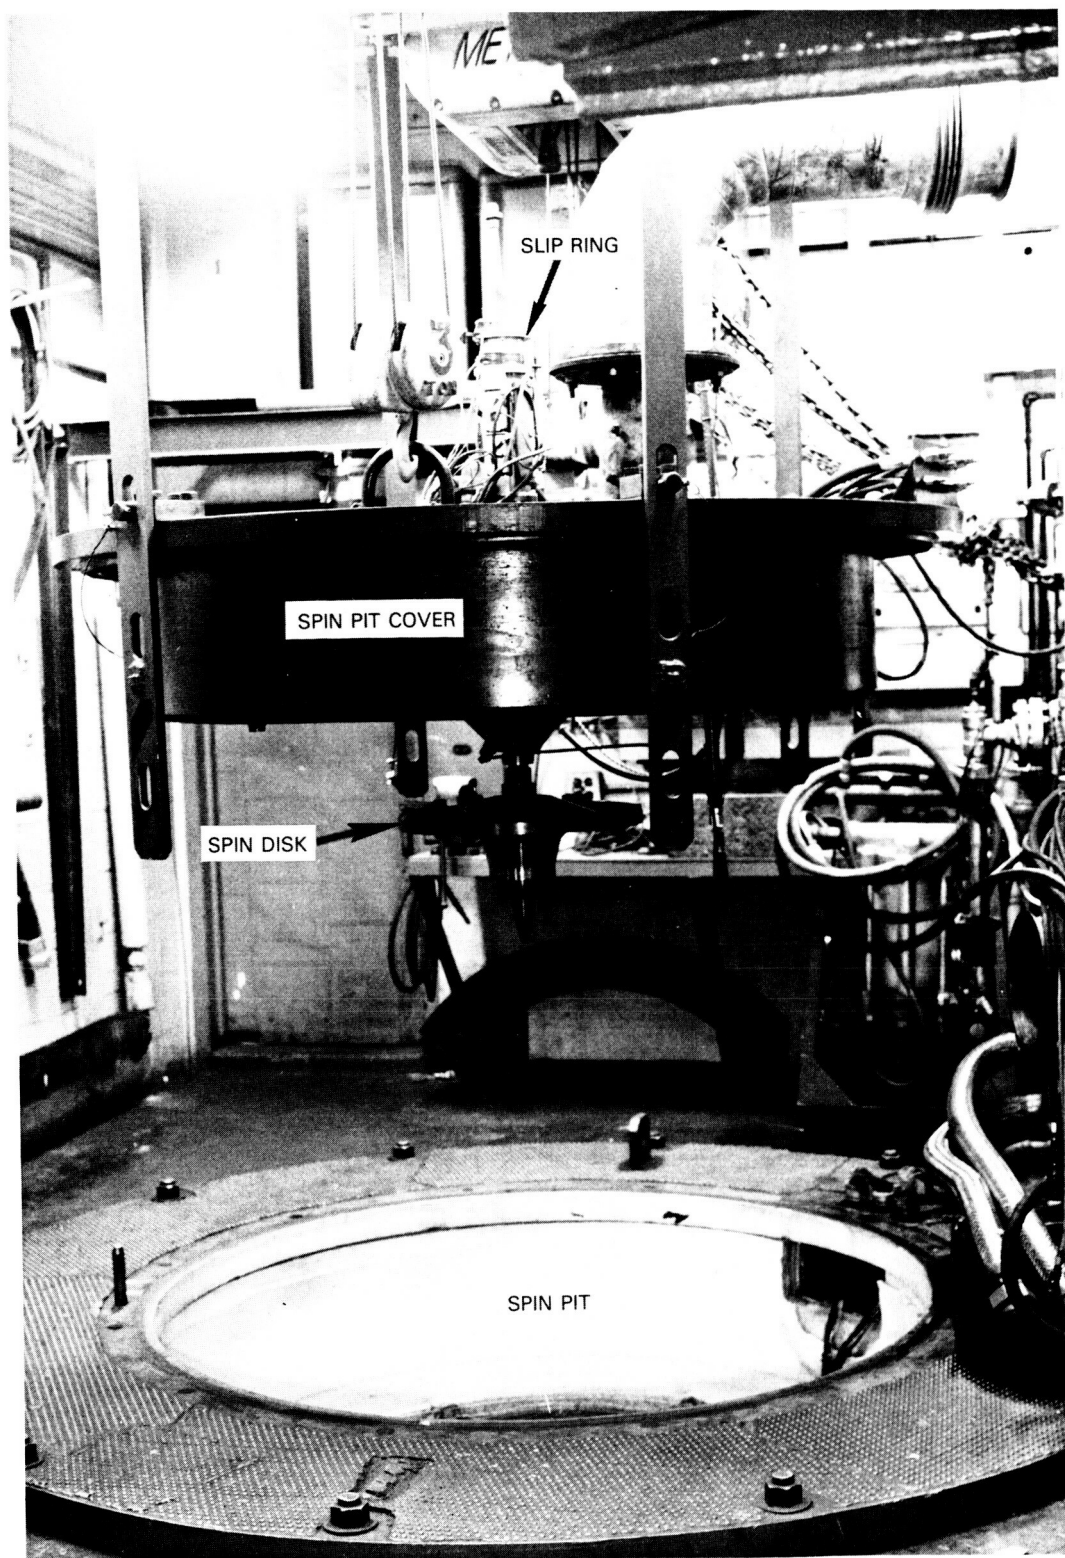
Figure 20 Spin Rig Mounted on Spin Pit Cover, before Lowering into Spin Pit.  
(83-C0734-0001)

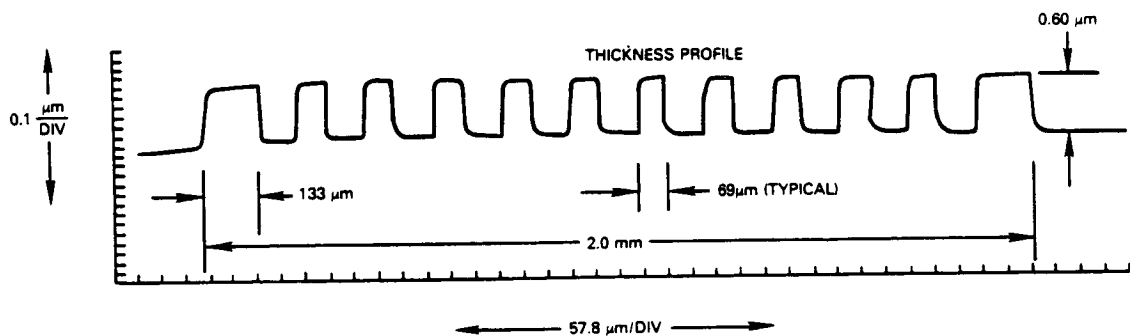
Figure 21 Thin Film Strain Gage Thickness Profile for NC Gage on a Polished Glass Slide. The profile shows that the applied strain gage pattern was sharply defined.

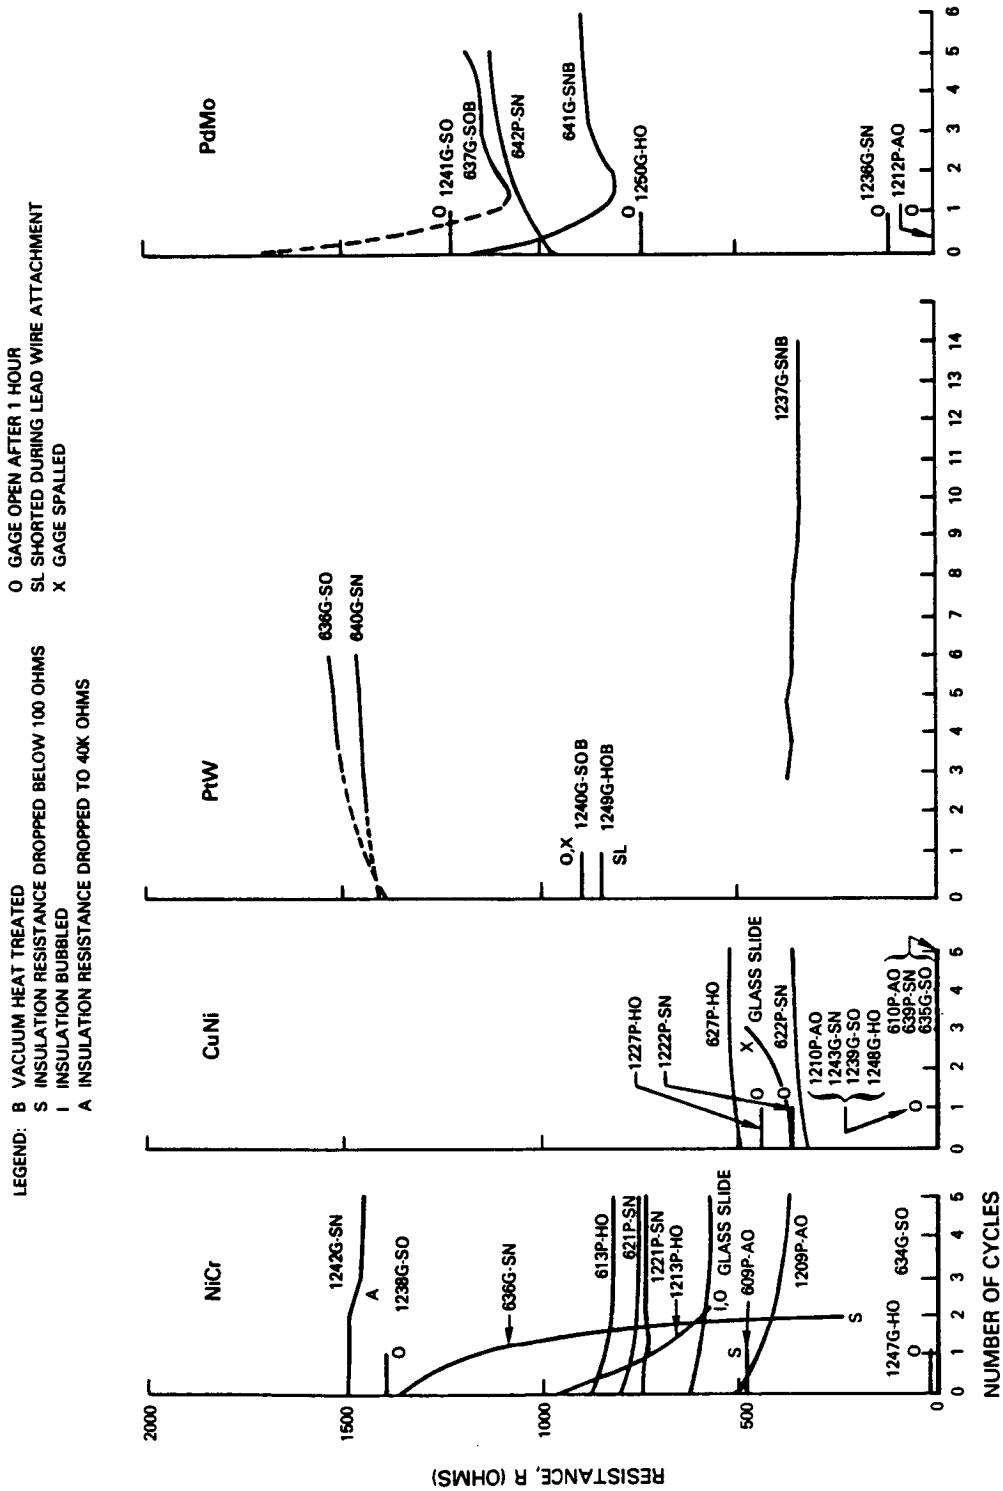
In Figure 22 it is evident that each gage alloy displays a characteristic drift trend. All five surviving NiCr gages (as well as the sample on a glass slide, also plotted in Figure 22) drifted downward in resistance in each cycle. The drift was less in each succeeding cycle. The total drift was -3 to -5 percent in five cycles. For three of these gages the drift rate reached zero in the fifth cycle. (Gage resistance is reported to the nearest ohm.) Insulation resistance (Table XXIII) remained above 20 megohms throughout the five cycles for four of these five gages and was not a factor influencing drift. In the fifth gage system (1242G-SN-NC) the insulation resistance dropped from its initial value of 20 megohms to 40 kilohms by the fourth cycle and then remained stable. This particular gage had an initial measured resistance of 1500 ohms and final measured resistance of 1460 ohms. The reduction in measured insulation resistance (increased shunting) therefore apparently accounted for about two-thirds of the -2.7 percent change in measured gage resistance.

Figure 22 Gage Resistance at Room Temperature versus Number of Cycles to Service Temperature for the 34 Adherent First-Generation Strain Gages.

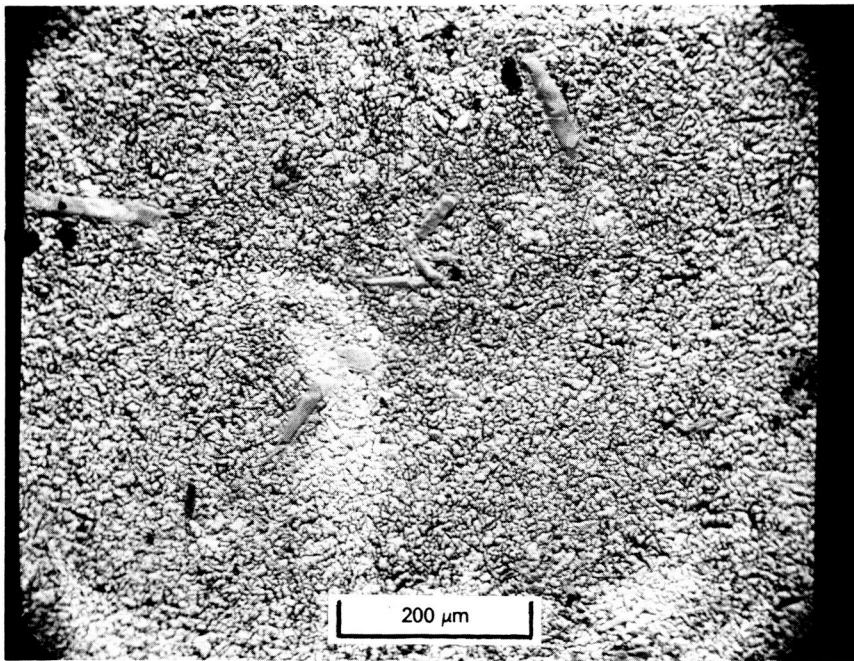
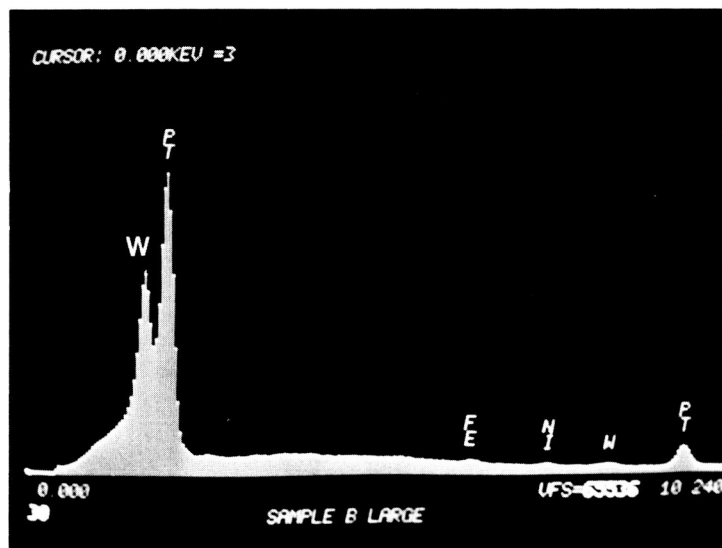
Figure 23 PtW Gage Material Surface Structure (A) and Electron Microprobe Composition Spectrum (B).

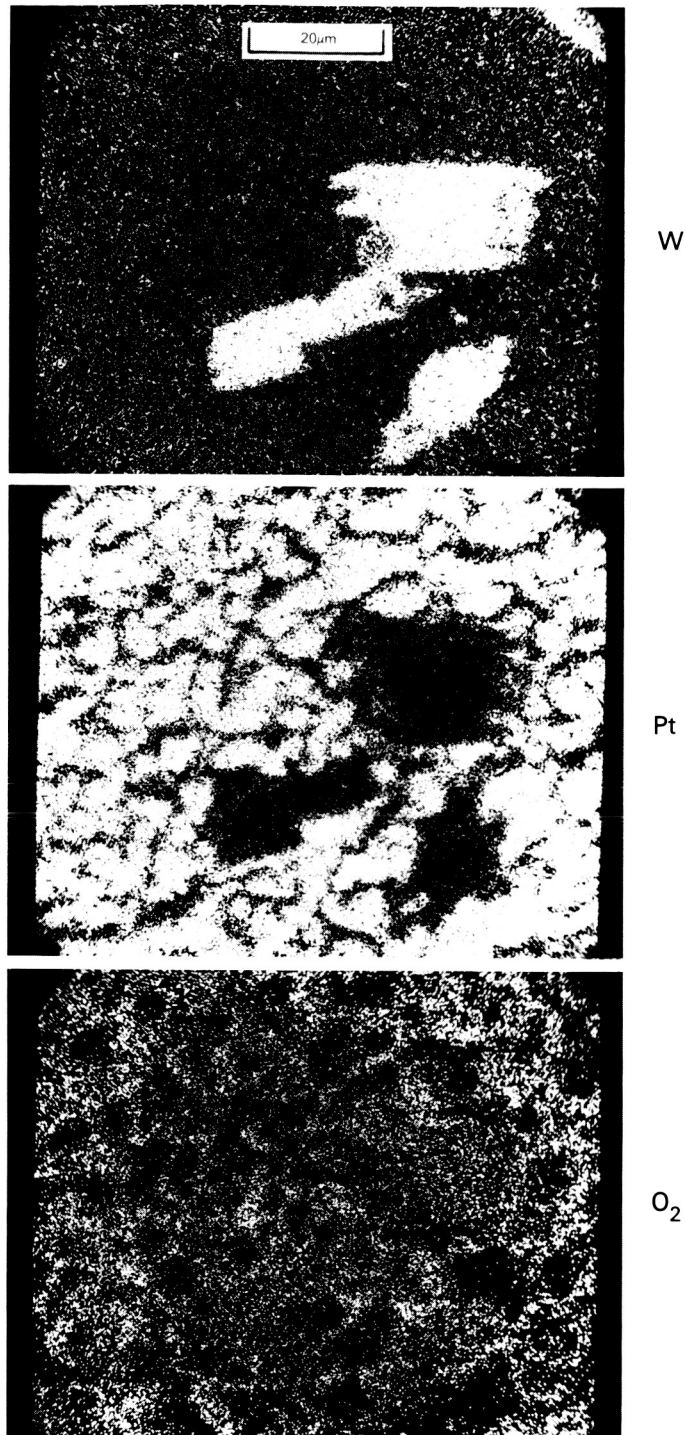
Figure 24 X-Ray Maps of W, Pt, and O<sub>2</sub> Over a 70  $\mu$ m by 80  $\mu$ m Region of PtW Film. A light area indicates a high concentration of the identified species. The same area is shown in each photo. The islands are rich in tungsten and contain almost no platinum. The oxygen is randomly distributed.

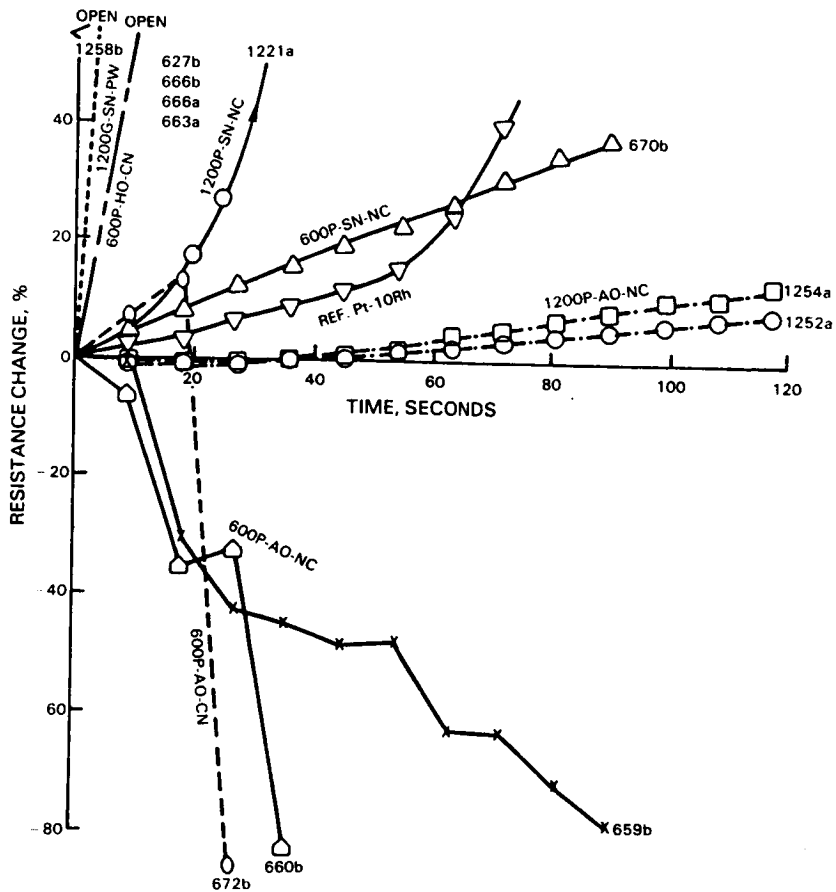
Figure 26 Erosion of Uncoated Thin-Film Strain Gages; Resistance Change versus Time.
