**THIN FILM STRAIN GAGE DEVELOPMENT PROGRAM  
FINAL REPORT**

**Contract NAS3-21262**

December, 1983

**Commercial Engineering  
Pratt & Whitney  
UNITED TECHNOLOGIES CORPORATION**

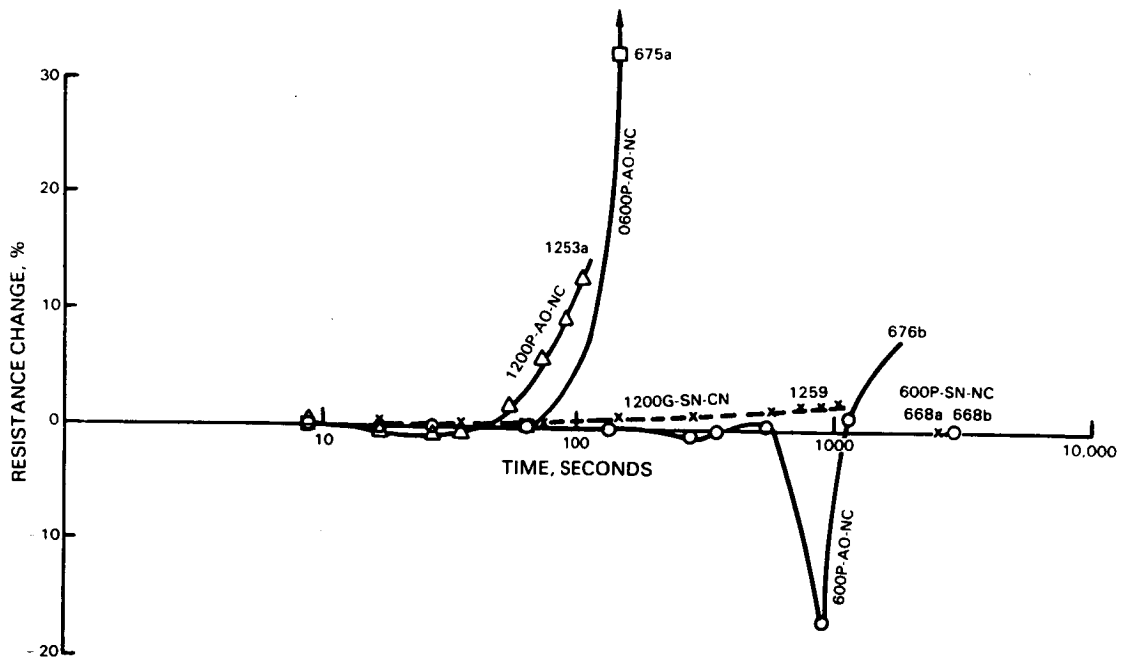
Figure 27 Erosion of Coated Thin-Film Strain Gages; Resistance Change versus Time.

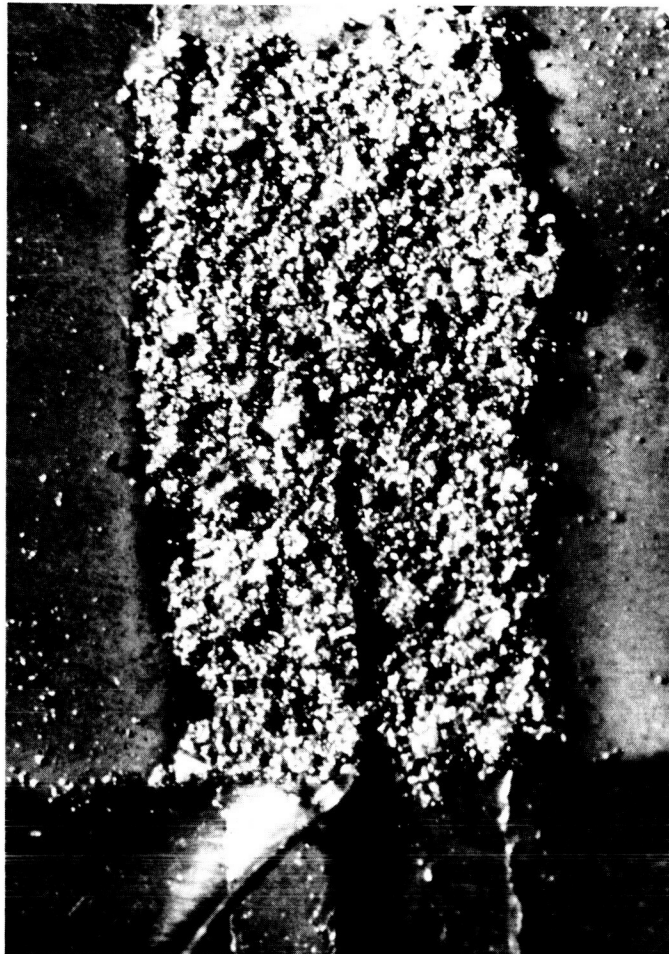
Figure 29 Flame-Spray Bonds of 76  $\mu\text{m}$  Wires (Ni-10Cr) to 5  $\mu\text{m}$  Films (Ni-30Cr). A - Partially completed installation. B - Another installation, completed.

The flame-spray technique described in 4.9 was successful in initial trials on 5  $\mu\text{m}$  lead films. The photograph at right in Figure 29 shows that the flame-sprayed Ni-Al formed a fine-grained coating over the lead wire and film, bonding them firmly together. The lead film and underlying insulating film were not damaged. Bond strength exceeded wire strength. Later trials revealed that the technique is sensitive to minor variations in flame spray parameters, and operator technique. Success rate dwindled to about 30 percent. In the photograph at left in Figure 29, the flame-spray application was stopped when the lead film became shorted to ground, before the flame-spray layer was sufficiently complete to provide a reliable low-resistance bond.

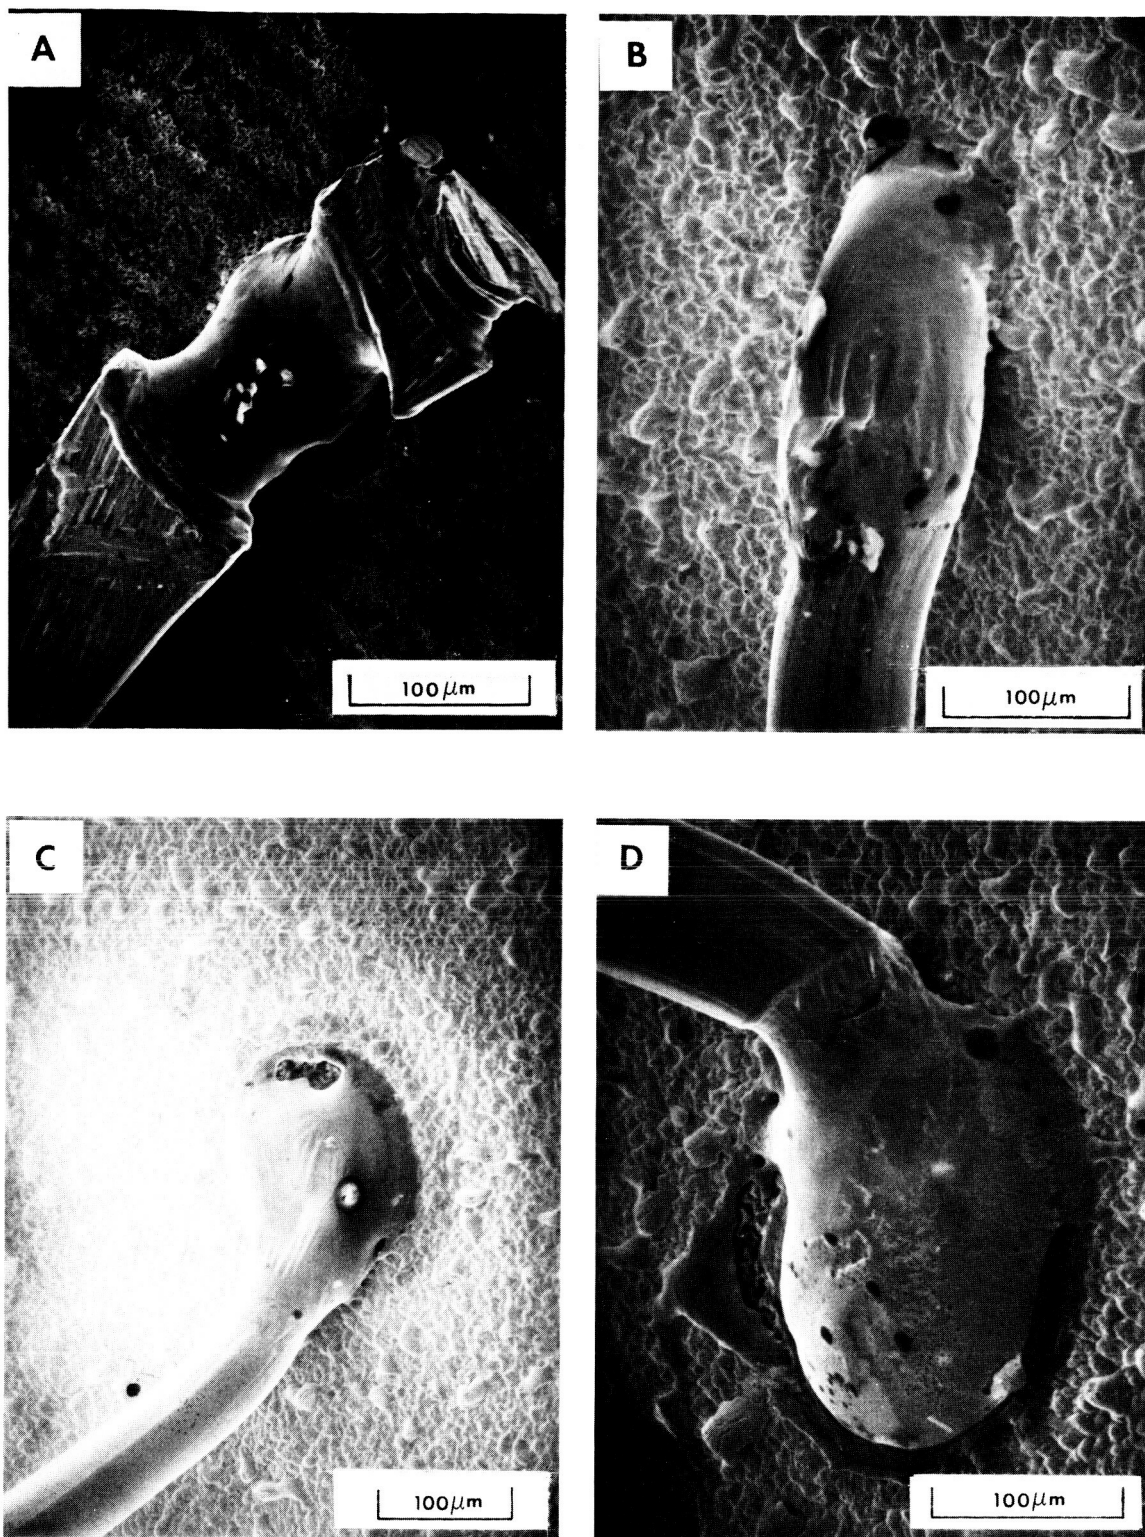
Figure 30 Laser Welds of 76 μm Wire (Pt-10Rh) to 2 μm Film (Pt-10Rh) on Al<sub>2</sub>O<sub>3</sub> Insulating Film. A and B were clamped under a glass slide during welding. All bonds were strong, but the underlying Al<sub>2</sub>O<sub>3</sub> films were damaged.

Excellent bonds of Pt wire to the 5  $\mu\text{m}$  PtW lead films were achieved at 900K using the hot compression bond procedure described in Section 4.9 without damaging the underlying insulation layer. (With 1 to 2  $\mu\text{m}$  PtW lead films, shorting sometimes occurred during hot compression bonding.) The procedure is nearly identical to that described in Reference 4 for platinum and platinum-10 percent rhodium wire-to-film bonds in sputtered thin film thermocouple systems used successfully in an engine hot section environment (1250K).

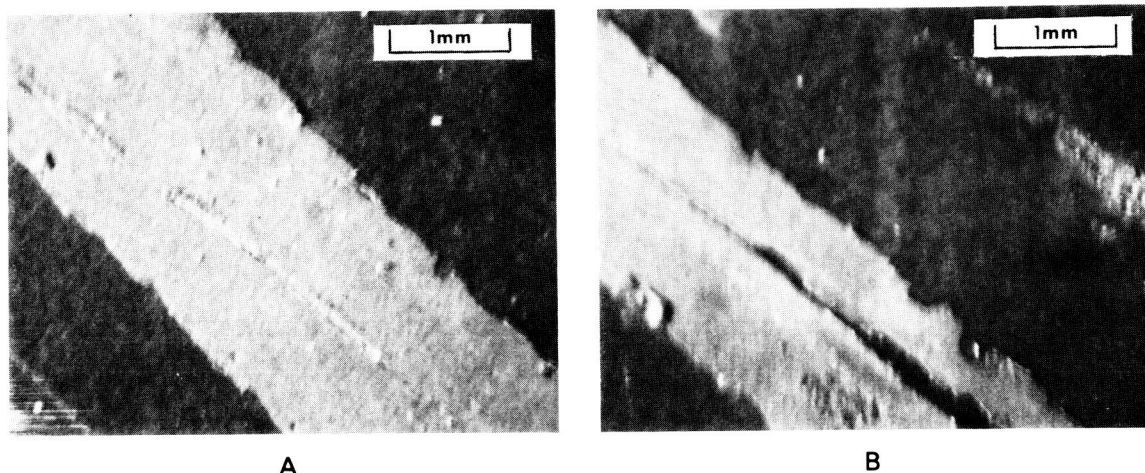
Weak bonds of 76  $\mu\text{m}$  Ni-10Cr wire to 5  $\mu\text{m}$  Ni-30Cr films were achieved by clamping for 24 hours at 980K. The bonds were too weak to support the weight of the 5 cm lengths of wire during normal handling. Figure 31 shows some film surface characteristics after the wire became debonded, including regions where no strong bonding occurred even though the clamping force was sufficient to leave an imprint of the wire in the film (Photo A) or even to crush the film (Photo B).

Figure 31 Surface of 5  $\mu\text{m}$  Ni-30Cr Films After Attempts to Bond 76  $\mu\text{m}$  Ni-10Cr Wires to the Films by Clamping for 24 hours at 980K. A - Shows an imprint of a wire. B - Shows crushing and delamination of a film in a region where a wire was clamped.

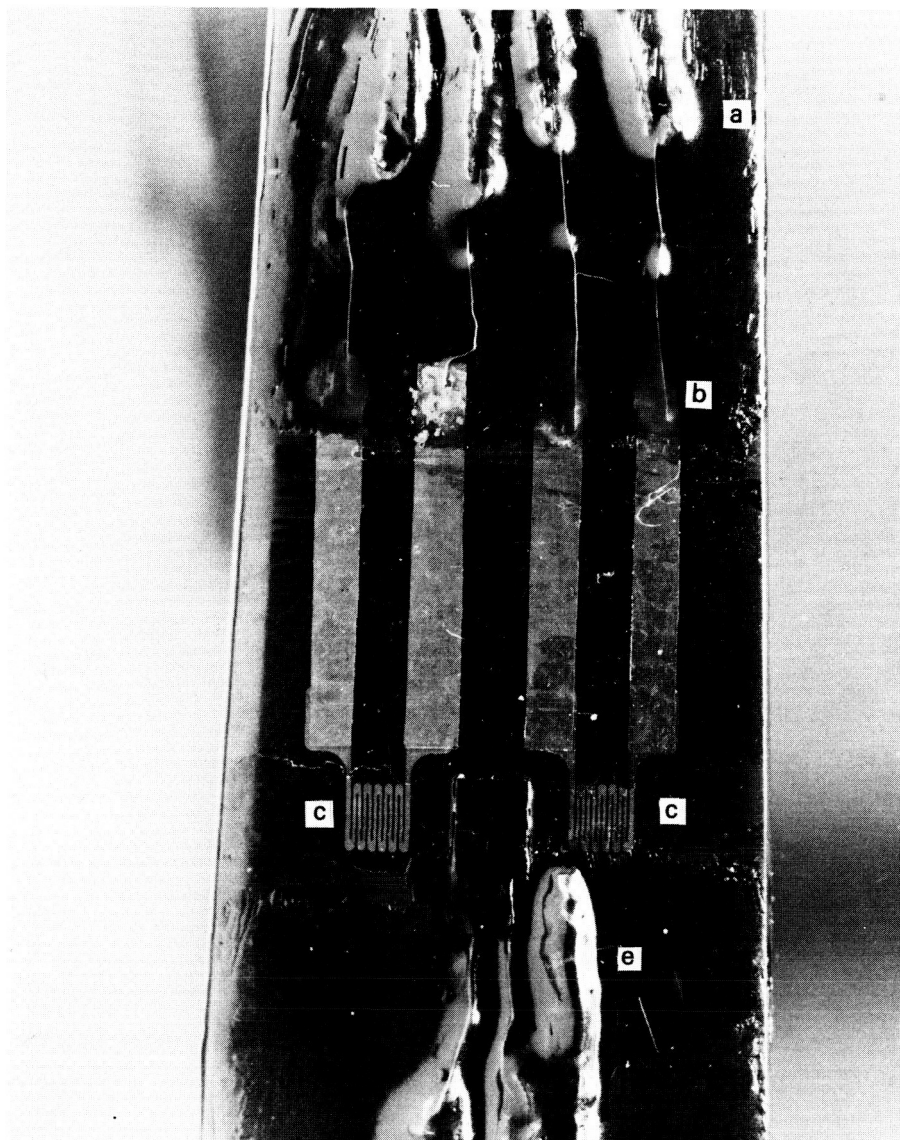
Figure 32 Thin Film Strain Gage Installation on AMS 4928 Bar 7. Details shown include: a) - Connection of sheathed extension wire to  $76 \mu\text{m}$  Ni-10Cr lead wire, b) - Connection of lead wire to  $1.3 \mu\text{m}$  Ni-30Cr lead film, c) - Ni-30Cr thin film strain gages, d) low-temperature reference foil gage, and e) - reference thermocouple. Sputtered insulation and overcoat is  $\text{Si}_3\text{N}_4$ . Photo No. 81C3373-002

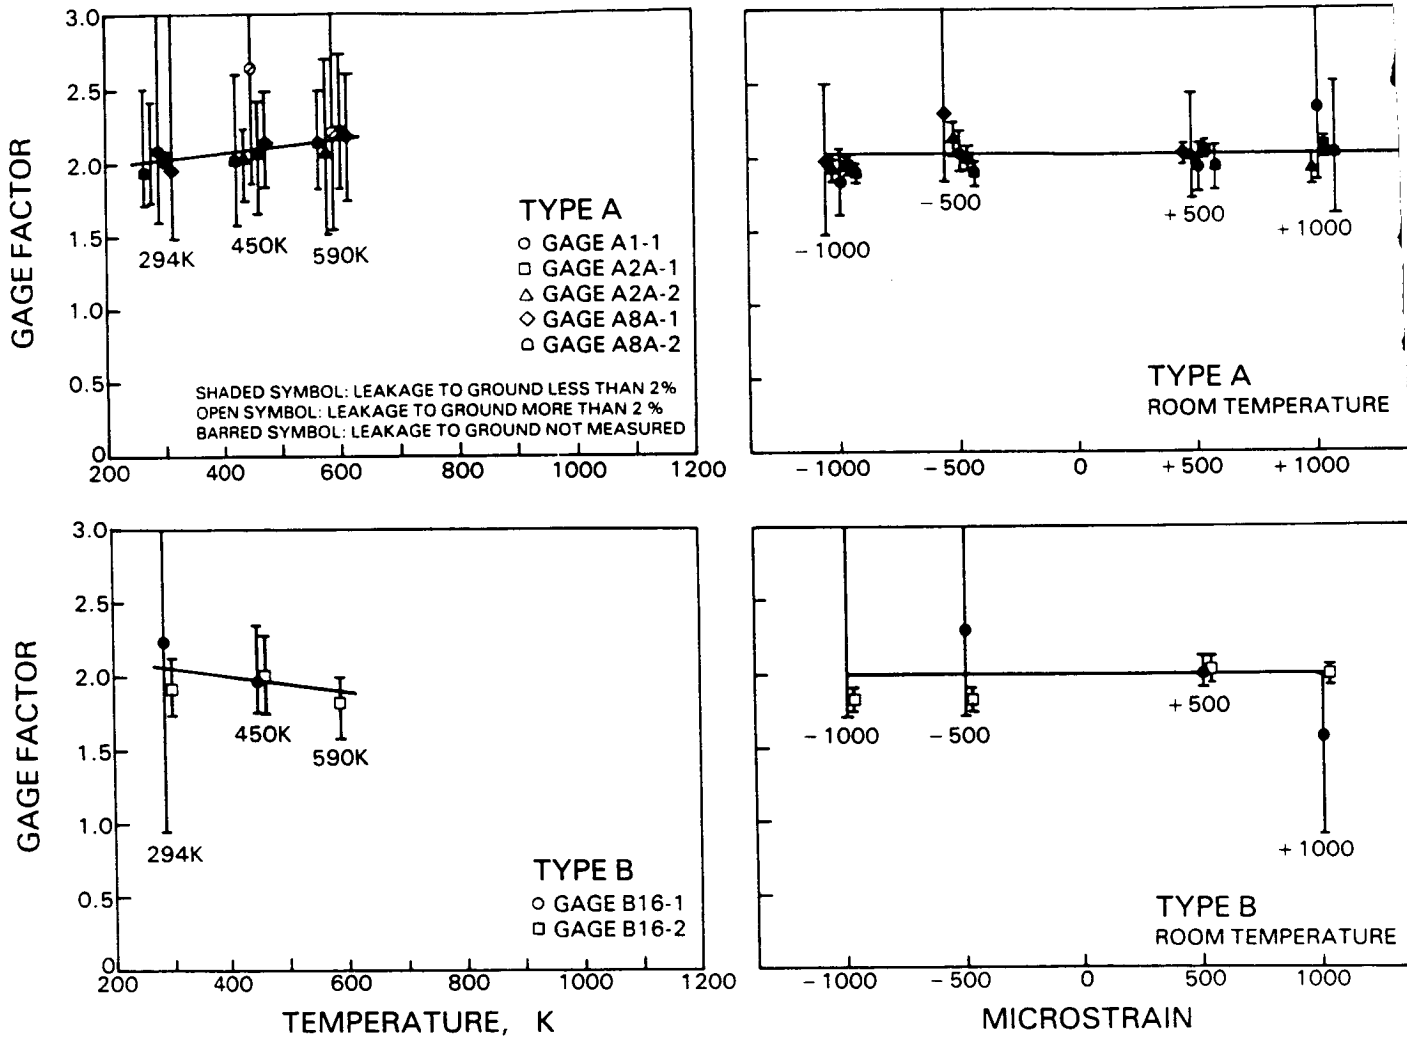
The evidence in Figure 34 and Appendix C is that the major contribution to scatter in all of the gage factor determinations was the lead wire attachment contact resistance variability. For example, repairs to the lead wire attachments eliminated the scatter (temporarily) in the case of gages B16-2, C17-1, C17-2, C24-1, C24-2, D31-1, D31-2, E33-1, E33-2.

Figure 34 Gage Factor versus Temperature and versus Strain (at room temperature).

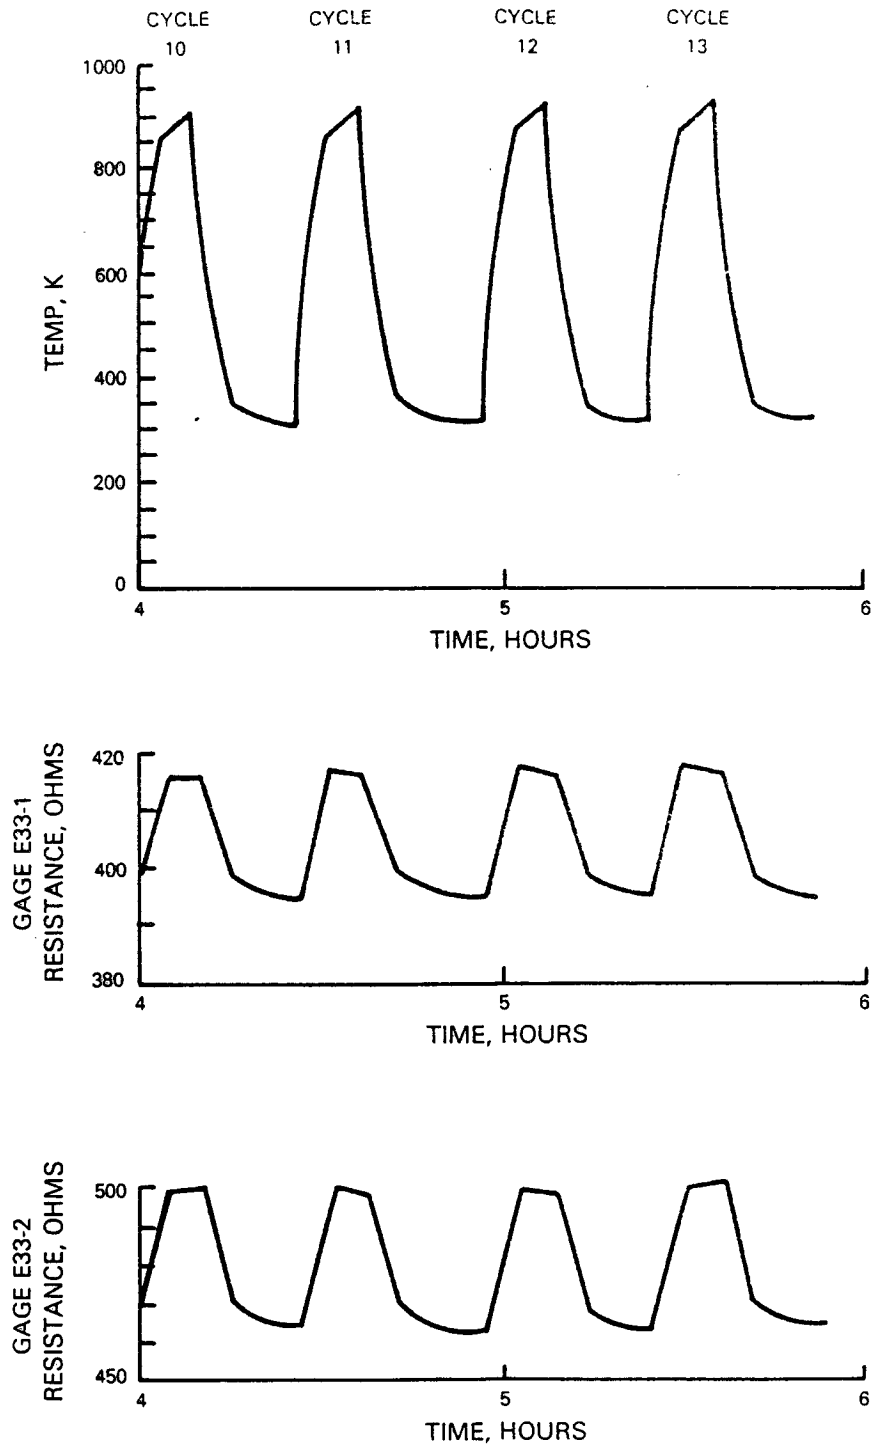
Figure 35 Sample Thermal Cycle Data. The gage resistances and temperature on test bar E33 are shown for cycle 10 through cycle 13 of the 50 thermal cycles.

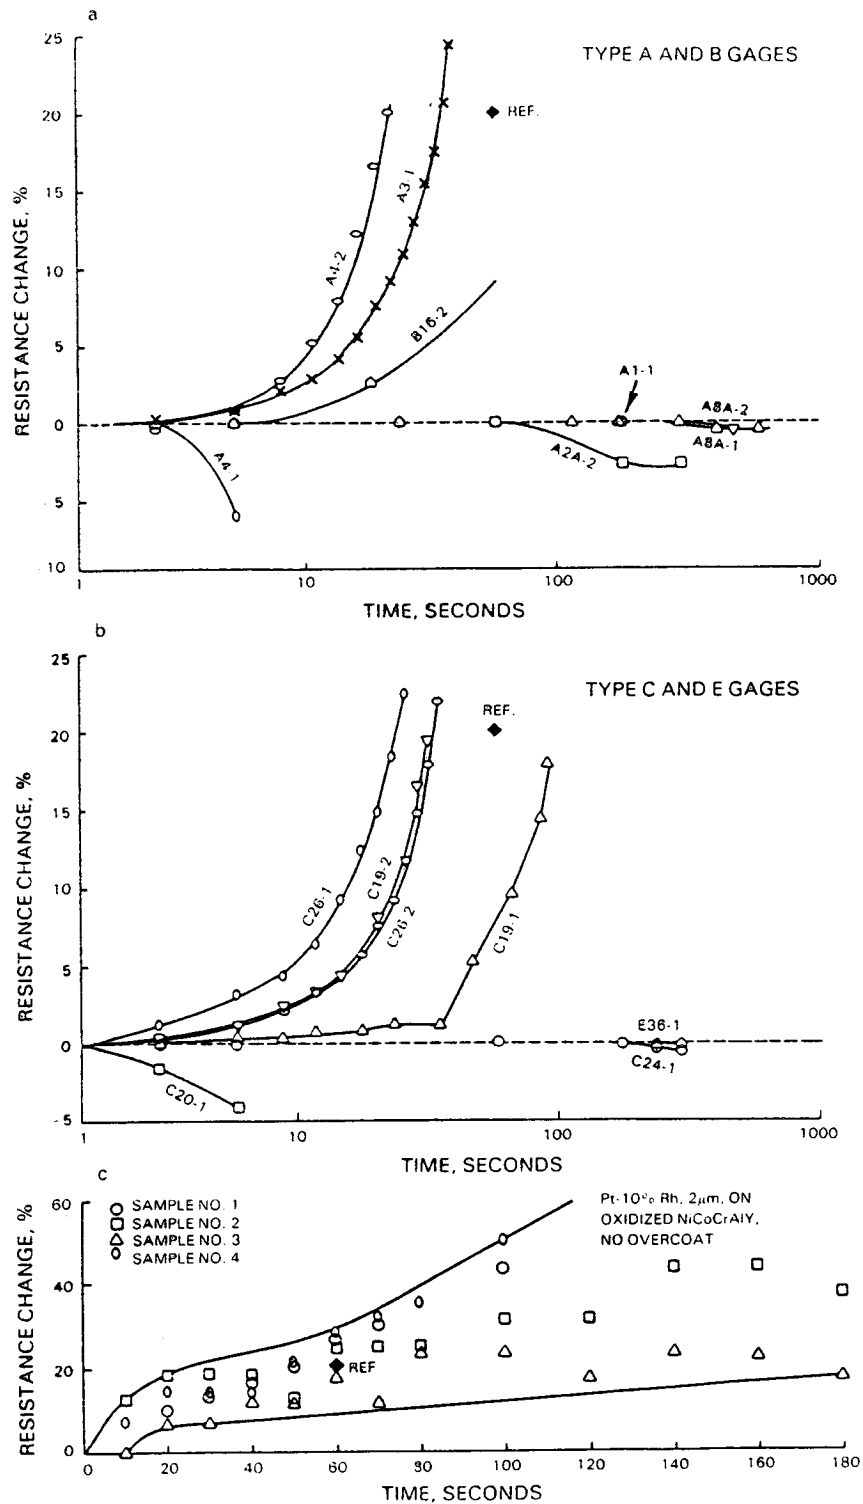
Figure 37 Erosion Test Data. (a) Type A and Type B Gages; (b) Type C and Type E Gages; (c) Reference Pt-10%Rh Films.

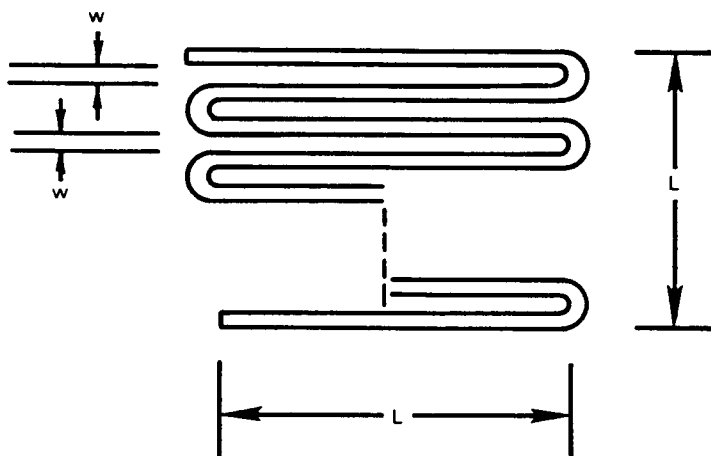
Figure 40 Strain Gage Pattern, Simplified Configuration.
