NASA Contractor Report 172359

# ACEE COMPOSITE STRUCTURES TECHNOLOGY

Papers by  
Douglas Aircraft Company

DAMAGE TOLERANCE AND FAIL-SAFE TESTING  
OF THE DC-10 COMPOSITE VERTICAL STABILIZER

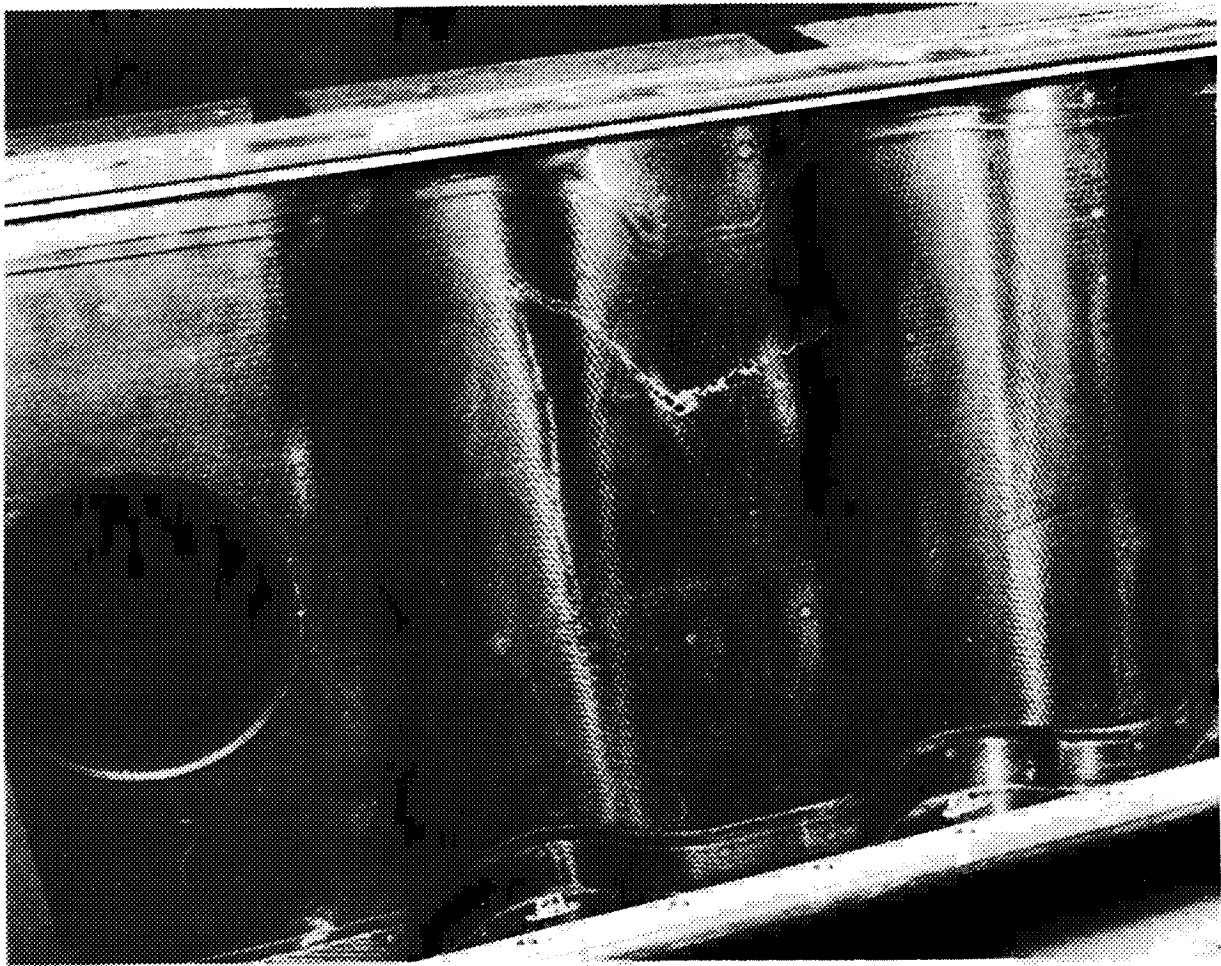
FIGURE 16.

Figure 16 shows the crack in the front spar web that occurred during the ultimate load test at 140 percent of design limit load.

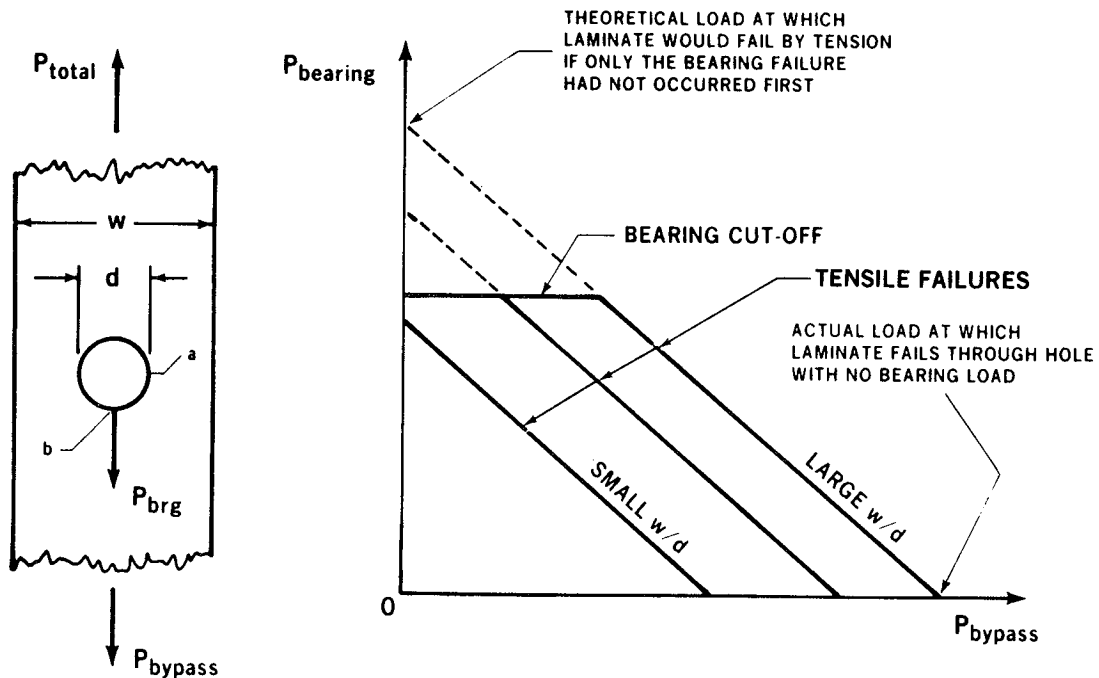
FIGURE 12.

Whether the load sharing between rows of bolts in a multi-row joint be established by the A4EJ computer program or by finite elements, it is necessary to have a failure criterion. The one built into the A4EJ program for tensile failures is illustrated below in Figure 12. Two failure modes - tension at a and bearing at b - are possible, depending on the geometry and bypass stress. The intercepts on the axes can be computed from the joint geometry, material allowables, and effective stress concentration factor  $k_{tc}$ . The bearing strength must be established by test. The total strength is the sum of the coordinates and is always maximized in the regime of high bypass loads combined with only low bearing stresses.

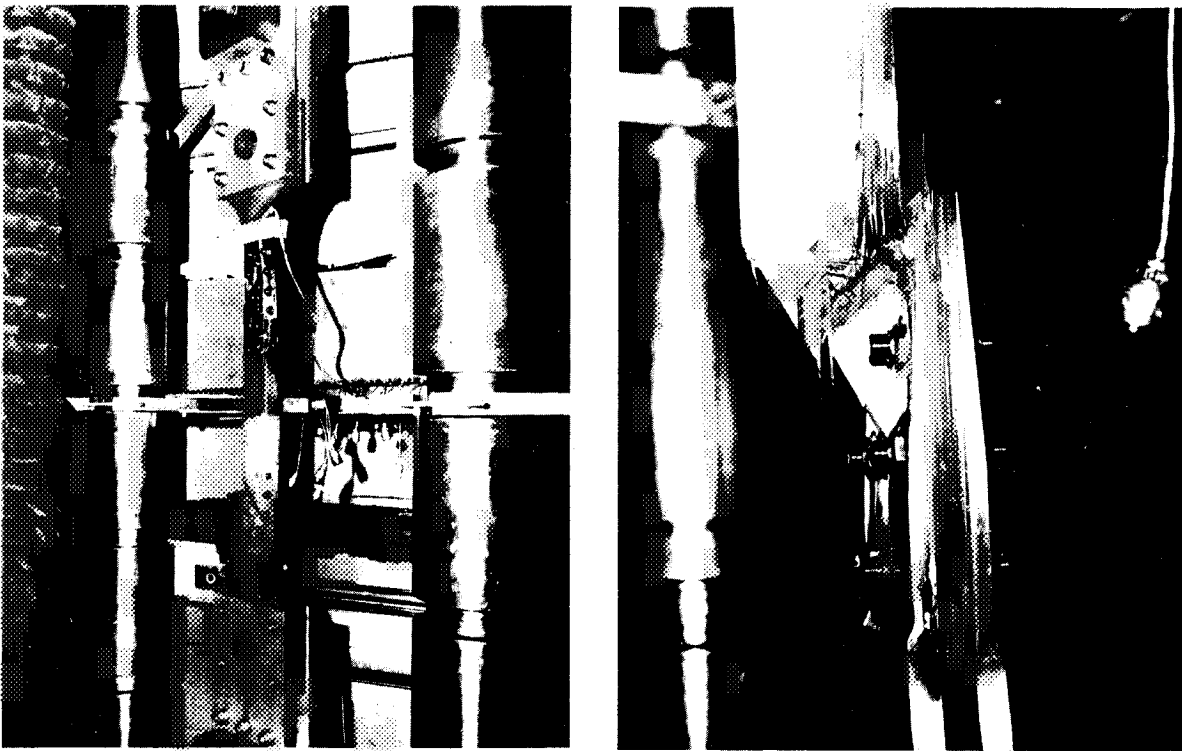
FIGURE 9.

The joint transition specimen was tested to static failure at an ultimate load of 197,200 pounds, or at a running load intensity of 34,300 pounds per inch. This corresponds to an average gross-section stress and strain of about 50,000 psi and 5,300 microstrain in the basic section, prior to the thickness buildup outside the joint. These are only average values, however, and as shown by the photo-elastic coating, the specimen was not under a state of uniform stress through the section. Strain gage data indicated a strain level in the skin prior to the buildup of about 5,900 microstrain, which corresponds to a strain level at the bolted joint of roughly 4,700 microstrain. (Young's modulus equals  $9.3 \times 10^6$  psi.) A net-section tension failure occurred through the first row of fasteners at a high-bypass, low-bearing load combination, followed by a tension failure through the minimum section of the stringer blade, as shown in Figure 9. This was precisely the failure mode that was anticipated and analytically predicted. Strain readings were taken throughout the test, with continuous readings taken from approximately two-thirds of the predicted strength to failure. The specimen failed, as shown, through the end which was equipped with the photo-elastic coating.

JOINT TRANSITION SPECIMEN  
ANALYSIS/TEST CORRELATION
