NASA Technical Memorandum 89929

Application of Scanning Acoustic Microscopy to Advanced Structural Ceramics

Alex Vary and Stanley J. Klima
Lewis Research Center
Cleveland, Ohio

Prepared for the
Symposium on Characterization of Advanced Materials
sponsored by the International Metallographic Society
Monterey, California, July 27-28, 1987

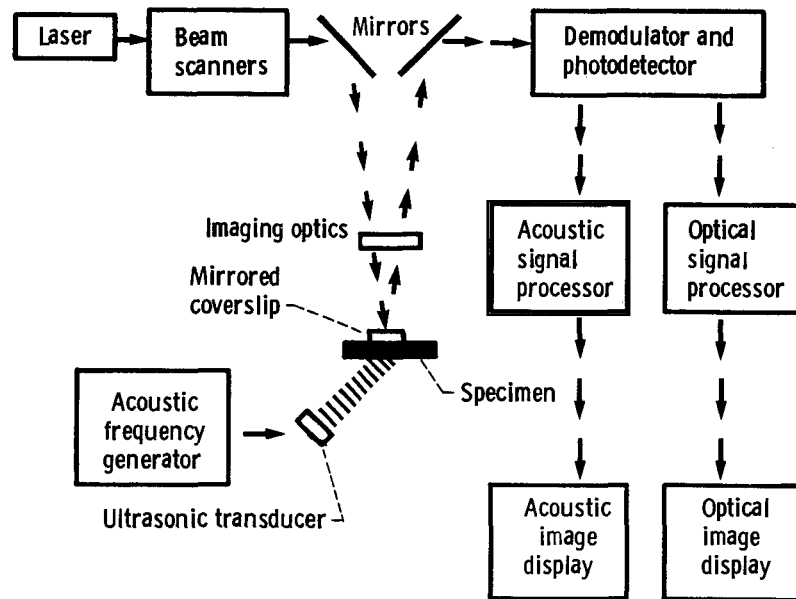
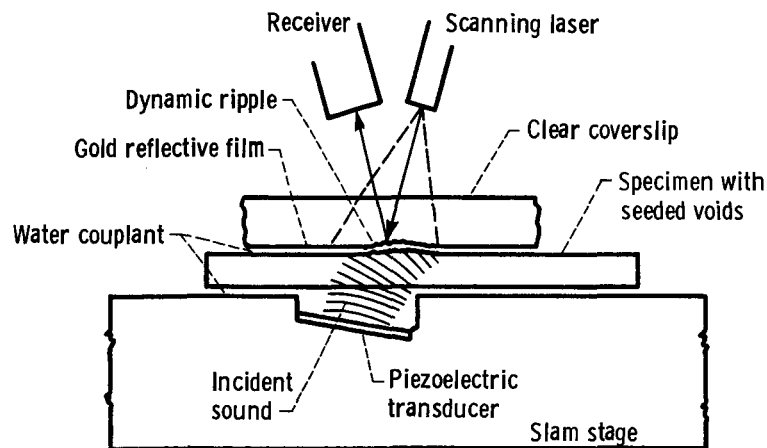
FIGURE 1. - DIAGRAM OF SCANNING LASER ACOUSTIC MICROSCOPE (SLAM).

A SLAM system is depicted in figure 1, where a continuous wave train produced by an ultrasonic crystal is transmitted through a material sample. The waves are modulated by surface roughness, material texture, anomalies and flaws. Intensity and phase variations of waves reaching the opposite surface create a disturbance pattern that is duplicated on the reflective cover-slip

coupled to the surface. The disturbance pattern is raster-scanned by a laser beam over an area approximately 2 mm^2 . The laser beam, modulated by the pattern, is reflected onto a photo-detector and converted into an electronic signal from which a video image is generated. The video image shows features within the material sample (cracks, voids, inclusions) that have intercepted the through-transmitted waves. The SLAM image is refreshed at video frame rates and is usually presented at a magnification of roughly 100X. The sample may be slid sideways to get new images at different locations. SLAM images generated by a 100 MHz crystal appear in figure 2.

(a) Schematic of SLAM system.

(b) Detail of specimen stage.

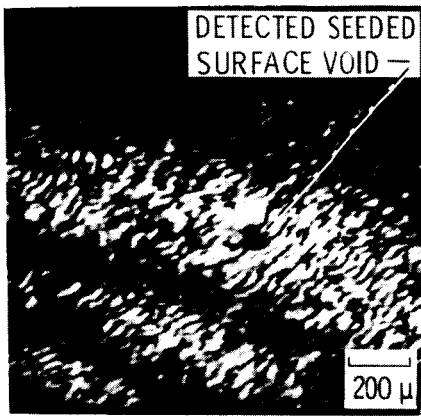
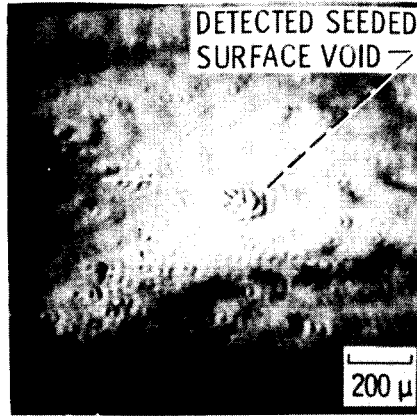
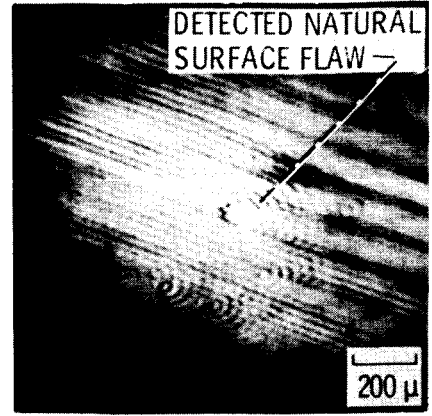
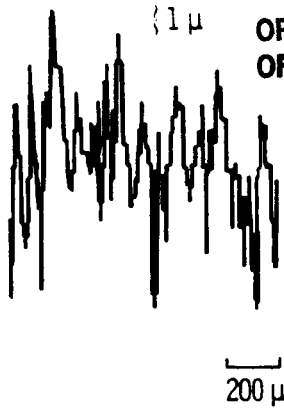
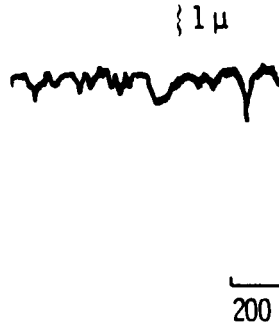
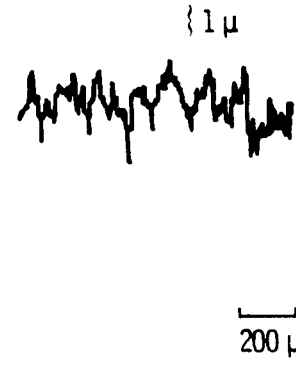
AS-FIRED BAR (SLAM)

AFTER POLISHING (SLAM)

DIAMOND-GROUND BAR (SLAM)

AS-FIRED SURFACE PROFILE

POLISHED SURFACE PROFILE

DIAMOND-GROUND SURFACE PROFILE

FIGURE 2. - REPRESENTATIVE SLAM IMAGES OF FLAWS IN SINTERED SILICON CARBIDE SPECIMENS SHOWING INCREASED FLAW DETECTABILITY AFTER SURFACE ROUGHNESS IS REDUCED BY POLISHING.

It is evident from figures 2 and 3 that surface preparation by polishing or grinding is needed to enhance the detectability even of near-surface voids greater than 50- μm diameter. Surface roughness affects the signal-to-noise ratio in SLAM images. Moreover, MOR bar samples with as-fired (as-sintered) surfaces show decreased flaw detectability with increased thickness. Flaw detectability also depends on the relative coarseness of the material microstructure. In silicon carbide samples flaw detectability was found to be significantly less than in silicon nitride samples that had a much denser grain structure (ref. 4).

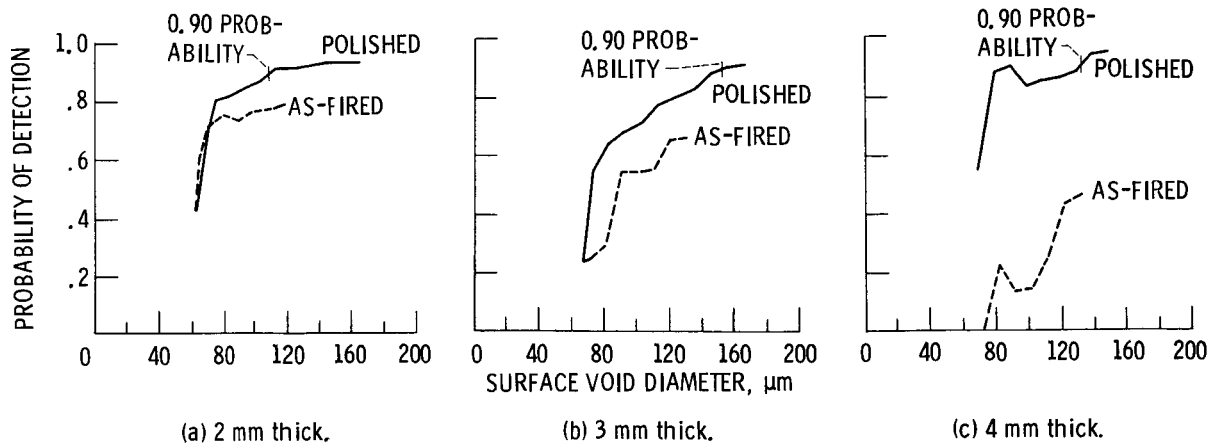
FIGURE 3. - REPRESENTATIVE PROBABILITY OF DETECTION (POD) CURVES BASED ON SEEDED VOID POPULATIONS SHOWING EFFECT OF SURFACE CONDITION AND SPECIMEN THICKNESS ON DETECTION OF VOIDS IN SINTERED SILICON NITRIDE USING SLAM.

The reliability of SLAM for flaw detection in silicon carbide and silicon nitride was evaluated by introducing known populations of microvoids into representative samples (ref. 2). Green ceramic powder compacts were seeded with plastic microspheres from 50 to 530- μm diameter. Voids formed after volatilizing the spheres in a preheat treatment. The seeded voids remained after sintering the compacts into modulus-of-rupture (MOR) bars. The seeded microvoids were representative of natural voids that account for roughly 25 percent of fracture origins found in ceramic MOR specimens (ref. 3). The numbers of seeded voids of various sizes were sufficient for generating probability-of-detection (POD) statistics. Results are shown in figure 3.

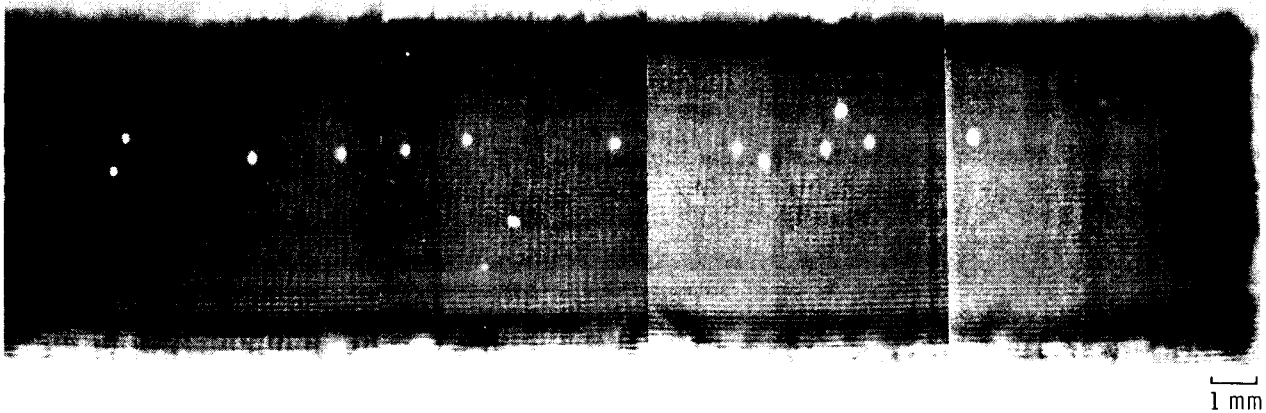
FIGURE 5. - REPRESENTATIVE SAM IMAGES OF VOIDS IN SILICON NITRIDE MODULUS OF RUPTURE (MOR) SPECIMEN. SEEDED VOIDS 20 μ m DIAMETER WERE 1 μ m DEEP, SPECIMEN SURFACE WAS DIAMOND GROUND. IMAGES OF THE VOIDS APPEAR LARGER THAN THEIR TRUE SIZE BECAUSE OF SIGNAL PROCESSING ENHANCEMENT.

a frame scan, the completed image is called up on a video monitor. A SAM image generated with a transducer operating at a center frequency of 50 MHz appears in figure 5.

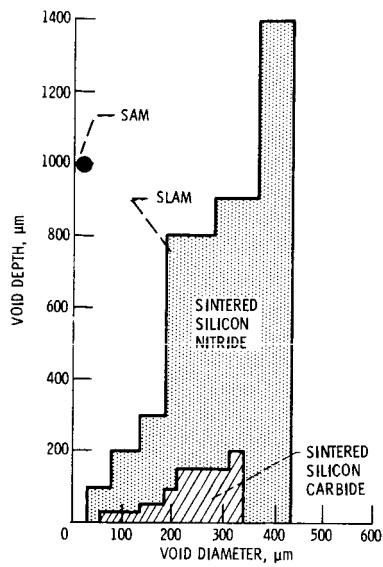
Figure 6 compares SLAM POD data for seeded microvoids in silicon carbide and silicon nitride MOR bars. A preliminary SAM datum is plotted in figure 6 to show the roughly tenfold increase in the depth at which 20- μm diameter voids are detected by SAM. The SAM datum is based on 14 detected 20 μm voids out of 14 seeded in silicon nitride at a depth of 1000 μm .

FIGURE 6. - COMPARISON OF INTERNAL VOID DETECTION CAPABILITIES OF SAM AND SLAM. DATUM FOR SAM IS FOR FOURTEEN 20 μm DIAMETER SEEDS IN SILICON NITRIDE. DATA FOR SLAM ARE FOR 90 PERCENT PROBABILITY OF DETECTION AT 95 PERCENT CONFIDENCE LIMIT.

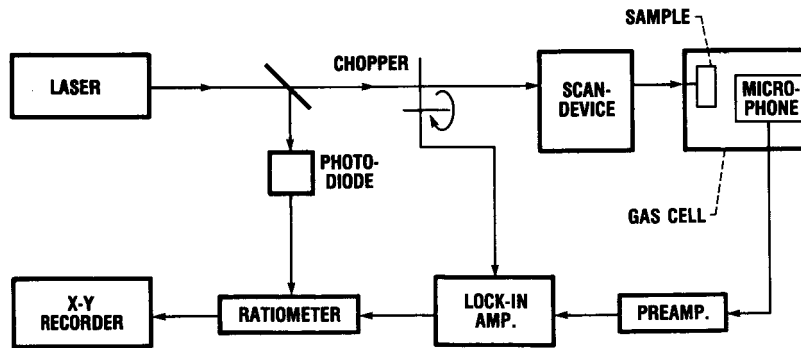
CD-86-22645

A PAM system is depicted in figure 7. The sample to be inspected is enclosed in a gas (air) filled acoustic isolation cell containing a sensitive microphone. The cell contains a clear window through which a laser beam can raster scan the sample surface. The laser beam is chopped and its diameter and intensity are adjusted so that each point hit by the beam is periodically heated. This results in highly localized thermal cycling of the substrate and periodic motion of the surface. The resultant pressure fluctuations (sound waves) in the gas are sensed by the microphone. These acoustic signals are collected for each x-y coordinate position of the laser beam. The signals are used to generate maps (images) of material variations and flaws. The magnitude and phase of the acoustic waves are related to thermal property variations and any flaws that are present near the surface. The depth to which flaws can be detected depends on the material's thermal diffusion length (ref. 7).

FIGURE 7. - DIAGRAM OF PHOTO-ACOUSTIC MICROSCOPY (PAM) SYSTEM.

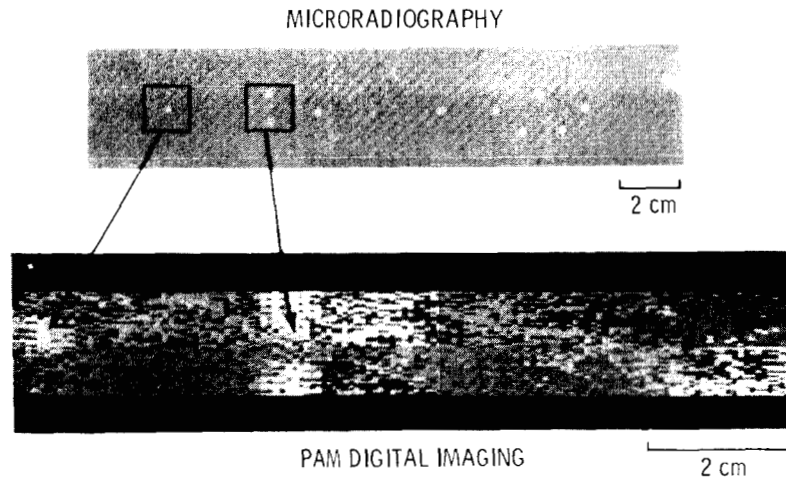
FIGURE 8. - DIGITIZED PAM IMAGE SHOWING DETECTABILITY OF SEEDED INTERNAL VOIDS IN AS-FIRED SILICON CARBIDE MOR BARS. RADIOGRAPH IS INSERTED TO SHOW WHICH VOIDS WERE DETECTED OR MISSED. VOIDS DETECTED BY PAM WERE 450 μm diam, 270 μm DEEP. VOIDS MISSED BY PAM WERE 450 μm diam, 810 TO 1260 μm DEEP.

Surface-connected pores and inclusions 25 μm and larger were detected in sintered silicon nitride. Subsurface pores and inclusions 35 μm and larger were detected to 70 μm below the surface. Voids 200 μm in diameter and 200 μm below the surface were missed. Additional detection capabilities are cited in figure 8 which shows a PAM image of an as-fired silicon nitride sample. In PAM as in SLAM images background noise tends to be high, apparently because of surface roughness, material microstructural coarseness, and nonresolvable flaw populations.

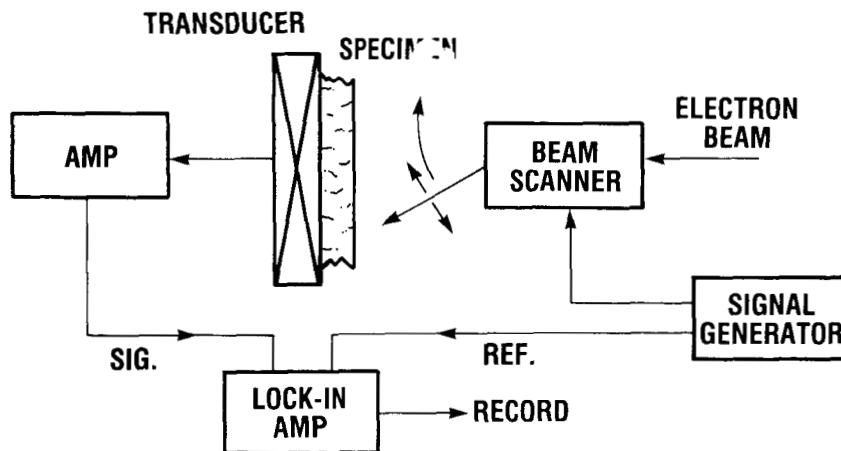
CD-86-22644

A SEAM system is depicted in figure 9. An electron beam raster scans and cyclically heats micron diameter areas on the sample surface. To allow electron beam current flow, it is necessary that the sample be housed in a high vacuum enclosure which is usually shared with a scanning electron microscope (SEM) system. Then, the system operates in two modes: SEM and SEAM. The SEM mode will produce a conventional backscatter electron image of the sample surface. In the SEAM mode the electron beam is of higher intensity and cyclically modulated, usually at frequencies in the range from 100 Hz to 10 kHz. As each spot in the rastered area is heated, acoustic emission waves are generated within the sample. These thermally induced acoustic emissions are modulated by flaws and other imperfections. The resultant signals are sensed by a piezoelectric crystal bonded to the sample, usually to the face opposite the one being scanned. SEM and SEAM images of the same area of a silicon carbide sample appear in figure 10.

FIGURE 9. - DIAGRAM OF SCANNING ELECTRON ACOUSTIC MICROSCOPE (SEAM).

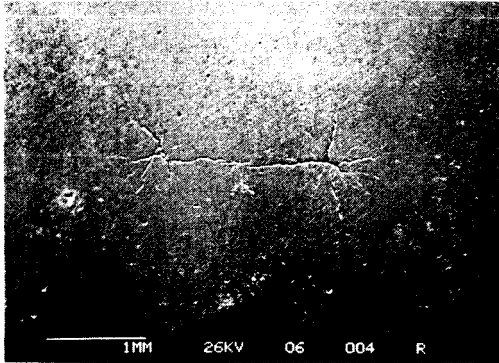
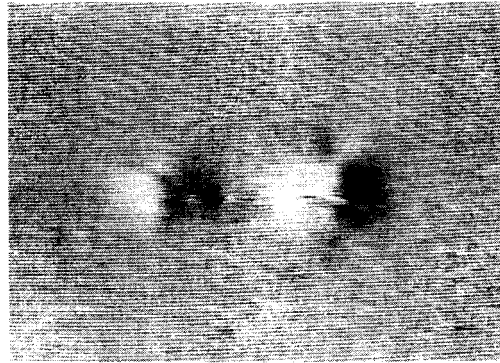
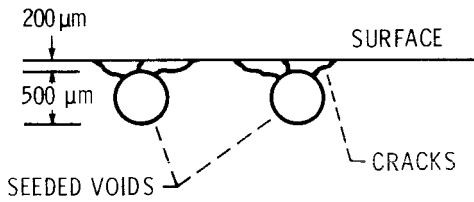
CD-85-18069

SEM IMAGE (SURFACE)

SEAM IMAGE (SUBSURFACE)

1000 μm
SCALE: BOTH IMAGES

FIGURE 10. - COMPARISON OF SEAM IMAGES OF SUBSURFACE VOIDS AND SCANNING ELECTRON MICROSCOPE (SEM) IMAGES OF ASSOCIATED SURFACE CRACKS IN SILICON CARBIDE MOR BAR.
