A NORMAL INCIDENCE X-RAY TELESCOPE SOUNDING ROCKET PAYLOAD

Semiannual Progress Report Nos. 3, 4, and 5

For the Period 1 August 1985 through 31 January 1987

**Smithsonian Institution
Astrophysical Observatory
Cambridge, Massachusetts 02138**

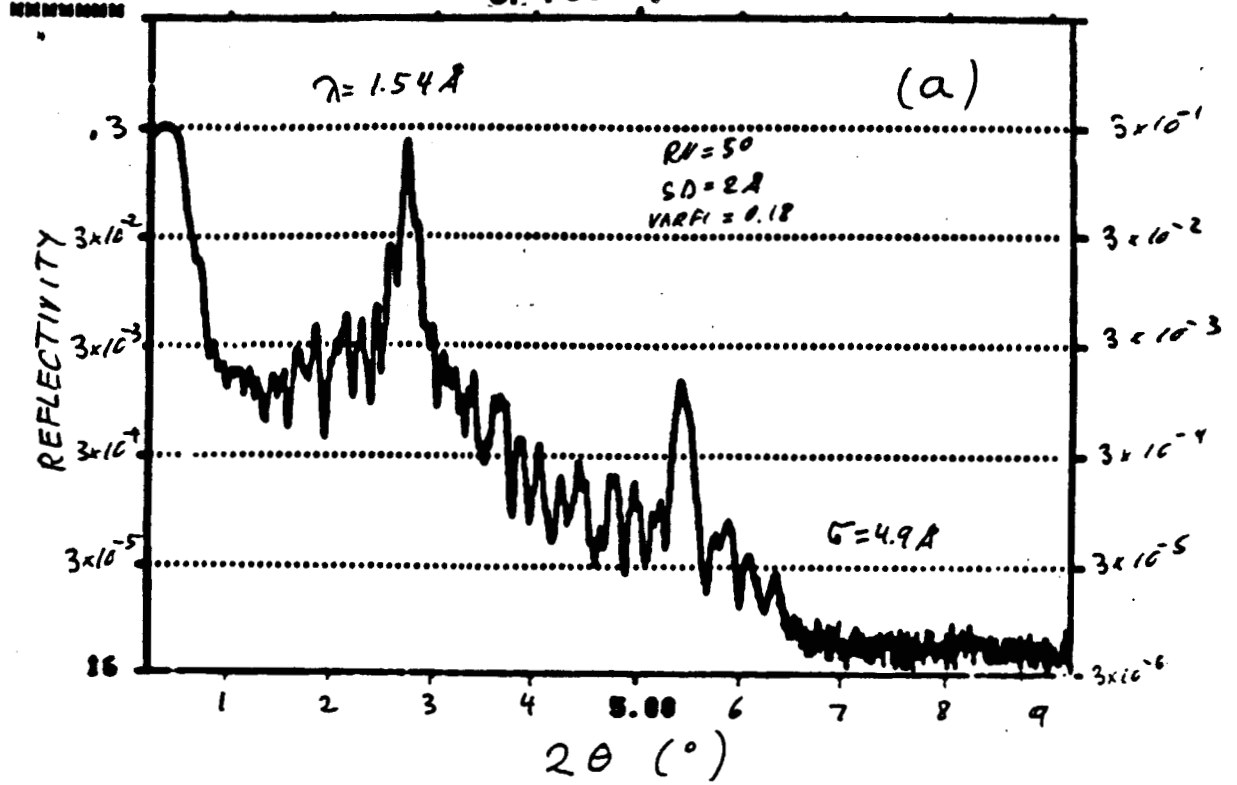
Fig. 1. Grazing incidence reflectivity measurement, showing first and second order diffraction peaks.

The second method is our primary means of characterizing mirror performance. A reflectometer using 1.54 \AA radiation is available at IBM and provides the ability to measure samples with very rapid turnaround time. From measurements of reflectivity vs. angle we can predict the normal incidence performance of a mirror, the effective roughness of the layer boundaries, and the thickness errors of the multilayer stack. An example of these measurements is shown in figure 1.

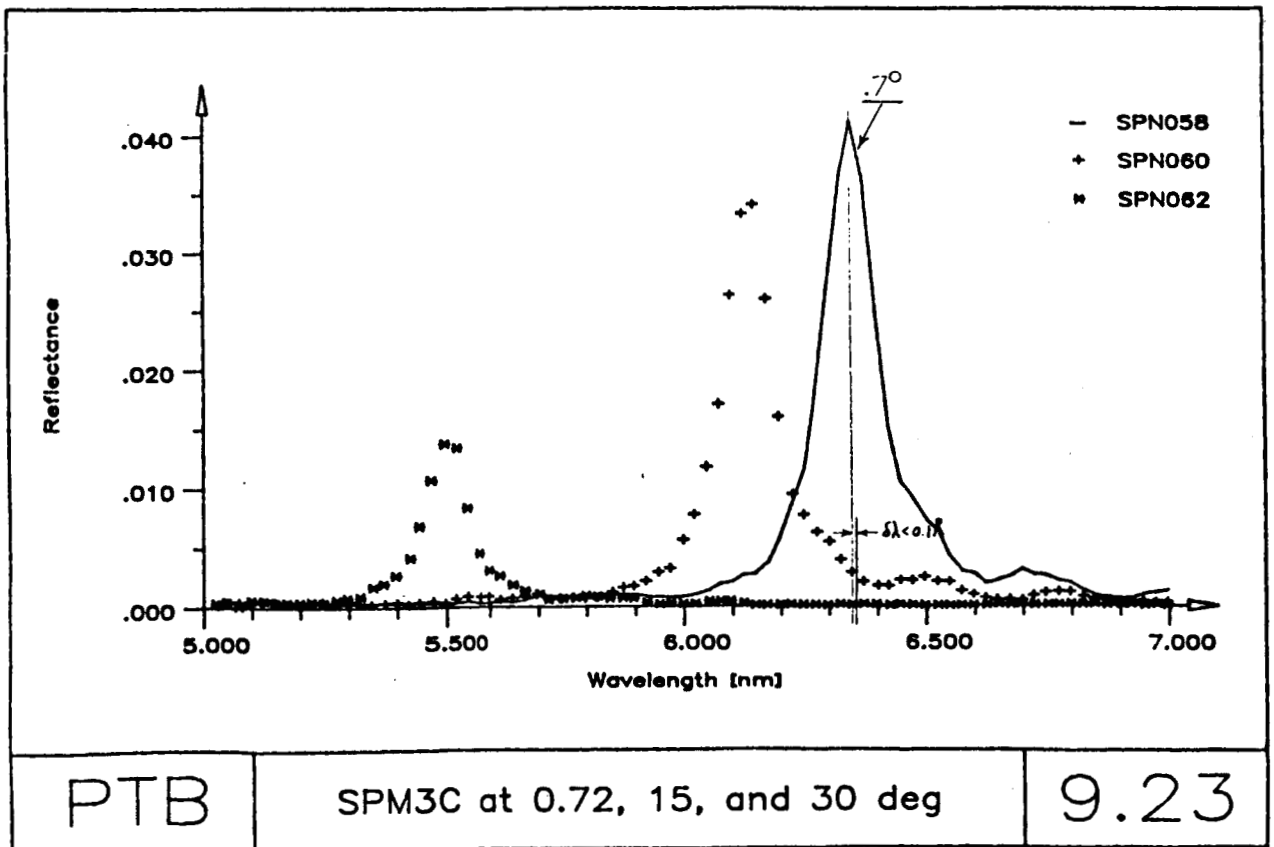
Fig. 2. Normal-incidence reflectivity measurements; peak is within 0.1 Å of predicted position.

at 63.5\AA and the result shows that this was accomplished to within 0.1\AA accuracy. The main drawback to mirror testing at synchrotrons is that turnaround time for obtaining results is usually several months.

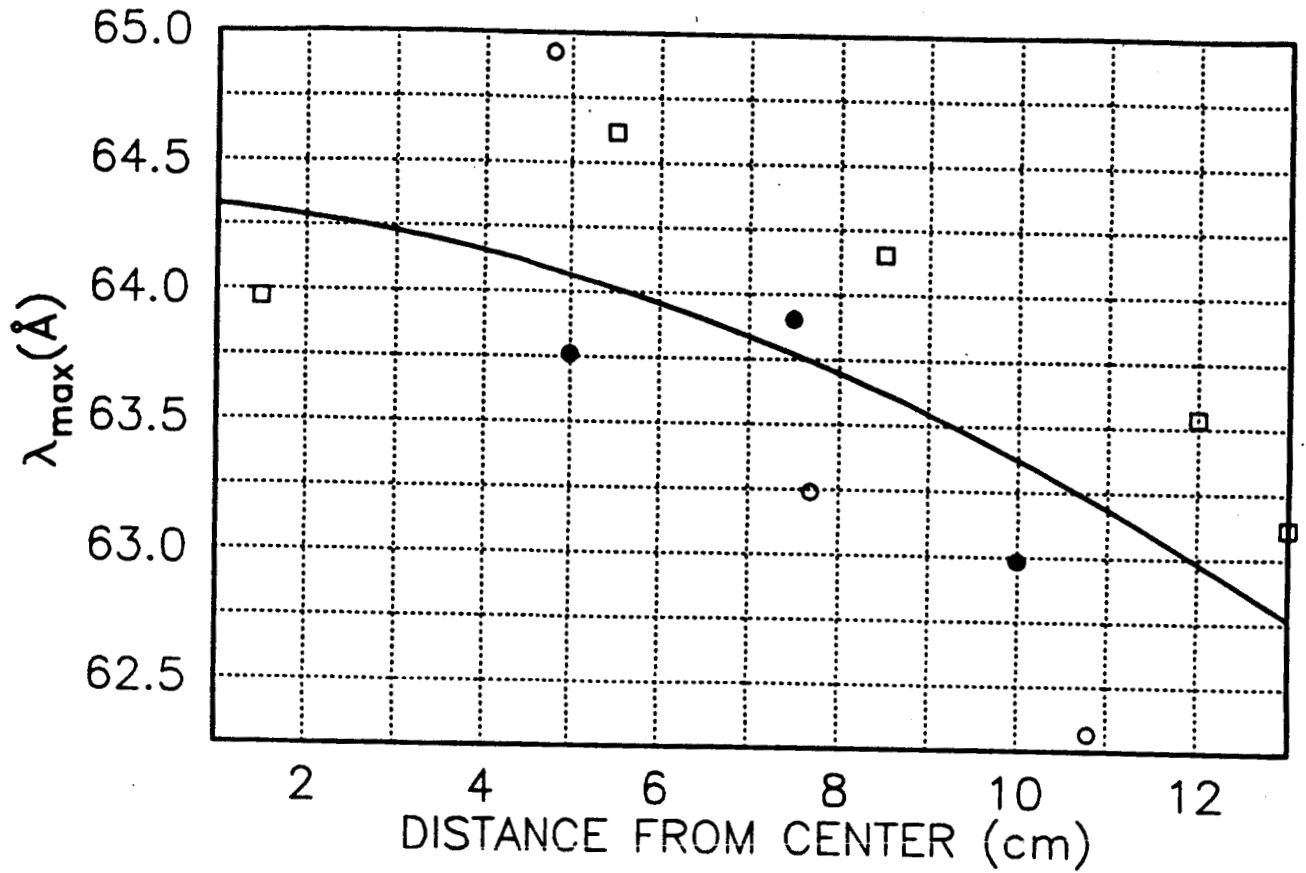
Fig. 3. Test results showing coating uniformity of the NIXT primary mirror; also shown are test results on Si wafers and on float glass samples. Solid curve shows expected result.

The uniformity of the coating on the flight primary mirror is shown in Figure 3. The measured values are centered around the desired wavelength of 63.5\AA and the coating becomes thinner toward the edge of the mirror, as anticipated. Similar measurements for the secondary mirror are shown in Figure 4. Based on these measurements we can calculate the expected performance of the telescope for imaging of the desired coronal lines, and we can also calculate the increase in effective collecting area possible with perfectly uniformity and overlap of the passbands in the two mirrors' coatings. The results are:

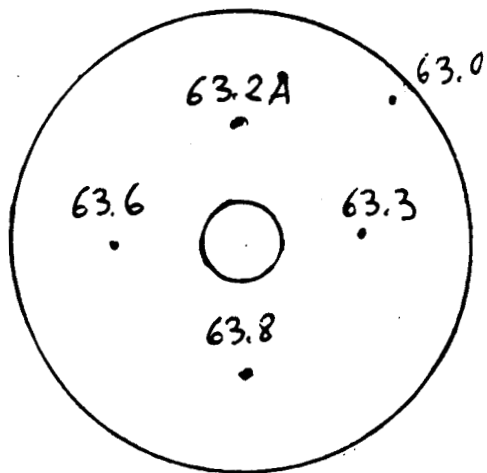
Fig. 4. Coating uniformity of the NIXT secondary mirror, showing wavelength of peak reflectivity at five positions on the mirror.
